# RightShip Ship Inspection Program

## List of Findings

RightShip Ship Inspection Report - 74586

| Vessel Name: | STAR PRINCESS |

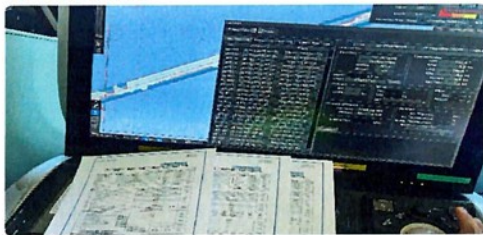
[Q307\\_15ea473e-e560-4f6e-8ff1-d0d2951358e9.jpg](#)

**Findings:** Sample inspection of UKC calculation for navigation from Huanghua anchorage to berth within confined water was conducted. The planned speed was set at 5 to 6.5 knots, while the actual transit speed recorded in the relevant ECDIS logbook ranged from 7 to 10 knots. No objective evidence was found to verify that the UKC calculation had been performed.

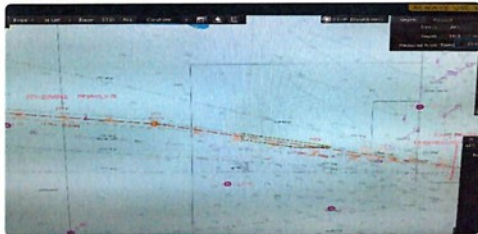
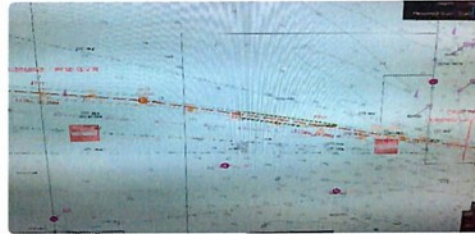
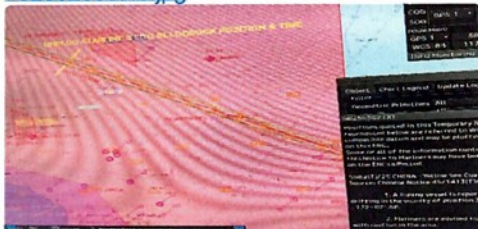
**Findings:** Sampled Temporary Notices to Mariners 2414(T)/25, 2485(T)/25 and 5582(T)/25, situated approximately 2 nautical miles alongside the planned route, were not manually amended and displayed on ECDIS.

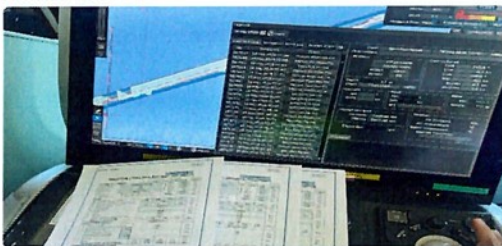
[Q307\\_15ea473e-e560-4f6e-8ff1-d0d2951358e9.jpg](#)

**Findings:** Sample inspection of UKC calculation for navigation from Huanghua anchorage to berth within confined water was conducted. The planned speed was set at 5 to 6.5 knots, while the actual transit speed recorded in the relevant ECDIS logbook ranged from 7 to 10 knots. No objective evidence was found to verify that the UKC calculation had been performed.

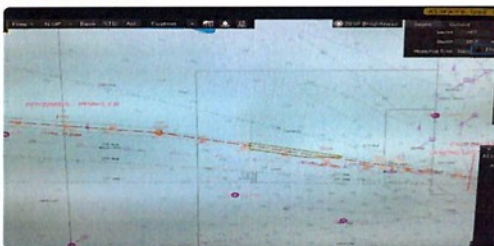
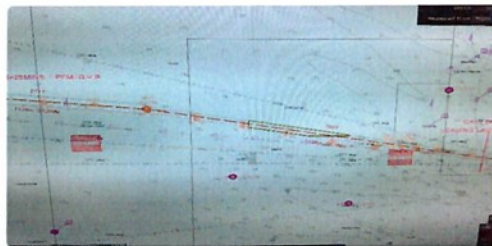
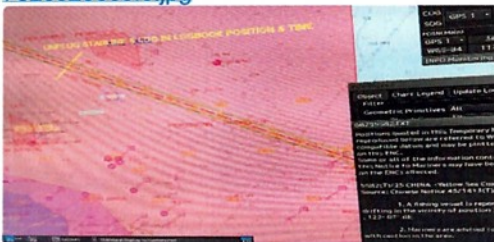
**Findings:** Sampled Temporary Notices to Mariners 2414(T)/25, 2485(T)/25 and 5582(T)/25, situated approximately 2 nautical miles alongside the planned route, were not manually amended and displayed on ECDIS.

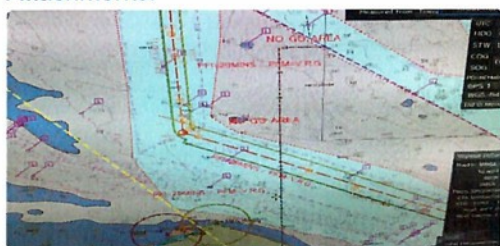
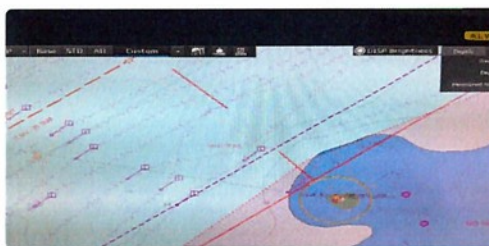
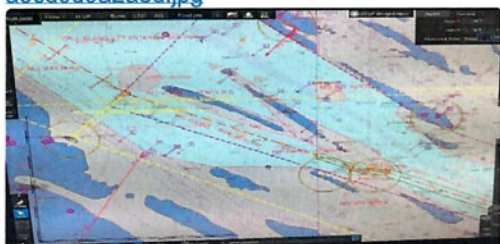
**Findings:** Parallel indexing technique was not utilised in the vicinity of sampled landmarks and course alteration points, including One Fathom Bank, deep water route within the Malacca Strait, the western sector of Singapore Strait TSS and Horsburgh Lighthouse.

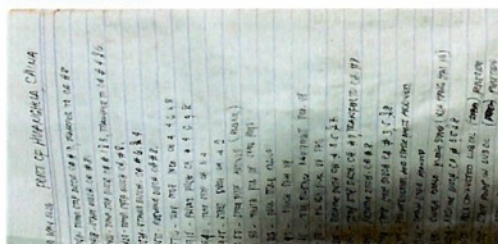
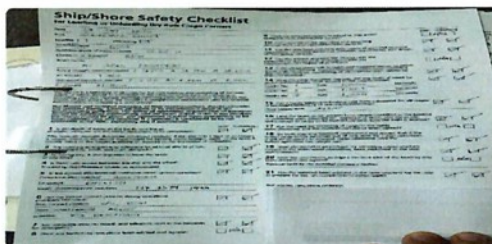
**Findings:** Stevedore familiarisation section with emergency procedures and verify compliance with cargo hold entry procedures (at least once every watch) were not incorporated in the ship-shore safety checklist.

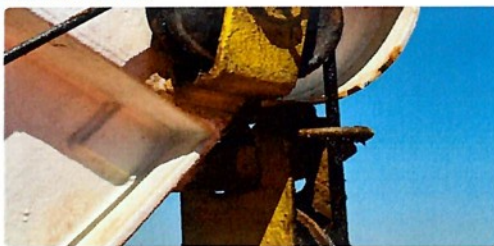
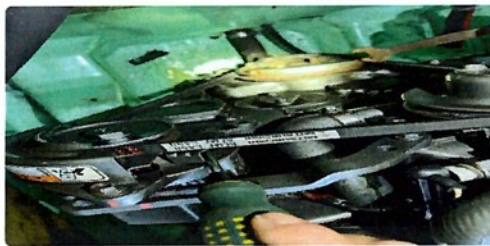
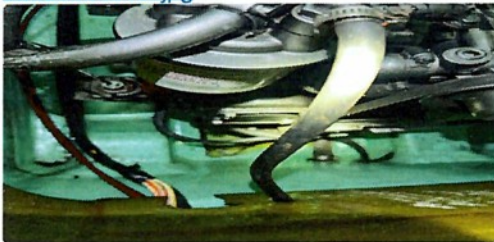
**Findings:** 1. Approximately 200 millilitres of oily water was present underneath the engine of the port davit-launched lifeboat. 2. The starboard davit-launched lifeboat stowed with its weight not fully resting on the davit. 3. The engine of the starboard davit-launched lifeboat failed to start during initial testing, neither with a single dedicated battery nor two batteries together. It started successfully after the engineer manually turned the engine pulley.

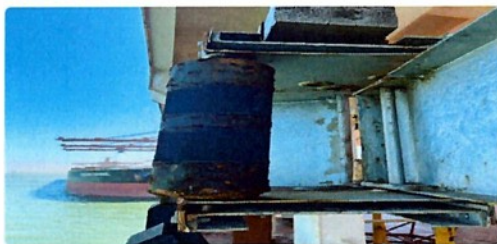
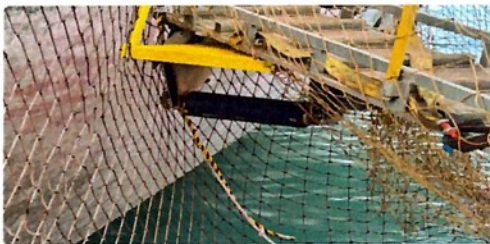
**Findings:** The rubber roller of starboard accommodation ladder was present with corrosion and rubber wear out.

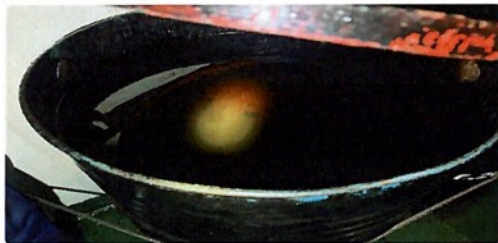
[Q519\\_ee72acb7-c4d7-46f0-90e8-03a55744d390.jpg](#)

**Findings:** Approximately 150 litres of waste sediment with oil was stored in an open-topped drum (metal cover present) located at the engine room garbage station adjacent to the waste oil tank.

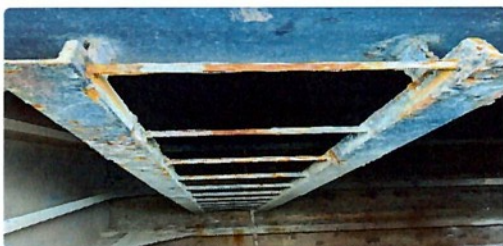
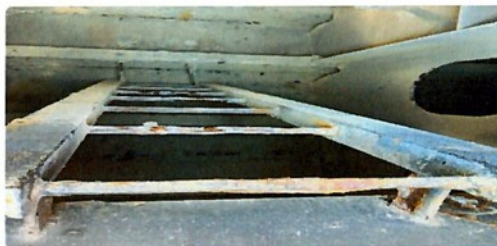
**Findings:** Rungs 1 and 2 of the access ladder inside sampled No.1 starboard ballast tank (TST), rungs 2 and 4 of the access ladder inside sampled No.2 starboard ballast tank (TST), were corroded down to approximately 70% of their original dimensions.

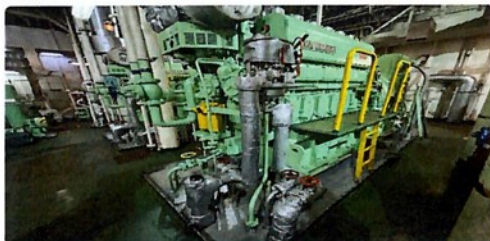
[Q7a10\\_f97d3175-d0dc-48e7-8f30-c646b1b737e7.jpg](#)

**Findings:** Fuel supply lines to generators (multi-engine common source) not fitted with quick closing valves operable from a safe position remote from the engines. The manual closing valve located beside generators.

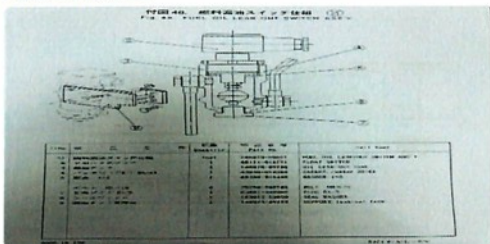
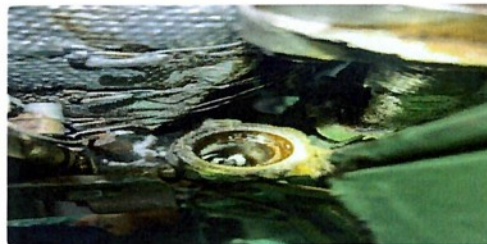
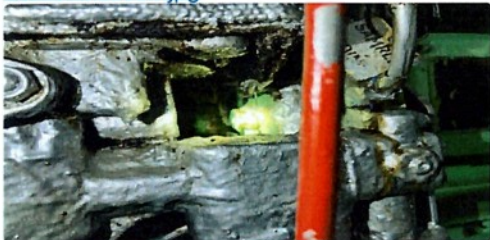
**Findings:** A makeshift drain pipe was fitted to the bottom of the oil leakage alarm arrangement for three generators, while a plug was specified at this position on relevant drawings. During functional test, leaked oil drained off immediately via the pipe, rendering the alarm ineffective.

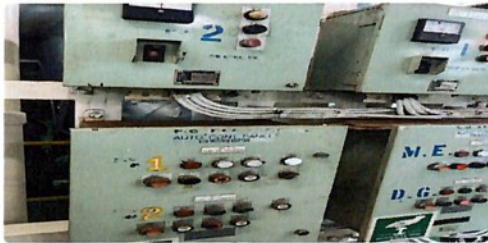
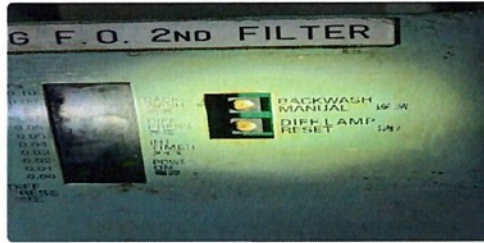
**Findings:** 1. The main power indicator light of the fuel oil purifier in the purifier room was out of service, and the multiple button was damaged. 2. Buttons including backwash manual and diff lamp rest of the second fuel oil filter were defective.

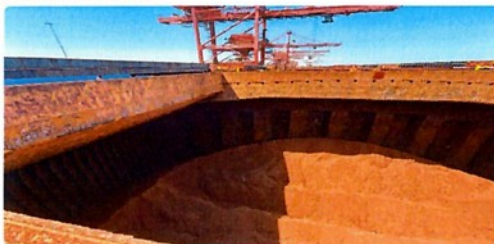
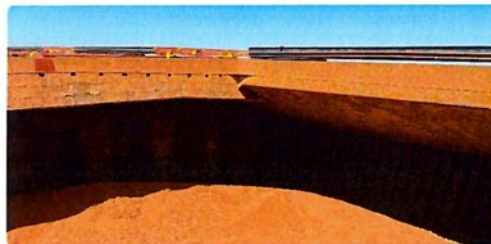
**Findings:** Corrosion is present on the coating of No.6 cargo hold, covering 60% to 70% of the surface area.

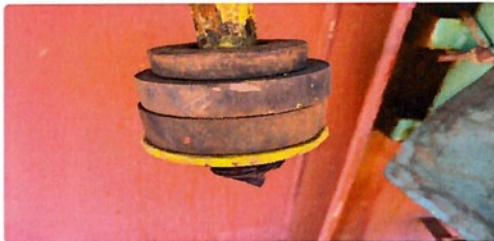
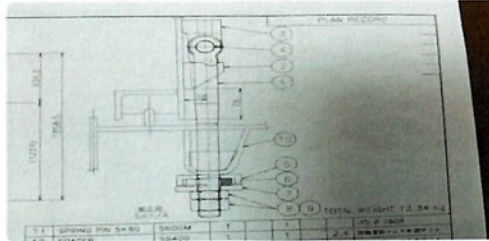
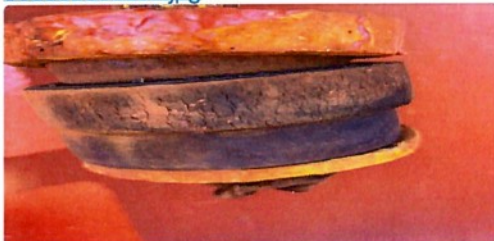
**Findings:** Two or three layers of rubber washers were stacked and fitted on all hatch cover quick acting cleats. Around 20% of these rubber washers were present with cracks.

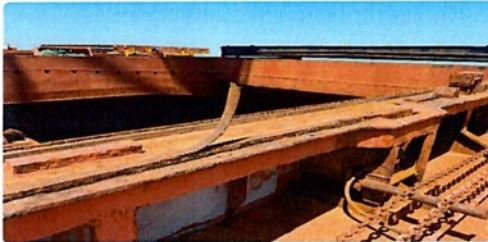
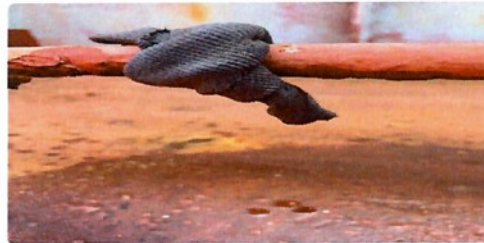
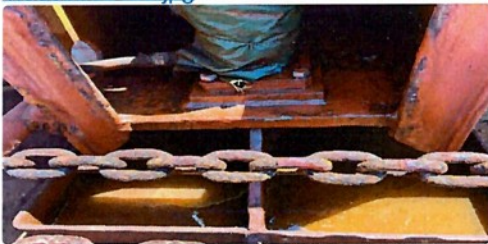
**Findings:** 1. Oil seepage was observed on one hydraulic jack at the forward part of No.2 cargo hold and another at the aft part of No.3 cargo hold, with oily water accumulated in the save-all. 2. The steel plates covering the trackways at the aft sections of No.2 and No.3 cargo holds were corroded and warped. 3. Evidence of oil leakage was found on hydraulic valve control units in the forecastle bosun store, midship store and main deck. 4. The hydraulic pipeline between No.2 and No.3 cargo holds was leaking, with a rag secured around the pipe.

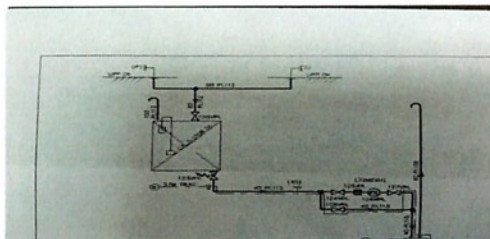
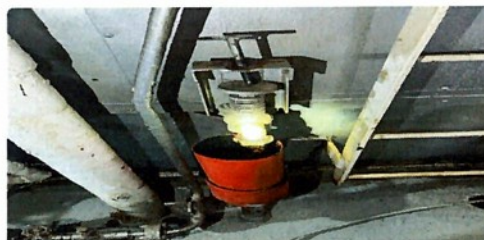
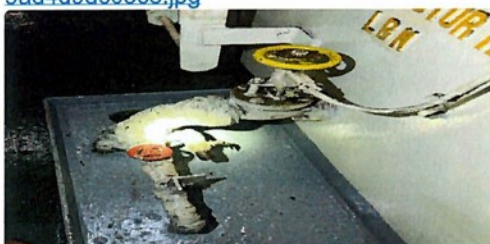
**Findings:** 1. Improvised gagging devices were fitted to the spring-loaded drain valves of the fuel oil settling tank and service tank in the purifier room. 2. An improvised drain valve was installed on the pipeline downstream of the quick closing valve of the cylinder oil storage tank.

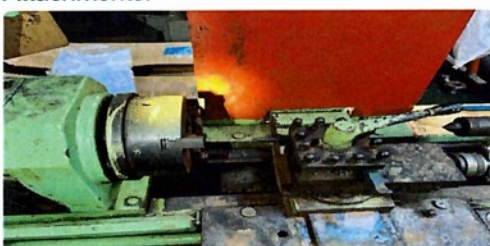
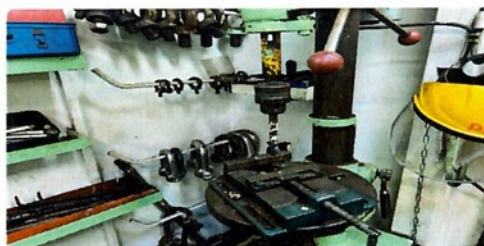
**Findings:** The lathe and drilling machine located in the workshop were not fitted with transparent, impact-resistant protective guards.

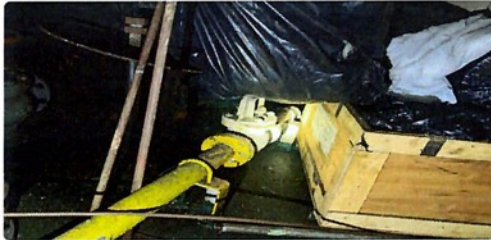
[Q1329\\_50589b3e-4191-4aef-98c2-9aa01d4a0b3d.jpg](#)

**Findings:** The bilge fittings at the port side corner of the steering gear room were obstructed by pipes and spare parts which was not accessible.

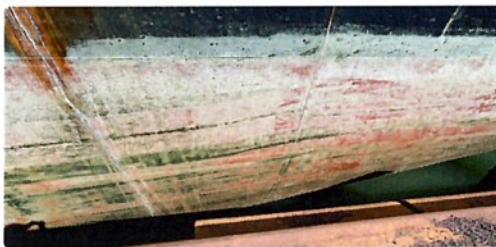
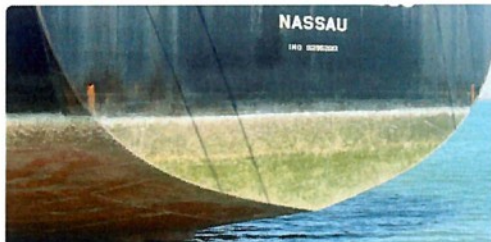
**Findings:** Marine growth (barnacles) were attached to the aft hull shell, and dry green algae were observed over the vessel's underwater hull.

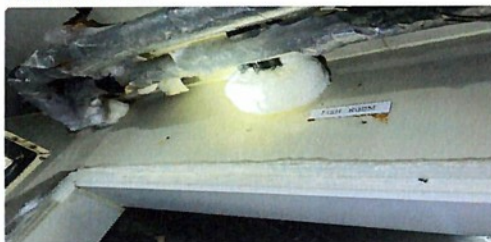
[Q1416\\_b803d810-6215-4ca4-a240-b80b2f5b12de.jpg](#)

**Findings:** Built up ice was present on the door frame around the door seal and on the pipes inside the refrigerated space.

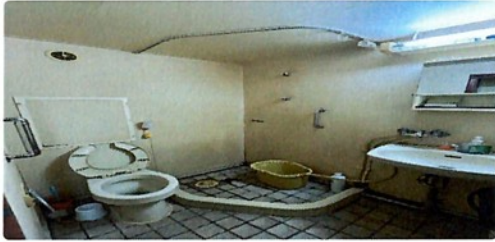
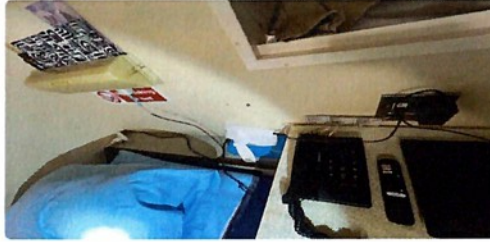
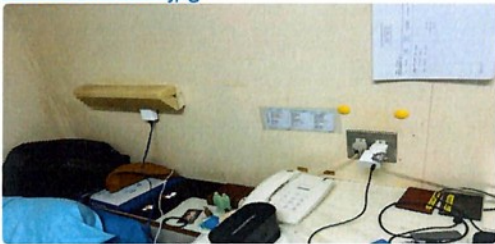
**Findings:** 1. Shower curtains were missing in two sampled crew cabins. 2. Extension cords connected to the projector and mobile charging sockets, with repair tape applied on the wiring, were plugged into bedside lamp sockets.
