# RightShip Ship Inspection Program

## List of Findings

RightShip Ship Inspection Report - 70426

| Vessel Name: | TIBERIUS |

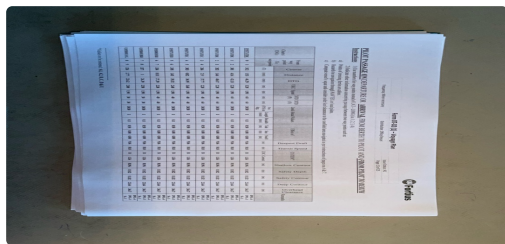
[Q307\\_4f76d2ed-5eb3-456c-baa5-aeef39cd10cf.jpg](#)

### 3.7 Has the vessel's manager produced a guideline for under keel clearance and air draft clearance? (M)

**Findings:** The vessel passed under two bridges during the passage in Houston ship channel. The company has not created an air-draft calculation form to calculate the air-draft clearance while passing under overhead obstructions. The air-draft calculations were made manually by the navigation officer however they did not account for all corrections.

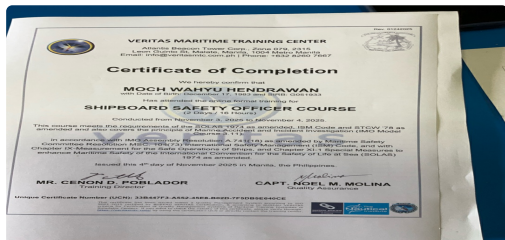
[Q402\\_009760ce-0412-4c5f-acc8-331d73eb9fa6.jpg](#)

### 4.2 Has a safety officer been appointed and adequately trained, onboard safety meetings held regularly and acknowledged by the vessel's manager, with feedback provided where necessary, and are safety inspections of the main deck, machinery space, accommodation and forecastle store conducted at regular intervals in accordance with the company's procedures, and are health, safety, and environmental hazards effectively identified? (V)

**Findings:** The company has not established a specific checklist or guidance for the safety officer to carry out safety audits at regular intervals on board the vessel to identify hazardous situations, unsafe conditions, and or unsafe facts.

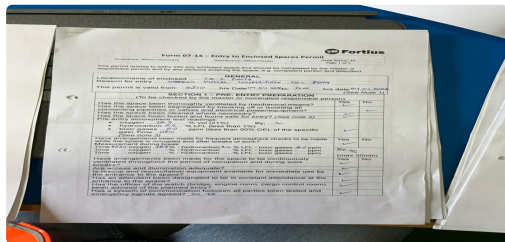
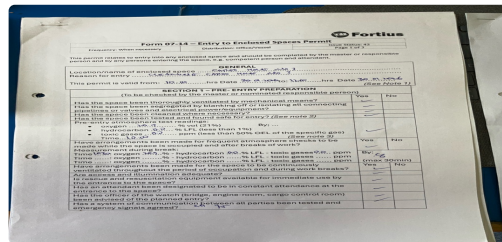
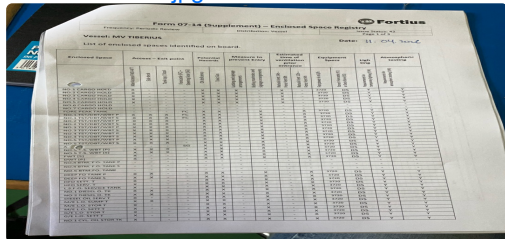
**4.5 Is the vessel provided with an enclosed space entry procedure, and is there documented evidence that it was followed, and is there evidence that the crew assigned to responsibilities requiring entry into enclosed spaces has attended a dedicated enclosed space entry course?**

**Findings:** 1. During the last two enclosed spaces entries dated 11 April 2026 and 04 April 2026, a junior deck rating was assigned as the attendant. Interviewing the crew member revealed he was unaware of the attendant duties. 2. All enclosed space permits were issued at the same time as the pre-entry checks (for example the pre-entry gas monitoring was completed at 15:00 and the Permit was issued at 15:00) this does not seem to have allowed enough time between (the pre entry measurements and the remaining checks to be made) and the permit issuance time. 3. 2 officers were interviewed and found unaware of the gas detector GX-8000 pump capacity and the time required to clear the air from the hose before trusting that the gas measurements are a true representation of the atmosphere condition inside the tank. 4. None of the cargo holds access manholes nor the on deck stores adjacent to the cargo holds were marked as enclosed spaces even though they were included in the enclosed space register.

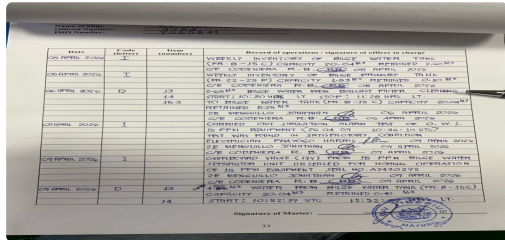
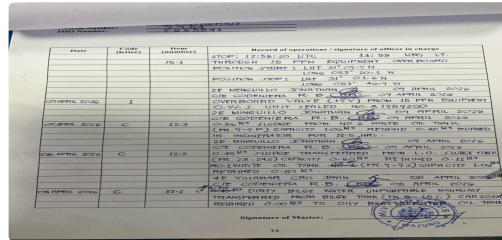
### 5.1 Is the Oil Record Book (Part 1) completed correctly? (V)

**Findings:** 1. Oil record book entry (D 13/14/15.3) dated 06 April 2026 for the transfer of bilge water to a tank listed under 3.3 of the IOPP supplement was incorrectly made to reference bilge water from ballast filter cleaning instead of Engine room bilge wells. 2. Oil record book entry under C12.2 dated 08 April 2026 was made to transfer bilge water from Bilge tank (listed under IOPP supplement 3.3) to Oily bilge separated oil tk (Listed under IOPP supplement 3.1) whereas the IMO CIRC/MEPC/01/736-Rev-2 Only allows transfer from a tank listed under 3.1 to a tank listed under 3.3 (not vice versa).

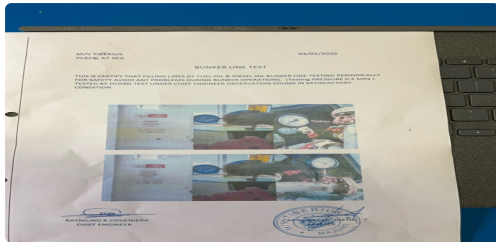
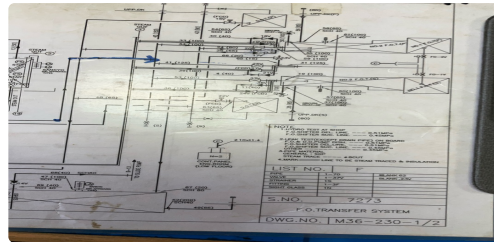
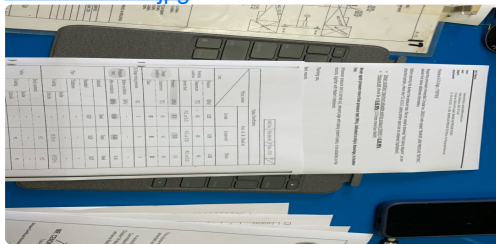
## 7A.2 Are bunker transfer systems hydrostatically tested to their Maximum Allowable Working Pressure (MAWP) on an annual basis and to 1.5 times their MAWP at least twice within any five years period?

**Findings:** Bunker transfer line annual test for 2025 was missing. The test statement of 2024 indicated the MAWP as 4.5 kg/cm and the test pressure of 1.5 times the MAWP was carried out at 5.0kg/cm (which does not correspond to the correct calculation of 1.5MAWP). The vessel maintained contradicting documents onboard to indicate the MAWP and the 1.5MAWP testing pressure. According to a msg from the company dd 04 Feb2022, the MAWP was 0.3 MPa and the Test pressure was 0.45MPa. However, the onboard piping diagram showed the testing for the FO. Del line was 0.51MPa and for the suction line 0.45MPa for shop test. The onboard test was to be conducted at 0.51MPa.

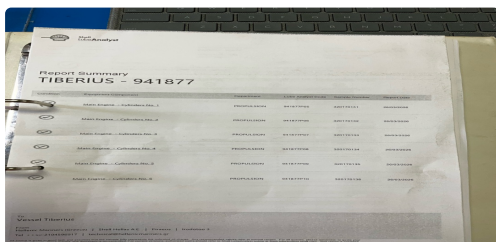
[Q7a05\\_19c4d576-f772-49d1-8ed7-31e091fd106d.jpg](#)

## 7A.5 Are there procedures for the analysis of fuel, lubricating and hydraulic oils, and are oil sampling requirements aligned with equipment manufacturer's recommendations? (V & M)

**Findings:** The vessel utilizes VLSFO and LSMGO. The company has only subscribed to bunker oils sampling, and analysis service for VLSFO. The LSMGO was always used without analysis.

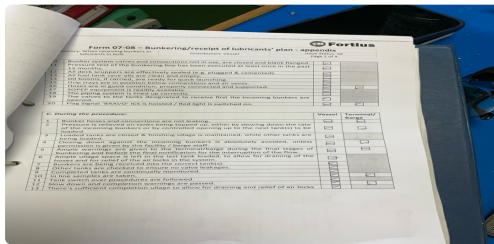
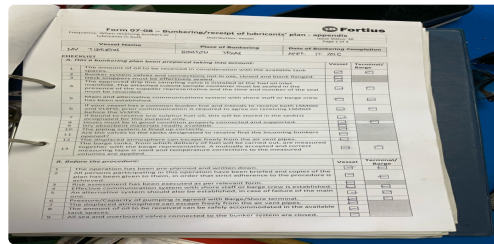
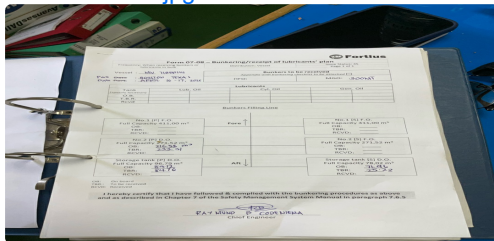
**7A.7 Are bunkering and oil fuel transfer procedures carefully planned and executed in accordance with industry standards, are the details of the last operation in accordance with industry standards, is the vessel equipped with a procedure for sampling the oil fuel used on board, and are bunker samples stored in a sheltered location? (V)**

**Findings:** The vessel received bunker at Houston (LSMGO, and Lub Oil). The company's bunkering plan form and checklist did not include the following: 1. Initial, Maximum and Top-up rate 2. Bunker line draining procedures 3. Valve line up 4. Tanks to be filled were identified but the filling sequence was not included 5. The method of tank level verification (sounding or ullaging) 6. Schematic diagram 7. Emg. Stop procedures.

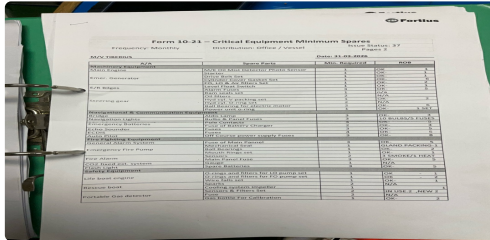
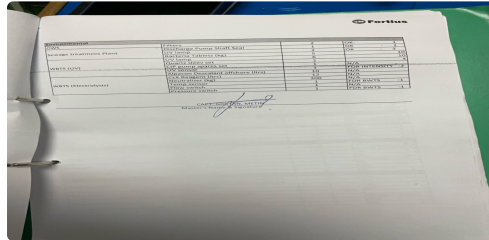
**13.11 Is an effective and up to date planned maintenance system available and being followed on board the vessel? (V & M)**

**Findings:** 1. The vessel was not equipped with a computer based planned maintenance system. 2. Three critical equipment spares were noted to be below the Minimum required quantity. Those were UV Sensor, WBTS Temp Sensor and WBTS Pressure Switch.
