# RightShip Ship Inspection Program

RightShip Ship Inspection Report - 72171

| Vessel Name: | ANADOLU S |
| IMO Number: | 9667758 |

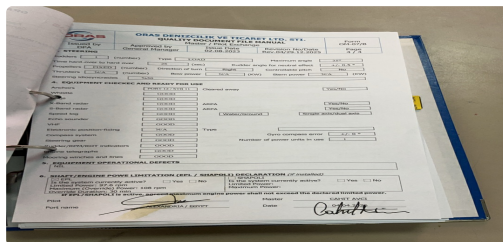
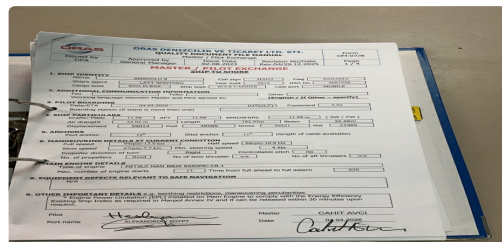
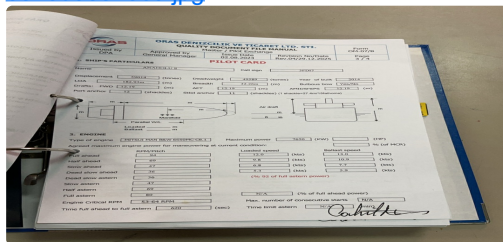
### 3.6 Has the Master/Pilot information exchange been taking place effectively and is the standard pilot card being completed as required? (V)

**Findings:** The pilot card for the previous and present port was reviewed. It was noticed that the form didn't clearly indicate whether a power limiter is engaged, the time necessary to override the power limitation systems, and the ship's maximum power capacity, both with and without the application of the limiter.

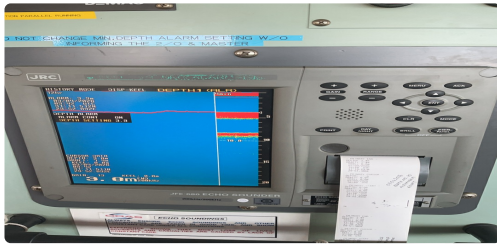
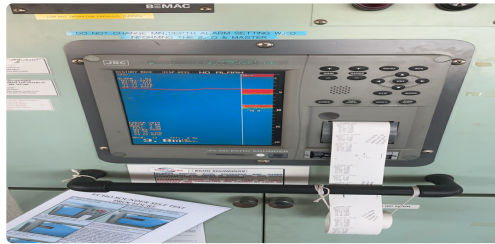
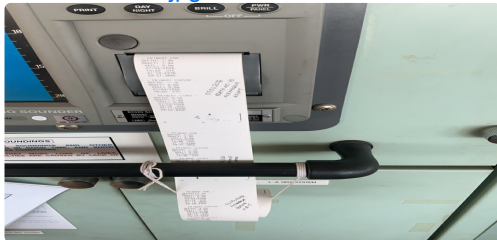
**3.22 Are records available to show that the echo-sounder recorder is being switched on prior to each approach to shallow water, port entry and departure and has the echo sounder remained in operation while the vessel has been transiting in shallow waters?**

**Findings:** No records were made to check the units of soundings on the echo sounder are the same as those on the chart in use.
