PHASE 1 ENVIRONMENTAL SITE ASSESSMENT

**COUNTRY CLUB CREEK APARTMENTS
4501 E. RIVERSIDE DRIVE
AUSTIN, TX 78741**

PE Project No. 15.2356.01
August 11, 2016

***Phase 1 Environmental Site Assessment
Country Club Creek Apartments
4501 E. Riverside Drive
Austin, Texas 78741
PE Project Number 16.2444.01***

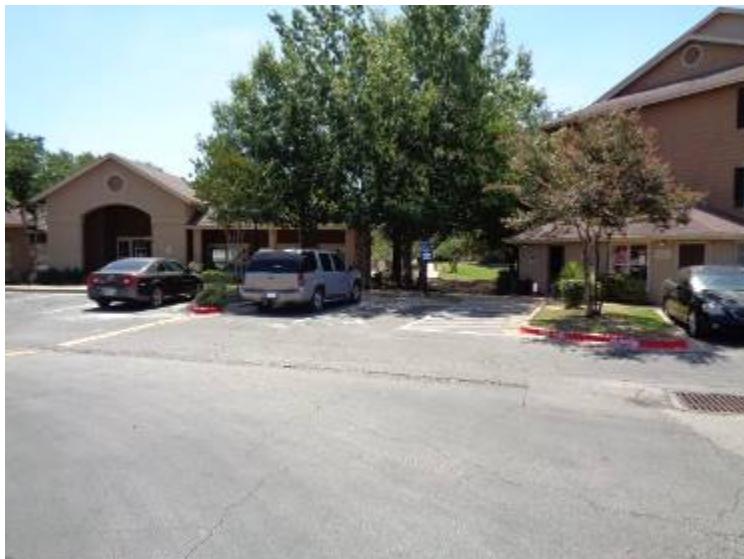
1. This photo shows the office/clubhouse building (left) and the maintenance shop (right) that is attached to Building 5.

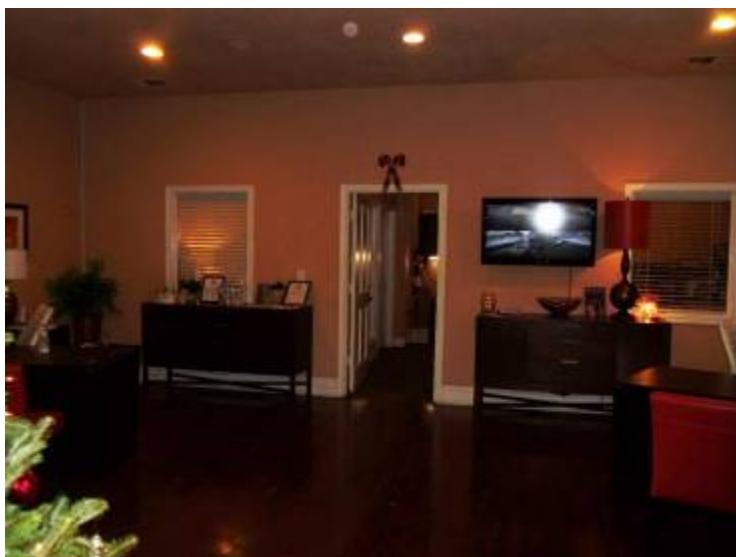
2. View of the office building lobby.

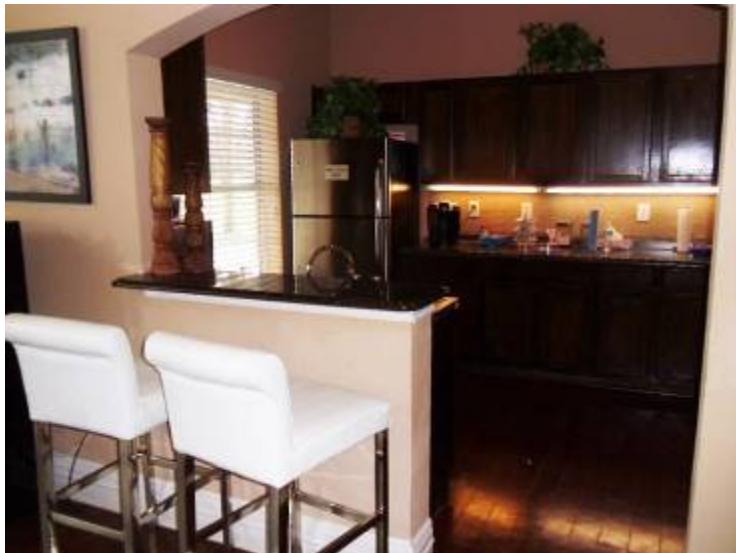
4. A kitchen is provided in the clubhouse area of the building.

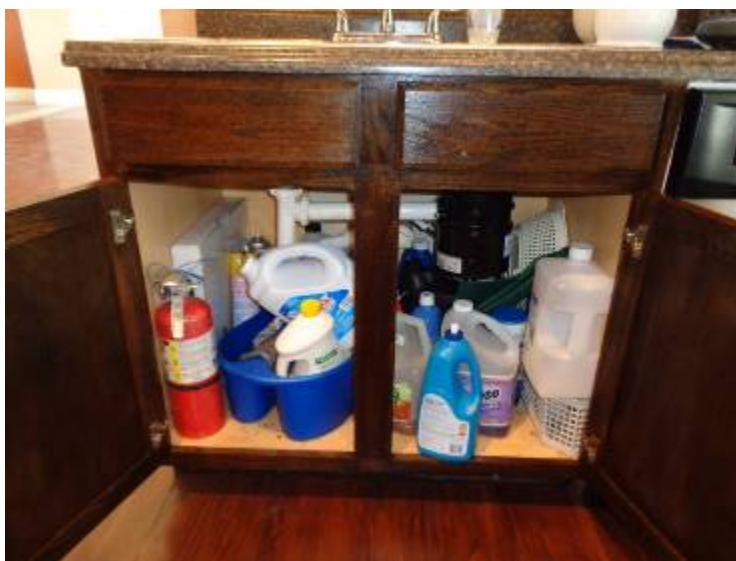
5. Janitorial supplies are stored in the kitchen beneath the sink. The hazardous substances are stored in their original containers and there was no evidence of spills.

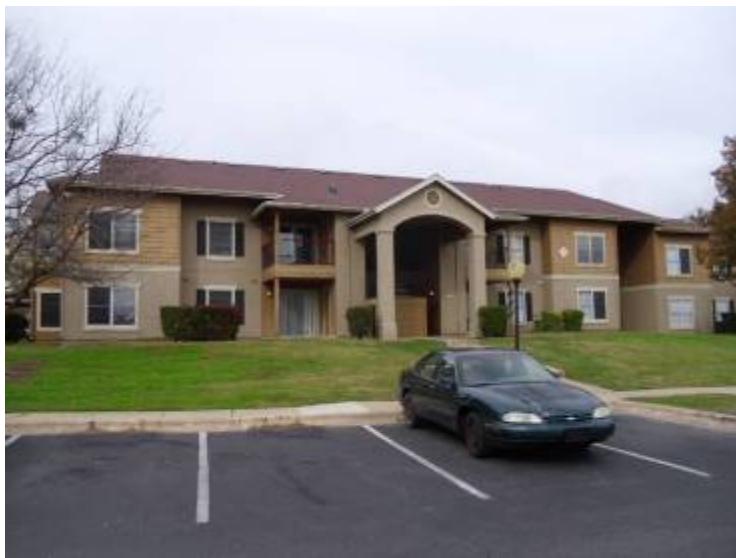
6. All residential buildings are wood-framed with pitched roofs. Exterior walls are HardyPlank and stucco cement. Since the property was constructed in 1997, asbestos-containing materials and lead-based paint were not used.

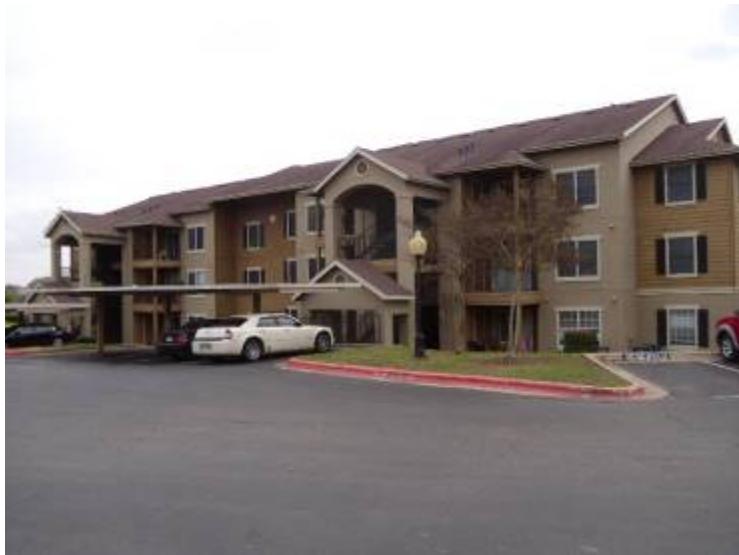
7. Site buildings are two and three-stories in height.

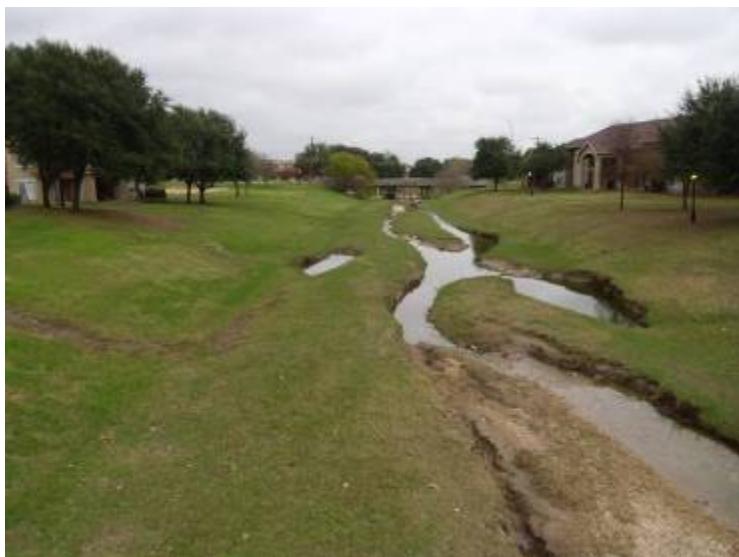
8. A stormwater drainage creek traverses the Project Site in a north-south orientation. Several apartment buildings are visible in the left and right in the photo.

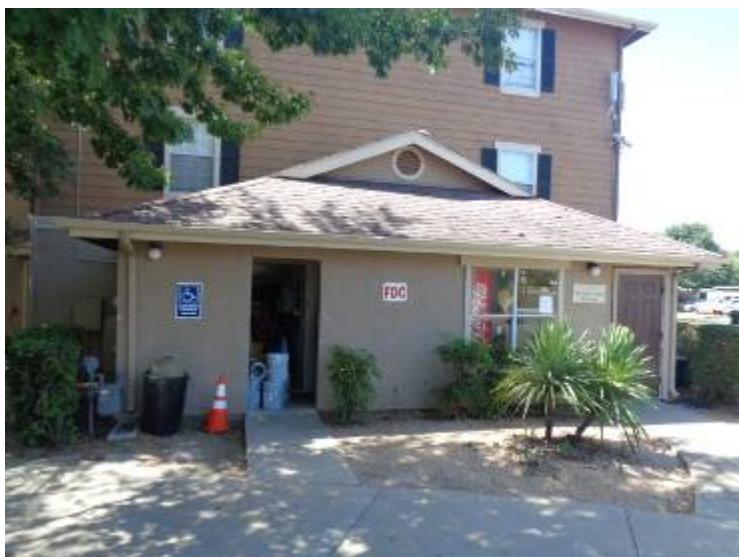
9. The maintenance shop is located in a structural extension on the north end of Building 5.

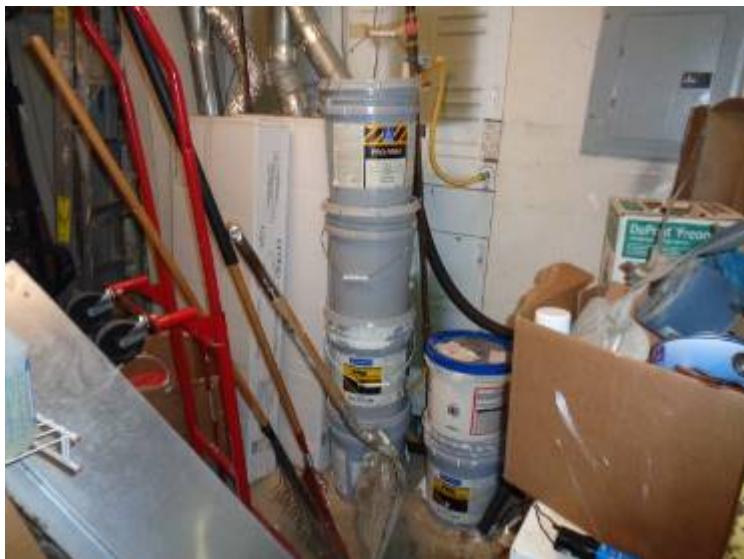
10. Various maintenance chemicals and non-hazardous latex paints are stored in the shop.

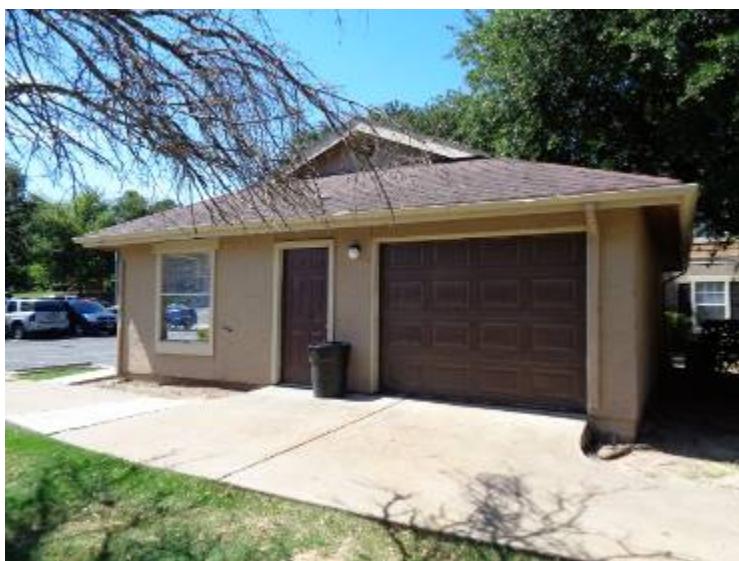
11. A laundry/mail/storage building on the east side of the property is used to store maintenance items and hazardous chemicals.

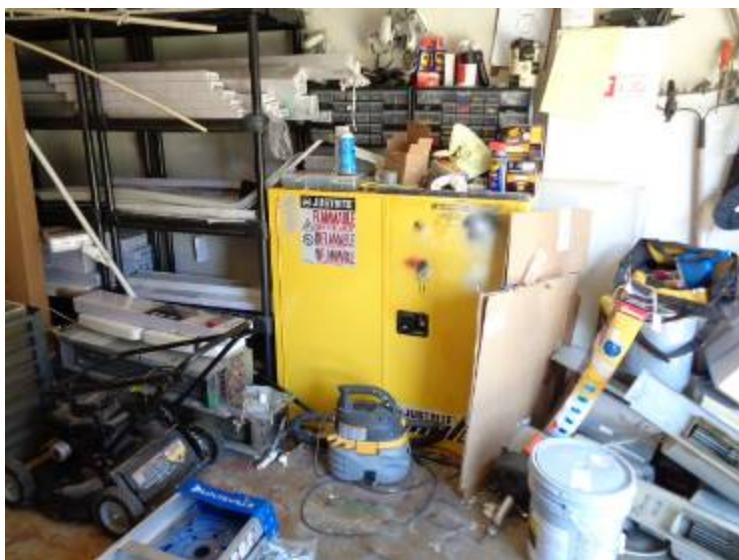
12. View of the shop interior.

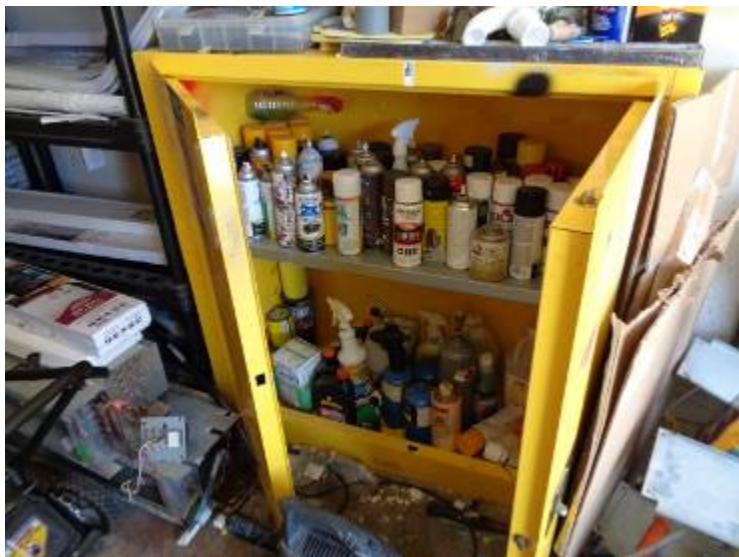
13. Flammable materials are stored in a steel cabinet in the shop. All chemicals are stored in their original containers and there was no evidence of spills.

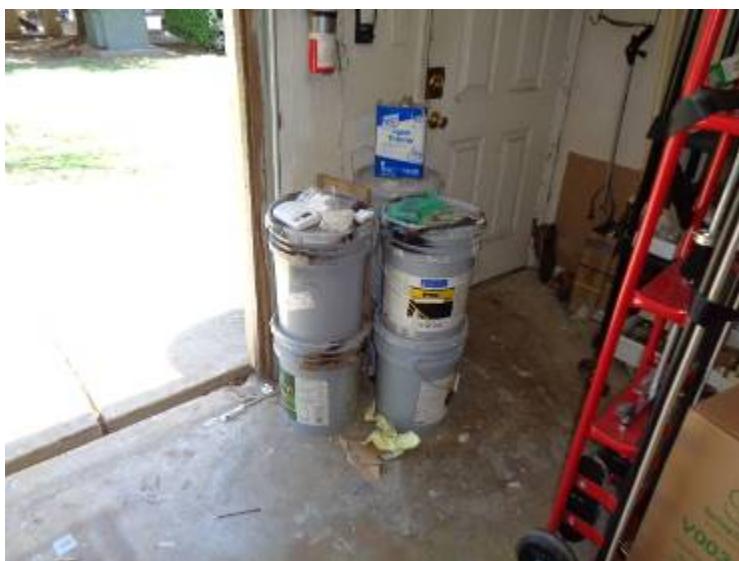
14. Latex paint is also stored in the building.

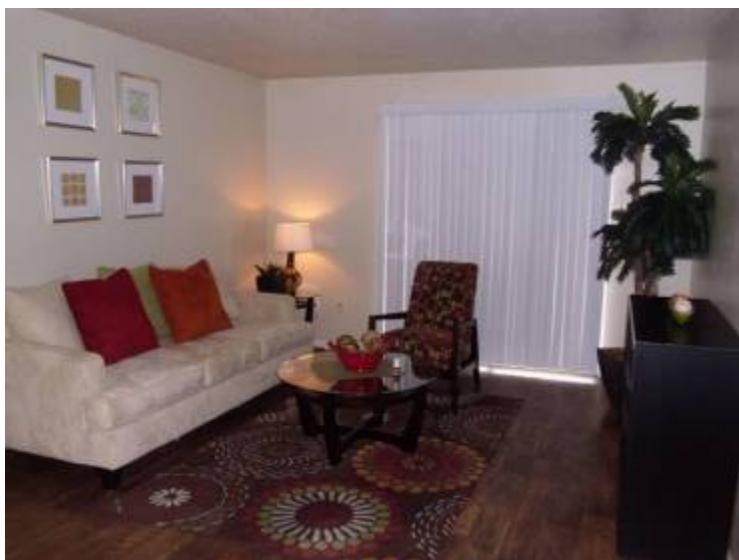
15. This photo is of the living room in a typical apartment unit.

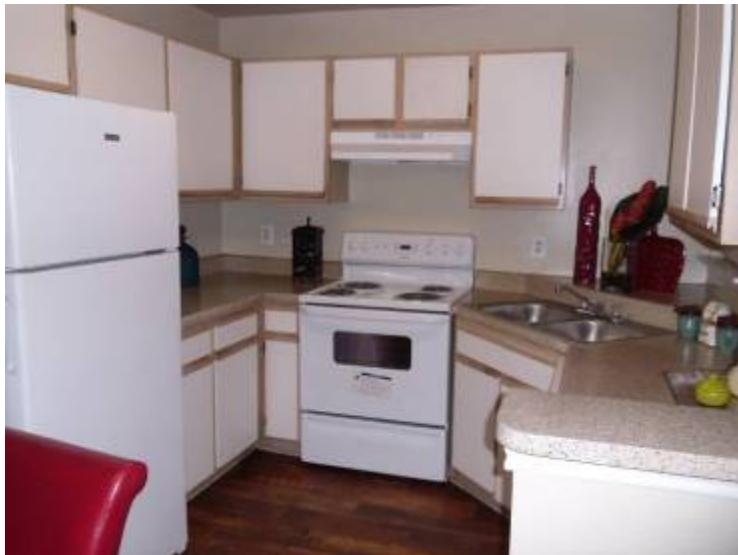
16. View of a typical kitchen.

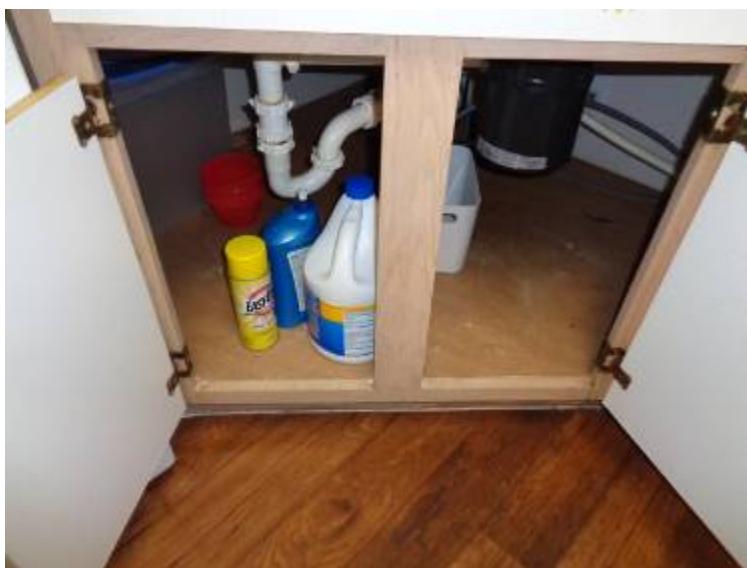
17. Cleaning and other chemicals stored in the apartments are the responsibility of the tenant.

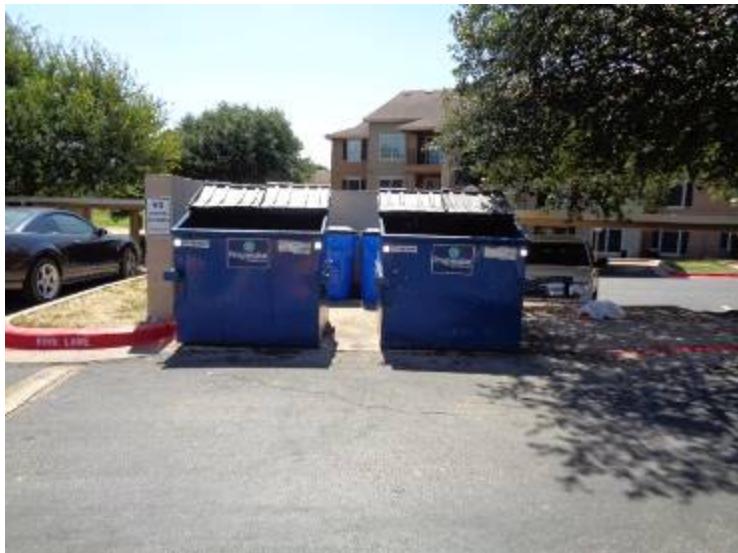
18. Solid waste is collected twice weekly by Progressive Waste Services, a state-licensed solid waste collection, transport, and disposal company. No evidence of the illegal disposal of hazardous or petroleum wastes was observed within the dumpster enclosures or elsewhere on the site.

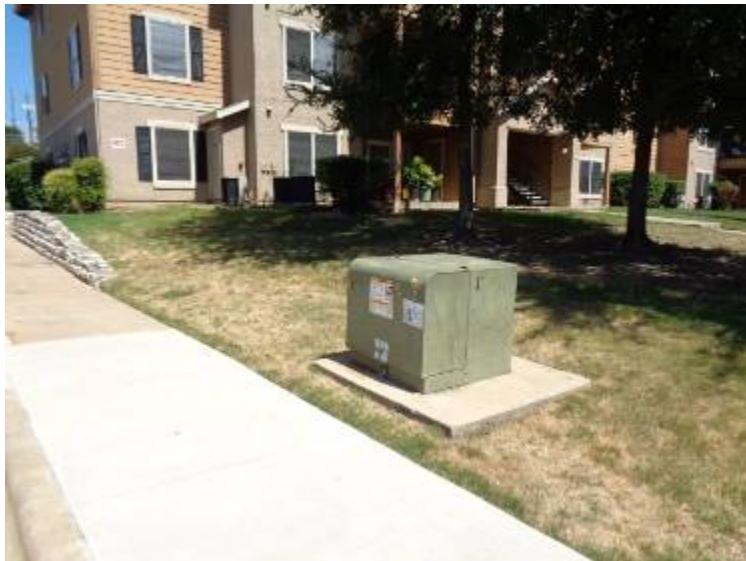
19. No electrical equipment on the site contains PCBs.

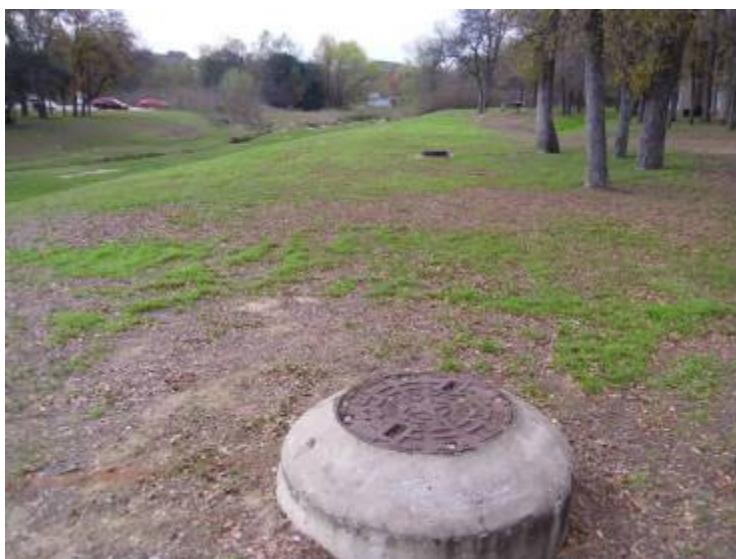
20. This is a view of manholes for the sanitary sewer line that runs parallel to the on-site creek.

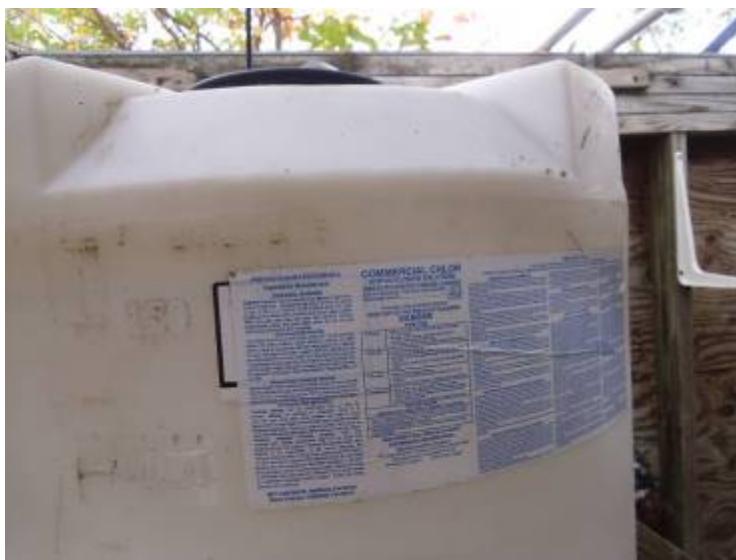
21. Pool water treatment chemicals, such as this liquid chlorine, is stored in a wood enclosure surrounding the pool equipment.

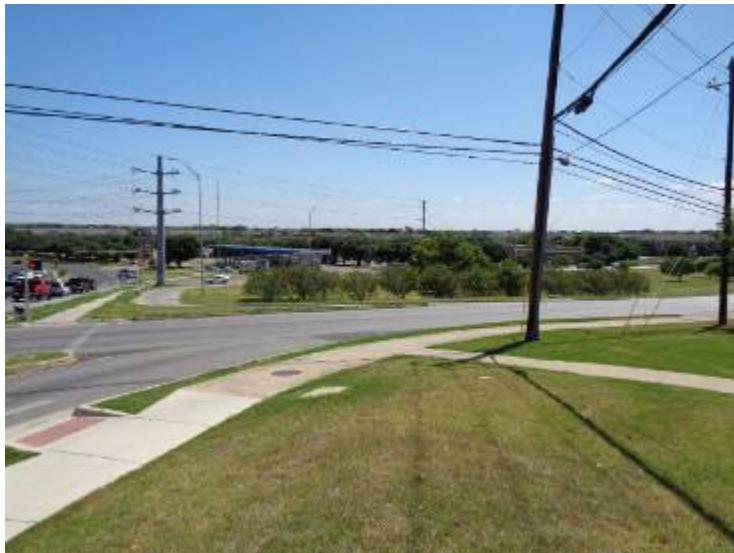
22. This photo was taken at the intersection of S. Pleasant Valley Road and E. Riverside Drive (shown). About 350' to the north is a Chevron gasoline station that is down-gradient of the Project Site. All surrounding properties were undeveloped land or farmland prior to the construction of the existing structures.

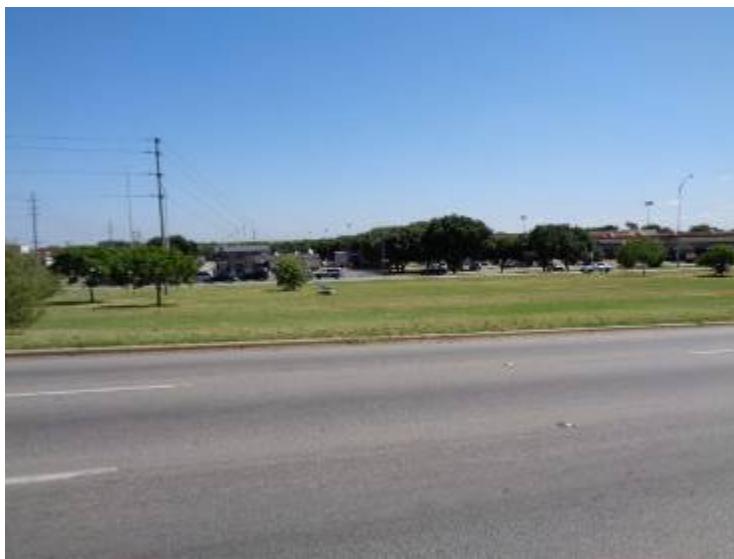
23. A shopping center is located about 225 feet north of the Project Site and E. Riverside Drive. The property was undeveloped or used as farmland prior to the construction of the shopping center.

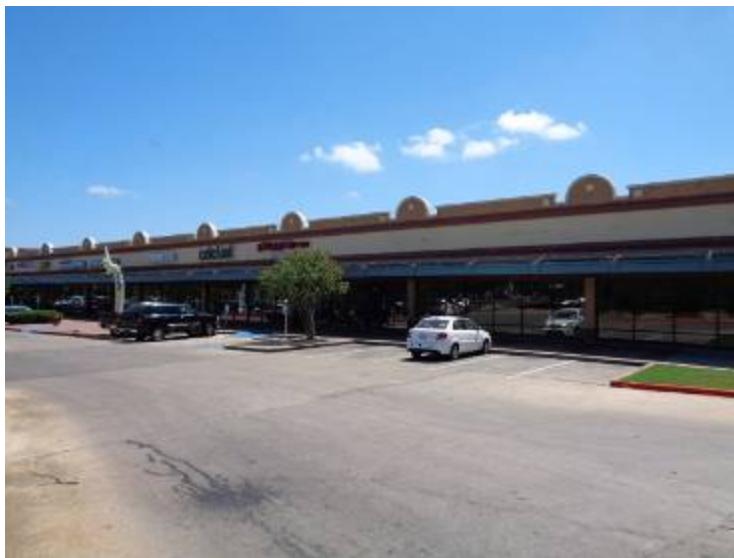
24. None of the retail tenants at the shopping center present a REC for the Project Site.

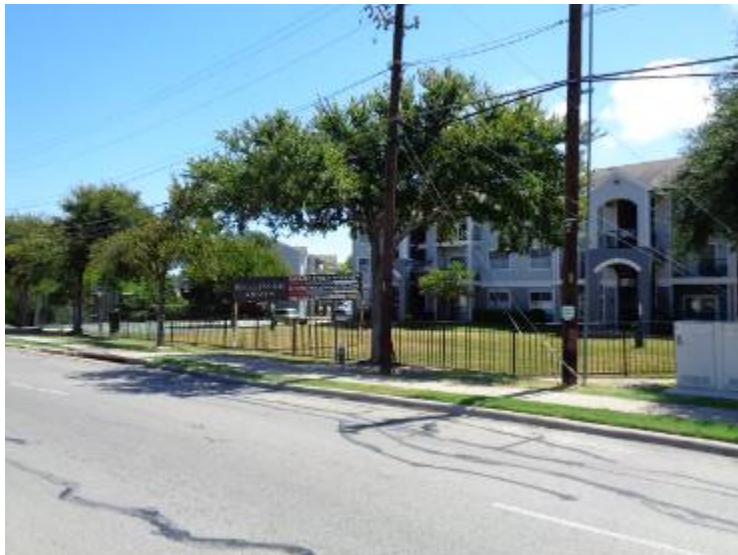
25. The Ballpark South Apartments is located northeast of the Project Site.

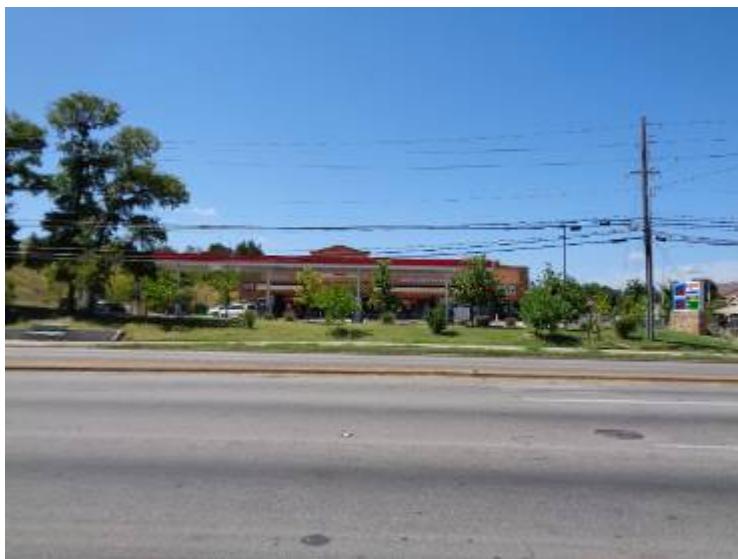
26. This Exxon gasoline station was constructed circa 2013 at the southeast corner of Wickersham Road and E. Riverside Drive near the northeast corner of the Project Site. The gasoline station does not present a REC for the Project Site, and should present a low environmental risk over time.

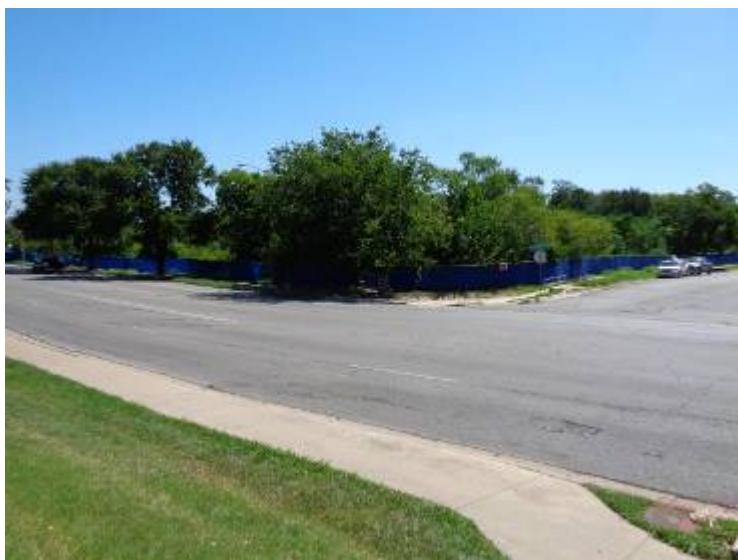
27. Undeveloped land parcels are located east of the Project Site across Wickersham Road. No evidence of illegal dumps was observed on the property.

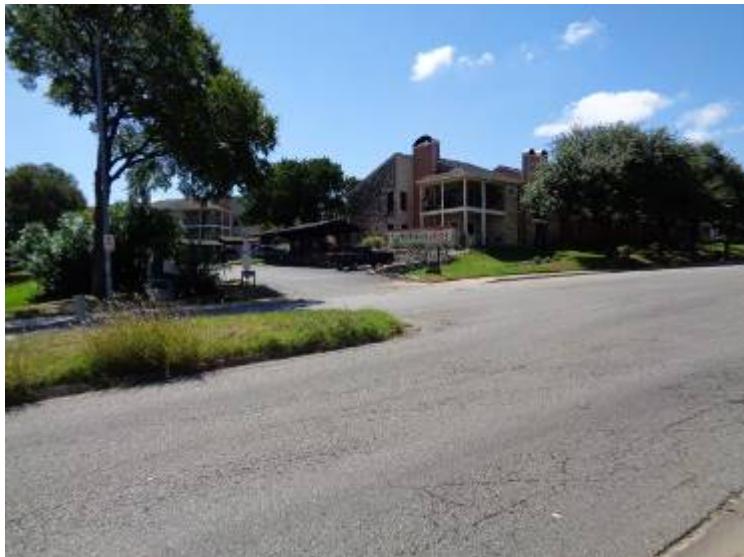
28. The Hillside Villas Apartments is located southeast of the Project Site across Wickersham Road.

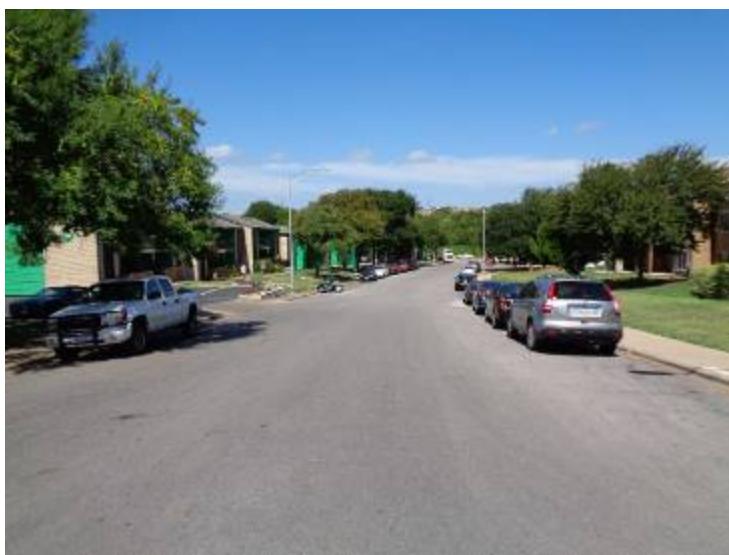
29. The Verde Apartments lie south of the eastern portion of the Project Site across Sheringham Drive. The property was undeveloped land prior to the construction of the community.

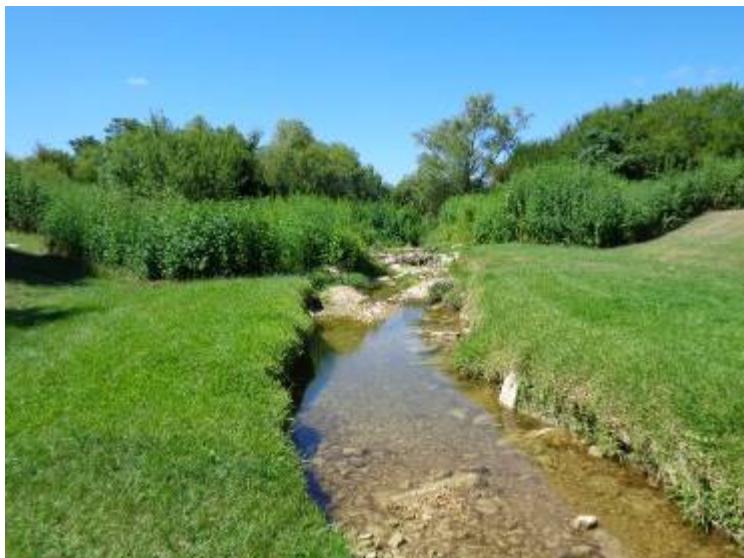
30. Undeveloped land associated with Country Club Creek lies south of the Project Site. The water in the creek flows to the north.

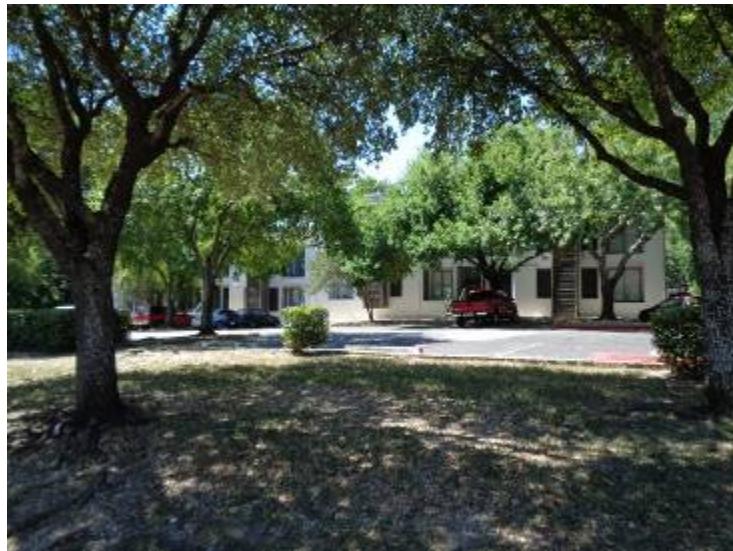
31. The Trio Apartments lies south of the western portion of the Project Site across Sheringham Drive.

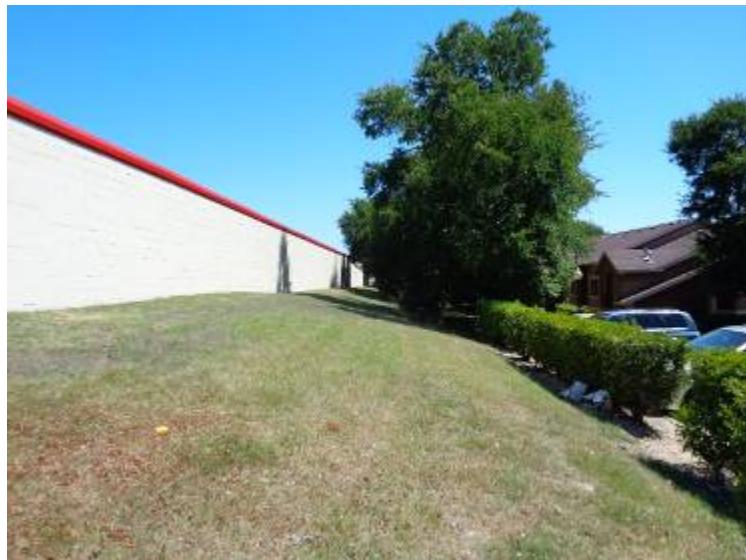
32. A CubeSmart self-storage facility borders the west property boundary. The storage building is shown on the left and a building on the Project Site is shown to the right.
