ROOFING PROPOSAL

Roof Replacement — Smith Residence, Pataua South

Prepared for Smith Residence · 14 Pataua South Rd, Whangarei

REFERENCE  
FR-2026-051

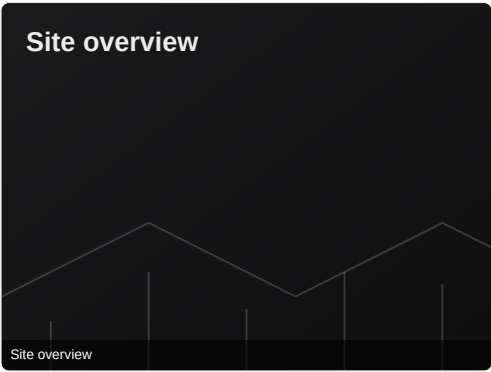
- Paint film failure 60-70% on north + west faces (chalk + flake)
- Surface rust at all fixing points, perforation starting at 4 fixings
- Ridge cap lifted in 3 locations — flat-bar fixings outdated
- Underlay has degraded (visible from inside ceiling space)
- 6m of south-elevation spouting sagging; downpipe undersized
- No identified asbestos products in the existing roof structure

Site overview
