## Inspection Report

**Address of Inspection** 1428 Ridgeline Dr

Ogden, UT 84403

**Date of Inspection** 09/29/2026

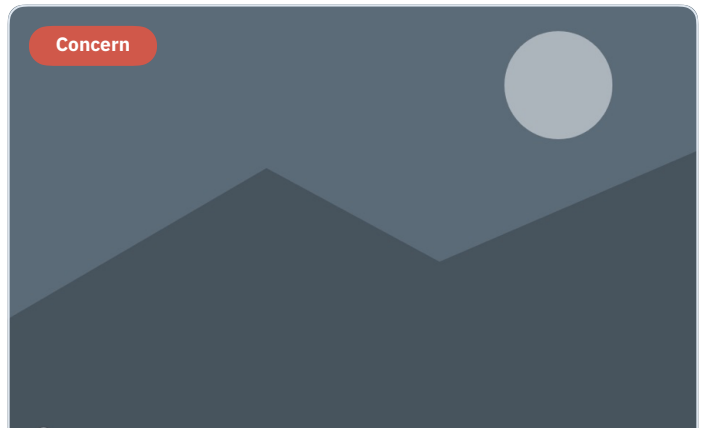
Concerns

**Cat 1** No power to exterior receptacle — wiring damaged at housing (back of property).

**Cat 1** Tree branches in contact with the structure.

Cat 1

Vegetation is well kept. Recommend trimming tree branches back from the roof line.

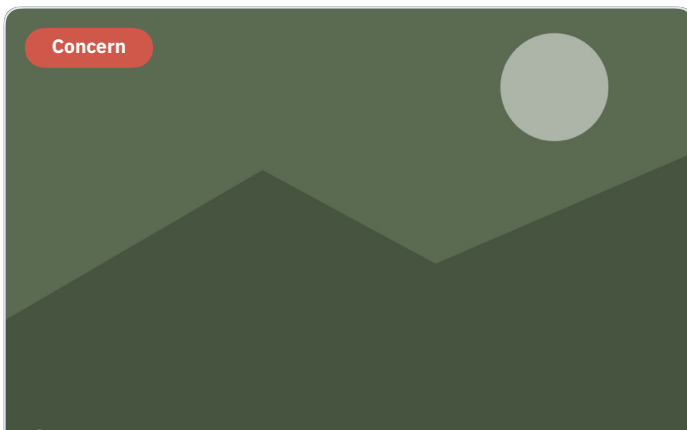
Concerns

**Cat 2** Section of concrete is lifting — trip hazard.

Cat 2
