**Vision Property Inspections**  
2029 N Main St Suite 103  
Sunset, UT 84015  
VisionPropertyInspections@Gmail.com

## Inspection Report

**Address of Inspection** 1428 Ridgeline Dr  
Ogden, UT 84403, NH

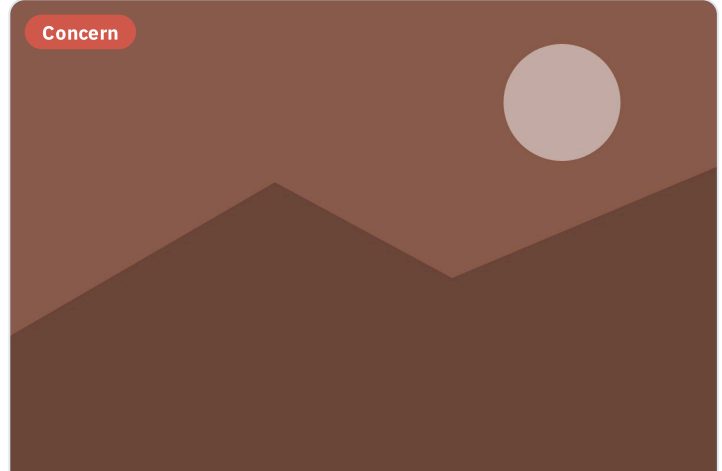
Concerns — Safety concern - address immediately

**Cat 1**
