## Quality Assurance and Quality Control of HDPE Liner Installation

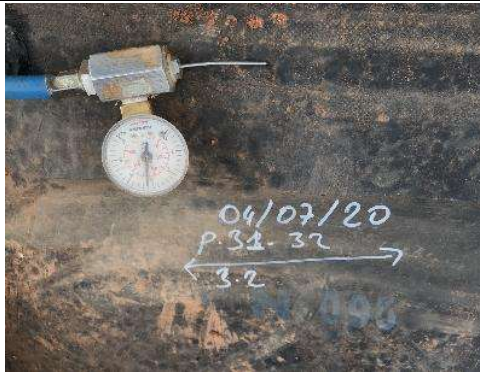
| P31 | - | P32 | 7/3/2020 | 7/4/2020 | MA | 3.2 | 3.2 | PASS |

**Figure 1.** Air pressure testing of the dual-track fusion weld between Panels P31 and P32, corresponding QA/QC inspection record confirming acceptance.

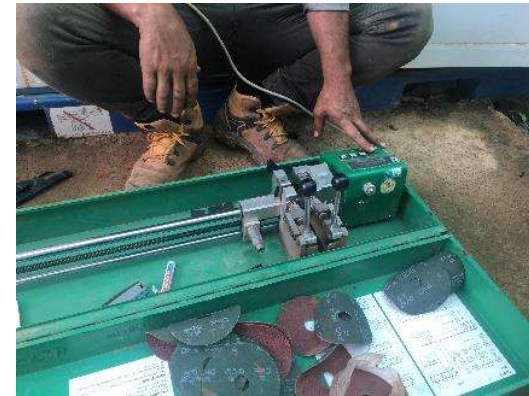
| WW - DS2 | 7/12/2020 | P180 - BOTTOM WELD | MA | 1 | 526 | 484 | 494 | 482 | 482 | 522 | 627 | 631 | 601 | 595 | PASS |

**Figure 2.** Destructive peel and shear testing undertaken to verify weld strength and continuity, with the corresponding QA/QC inspection record demonstrating compliance with project specifications.

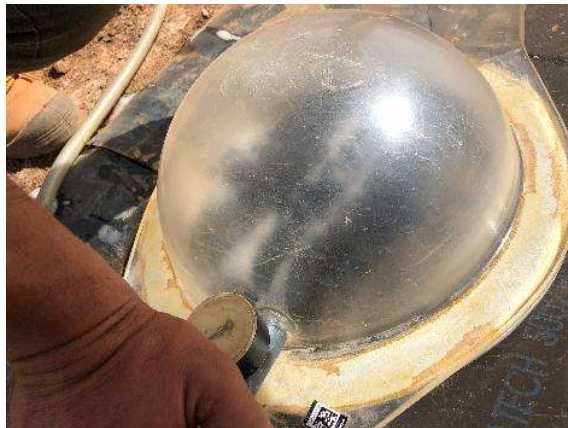
**Figure 3.** Vacuum box testing undertaken to verify the integrity of field seams and identify potential leakage prior to commissioning. Results were recorded as part of routine field QA/QC inspection activities.

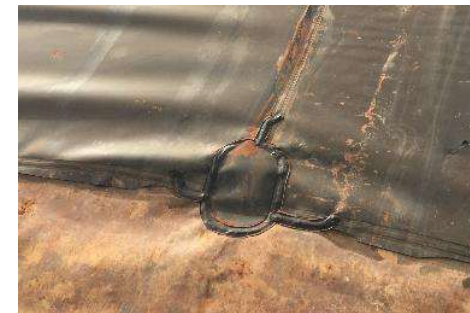
| R97 | 6/24/2020 | MA | 1 | P2 - P3 | 6/25/2020 | + | | PASS |

**Figure 4.** Extrusion welding carried out for detailing and repair works at localized connections, supported by the corresponding QA/QC inspection record demonstrating compliance with project acceptance criteria.
