# Your survey report

55 Avon Street Warwick CV34 4PX

08 January 2024

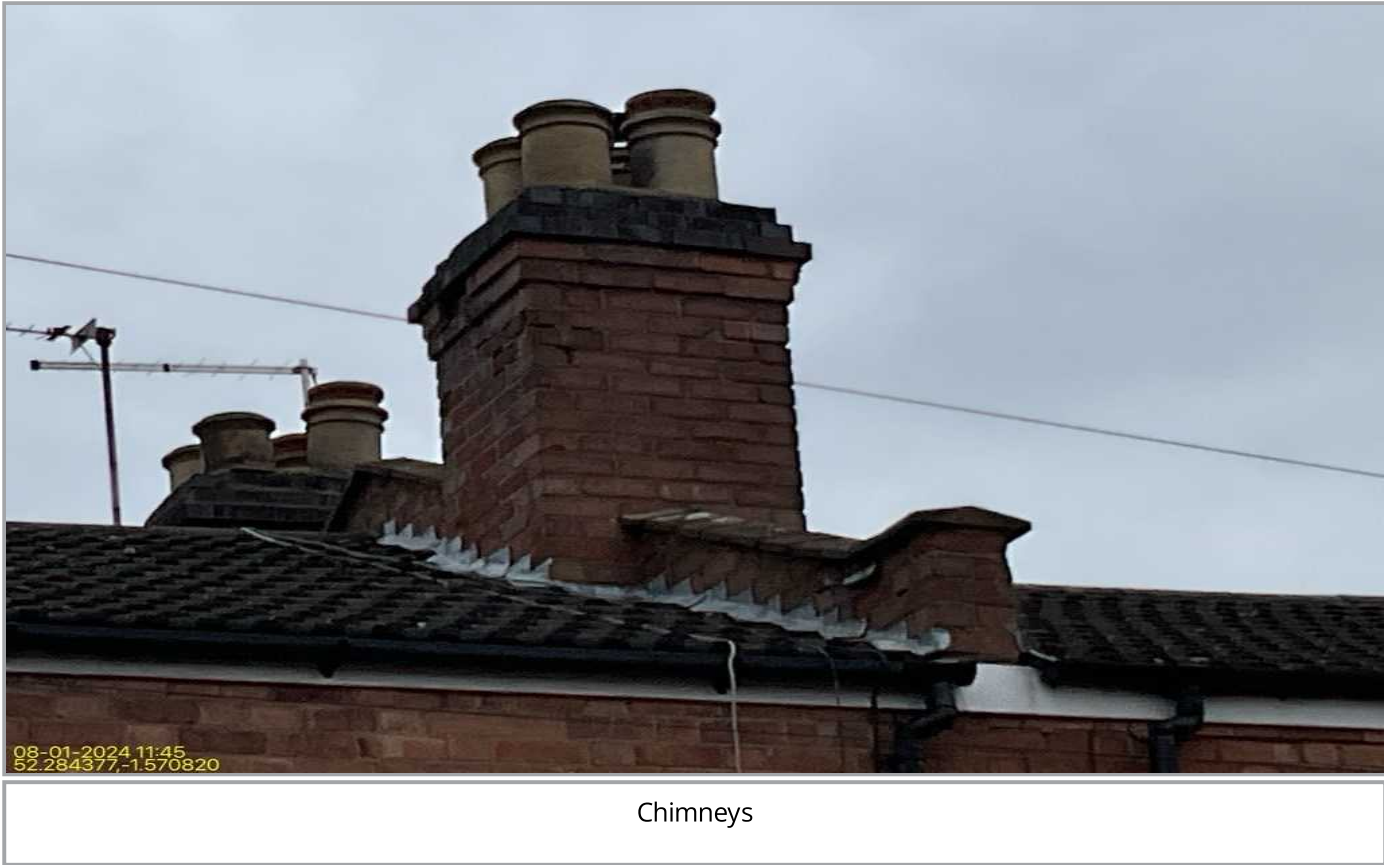
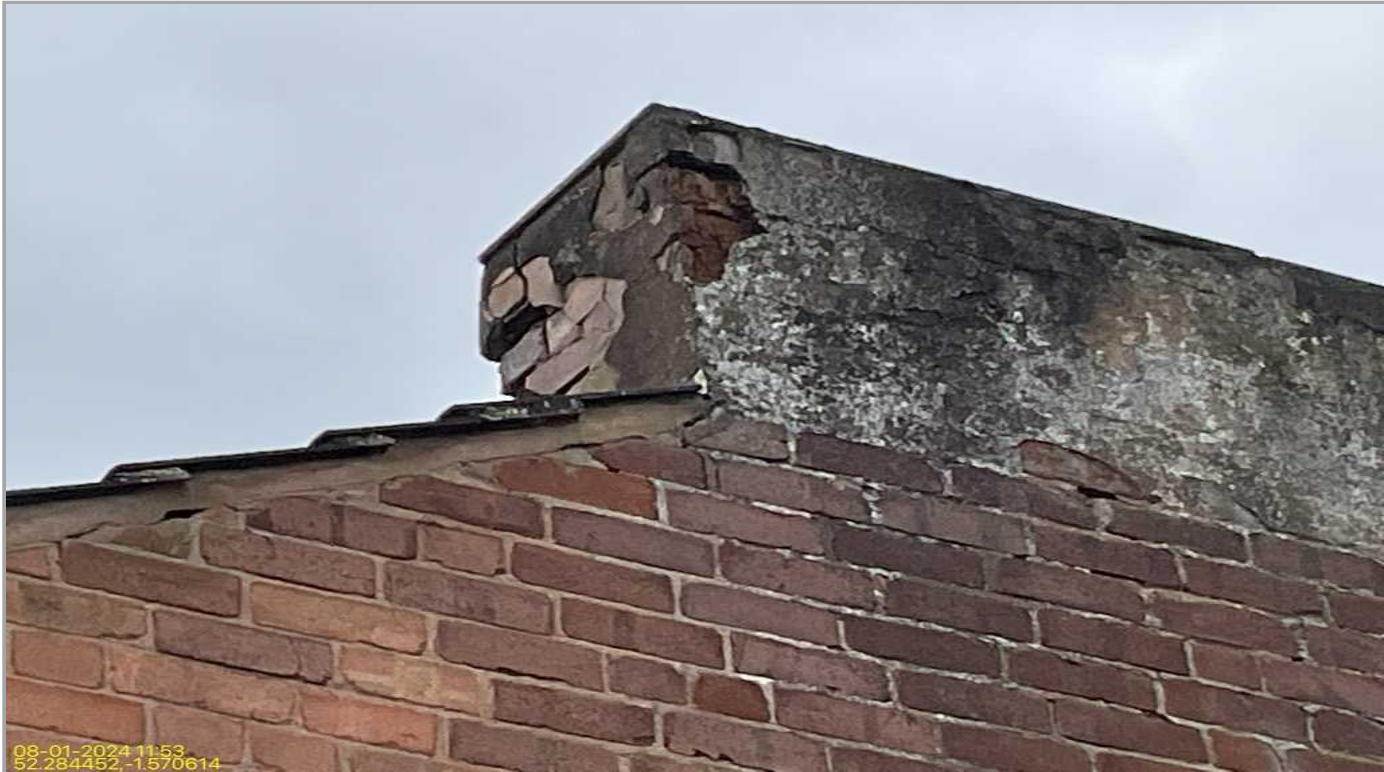
Chimneys

The mortar pointing to the left hand stacks is weathered. Some repointing is required to reduce further deterioration and structural problems arising.

Some bricks are weathered and spalled. All affected masonry should be cut out and replaced to reduce further deterioration, damp penetration and structural problems arising.

The render to the rear stack is badly cracked, loose and weathered and requires substantial repair or replacement. This may require the affected render to be removed, any underlying issues to the masonry below will need to be repaired and the area should be re-rendered.

The flashing to the chimneys is defective and should be replaced. This has resulted in water ingress and dampness internally and repairs should be undertaken as a matter of urgency to prevent further damage.

This work should be carried out as a matter of urgency to prevent the risk of damage to other elements.

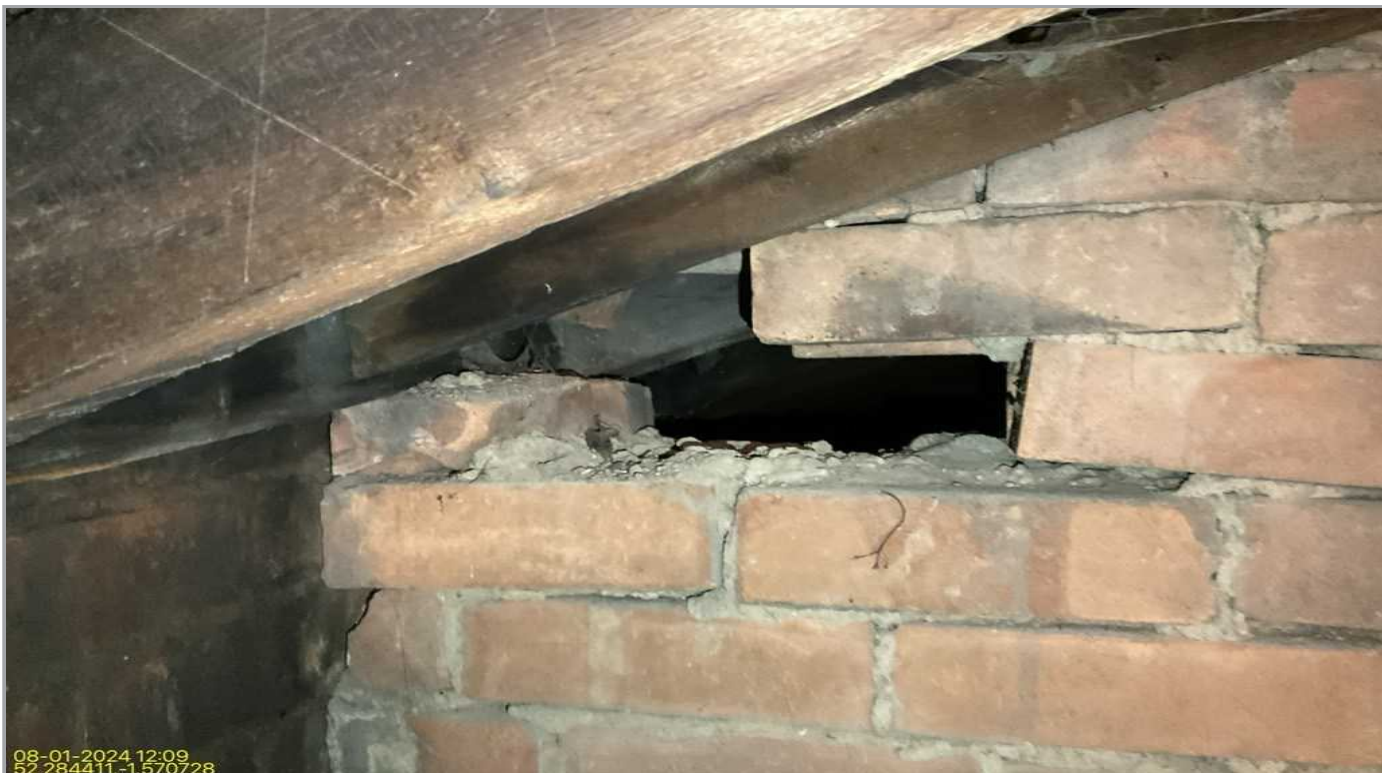
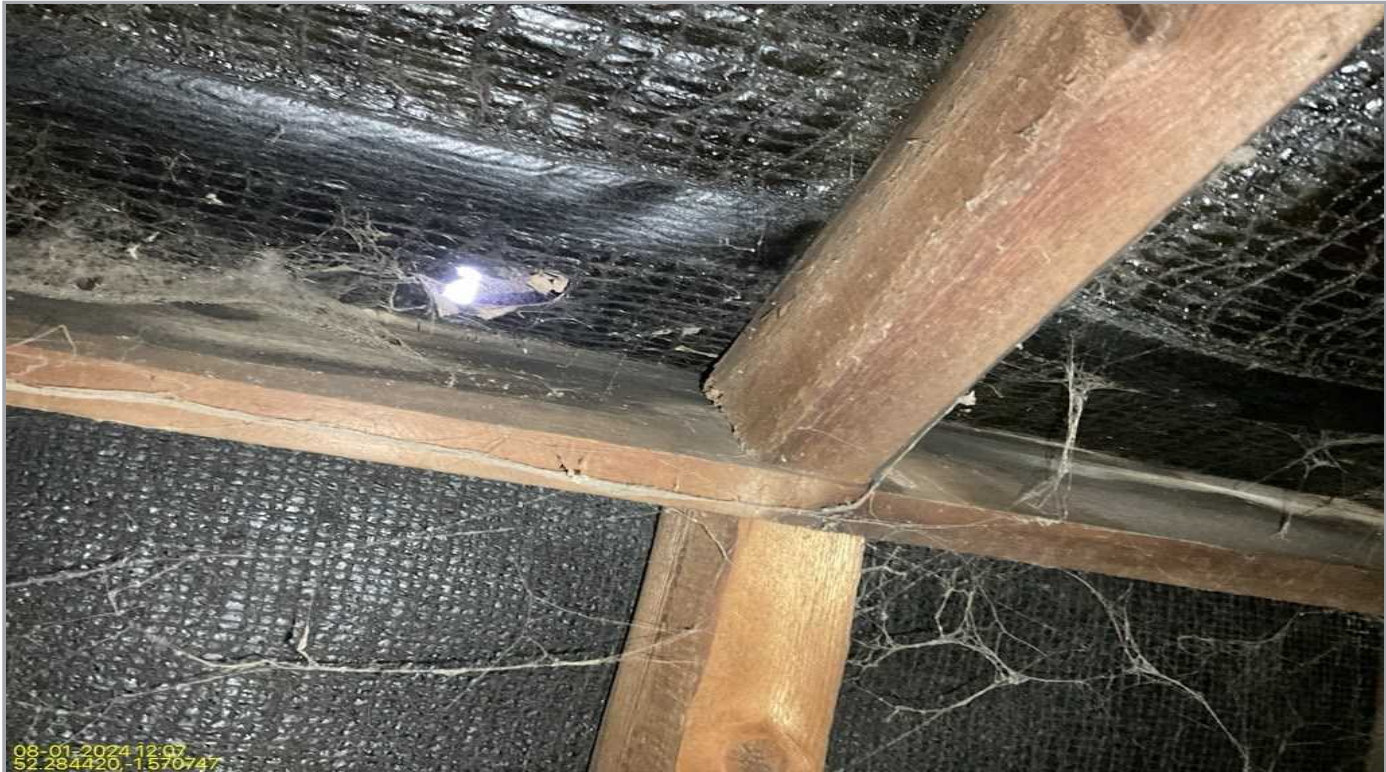
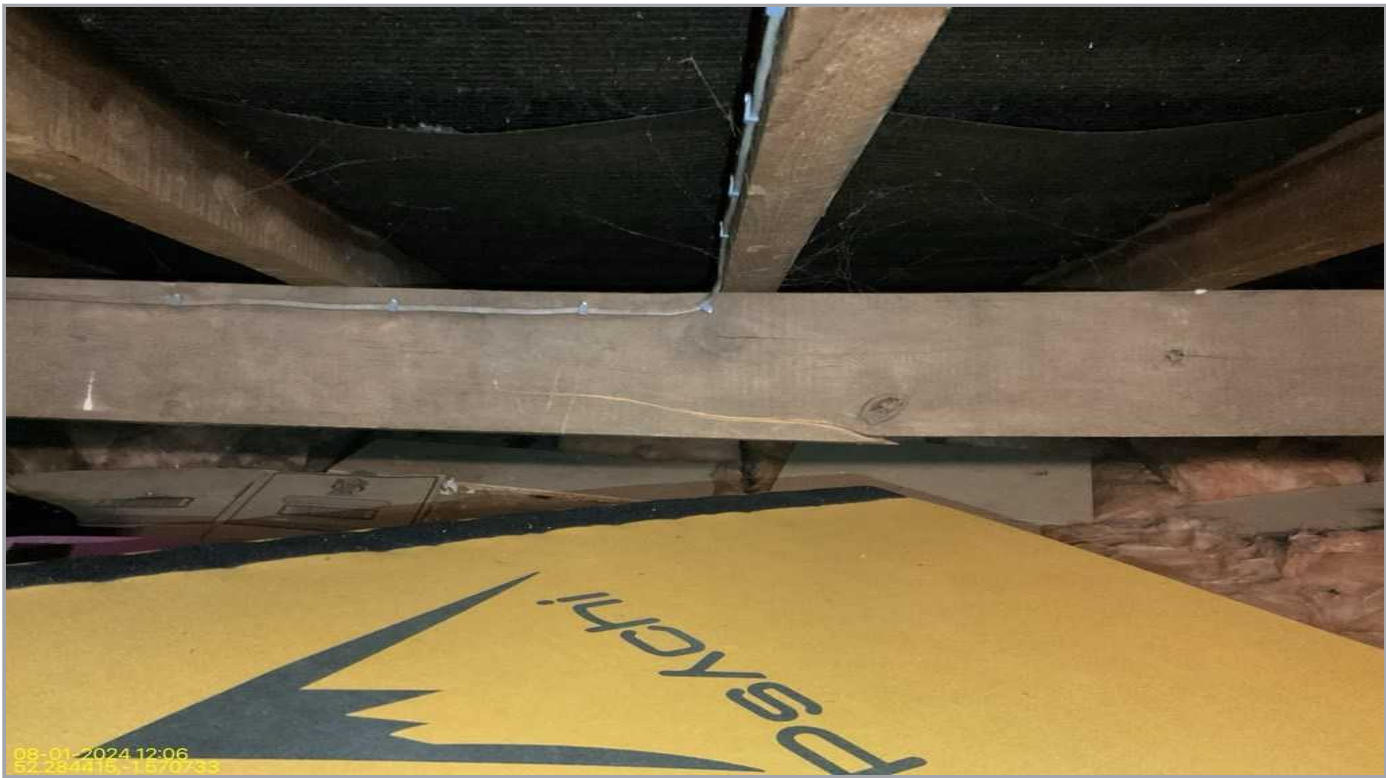
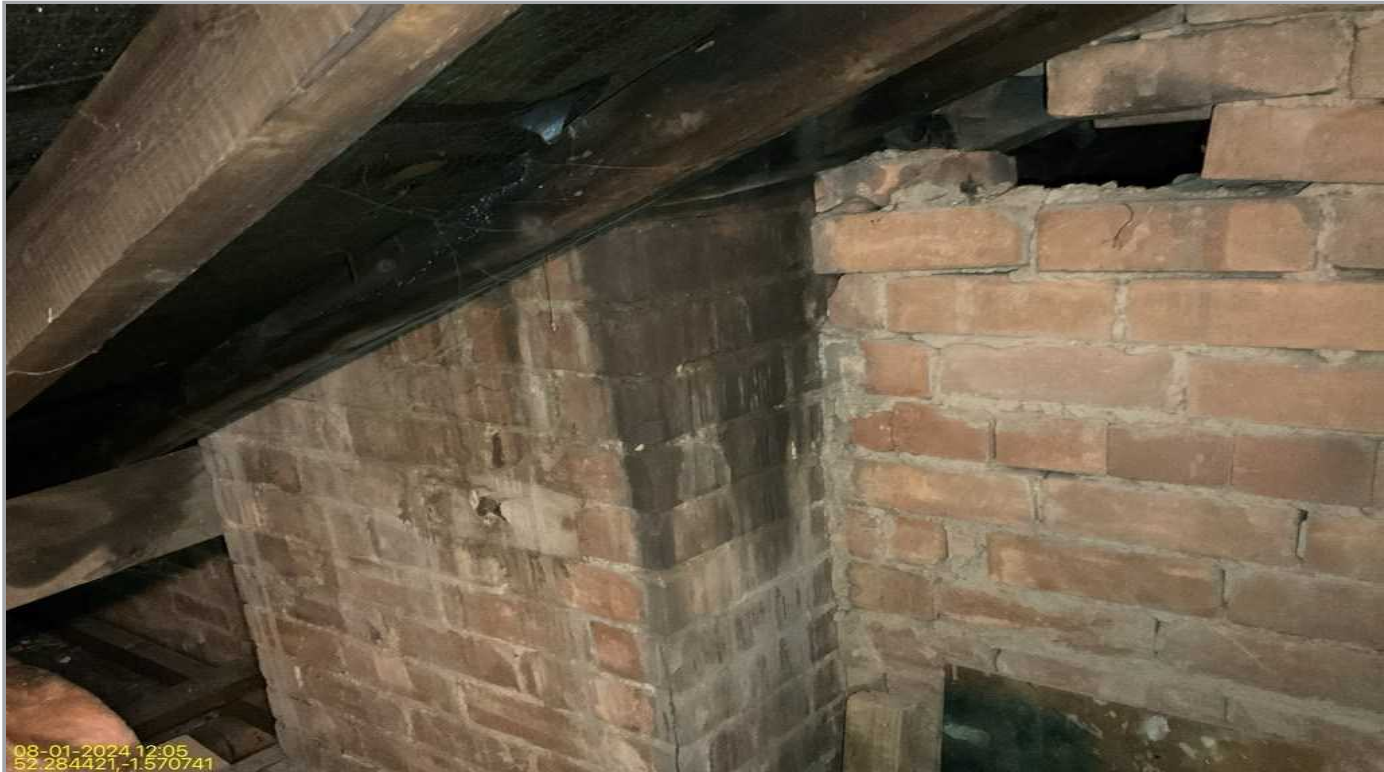
Roof structure

The main roof and rear outrigger roof coverings have been replaced with tiles which will be heavier than the original covering. The main roof structure has not been upgraded to compensate for the additional loads. The structure is sagging, split timbers and is overloaded. The roof structure needs to be improved. You should take more detailed professional advice from a suitably competent person such as a Chartered Structural Engineer. Repair works could be costly and estimates should be obtained before a commitment to purchase.

Some staining is present to some of the rafters and purlins. This appears to have been caused by a leak and further investigation of the flashings and roof covering is required.

The ventilation within the main roof and outrigger space is inadequate and needs improving. Roof structures require ventilation in order to ensure any moisture and condensation is taken into the atmosphere. Excess condensation can cause timber defects such as rot and beetle infestation.

Leakage is occurring past the chimney flashings to the right hand side. Repairs are needed and nearby timbers checked for decay.

There is evidence of possible condensation within the roof space caused by the lack of adequate ventilation to the roof space coupled with inadequate levels of insulation. Improvements are urgently required. If this is not rectified as a matter of urgency it could cause more serious defects to develop.

The right hand party wall to the main roof is incomplete. The gaps should be sealed.

The level of insulation is below modern standards and should be improved. You should arrange to have an adequate depth of insulation installed, currently the recommendation is to install not less than 270mm, however you should obtain advice of the installer as different types and makes of insulation have differing insulation properties.

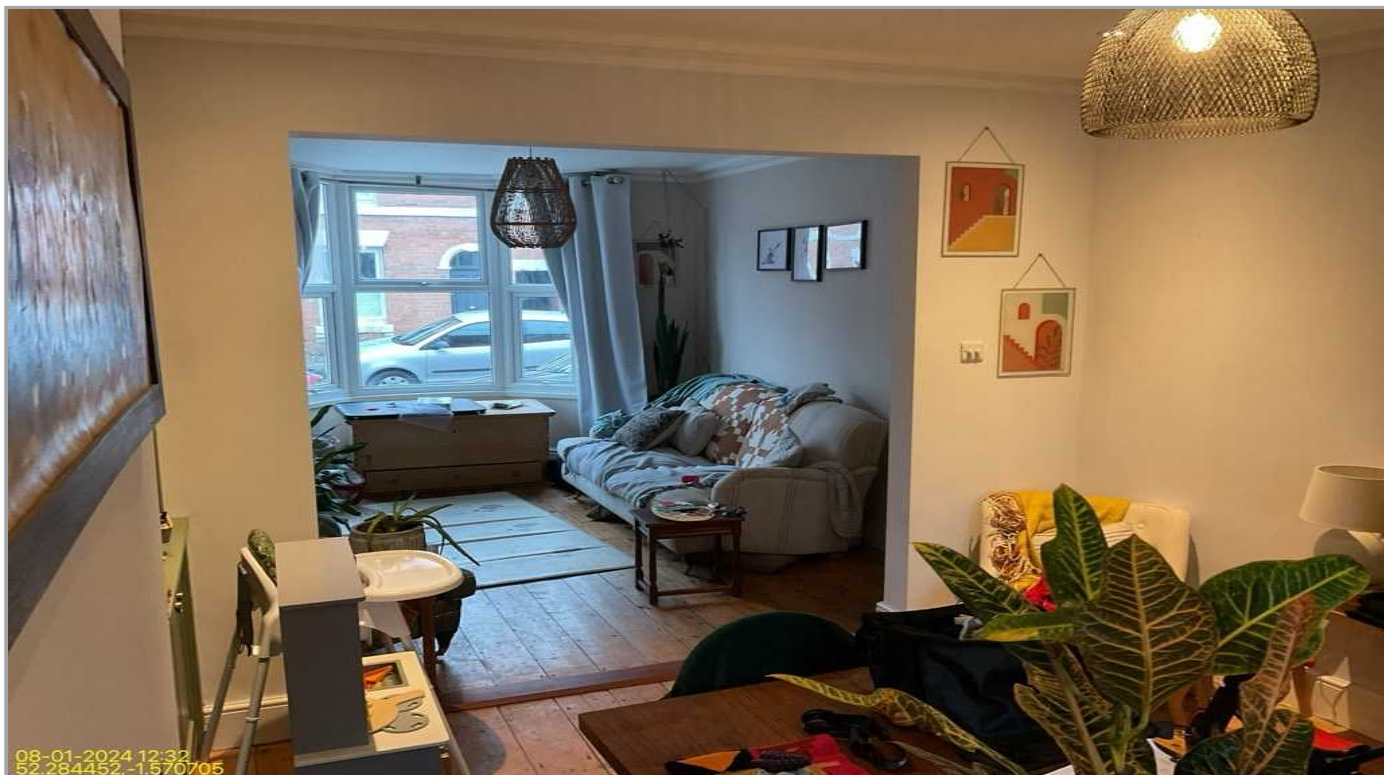
Walls (interior)

Localised high damp meter readings were recorded to the ground floor walls in the hallway, rear reception wall and middle reception wall and continuing dampness is inevitable unless proper damp-proofing is carried out. A decision therefore has to be made as to whether to live with the dampness in this location, or to have repair works undertaken.

Sections of plaster throughout the property are cracked and loose and repairs are required.

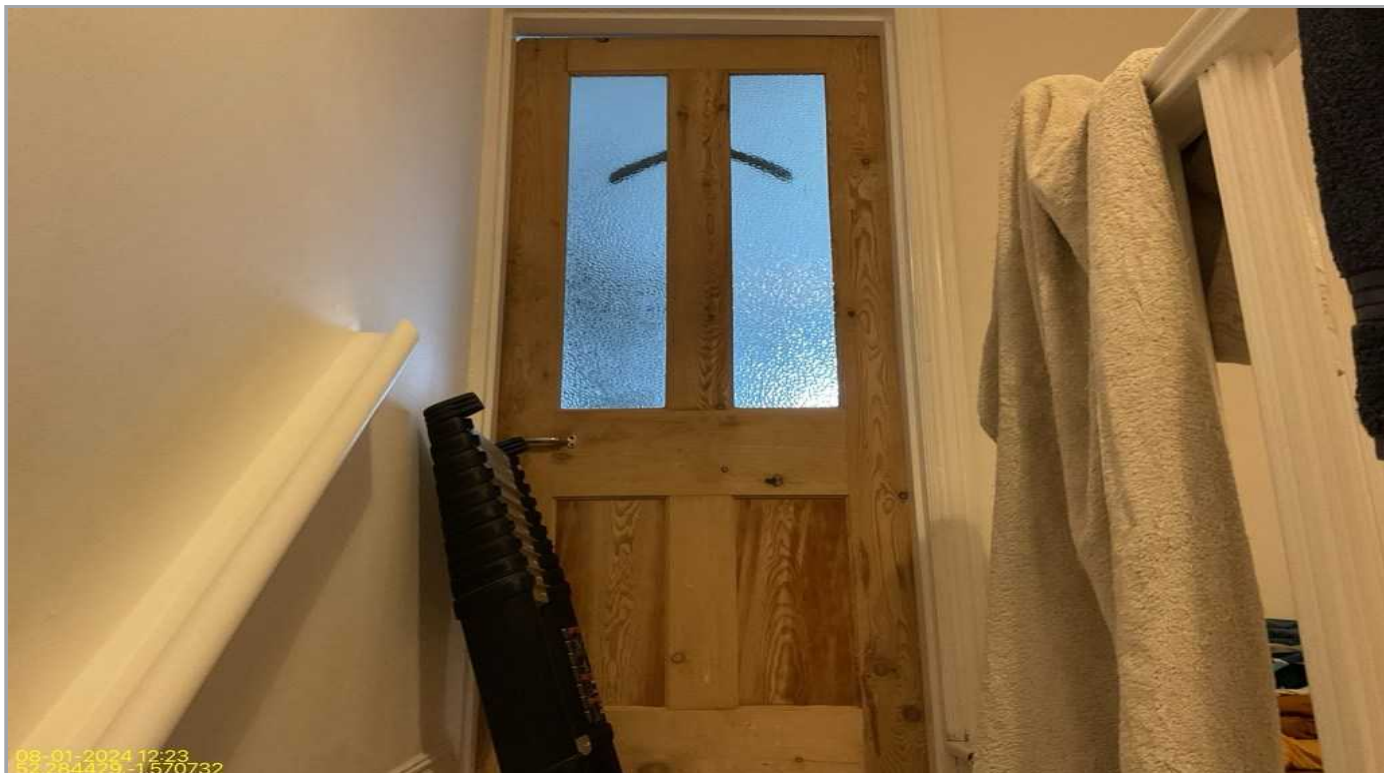
Woodwork / joinery

The property is of an age where there could be a lead content in the old paint finishes. I cannot confirm the presence of lead paint as this is outside the scope of this survey. Further advice can be found by visiting <https://www.gov.uk/government/publications/advice-on-lead-paint-in-older-homes>.

The doors have been stripped. This stripping agent can damage the glued joints and splits often occur due to moisture changes in the timber.

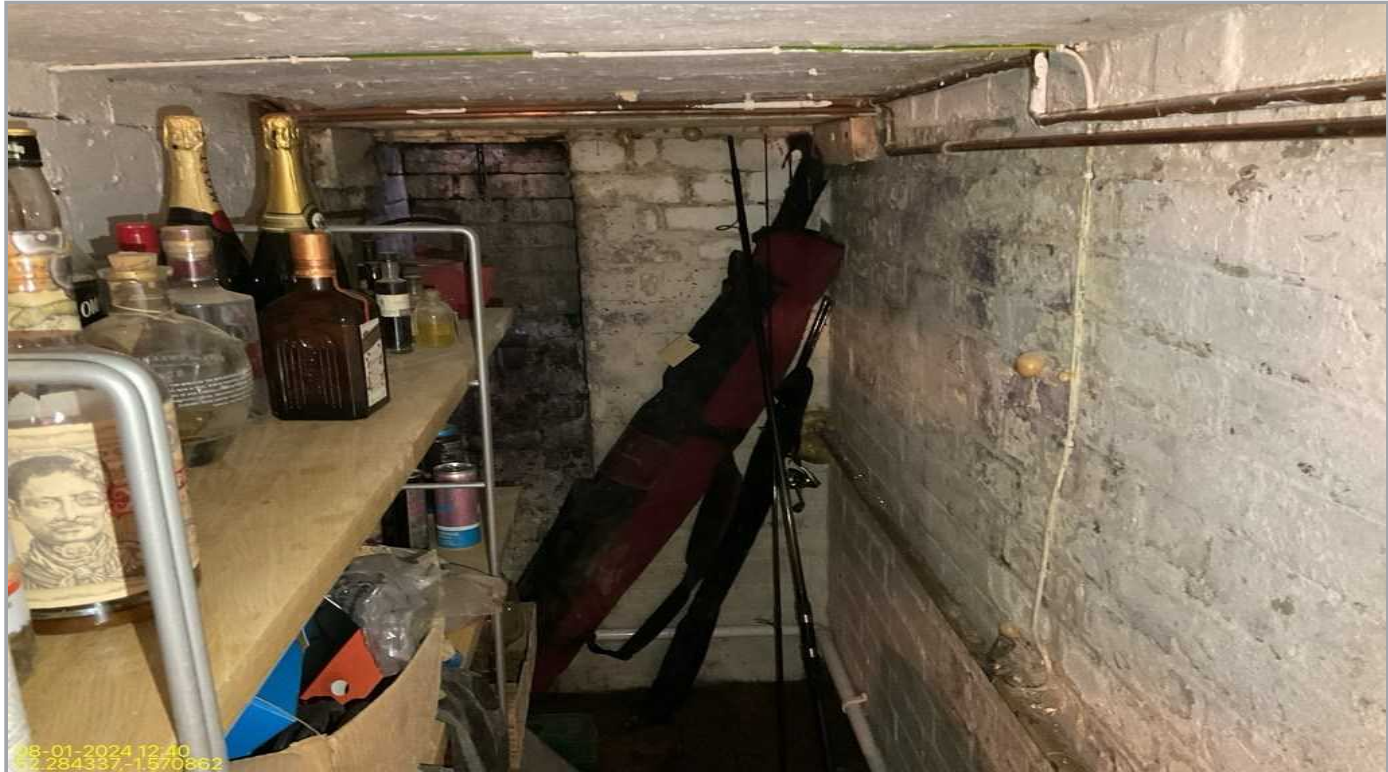
Other internal

It is important to ensure the cellar is adequately ventilated at all times. Cellars can be prone to flooding. I saw no evidence of flooding at the time of my inspection but there is always a risk this could occur in the future particularly following heavy rain.
