POTHOLE DETECTION REPORT

Generated on: November 24, 2025 at 14:58:21

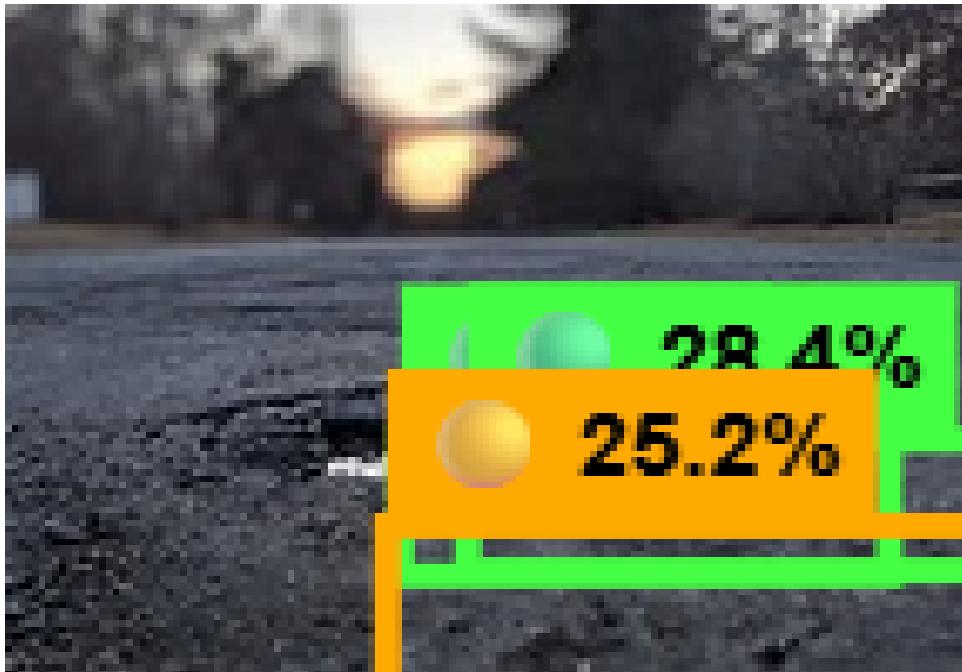
Detection Results

This report summarizes the pothole detection analysis conducted on November 24, 2025. The AI-powered detection system identified 3 potholes with varying severity levels.

Pothole #1 - **LOW SEVERITY**

Confidence	46.7%
Size	72.60269927978516 × 21.358699798583984 pixels
Area	1550.6992584838008 px ²
Severity Score	24.9/100
Description	Small pothole - monitor condition
Location	Lat: 13.375268 Lon: 77.096736

Pothole #2 - **LOW SEVERITY**

Confidence	28.4%
Size	101.97442626953125 × 20.804454803466797 pixels
Area	2121.52234243392 px ²
Severity Score	23.4/100
Description	Small pothole - monitor condition
Location	Lat: 13.375268 Lon: 77.096736

Pothole #3 - **MEDIUM SEVERITY**

Confidence	25.2%
Size	113.6593017578125 × 48.06478500366211 pixels
Area	5463.009902655613 px ²
Severity Score	45.8/100
Description	Medium pothole - schedule repair
Location	Lat: 13.375268 Lon: 77.096736

- **Schedule Repairs:** 1 medium-severity potholes should be addressed soon.
- **Monitor:** 2 low-severity potholes should be regularly monitored.
