POTHOLE DETECTION REPORT

Generated on: November 24, 2025 at 15:07:23

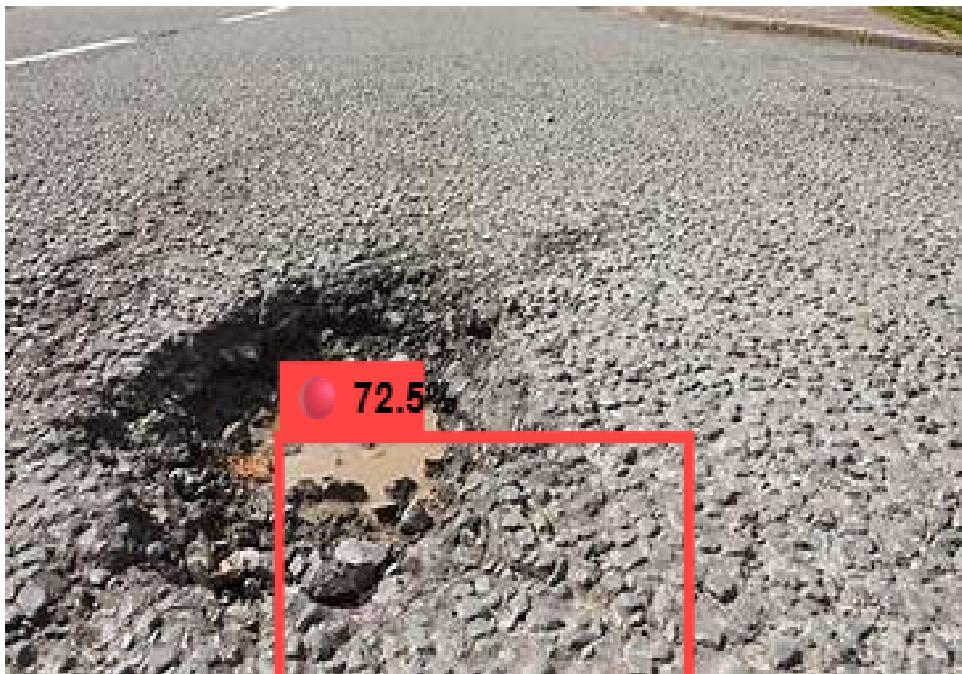
Detection Results

Pothole #1 - HIGH SEVERITY

Confidence	72.5%
Size	155.0137176513672 x 112.8165512084961 pixels
Area	17488.11301543482 px ²
Severity Score	91.8/100
Description	Large pothole - immediate attention needed
Location	Lat: 13.375310 Lon: 77.096782

- **Immediate Action Required:** 1 high-severity potholes need urgent repair.
