## 3 Payload Demonstration Flight

### 3.1 Payload Summary

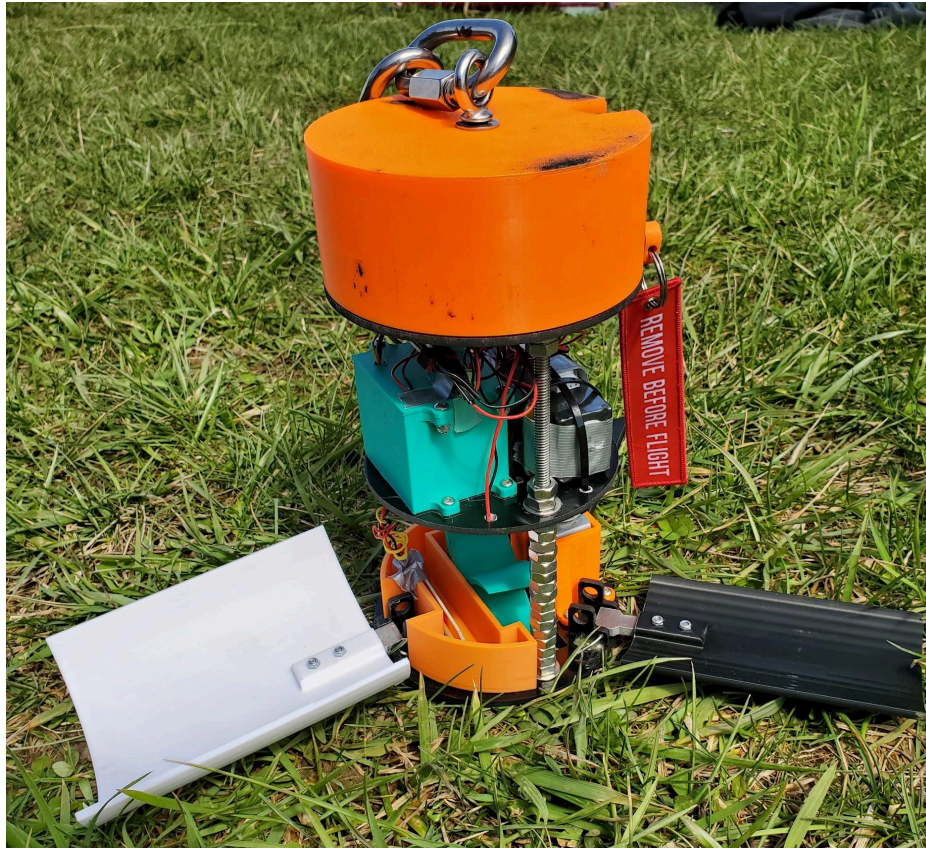
Figure 15: Assembled payload prior to launch

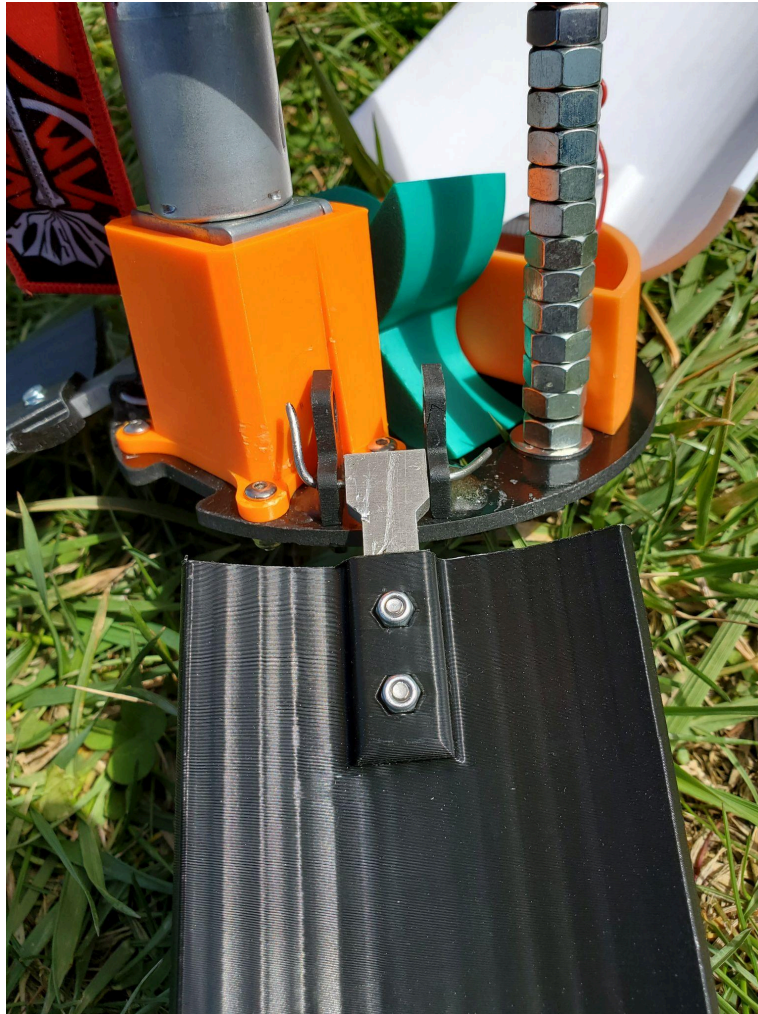
Figure 16: Hinge detail before launch. Note the aluminum flap tab

One of the major mechanical issues were the hinges on the payload flaps. The springs were providing insufficient force when the flaps were at the lowest position below the horizontal. Because of this, the payload would be unable to upright if it lands on its side.

The solution to this would be a hinge redesign on the payload. We will use modified [surface-mount light duty spring hinges](#) to provide sufficient force for the flaps at the lowest position. From ejection testing, the hinge system must be robust otherwise it breaks as it hits the ground. One of the hinge leaves will be mounted to fiberglass posts on the payload base and provide a robust structure for flap attachment. The other leaf of the hinge will be attached to the flap. To ensure resistance against vibrational loads, M3 locknuts will be used as the attachment from flap to hinge.

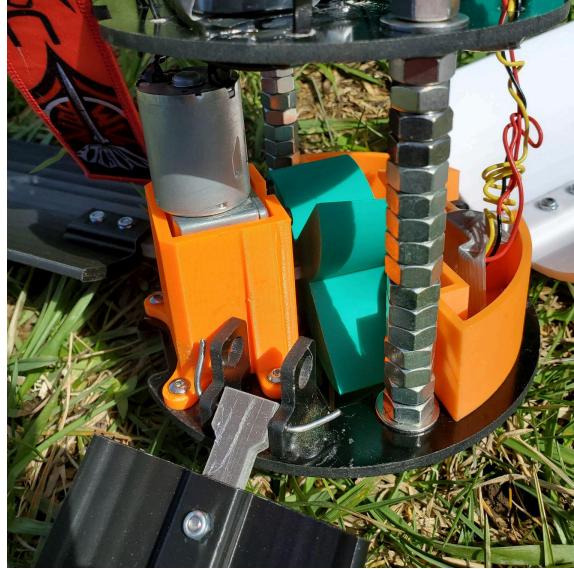
Figure 20: Lower level detail. Left: Motor; Center: Excavator; Right: Soil collection chamber with conductivity sensor

The motor ran for two hours straight due to a bug in the code. Instead of checking altitude and launch condition, the code just checked for altitude leading to the motor running while on the ground pre launch. The motor turned off during launch and didn't impact the flight of the rocket, then it turned back on after the rocket landed. This is a simple fix in the code, checking the boolean value launched is true as part of turning on the motor.
