Vehicle Damage Assessment Report

Make	kia
Model	sportage
Year	2017
VIN	UNKNOWN

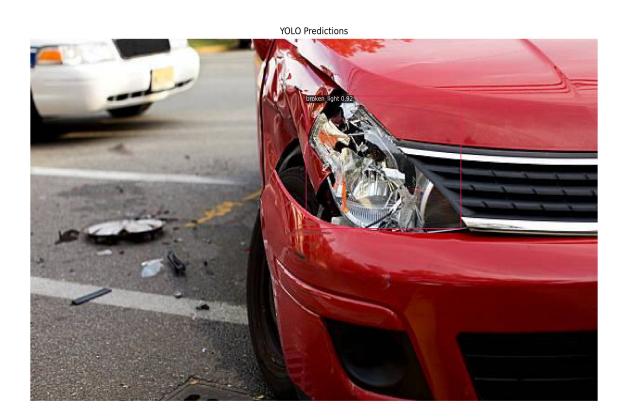
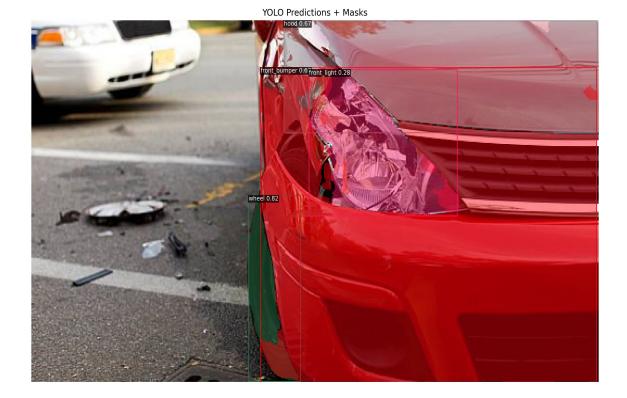
Vehicle Damage Assessment Report Report Date: 2025-08-21 Vehicle Information: - Make: Kia - Model: Sportage - Year: 2017 - VIN: UNKNOWN Detected Damages: - Broken headlight assembly with hood damage. Detection confidence: 92%. Localization accuracy: 10%. Estimated repair cost: \$450-850 USD. See attached image. Summary of Estimated Repair Costs: - Headlight assembly and hood: \$450-850 USD
