Vehicle Damage Assessment Report

Make	bmw
Model	m5
Year	2020
VIN	UNKNOWN

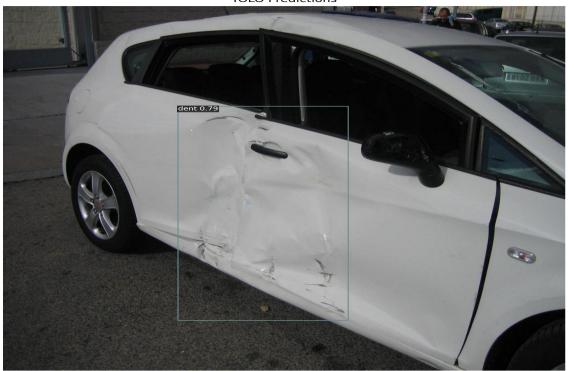
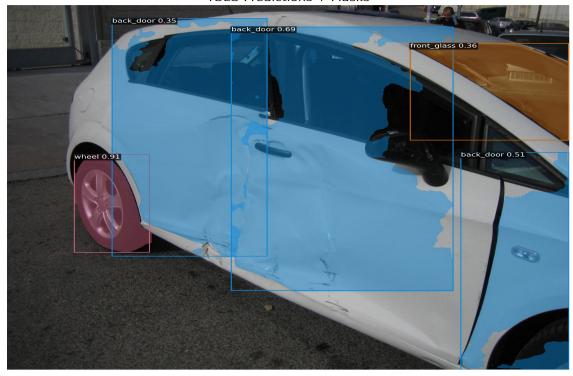
- Dent in back door (Detection confidence: 79%, Localization accuracy: 32% IoU). Estimated repair cost: \$453.75 (range: \$385.69–\$521.81). See attached image.
