Vehicle Damage Assessment Report

Report Date: 2025-08-23 14:45:19

Vehicle Information: - Make: Kia - Model: Rio - Year: 2021 - VIN: KIA_VIN

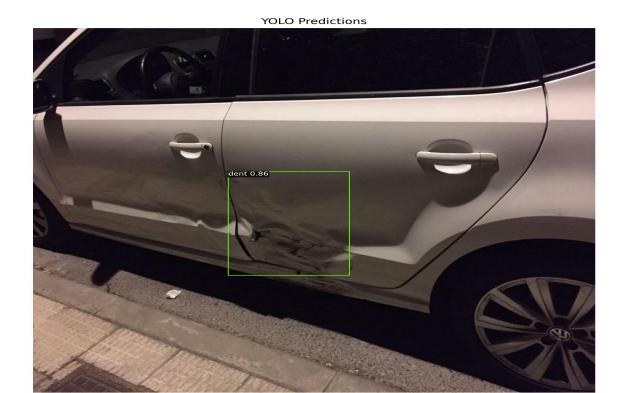
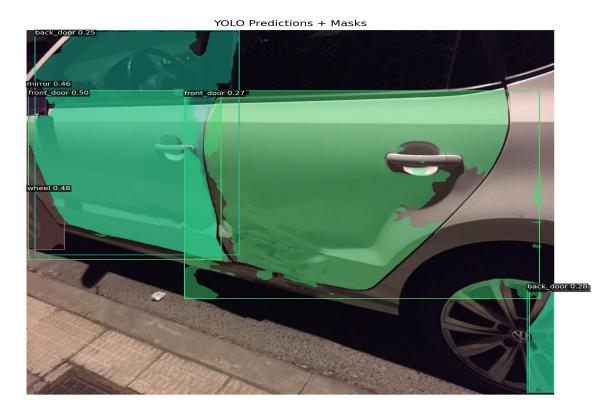
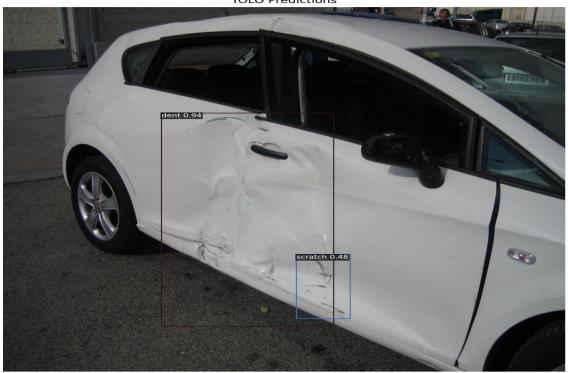
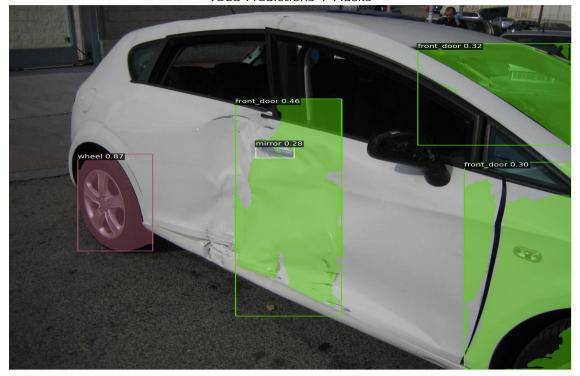
Detected Damages: - Dent in front door (conf=0.94, IoU=0.40) — Estimated Cost: \$427.58 (See attached image) - Scratch in front door (conf=0.48, IoU=0.09) — Estimated Cost: \$428.62 (See attached image)

Summary of Estimated Repair Costs: - Front door dent repair and refinishing: \$427.58 - Front door scratch repair and refinishing: \$428.62 Total Estimated Repair Cost: \$856.20
