# **SX-70 Circuit Board Question**

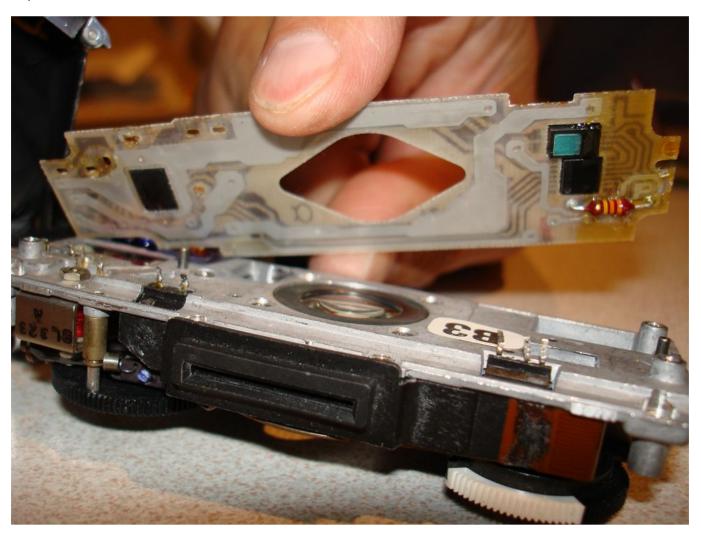
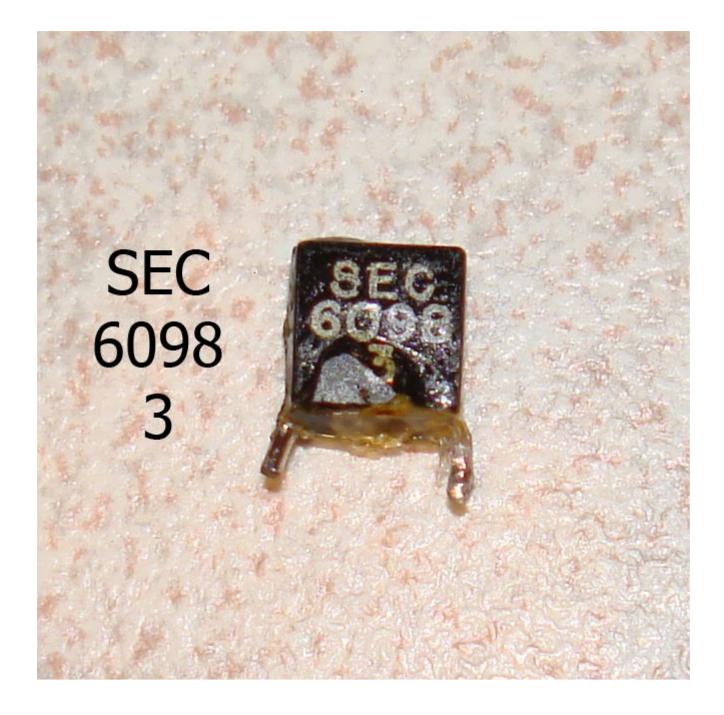
I'm attempting the internal electronic modification and Georg of the superlative

www.chemie.unibas.ch/~holder fame suggested I post a photo of my board on here, should the Capacitor value not be apparent.

I'm hoping someone can tell me the spec of this capacitor, and if anyone has completed the modification on a camera with this build - what size cap they found worked best in all conditions for them!

Try 150 or 180 pF for 600 film.

Try a 100pf cap - should do the trick based on the circuit board.

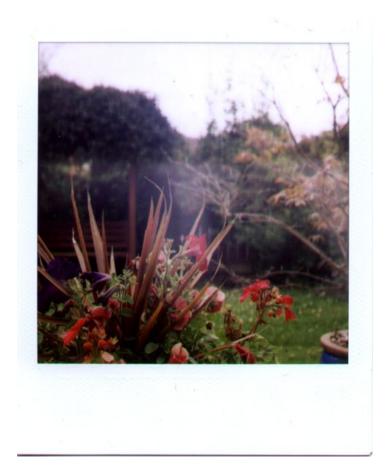
The cloudyness is visible on this one in a band across the centre, being worst in the center and right:

The 2 'cloudy example' polaroids above were taken with the original cap, no faceplate (so no fliter on electronic eye), set to fully darken. The scans make them look darker than the originals, they are quite noticably overexposed in the originals.

It could be dirty rollers causing the goo to spread unevenly. A little alcohol and a qtip is all you would need to clean them.

As for the white areas on your photo - looks to me like you have a light leak somewhere on the camera.

Check / clean the taking mirror.

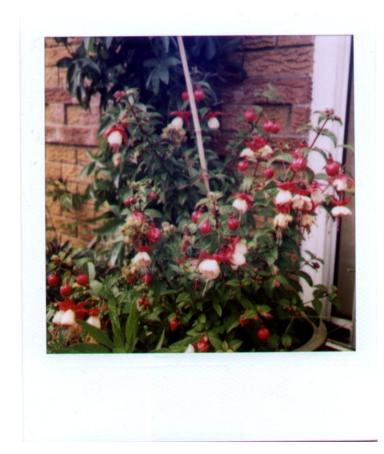
This one appears much more evidently on the original, the cloudy/light band extends from about an inch from the bottom of the frame all the way to the top.

On ejection, it seems like the motor is a little bit laboured which is why I thought it was the rollers. Exactly how free should they be under the fingers? At the moment, it feels like there is some friction/resistance from the cogs at the side, but it doesn't seem to get stuck at all (I don't want to give the impression the rollers are hard to turn, simply that you can feel some resistance of the cogs turning; they dont freely spin like a bicycle wheel).
