POSTIRRADIATION EXAMINATION OF MATERIALS FROM THE MSRE

H. E. McCoy      B. McNabb

DECEMBER 1972

OAK RIDGE NATIONAL LABORATORY  
Oak Ridge, Tennessee 37830  
operated by  
UNION CARBIDE CORPORATION  
for the  
U.S. ATOMIC ENERGY COMMISSION

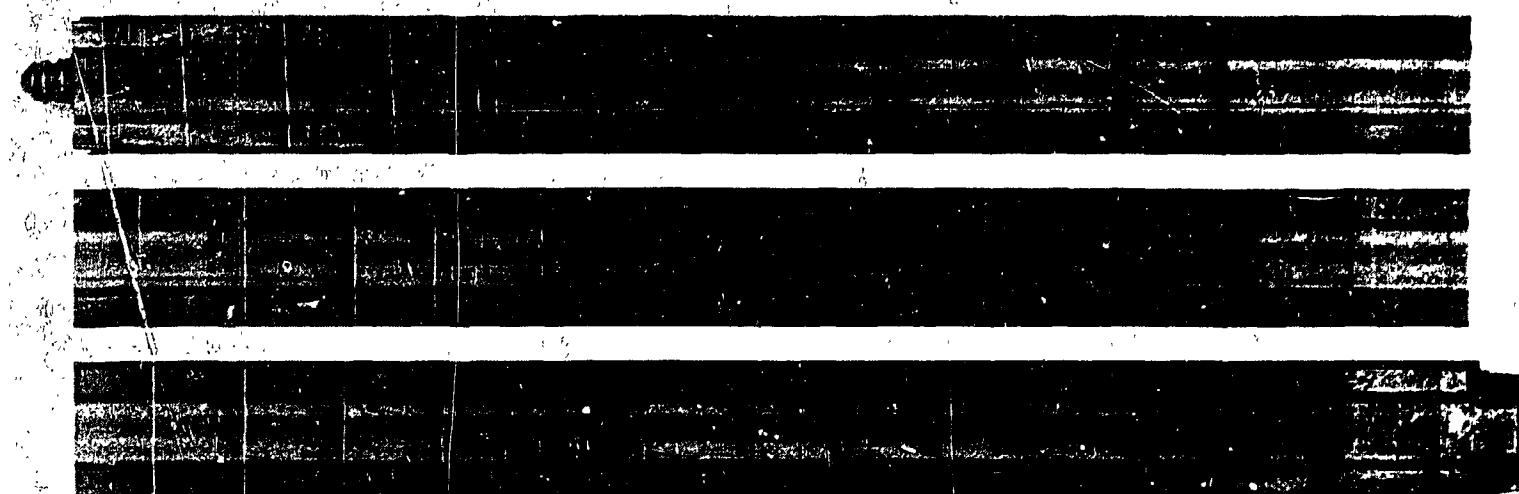
PHOTO 0370-71

One of the five removable graphite core moderator elements (1184) was examined in the High-Radiation-Level Examination Laboratory (HRLEL) after completion of the operation of the MSRE. Visual examination revealed machining marks still plainly visible in the fuel channels and on surfaces not exposed directly to flowing fuel salt, indicating little if any change during operation. Figure 6 is a photograph of the fuel channel facing the center of the reactor, and it shows the excellent condition of the core block. The small thumbnail flaw in the fuel channel about 39 in. from the top is likely a small crack that was in the bar during fabrication, since tool marks are on the top of the flaw and skip over an area at the end of the flaw. The few scratches on the surface are not very deep and were likely caused by handling.

Fig. 6. One of the removable graphite moderator elements after operation in the MSRE, showing the fuel channel facing the center of the reactor. Machining marks are plainly visible in the fuel channel, showing excellent condition of the core block.

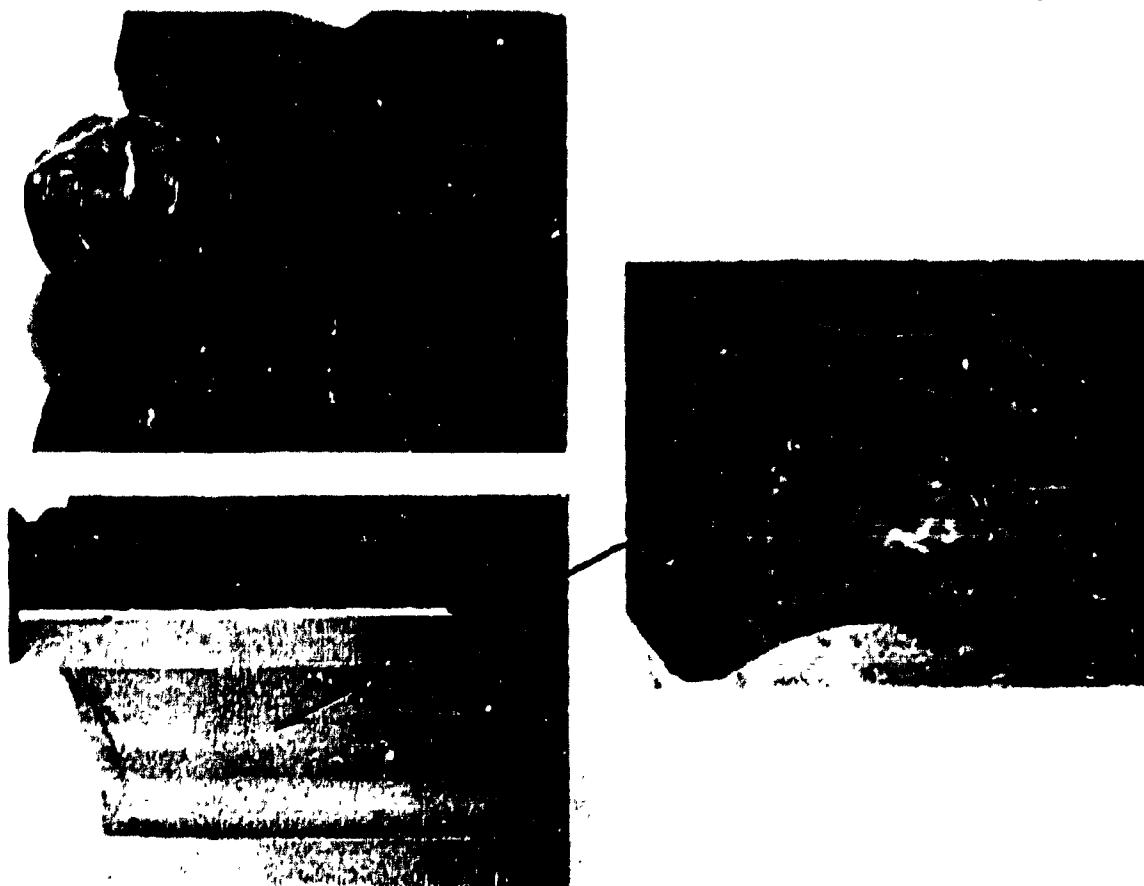
There was a crack in the graphite around the INOR-8 lifting stud that was screwed into the top of the bar. This crack extended about halfway around the bar, as shown by the short arrows in Fig. 7. The long arrow indicates the same channel in the different views. The small punch mark visible in the top view was made to indicate the fuel channel toward the center of the reactor, with a control rod on one side and the surveillance sample basket on the other side. The crack in the graphite did not affect the integrity of the bar, since it was on the end, and several threads remained to secure the lifting stud. The crack was probably caused by the approximate twofold difference in thermal expansion of graphite and INOR-8.

**Fig. 7.** Top of the graphite moderator element. The short arrows show the crack originating at the INOR-8 lifting stud and extending partway around the graphite block. The long arrow indicates the same channel in the different views. The crack was probably caused by the approximate twofold difference in thermal expansion between the INOR-8 and the graphite during thermal cycling of the reactor.

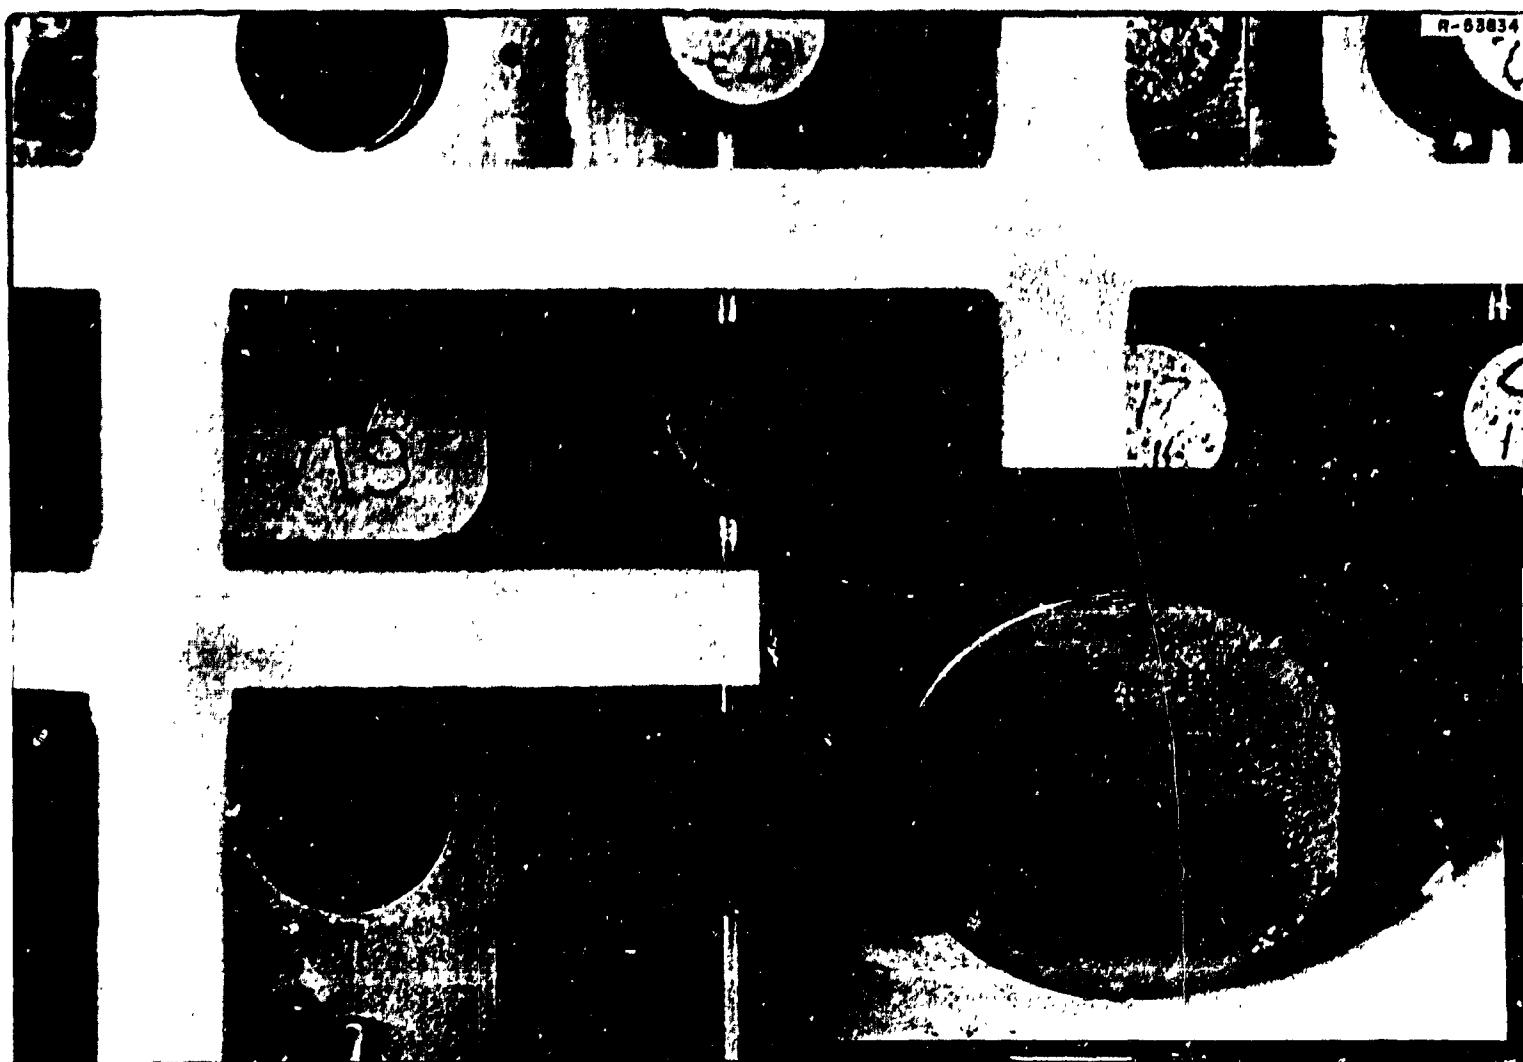
**Fig. 8.** Comparison of the bottom positioning stud on the graphite moderator element when initially installed in the MSRE and after operation. The large picture was made before the reactor was operational, and the small picture in the lower right corner was made in the hot cells after the moderator element had been at temperature for over three years.

exposure to molten salt). There is no apparent change, as the small cracks and the small chip missing from the bottom are apparent in both photographs, and the numbers are just as legible as before operation.

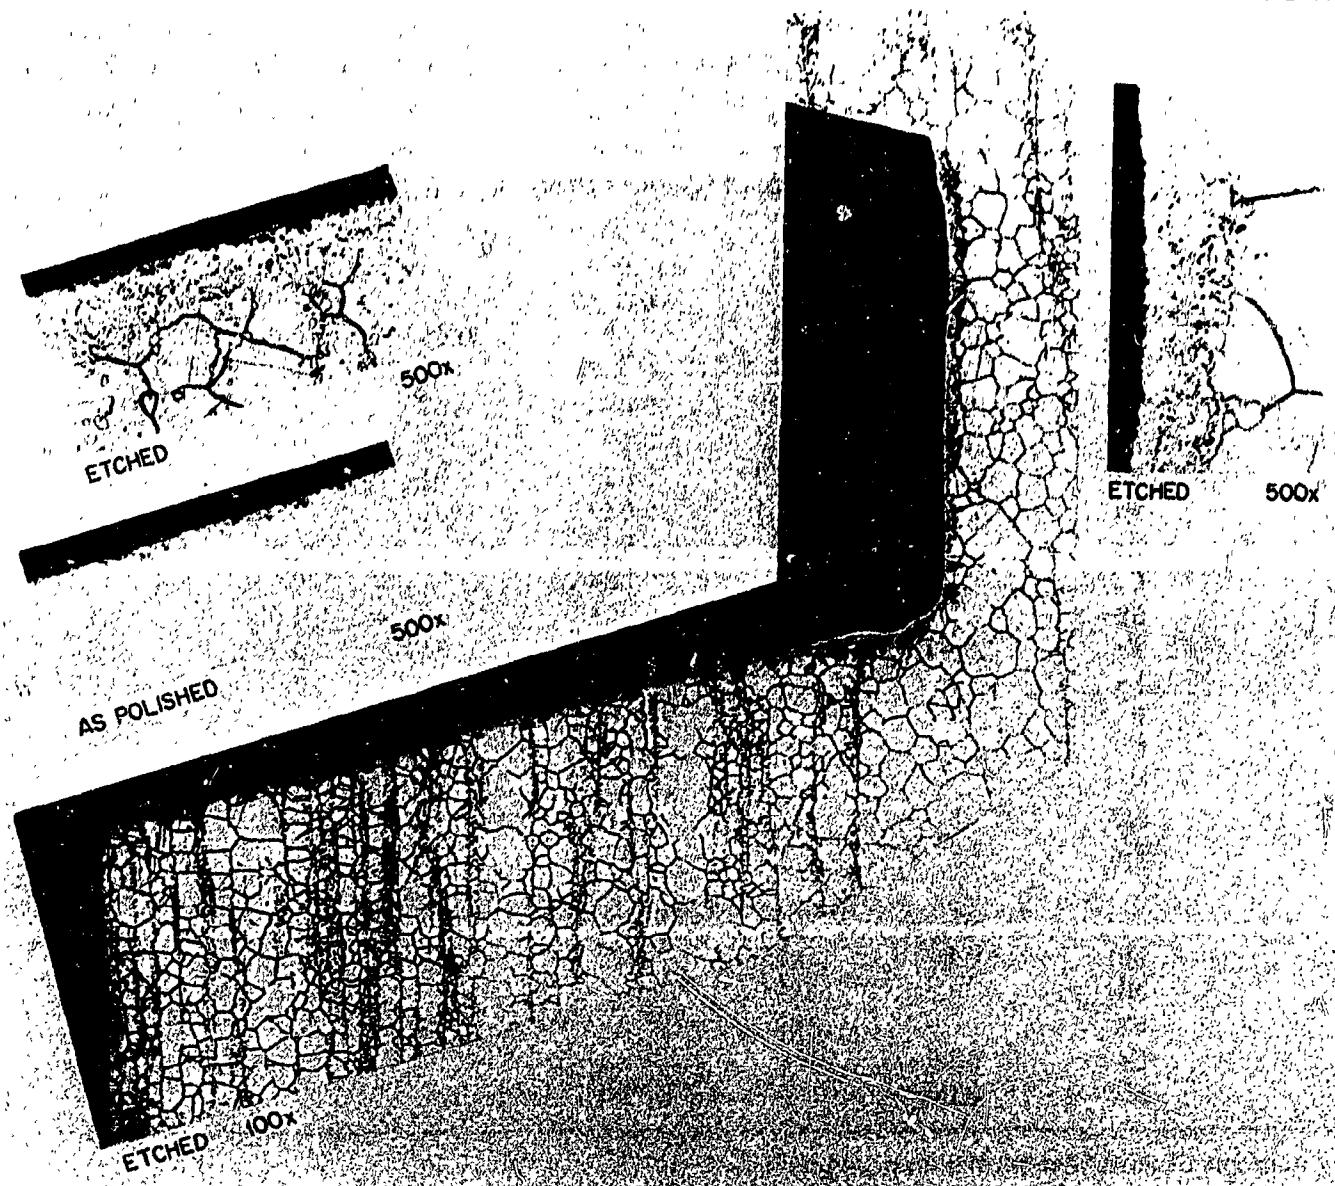
PHOTO 0372-71

A cross section of the INOR-8 lifting stud in contact with the graphite is shown in Fig. 9. There appears to be little if any reaction with the graphite. There is a surface modified layer about 1 or 2 mils deep similar to that observed on surveillance samples and attributed to cold working of the surface and subsequent heat treatment during service. There appears to be very little difference in the side of the thread in contact with the graphite and the root of the thread, which probably was not in intimate contact.

Fig. 9. INOR-8 thread that was in contact with graphite for about three years at 650°C. The modified layer is likely due to working effects from machining the thread. Reduced 35%.

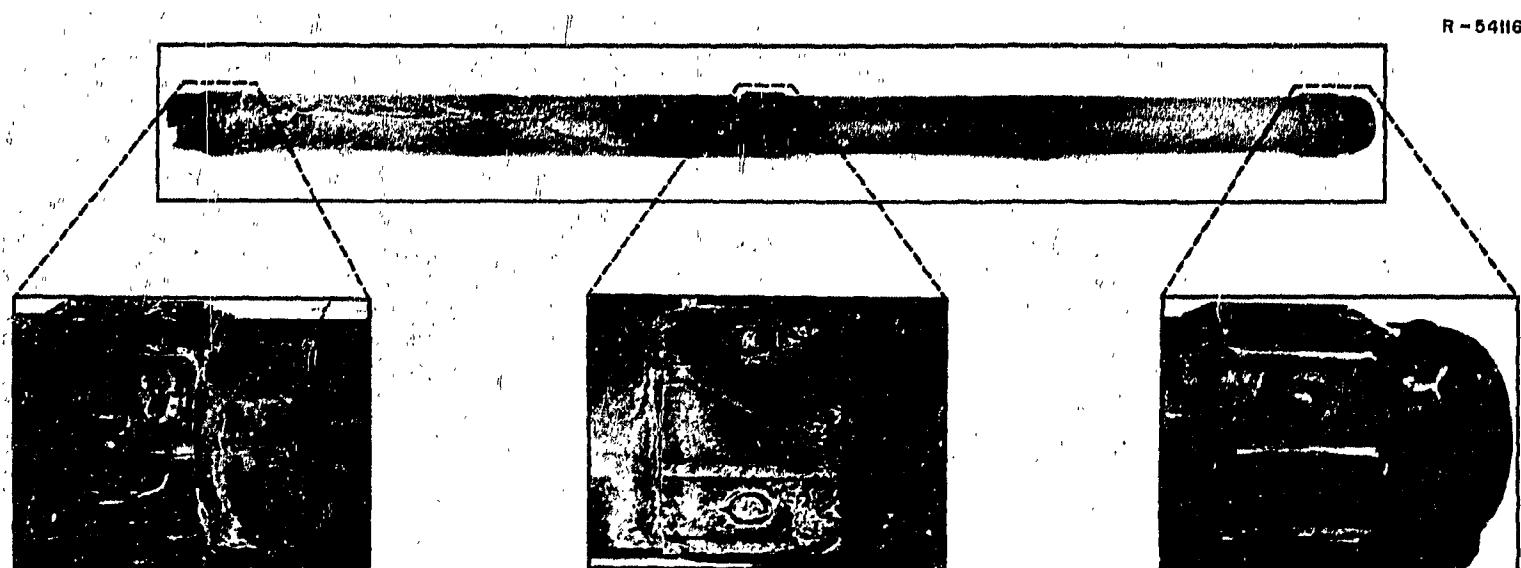
The exterior of the thimble was exposed to fuel salt and the interior to the cell environment of  $\text{N}_2 + \text{O}_2$ . The tubing was above 500°C for 30,807 hr and received a peak thermal fluence of  $1.9 \times 10^{21}$  neutrons/cm<sup>2</sup>. The lower portion of the control rod thimble was severed by electric arc cutting and moved to the hot cells for examination. Figure 12 shows the electric arc cut at the left (about at the midplane of the core), the spacer sleeves, and the end closure (located at the bottom of the core). The fuel salt appears to have wet the INOR-8 near the center of the core, where the temperature and flux were highest (as shown around the left and center spacer sleeves), but not at the bottom (as shown on the right sleeve). Some of

**Fig. 12.** Portion of control rod thimble examined after operation of MSRE was terminated. The thimble is made of 2-in.-OD × 0.065-in.-wall INOR-8 tubing (heat Y-8487). The electric arc cut on the left was near the center line of the core.

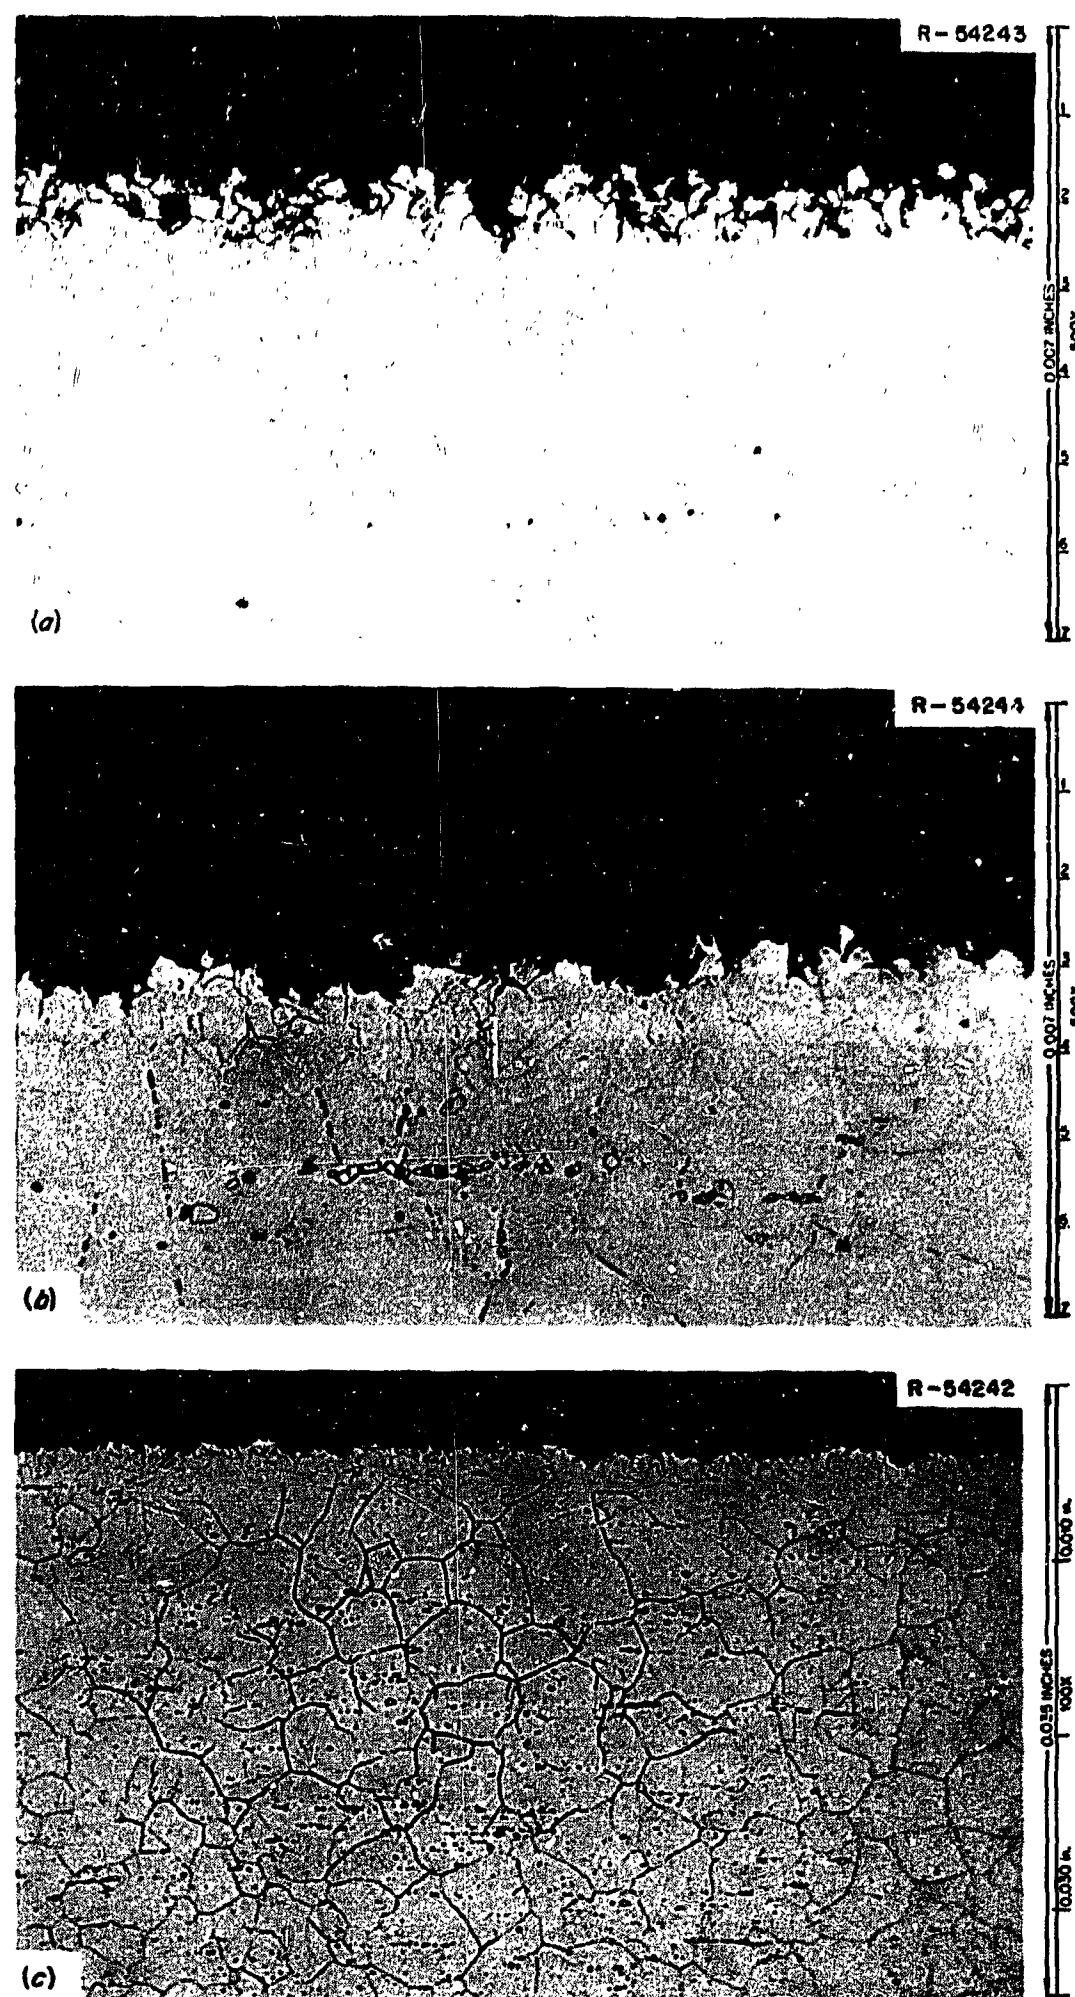
Samples of the control rod thimble and the spacer sleeve were cut and examined to determine their condition at the end of service. Typical photomicrographs of the inside of the thimble tube are shown in Fig. 13. This surface was oxidized to a depth of about 2 mils by the cell environment of nitrogen containing 2 to 5% O<sub>2</sub>. The oxidation process modified the microstructure to a depth of 4 mils, likely by the selective removal of chromium.

**Fig. 13. Inner surface of INOR-8 control thimble in as-removed condition. This surface was exposed to cell environment of N<sub>2</sub> containing 2 to 5% O<sub>2</sub>. (a) As polished; (b) etched; (c) etched, typical microstructure. Etchant: aqua regia. Reduced 30.5%.**

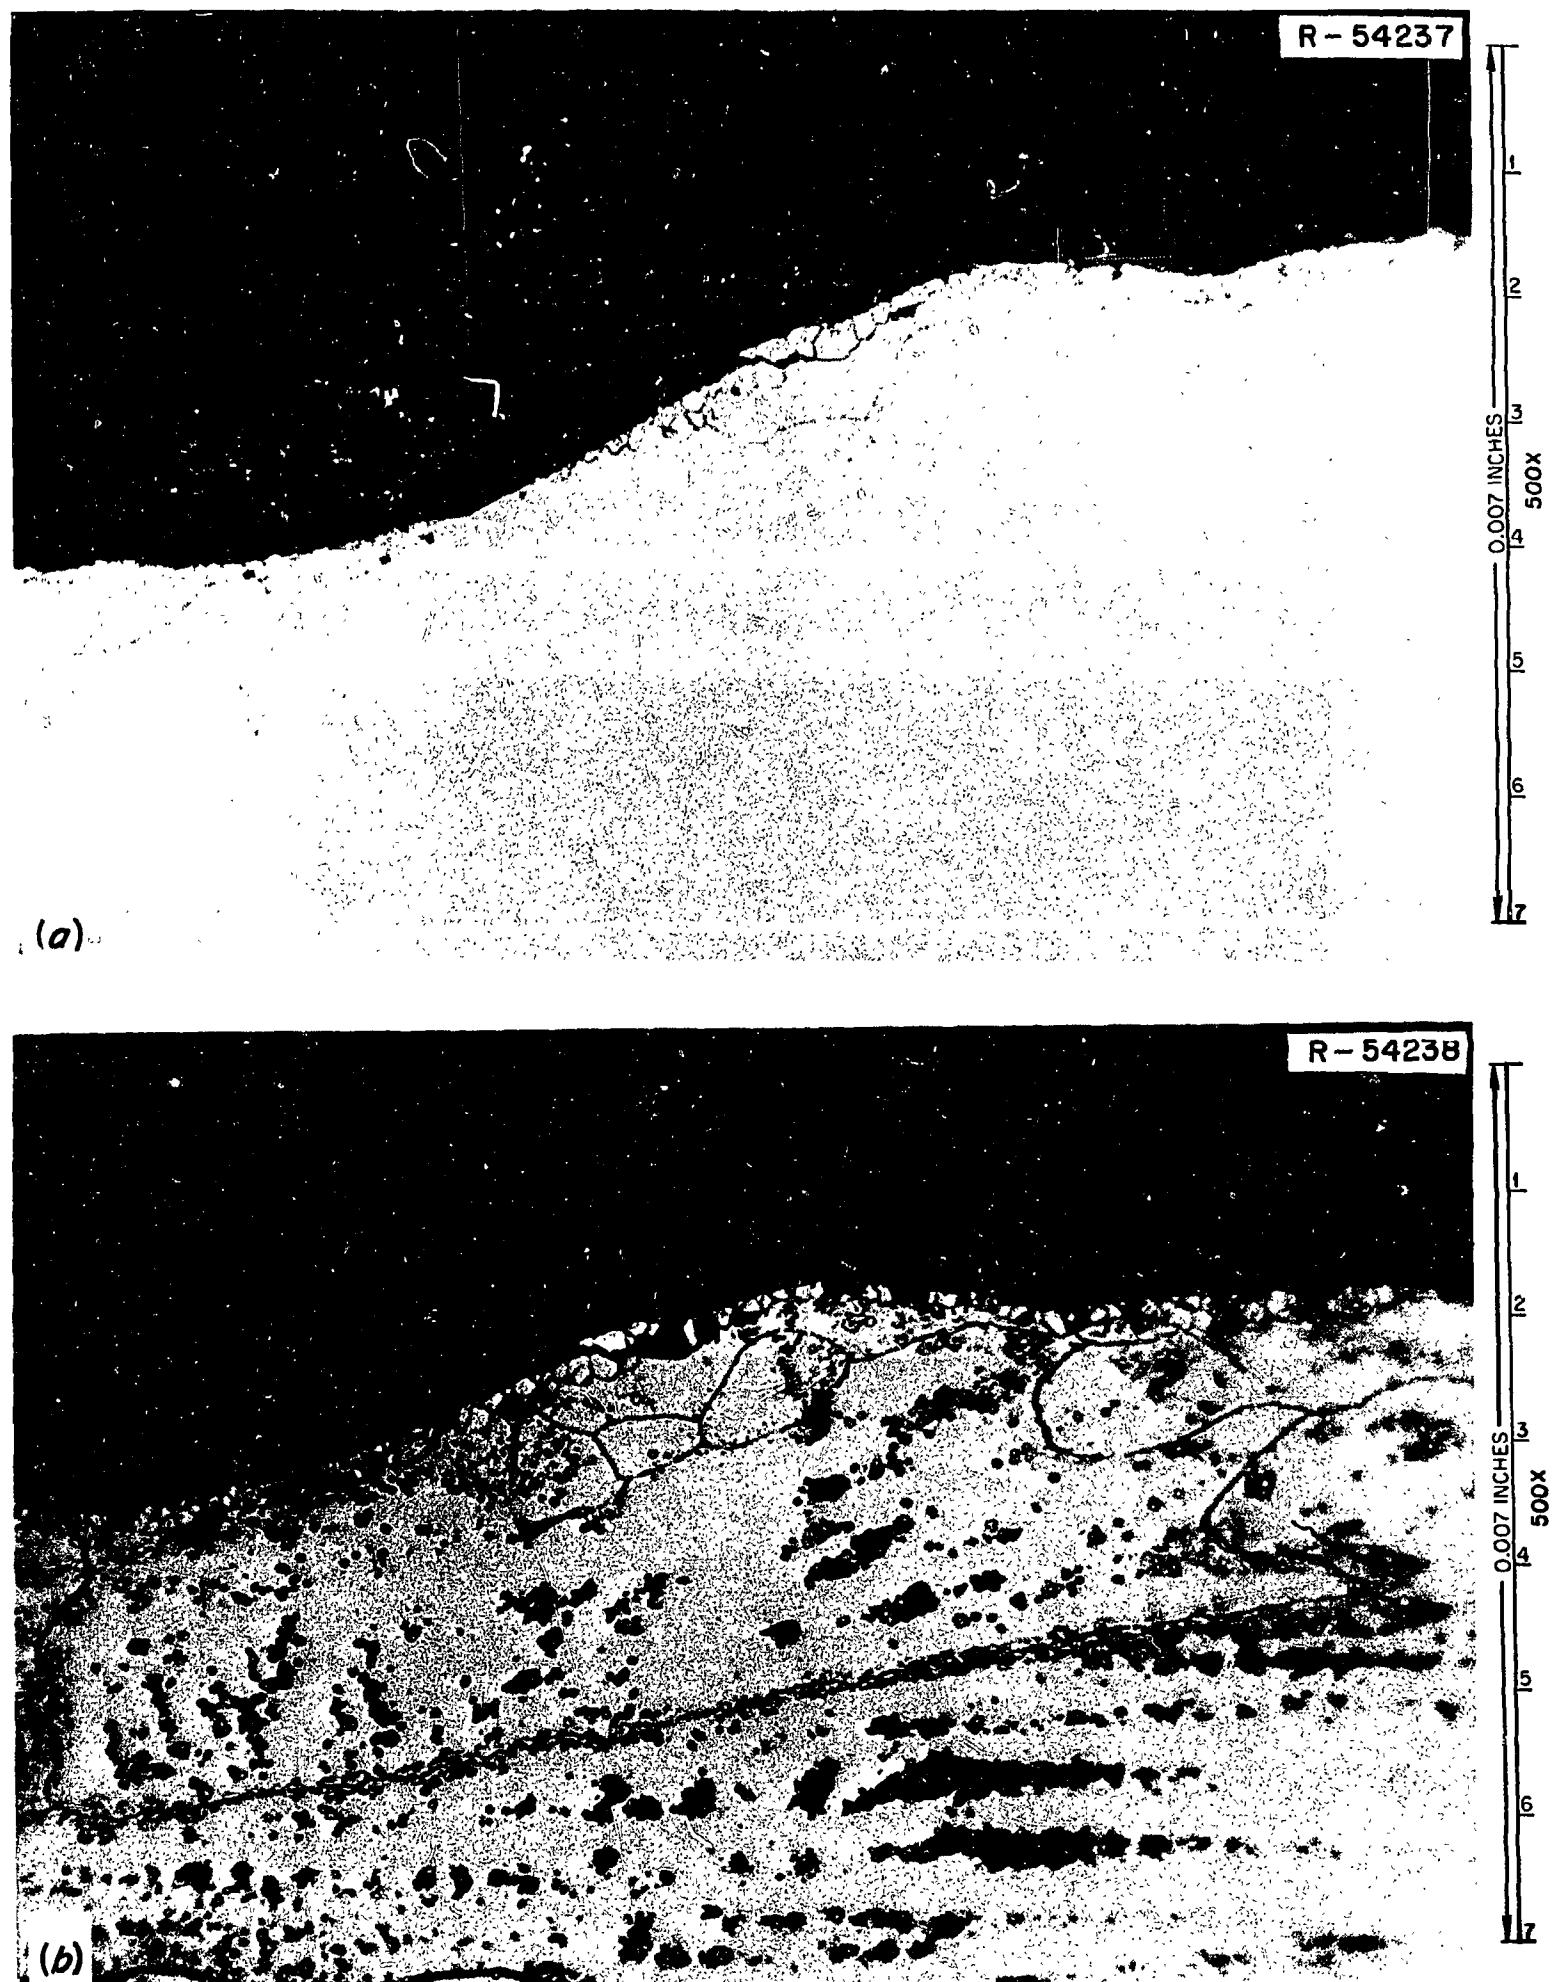
Photomicrographs of one of the weld beads are shown in Fig. 14. All of the surface shown was exposed to flowing fuel salt. Some grains were dislodged near the surface, and grain boundaries are visible in the as-polished condition to a depth of 1 to 1.5 mils.

Fig. 14. Outer surface of INOR-8 control rod thimble showing weld deposit made to hold spacer sleeve. The weld surface was exposed to flowing salt. (a) As polished; (b) etched with aqua regia.

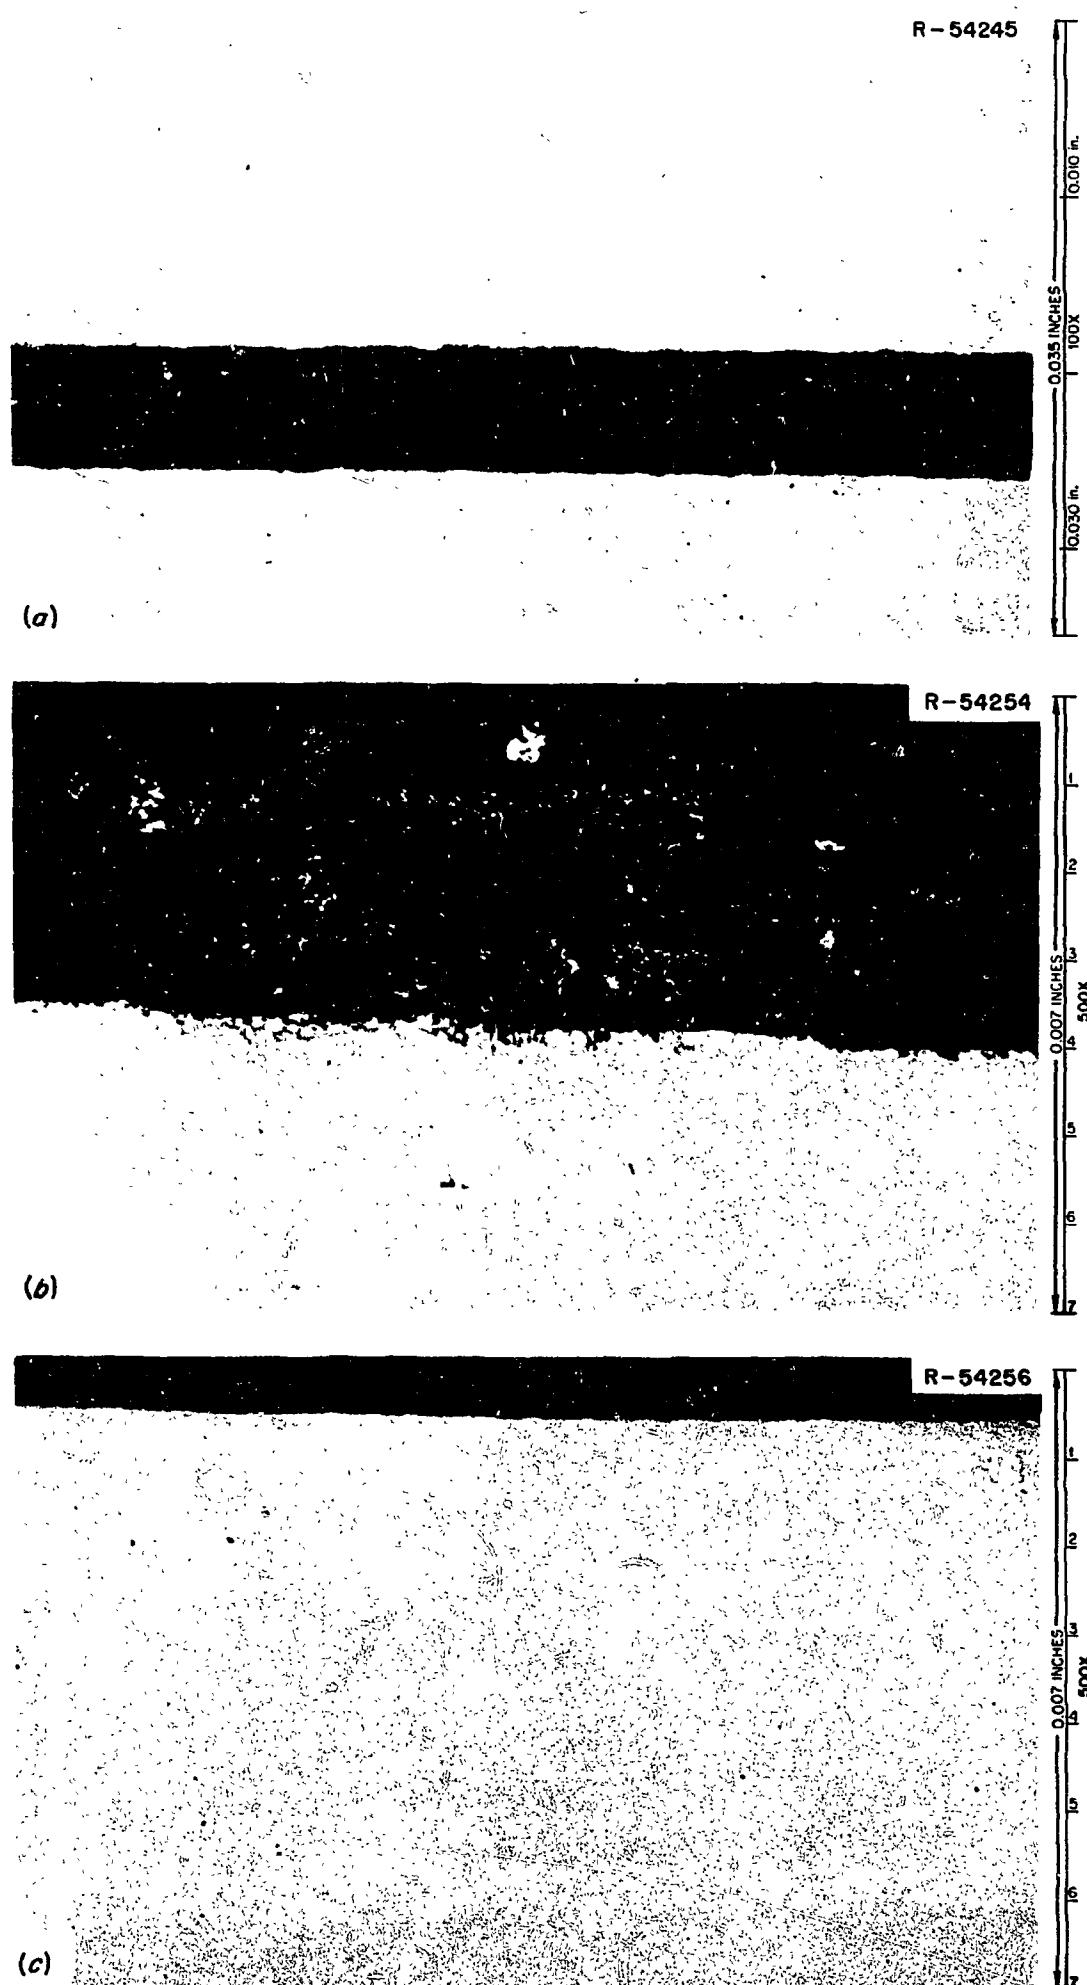
Photomicrographs involving the interface between the thimble and sleeve are shown in Fig. 15. Figure 15(a) shows the annular region with a separation of about 7 mils and some salt present. Few surface irregularities are visible at a magnification of 100x, indicating that they are considerably below 1 mil. Figure 15(b) is a 500x view of the thimble and shows some surface cracks to a depth of 0.3 mil. The outside of the sleeve is shown in Fig. 15(c); a few grain boundaries to a depth of about 1 mil are visible. Additional photomicrographs of the sleeve are shown in Fig. 16. The sleeve material does not appear to have received much work, since the carbide is very inhomogeneously distributed. Grain size is larger than usual away from the stringers. The inner and outer surfaces both have modified structures. A higher magnification view of the inner surface [Fig. 16(b)] shows that much of the modification is a high density of primary carbide. The outer surface [Fig. 16(c)] has a shallow layer of small grains, likely due to a working operation.

Fig. 15. As-polished surfaces of INOR-8 control rod thimble and sleeve. (a) Annulus between thimble and sleeve; thimble surface is in upper part of picture. (b) Outside surface of control rod thimble, showing presence of some salt and shallow surface cracking. (c) Outside surface of sleeve; surface exposed to flowing fuel salt.

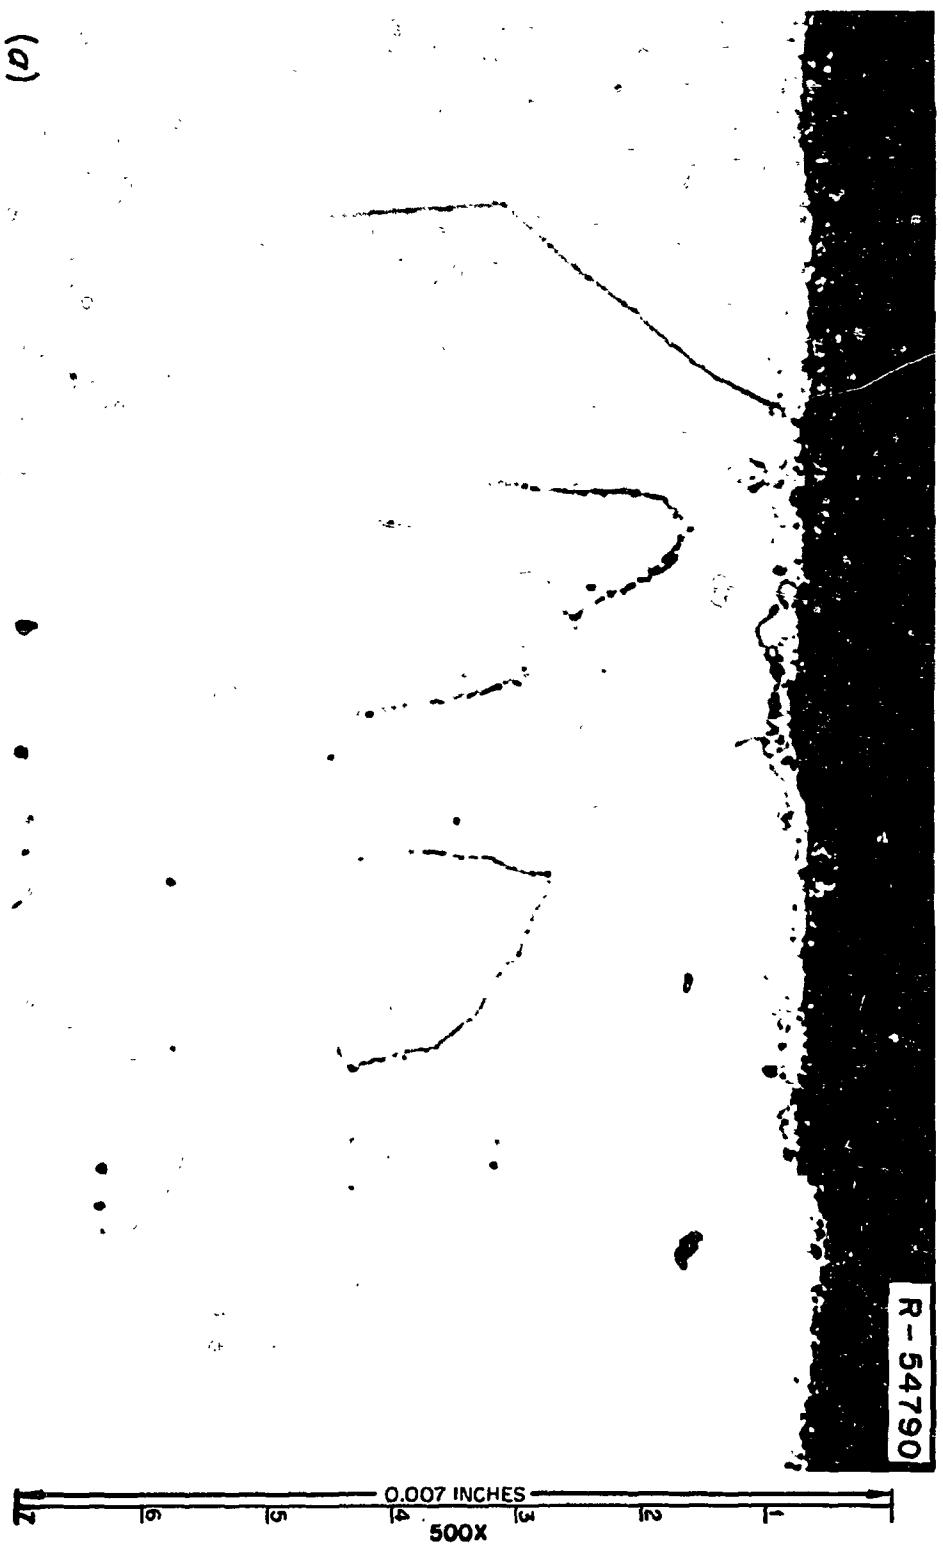
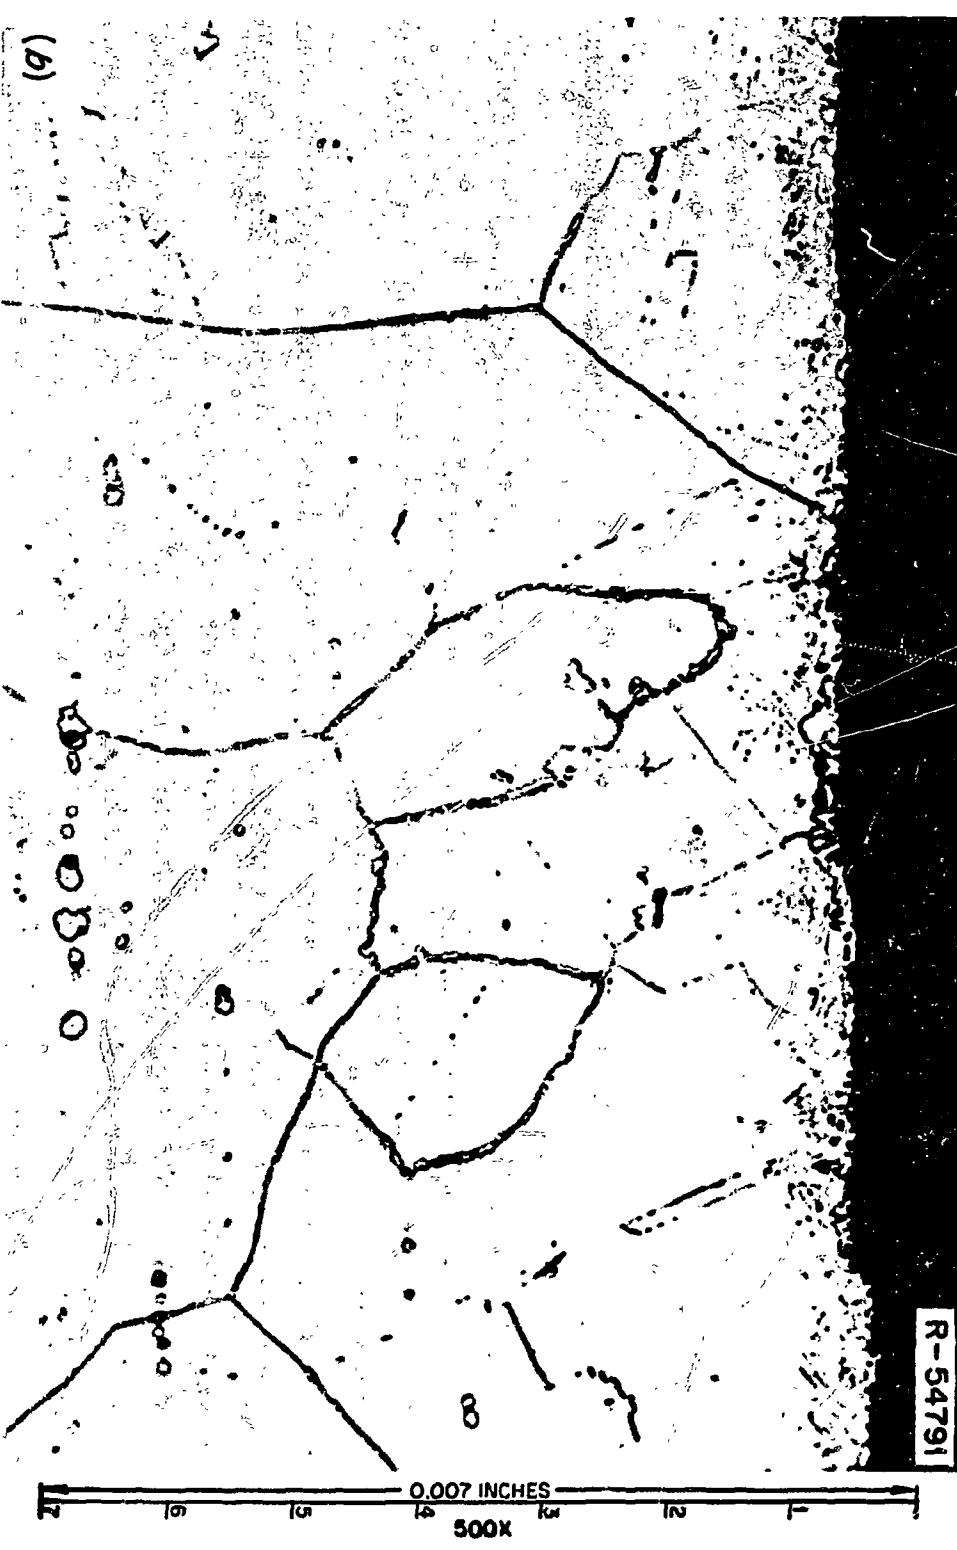
A second cut was made away from the sleeve, and typical photomicrographs are shown in Fig. 17. This part of the thimble was exposed to flowing salt. Some of the grain boundaries are visible in the as-polished condition to a depth of about 4 mils, and there is some surface modification [Fig. 17(a)]. Etching [Fig. 17(b)] delineates more of the grain structure and shows the shallow surface modification.

FIG. 17. INOR-8 control rod thimble where it was exposed directly to flowing salt. (a) As polished; (b) etched with aqua regia.

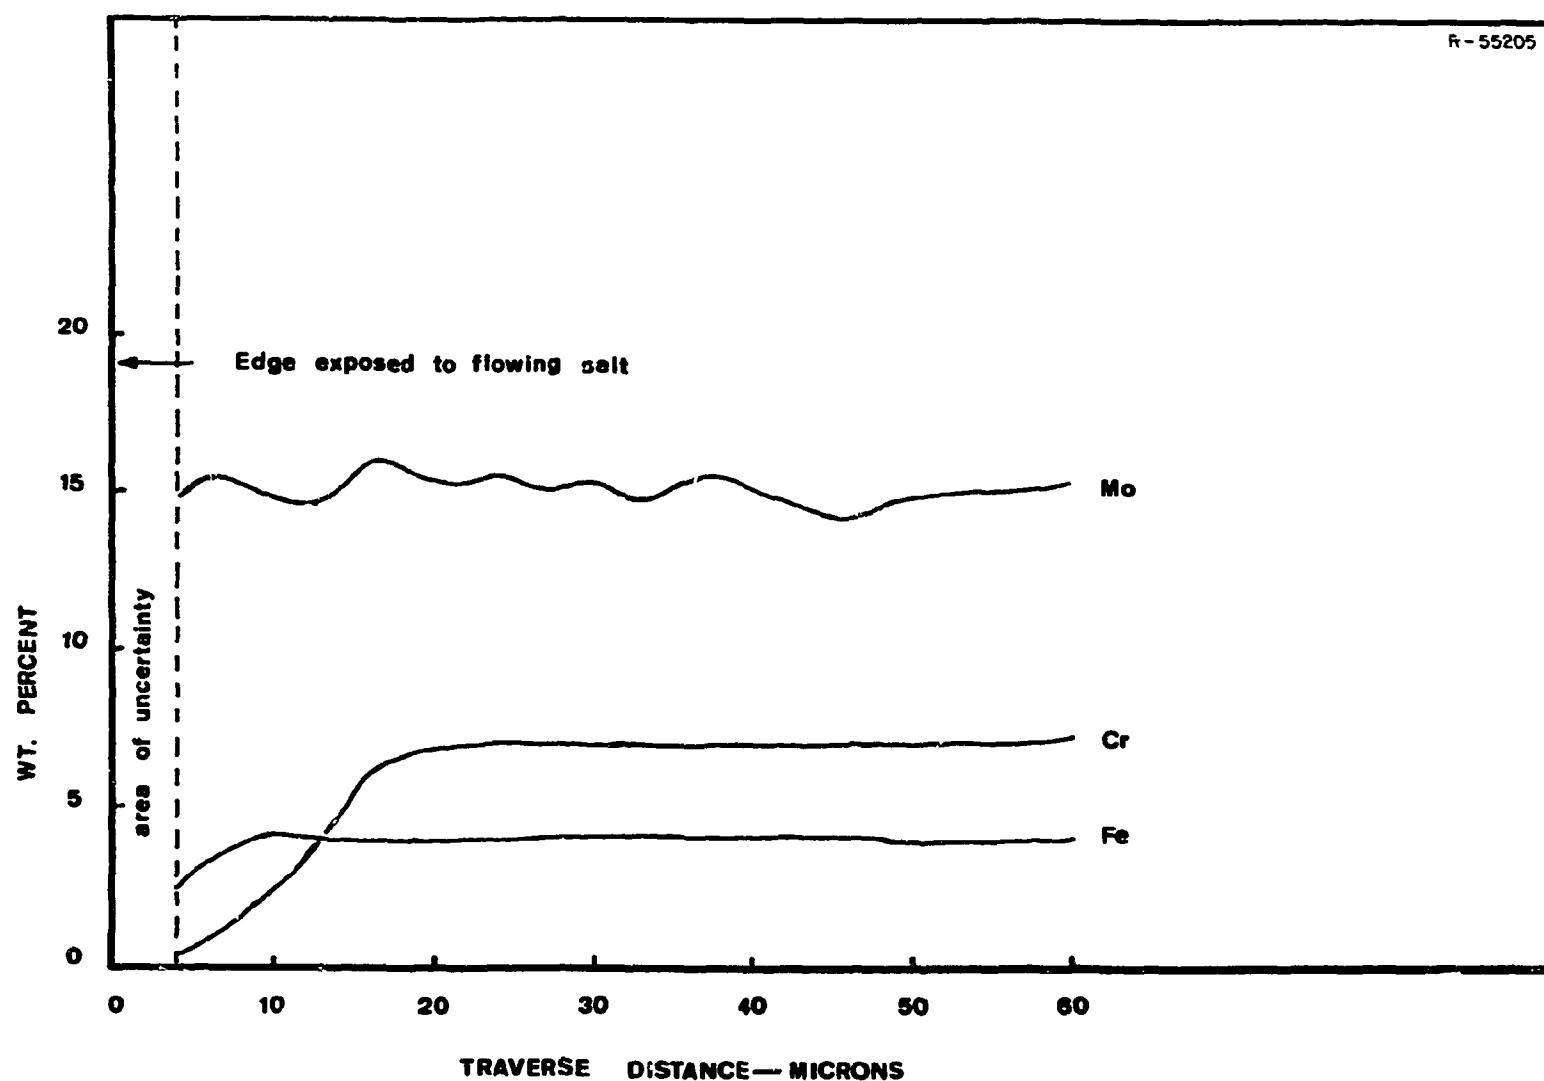
Microprobe scans were run on the thimble samples that were taken from under the sleeve and outside the sleeve. In the first case the thimble wall was exposed to almost static fuel salt, and no gradients in iron and chromium concentration could be detected within the 3- $\mu\text{m}$  region of uncertainty near the surface. The sample outside the sleeve, which was exposed to flowing fuel salt, was depleted in chromium to a depth of almost 20  $\mu\text{m}$  and in iron to a depth of 10  $\mu\text{m}$  (Fig. 18). Thus the amount of corrosion that occurred varied considerably in the two regions. Measurements were not actually made, but we would expect similar results for the spacer sleeve. The inside surface was exposed to almost static salt and was likely not corroded detectably. The outside surface was exposed to flowing salt and probably was depleted in iron and chromium.

Fig. 18. Electron microprobe scan of INOR-8 sample from control rod thimble. Thimble had been exposed to fuel salt for 21,040 hr and had been above 500°C for 30,807 hr.

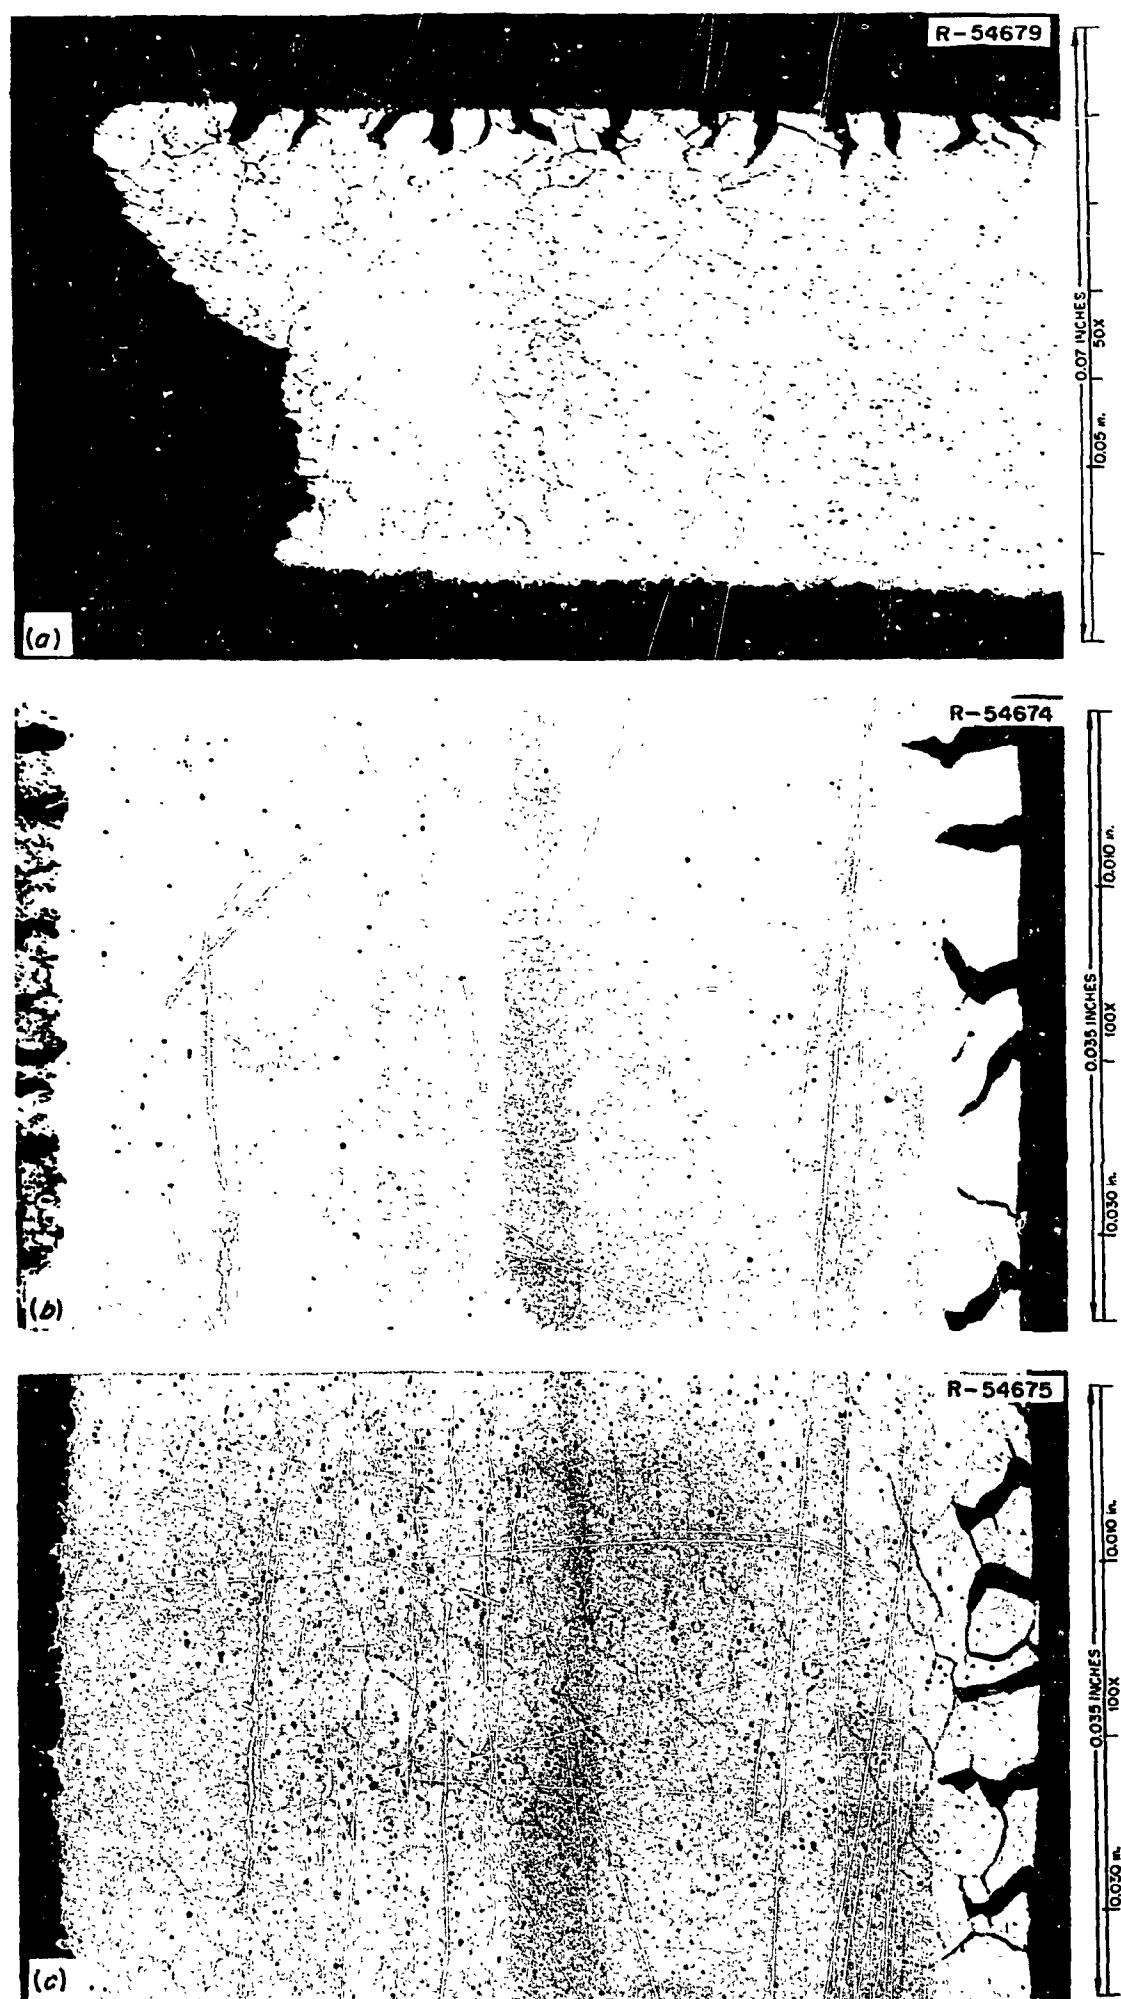
Several of the specimens that had been strained were examined metallographically to determine the extent of cracking during straining. Photomicrographs of the control rod thimble, which was exposed to flowing salt, are shown in Fig. 20. The inside surface was oxidized, and the oxide cracked as the specimen was strained. The oxide should be brittle, but it is important that these cracks did not penetrate the metal.

Fig. 20. INOR-8 control rod thimble specimen exposed to flowing salt and tested at 25°C. (a) Fracture — dark edge is oxide on inner surface of tube; cracks formed on outer surface; etched. (b) Cracks in outer surface of tubing as polished. (c) Cracks in outer surface of tubing; etched. Etchant: aqua regia. Reduced 30.5%.
