POSTIRRADIATION EXAMINATION OF MATERIALS FROM THE MSRE

H. E. McCoy      B. McNabb

DECEMBER 1972

OAK RIDGE NATIONAL LABORATORY  
Oak Ridge, Tennessee 37830  
operated by  
UNION CARBIDE CORPORATION  
for the  
U.S. ATOMIC ENERGY COMMISSION

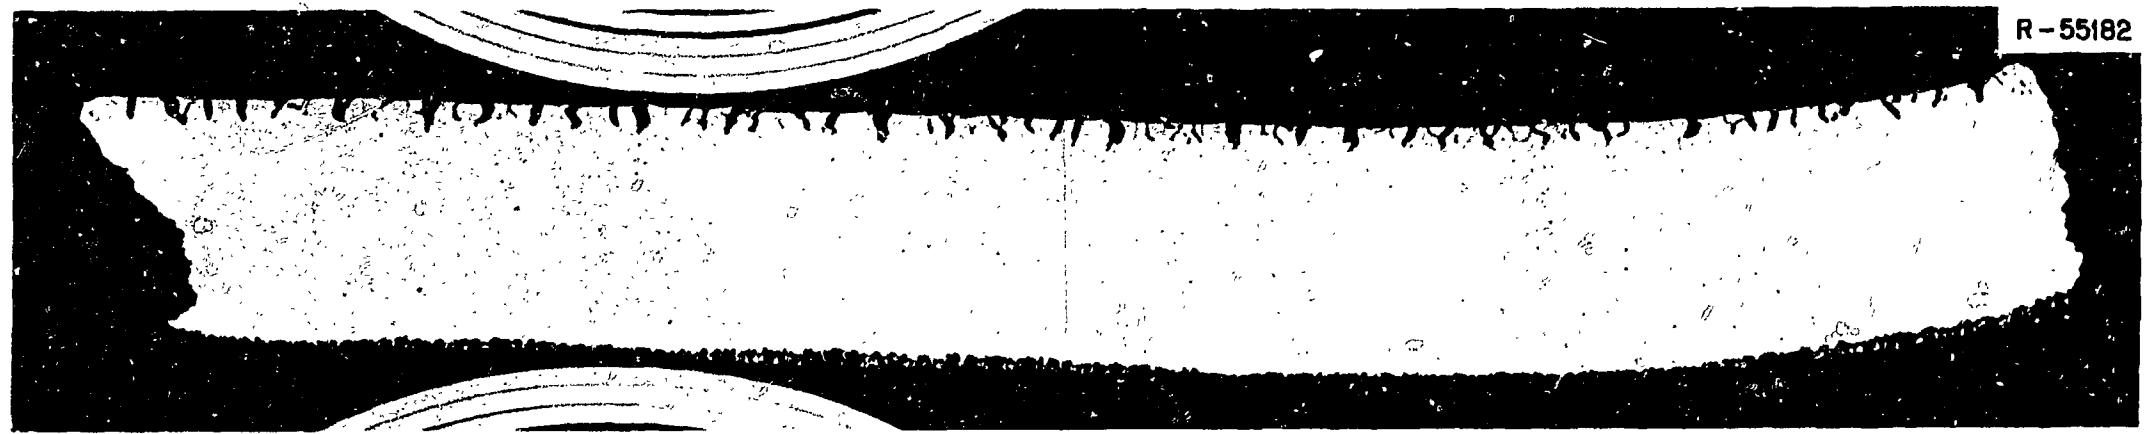
However, the side exposed to the salt exhibited profuse intergranular cracking. Almost every grain boundary cracked, and the cracks generally propagated to a depth of one grain, although there are several instances where the crack depth exceeded a depth of one grain. Several photomicrographs were combined and rephotographed to obtain Fig. 21. This sample had 192 cracks per inch, with average and maximum depths of 5.0 and 8.0 mils respectively. Many of the cracks shown in Figs. 20 and 21 have blunt tips, indicating that they did not propagate into the metal as the specimen was strained.

Fig. 21. Deformed section of INOR-8 control rod thimble. Fracture is on the left. The upper surface was in contact with flowing salt; the lower surface was exposed to the cell environment of  $N_2$  plus 2 to 5%  $O_2$ . The sample is about 0.06 in. thick.

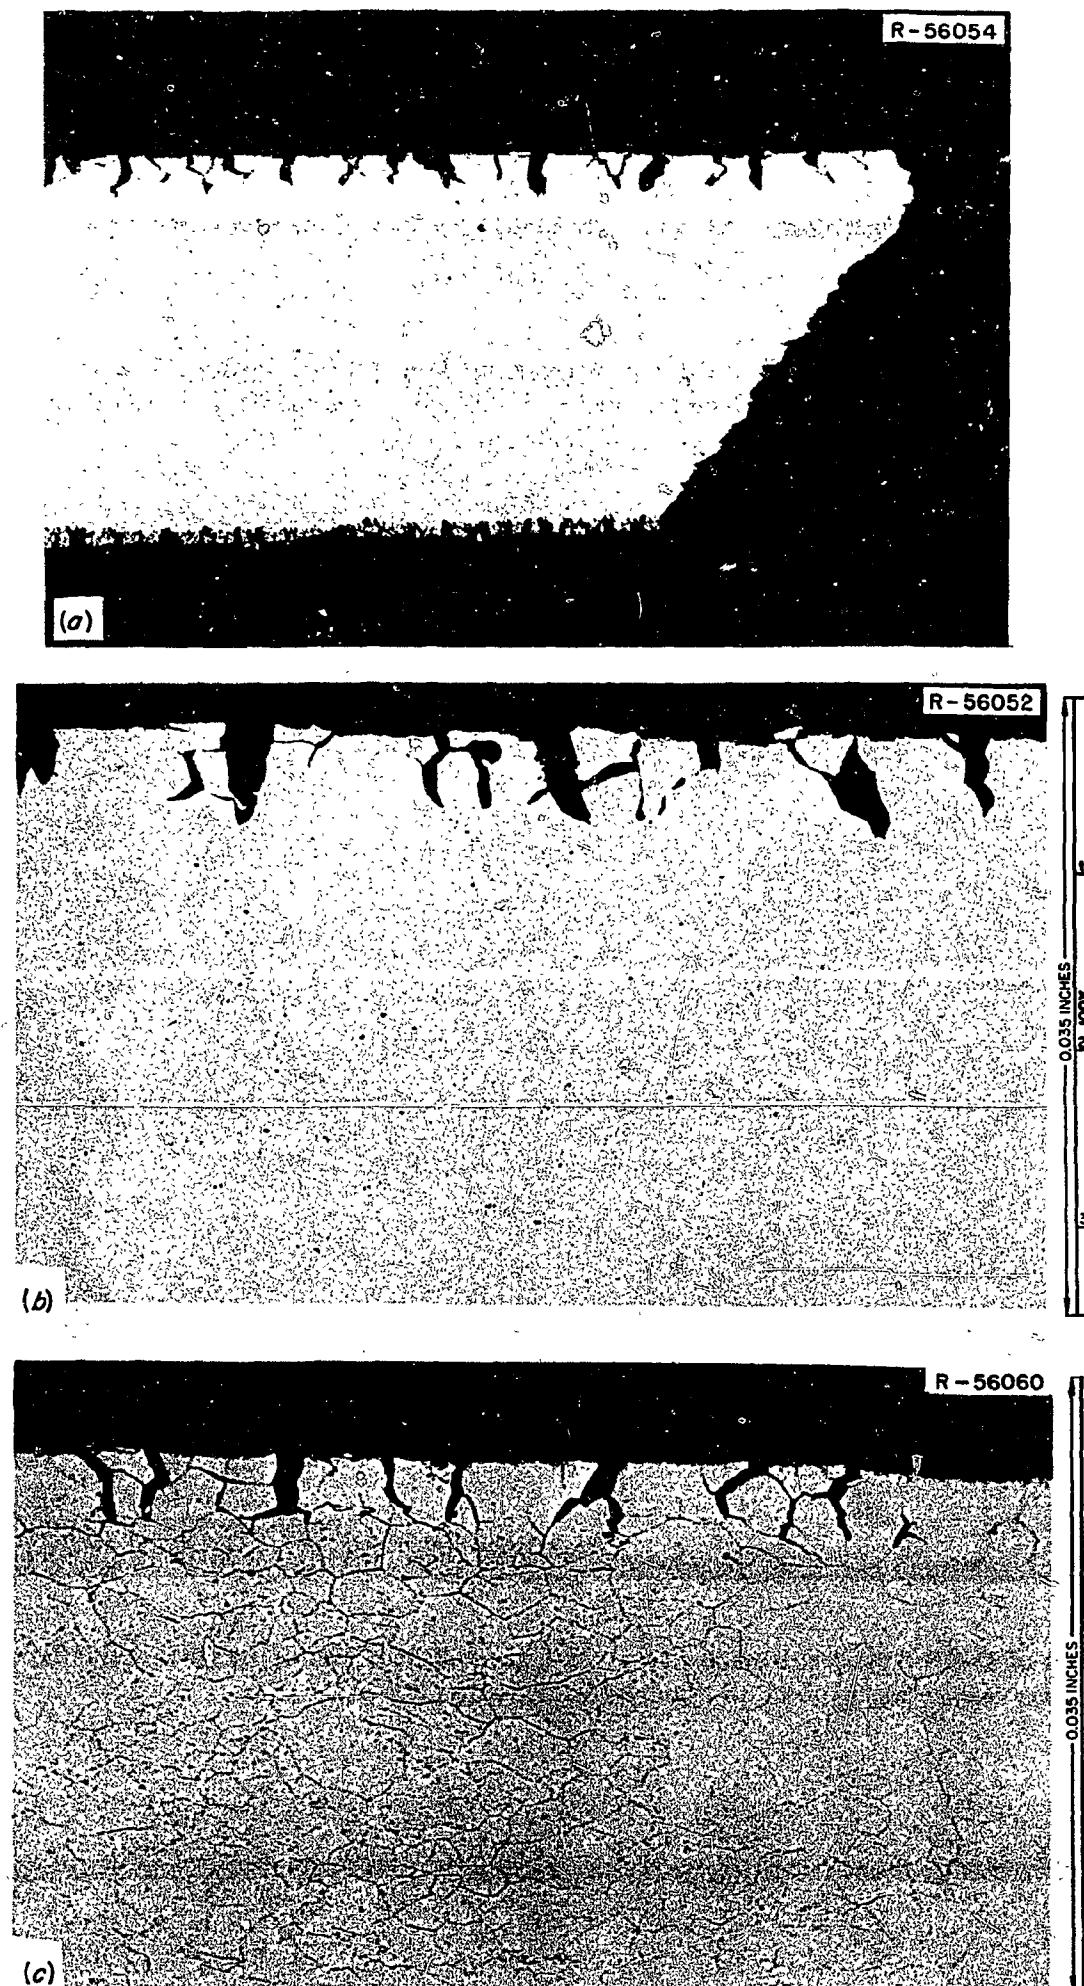
Fig. 22. INOR-8 control rod thimble exposed to fuel salt under a spacer sleeve and tested at 25°C. (a) As-polished view of fracture. 40X. (b) As-polished view of cracks. (c) Etched view of cracks. Etchant: aqua regia. Reduced 30.5%.

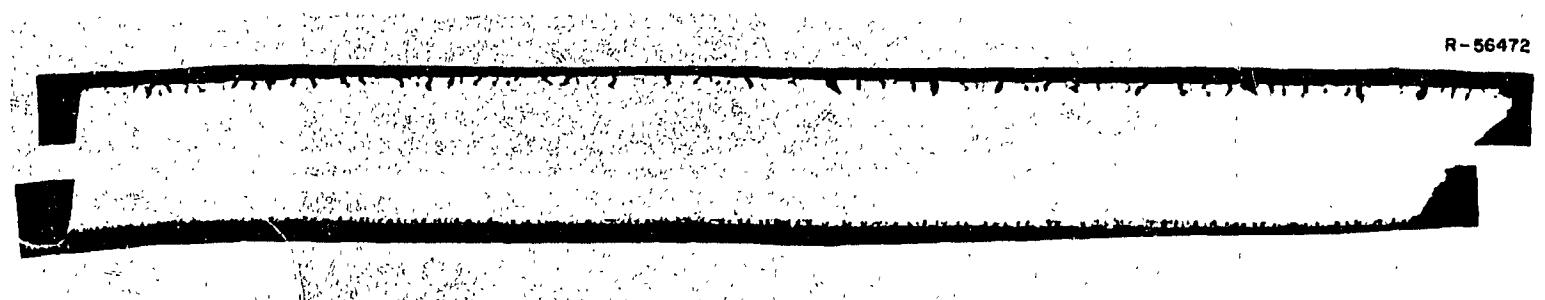
**Fig. 23.** Composite photograph showing density of cracking along edge of portion of deformed INOR-8 control rod thimble. 9.5X. The sample is 0.58 in. long. The fracture is on the right, the upper surface was exposed to fuel salt, and the lower surface was exposed to the cell environment of  $N_2$  plus 2 to 5%  $O_2$ .

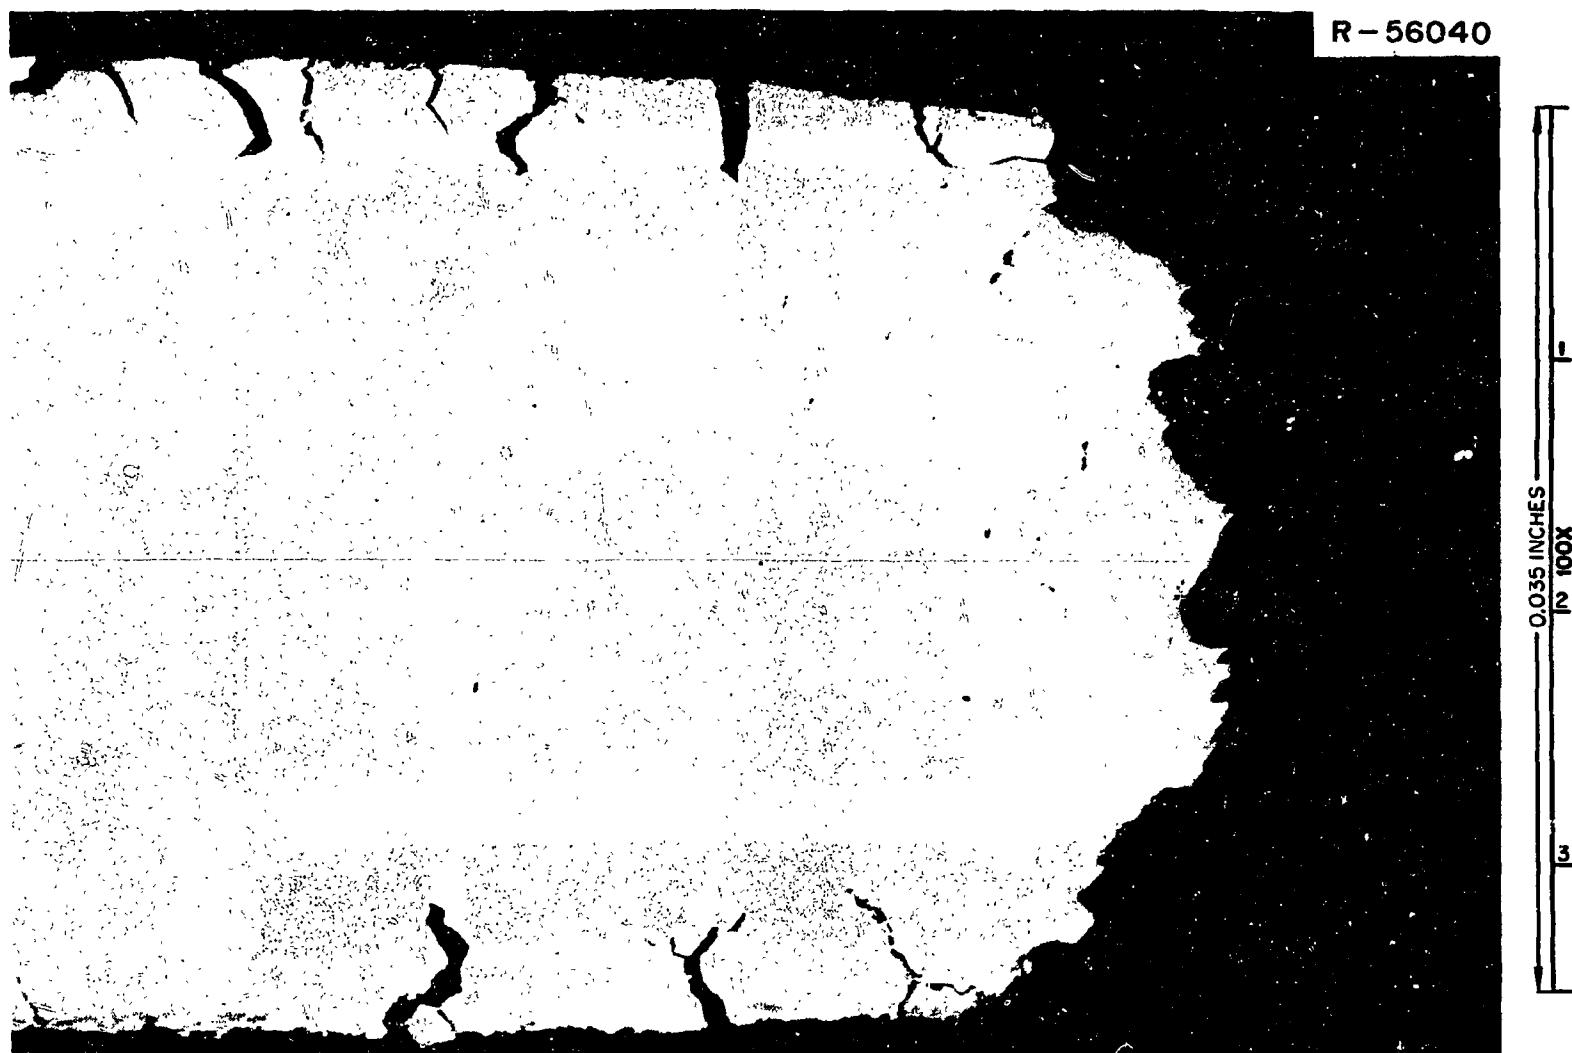
**Fig. 24.** Section of INOR-8 spacer sleeve tested at  $25^\circ C$ ; as polished. The upper surface was exposed to almost static fuel salt, and the lower surface was exposed to rapidly flowing fuel salt.

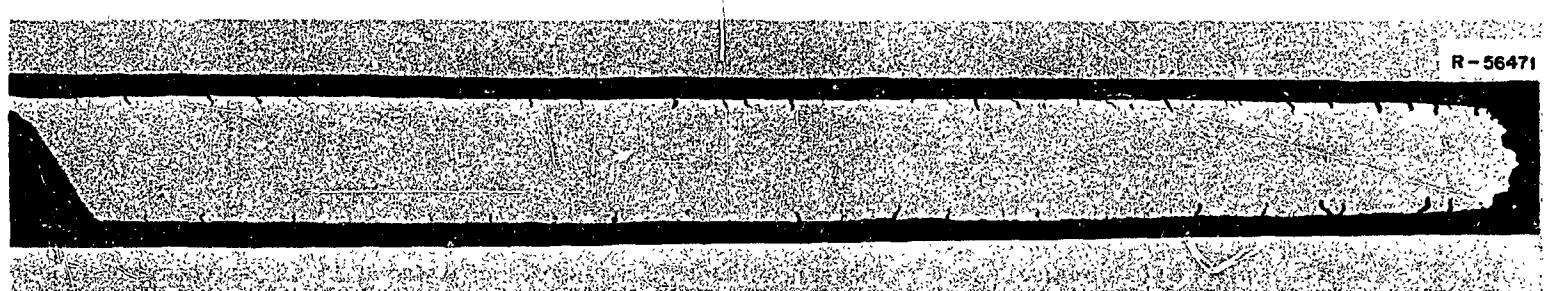
**Fig. 25.** Composite photograph comparing density of cracking on sides of INOR-8 spacer sleeve exposed to almost static salt (top) and to flowing salt (bottom). 11X. The sample is 0.52 in. long. Reduced 43%.

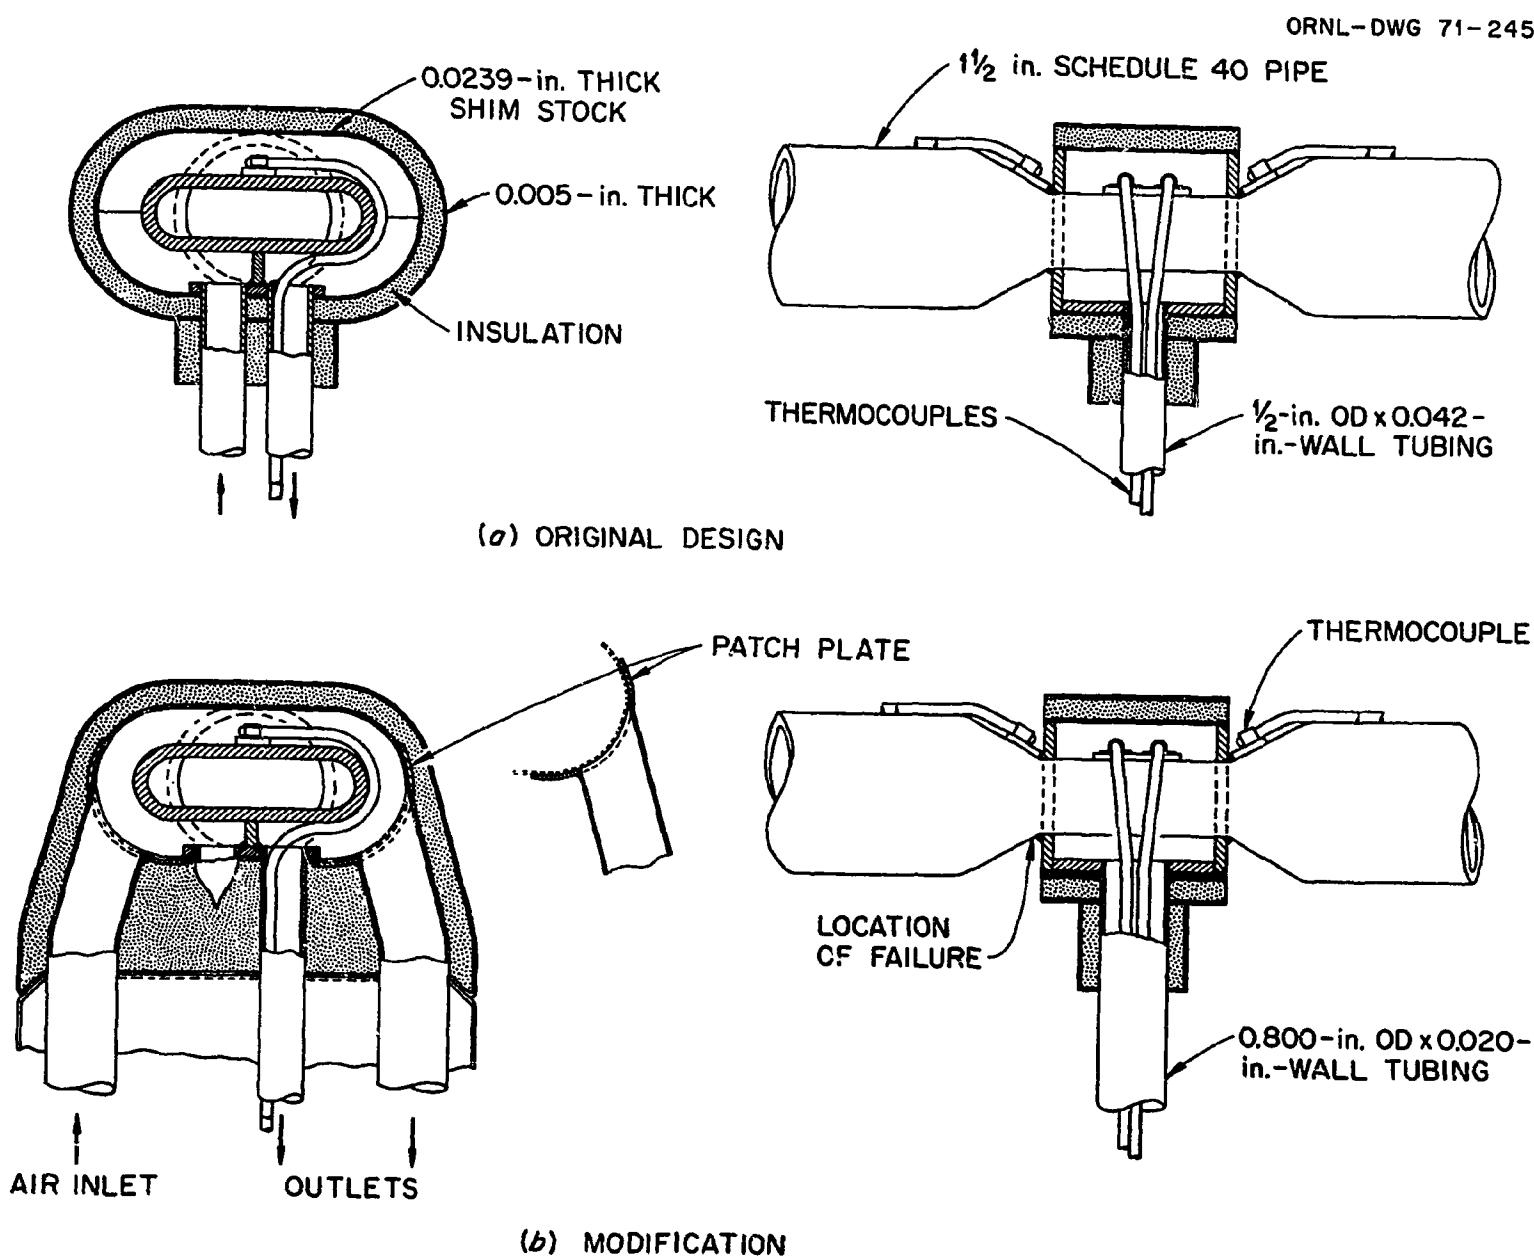
**Fig. 28. Diagram showing possible cause of freeze-valve failure after modification.**

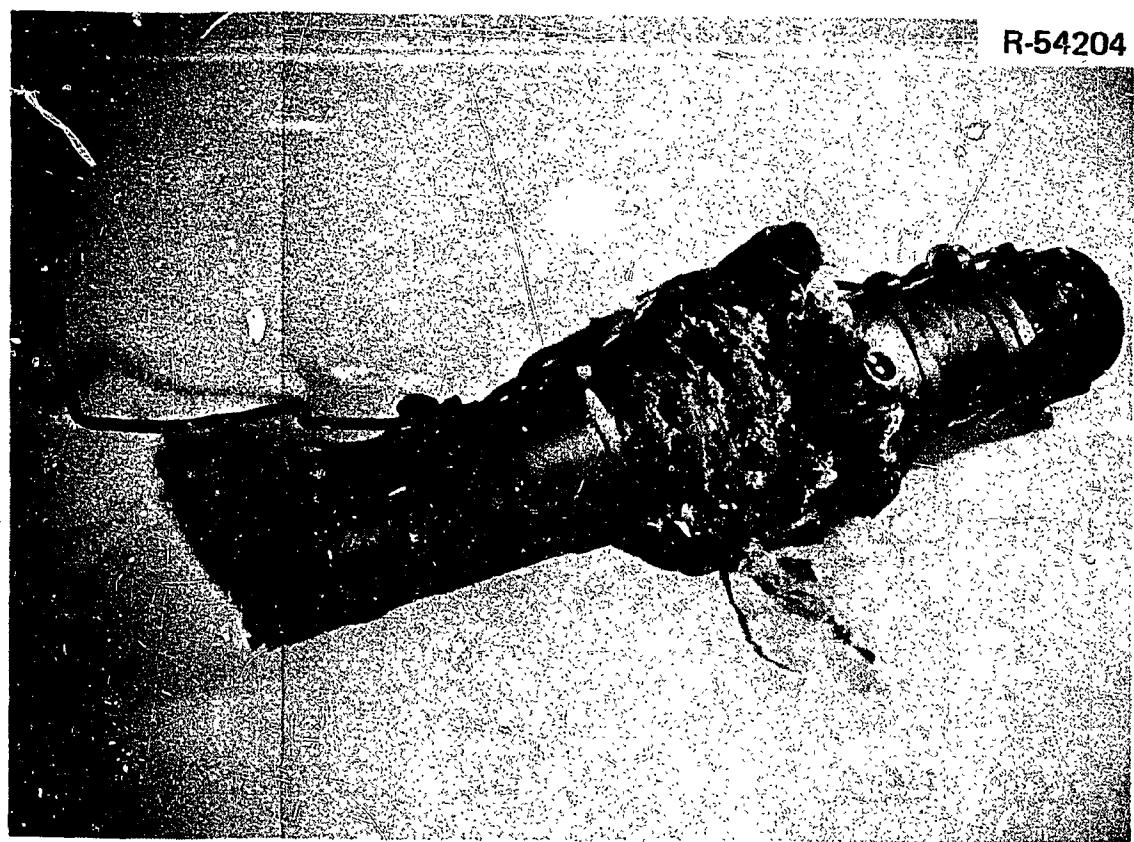
The salt was partially removed to reveal the crack shown in Figs. 30 through 32. The crack begins at the spot on the weld and proceeds about 1 in. parallel to the weld.

**Fig. 30. Bottom portion of freeze valve 105.**

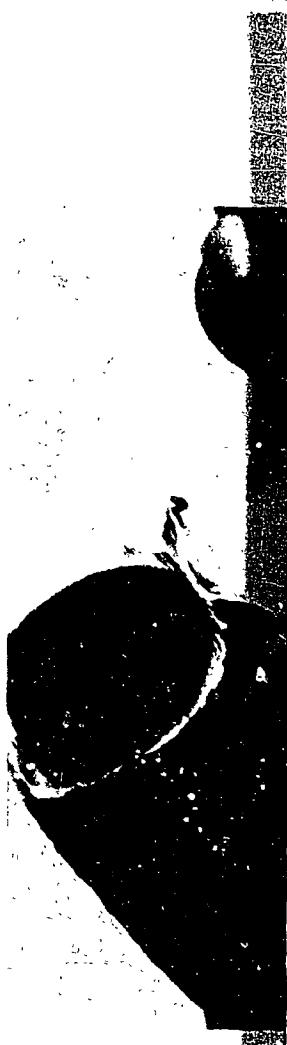
Fig. 31. Closeup of the bottom of freeze valve 105 showing INOR-8 gas inlet and outlet line of type 304 stainless steel was corroded completely. The crusty substance is the salt. Note that there is no salt in the air annulus.

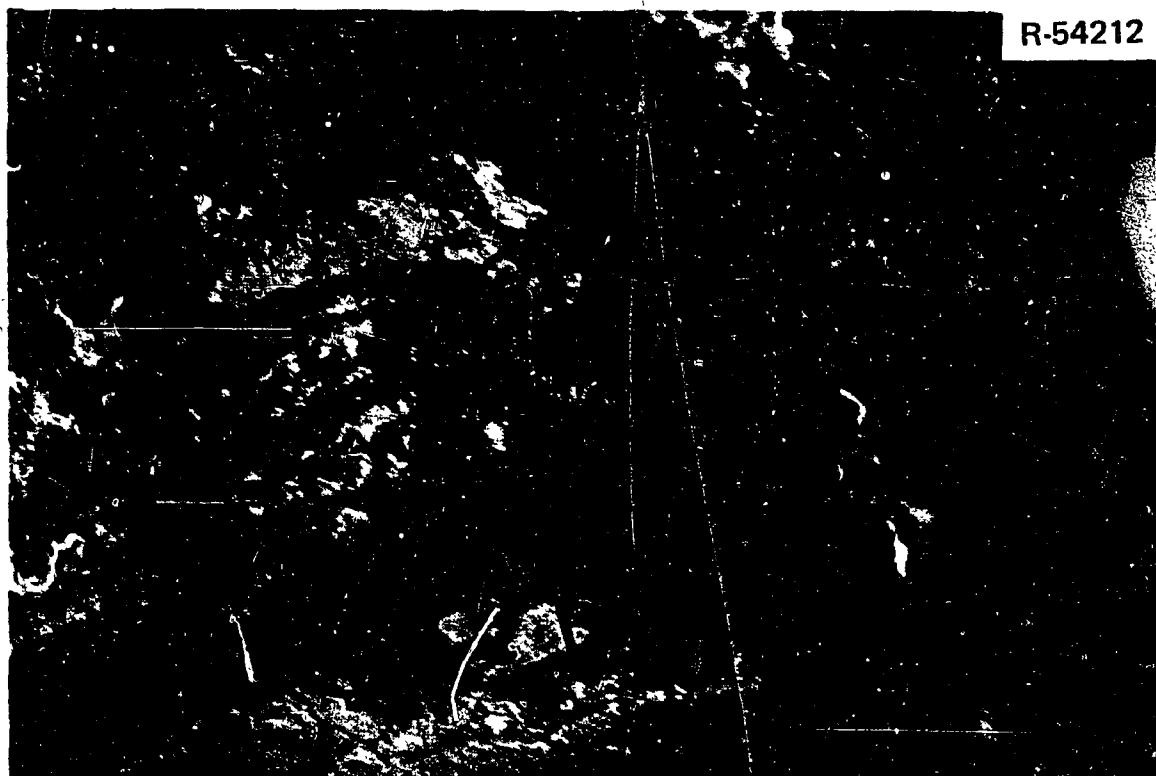
Fig. 32. Weld at one end of cooling shroud. The crack begins at the round salt stain and proceeds for about 1 in. along pipe. The arrow points to the salt stain with the crack at 90° to the arrow.

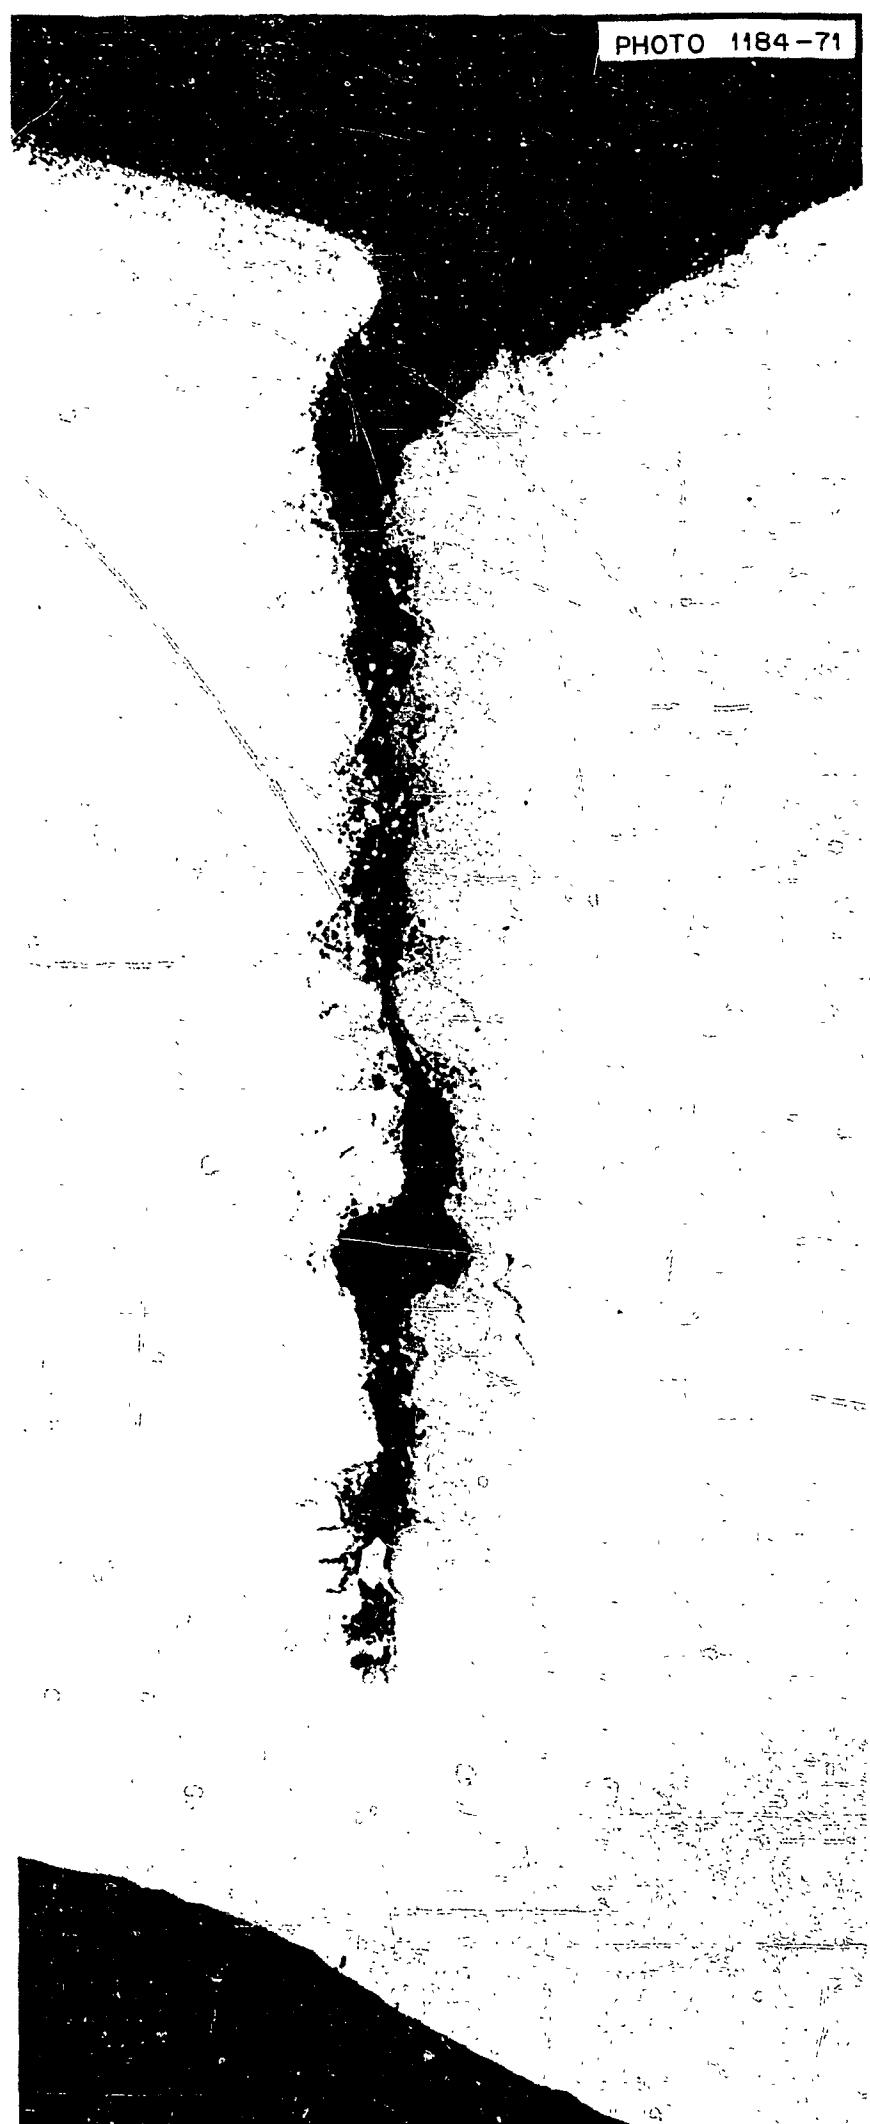
**Fig. 33. INOR-8 tube wall of freeze valve 105 where the failure occurred. As polished, 50X. Bottom surface was exposed to fuel salt and the upper surface to air, with some salt after the leak occurred. Reduced 15%.**

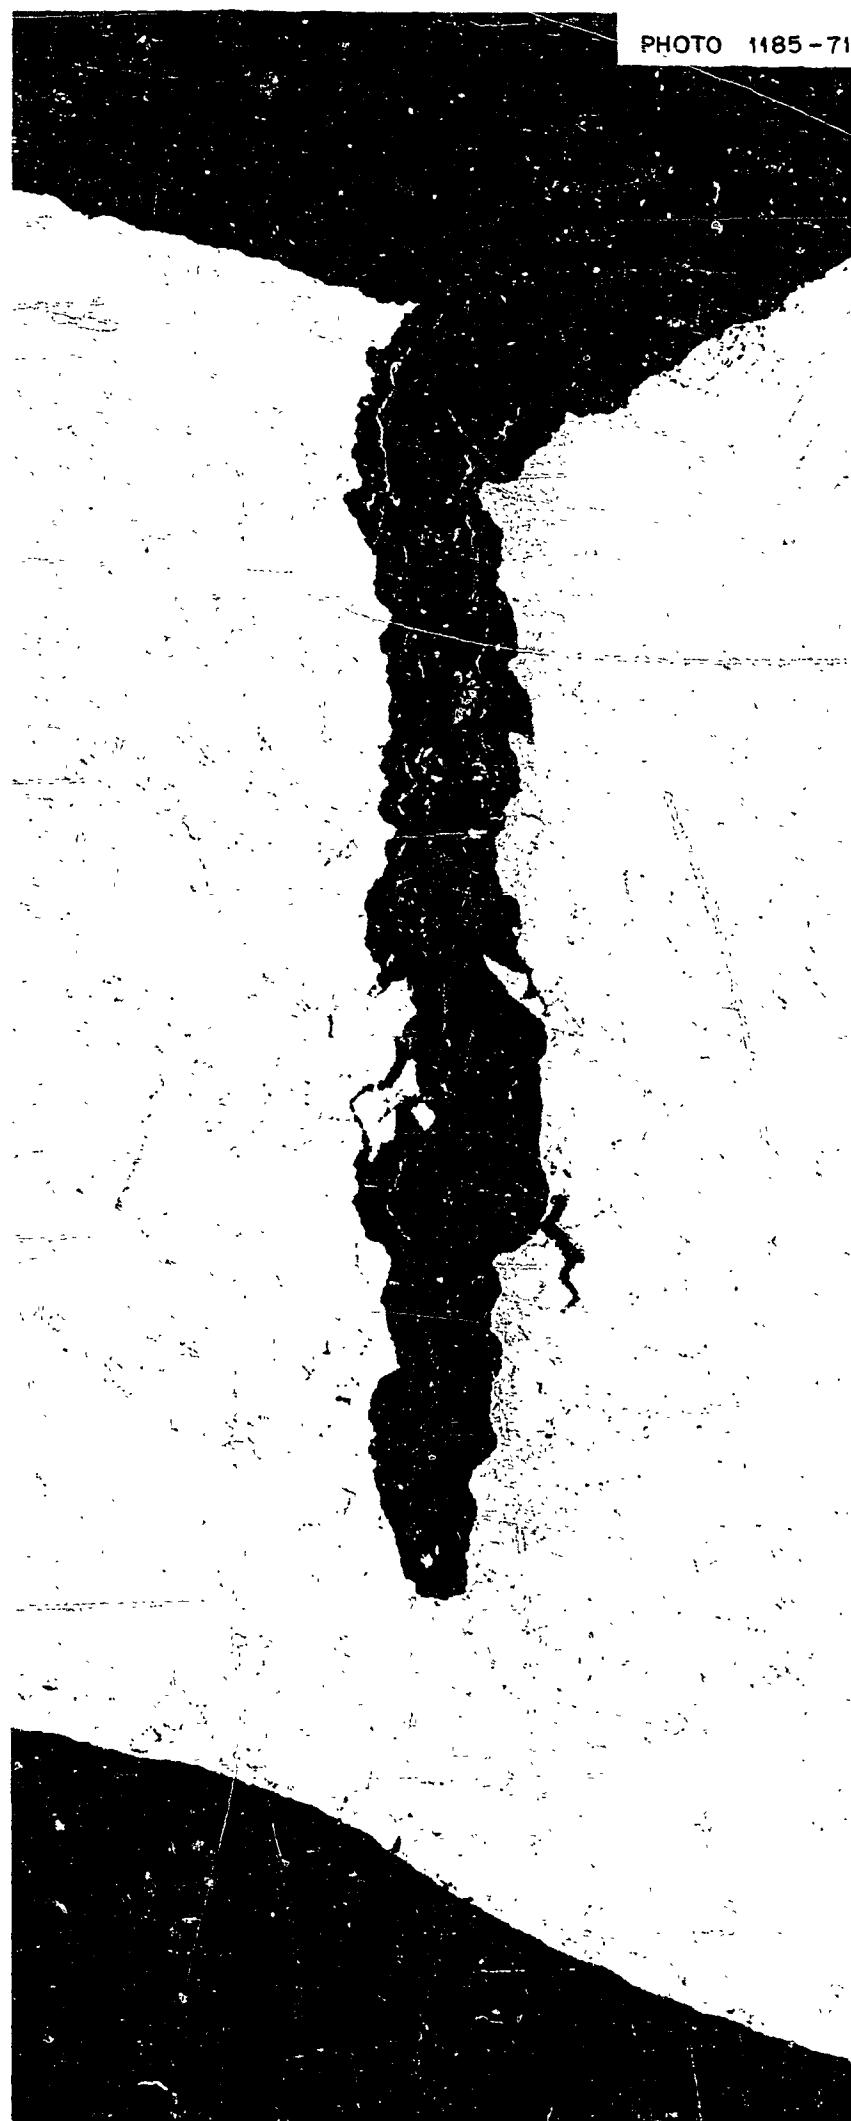
**Fig. 34. INOR-8 tube wall of freeze valve 105 where the failure occurred. The weld supports the end of the cooling shroud; the failure occurred outside the cooling shroud. Etchant: aqua regia. 50X. Reduced 15%.**

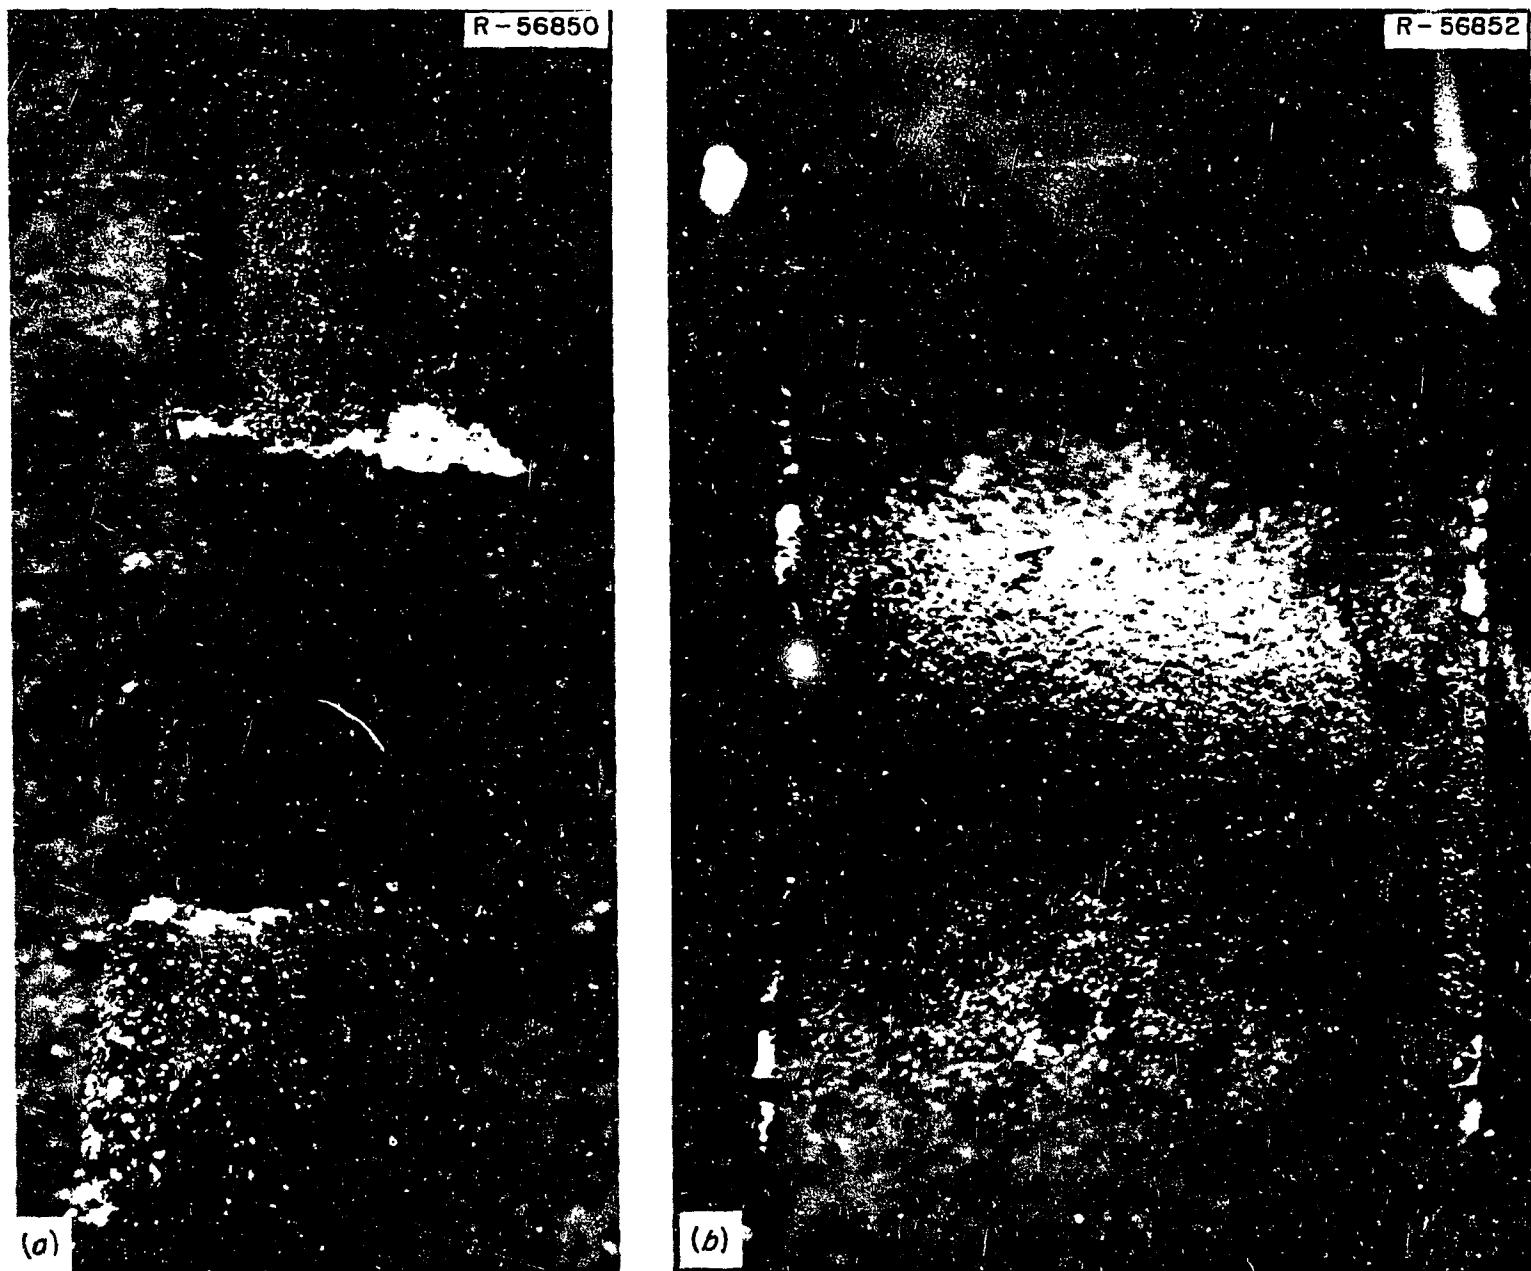
Fig. 35. INOR-8 surfaces exposed to salt in freeze valve 105 after deformation at 25°C. (a) Fracture of ring specimen pulled in tension. Note surface cracks near fracture. 4X. (b) Surface of bend specimen. Note some cracks on surface and edge cracks. 7X. Reduced 18.5%.

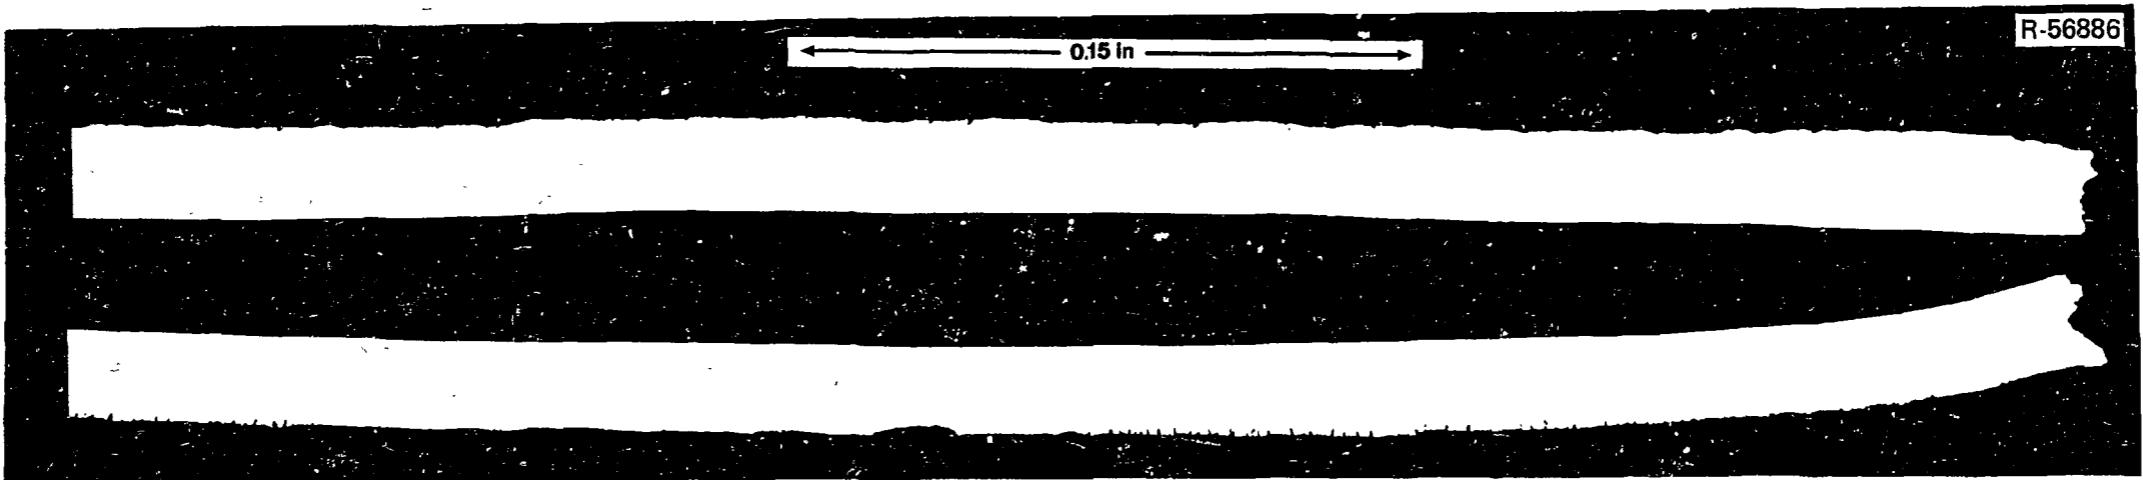
One of the three tensile-tested rings was examined metallographically. Figure 36 is a composite of photomicrographs of a section through the specimen showing the inside surface, which was exposed to fuel salt (top), and the outside, which was exposed to the cell environment of 2 to 5% O<sub>2</sub> in nitrogen. The reason for the unevenness of the oxide on the outside is not known. Possibly it was due to corrosion after the leak, although the rings were cut approximately 4 in. away from the nearest visible residue from the salt leak. Figure 37 shows at 500x the oxide in one of the worst areas. The crack ends tend to be blunted and did not penetrate the metal beyond the oxidized surface. Figure 38 shows at 500x the inside of the pipe exposed to fuel salt. About 1 crack per grain or 240 cracks per inch show, but the cracks are shallow and blunt, having an average depth of 0.75 mil and a maximum depth of 1.5 mils. Figure 39 shows that a large amount of strain occurred before fracture.

Fig. 36. Composite of photomicrographs of INOR-8 ring from freeze valve 105 that was pulled in tension. Upper surface was exposed to salt and the lower surface to the cell environment of N<sub>2</sub> plus 2 to 5% O<sub>2</sub>. Top portion is the tension side, and the lower part is the compression side.

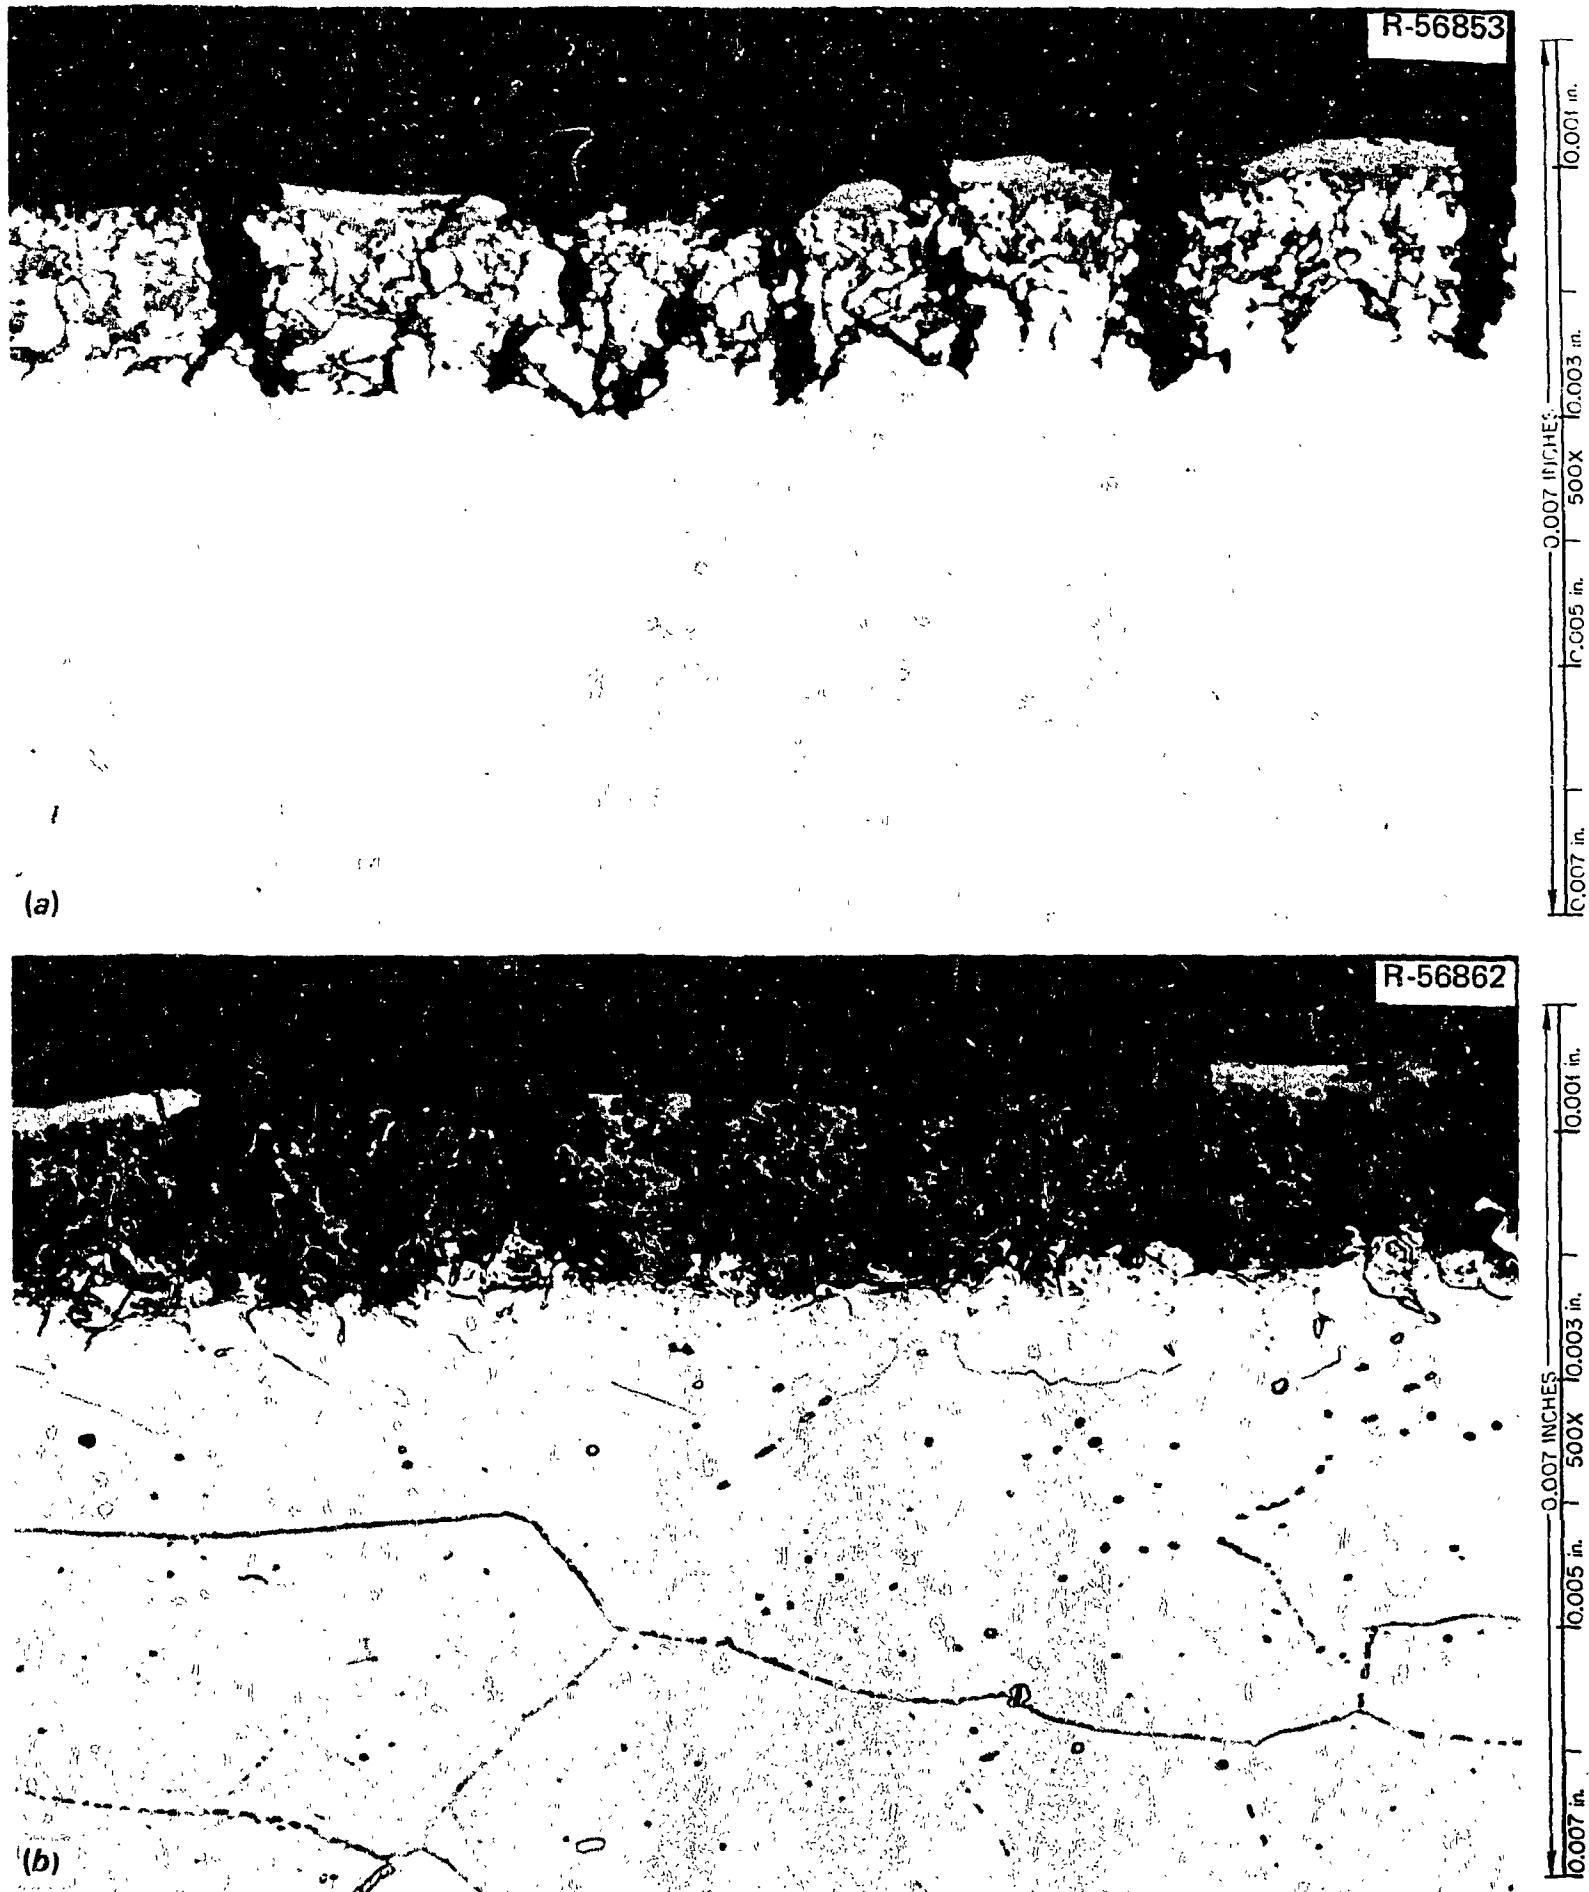
Fig. 37. INOR-8 tensile sample of freeze valve 105 showing the oxide that formed on the outside of the pipe. The cracks penetrated only the depth of the oxide. (a) As polished; (b) etched with lactic acid,  $\text{HNO}_3$ ,  $\text{HCl}$ .
