POSTIRRADIATION EXAMINATION OF MATERIALS FROM THE MSRE

H. E. McCoy      B. McNabb

DECEMBER 1972

OAK RIDGE NATIONAL LABORATORY  
Oak Ridge, Tennessee 37830  
operated by  
UNION CARBIDE CORPORATION  
for the  
U.S. ATOMIC ENERGY COMMISSION

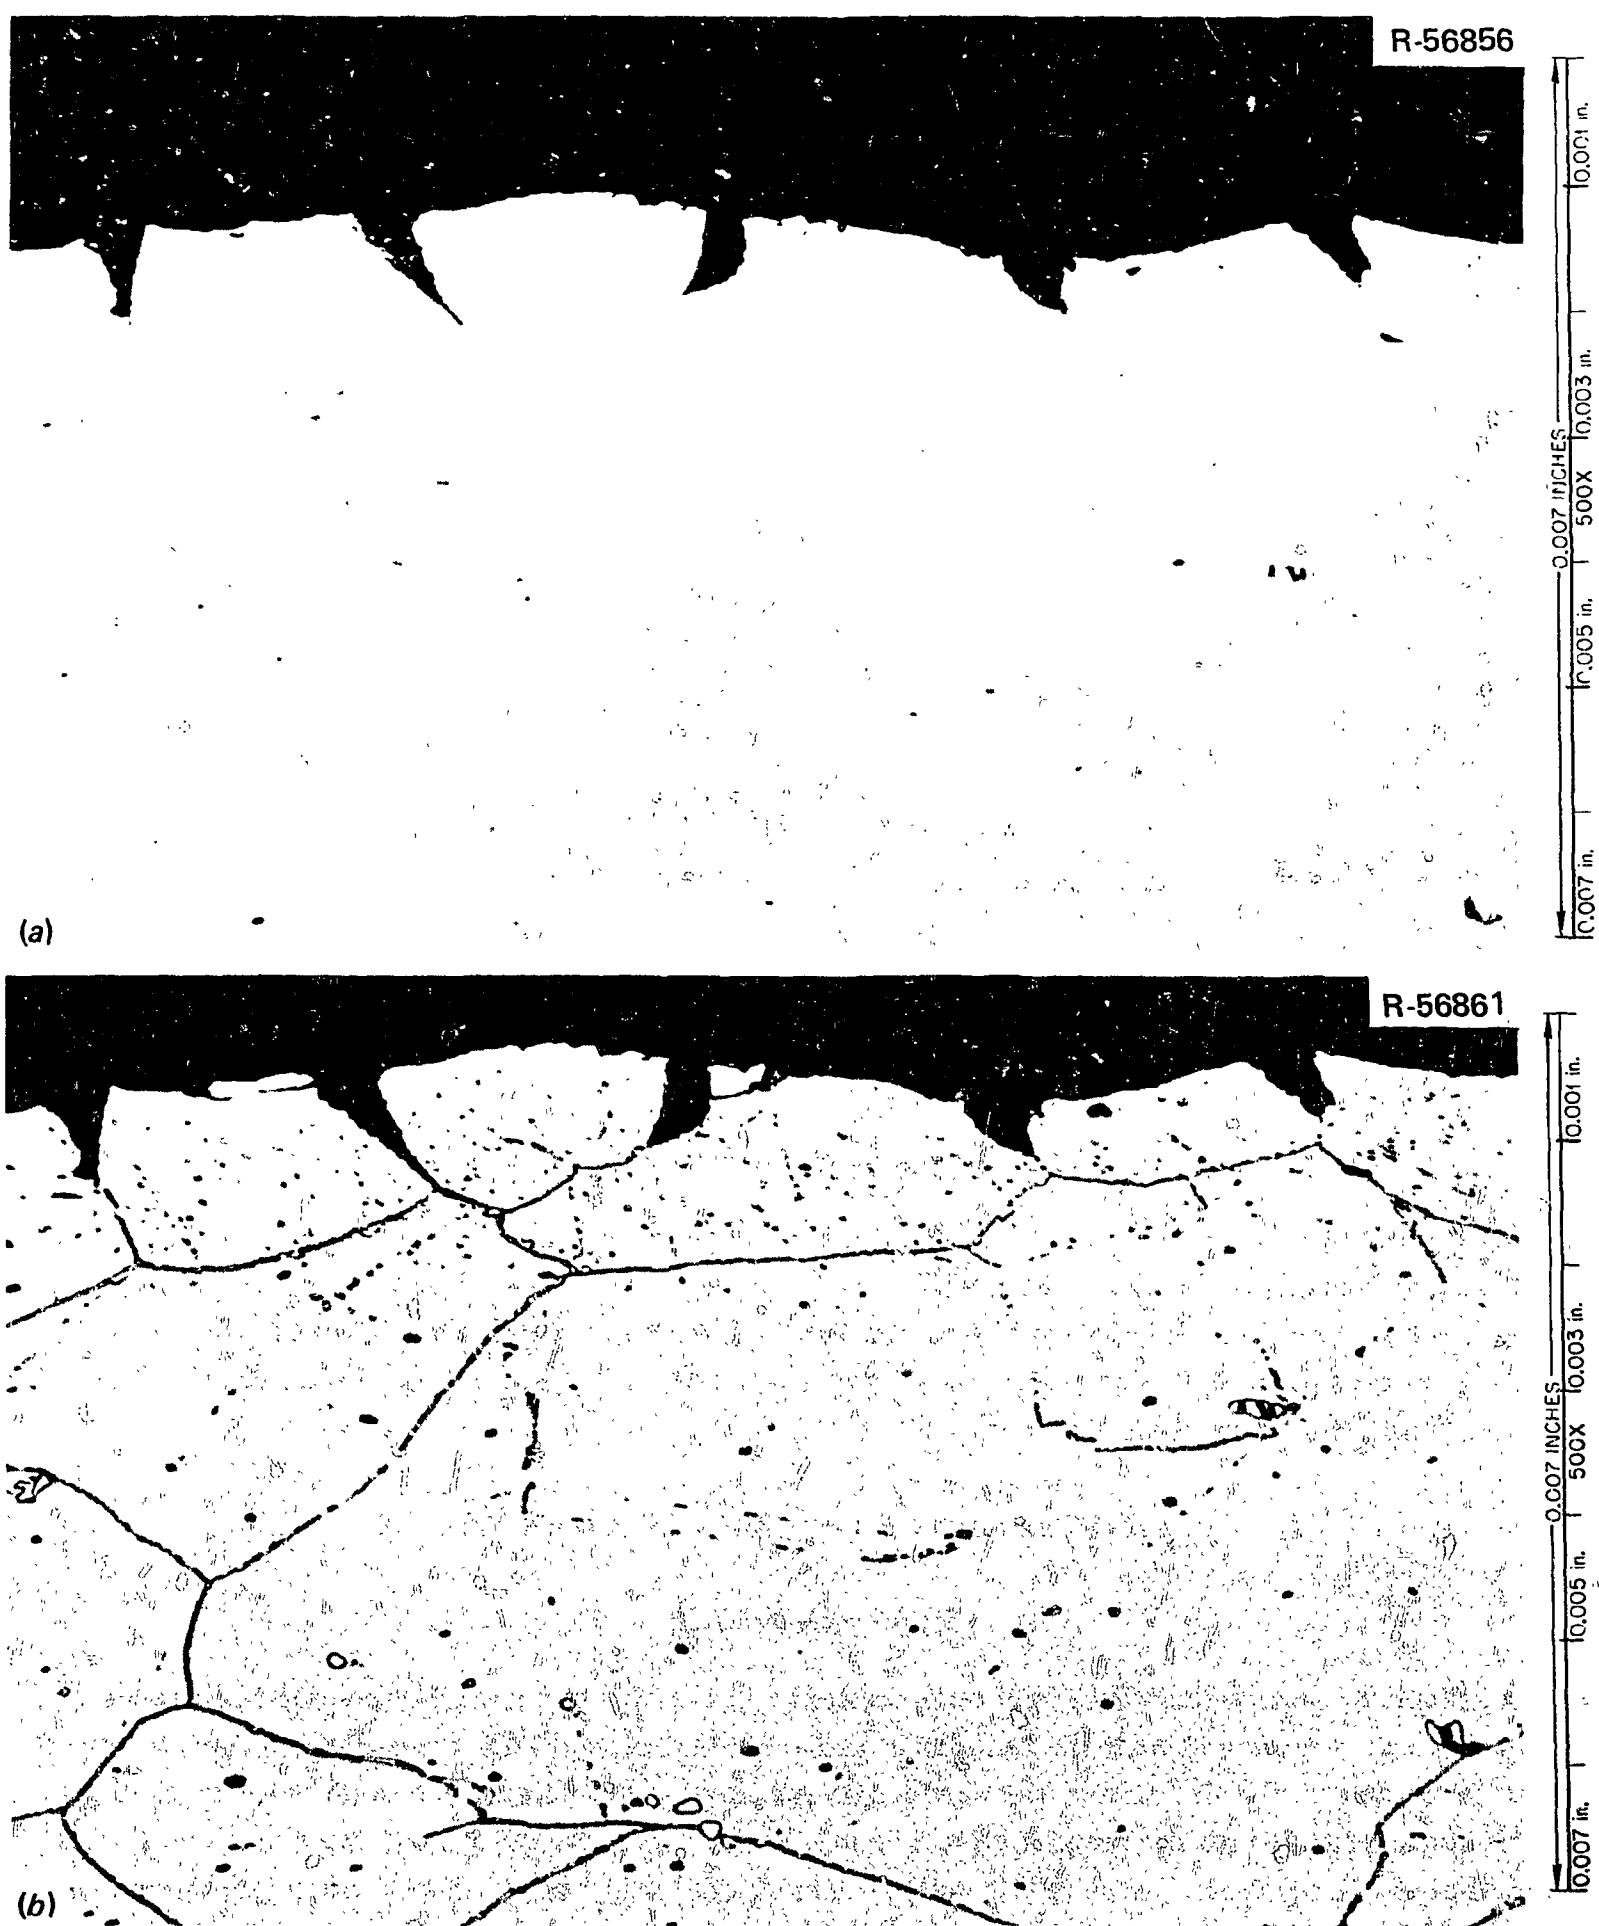
Fig. 38. Salt side of an INOR-8 tensile specimen from freeze valve 105. (a) As polished; (b) etched with lactic acid,  $\text{HNO}_3$ ,  $\text{HCl}$ .

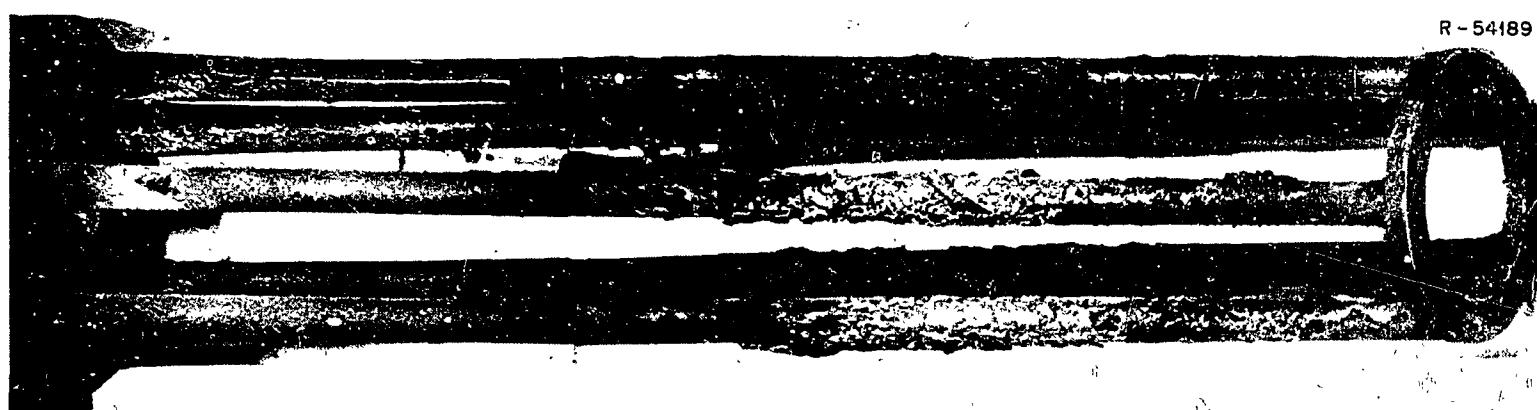
**Fig. 42. Sampler cage.** The assembly is 8.5 in. high. The salt-vapor interface corresponds with the region of highest material deposition.

The general appearance of the sampler cage is shown in Fig. 42. The salt normally stayed at a level near the center of the cage, but the level fluctuated slightly. The amount of material deposited on the surface is much greater below the liquid interface than above. A gross gamma scan had a similar profile with a maximum near the liquid interface. A carbonaceous deposit was present at the top of the sampler. The mist shield had some deposits, which were heavier below the liquid level and on the outer surface of the shield.

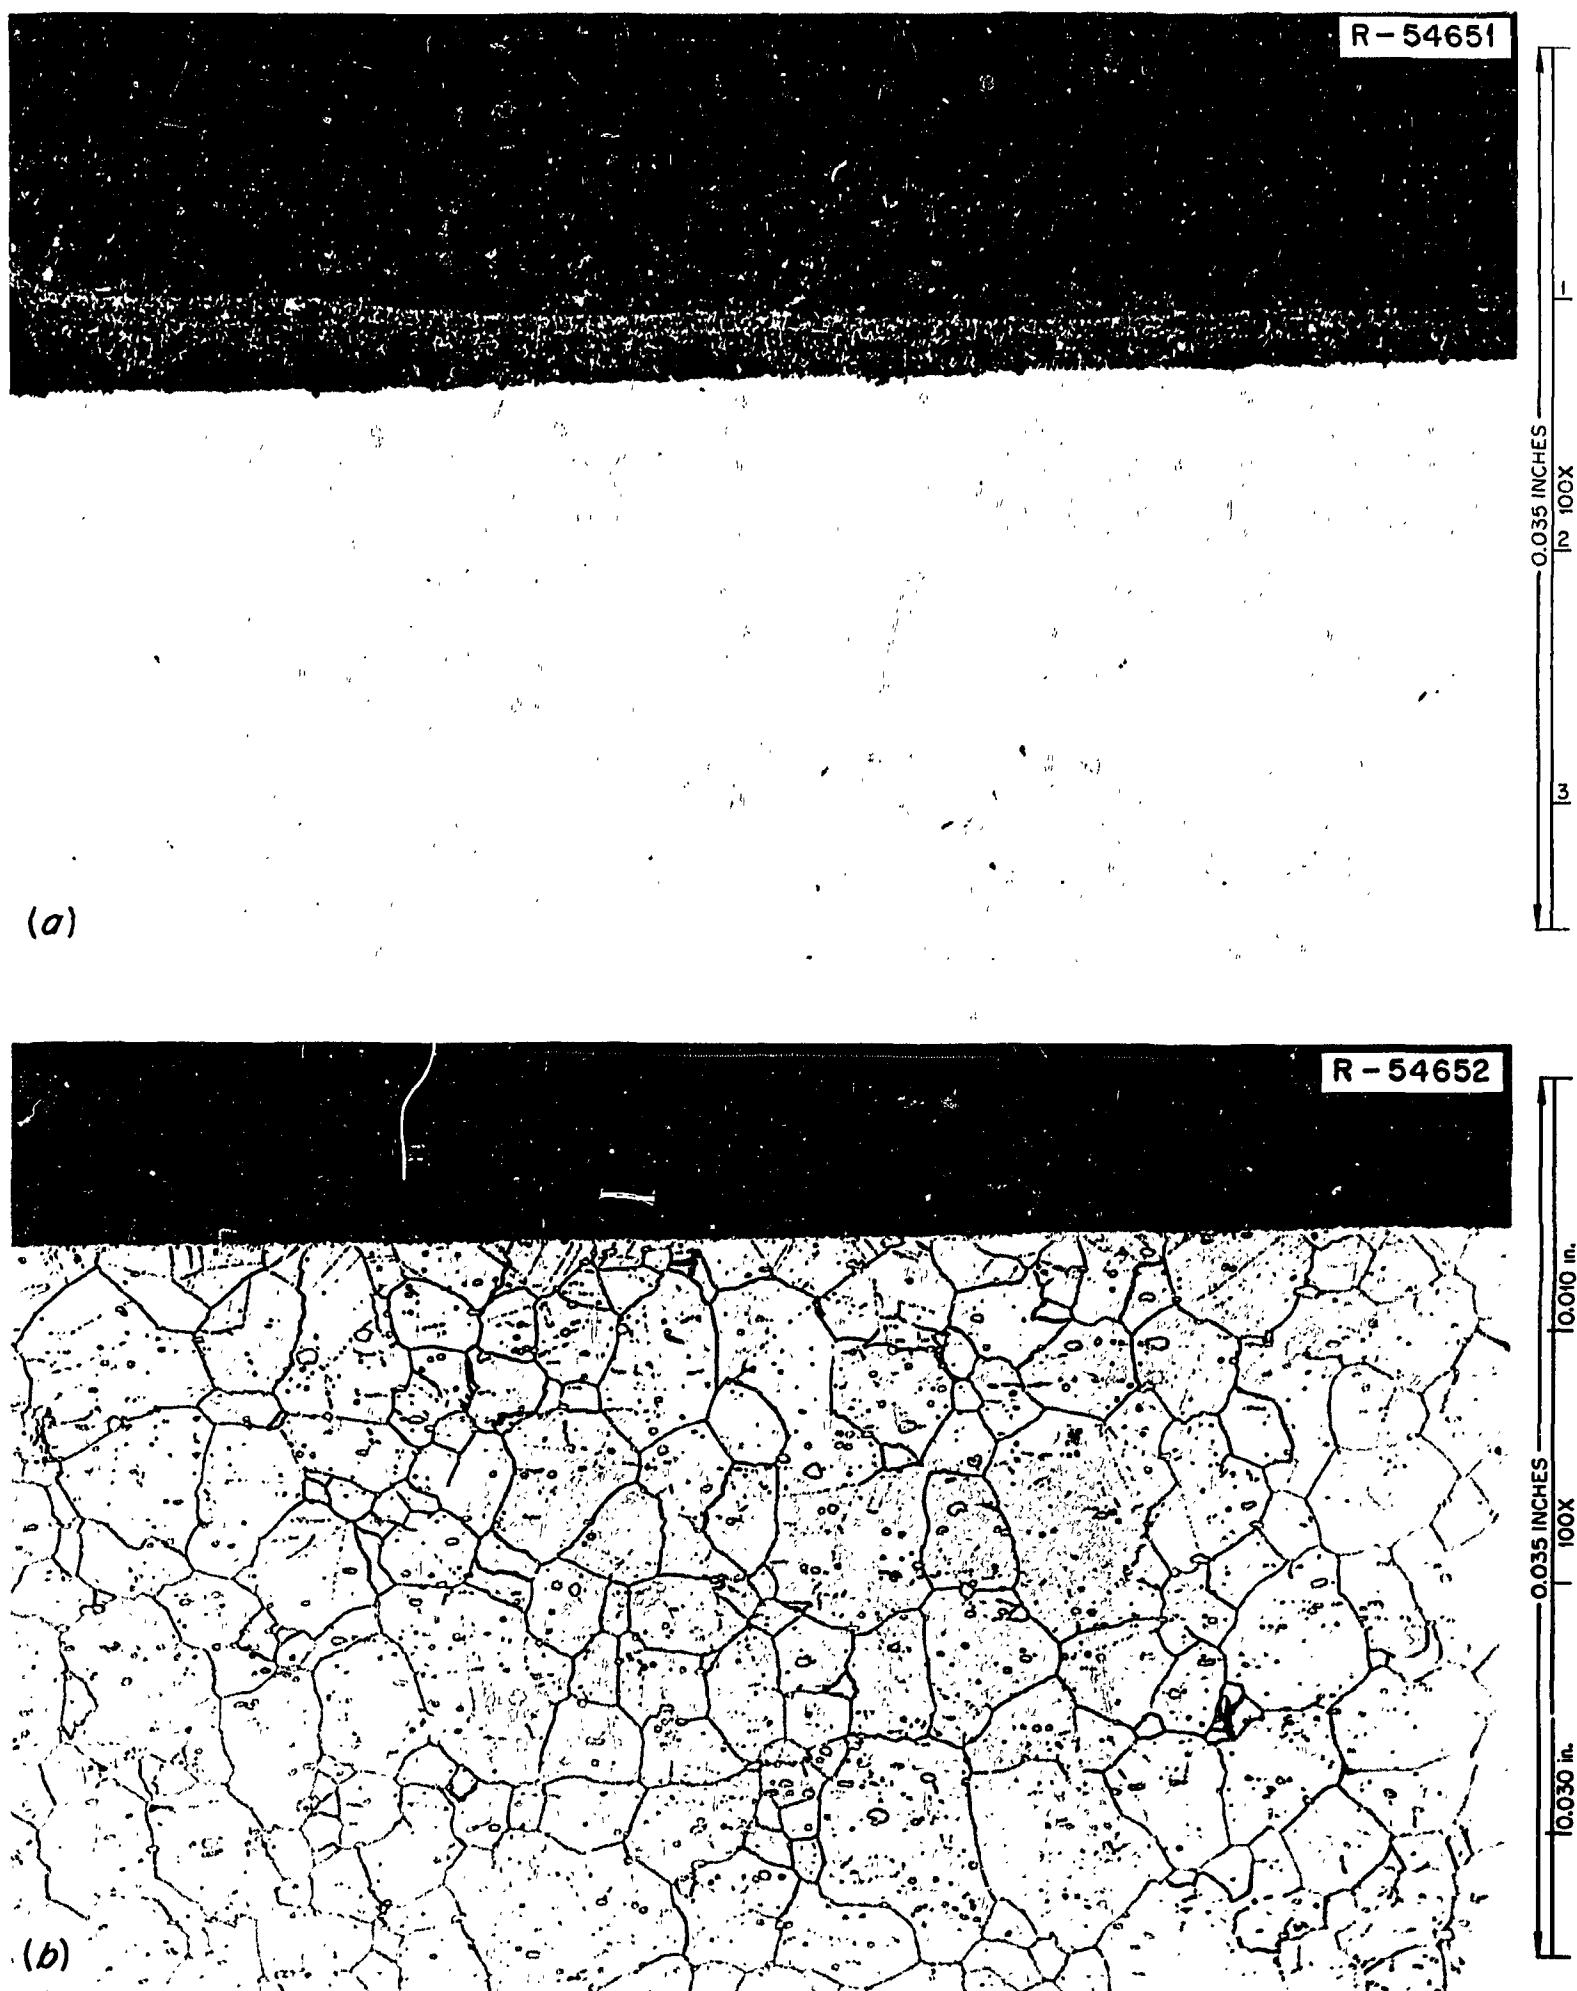
One of the sampler cage rods was examined metallographically. Photomicrographs of samples from the vapor and liquid regions are shown in Figs. 43 and 44 respectively. No intergranular penetration is visible at this magnification. A heavy surface deposit was on the sample from the liquid region. This deposit was examined by the electron microprobe analyzer. It contained some salt but had regions that were high in the elements of INOR-8: Ni, Cr, Fe, and Mo. This is illustrated by the x-ray displays in Figs. 45 and 46, which also show that the deposits were very inhomogeneous.

Fig. 44. INOR-8 rod from the sampler assembly. Normally located below the salt level. (a) As polished; (b) etched with aqua regia.

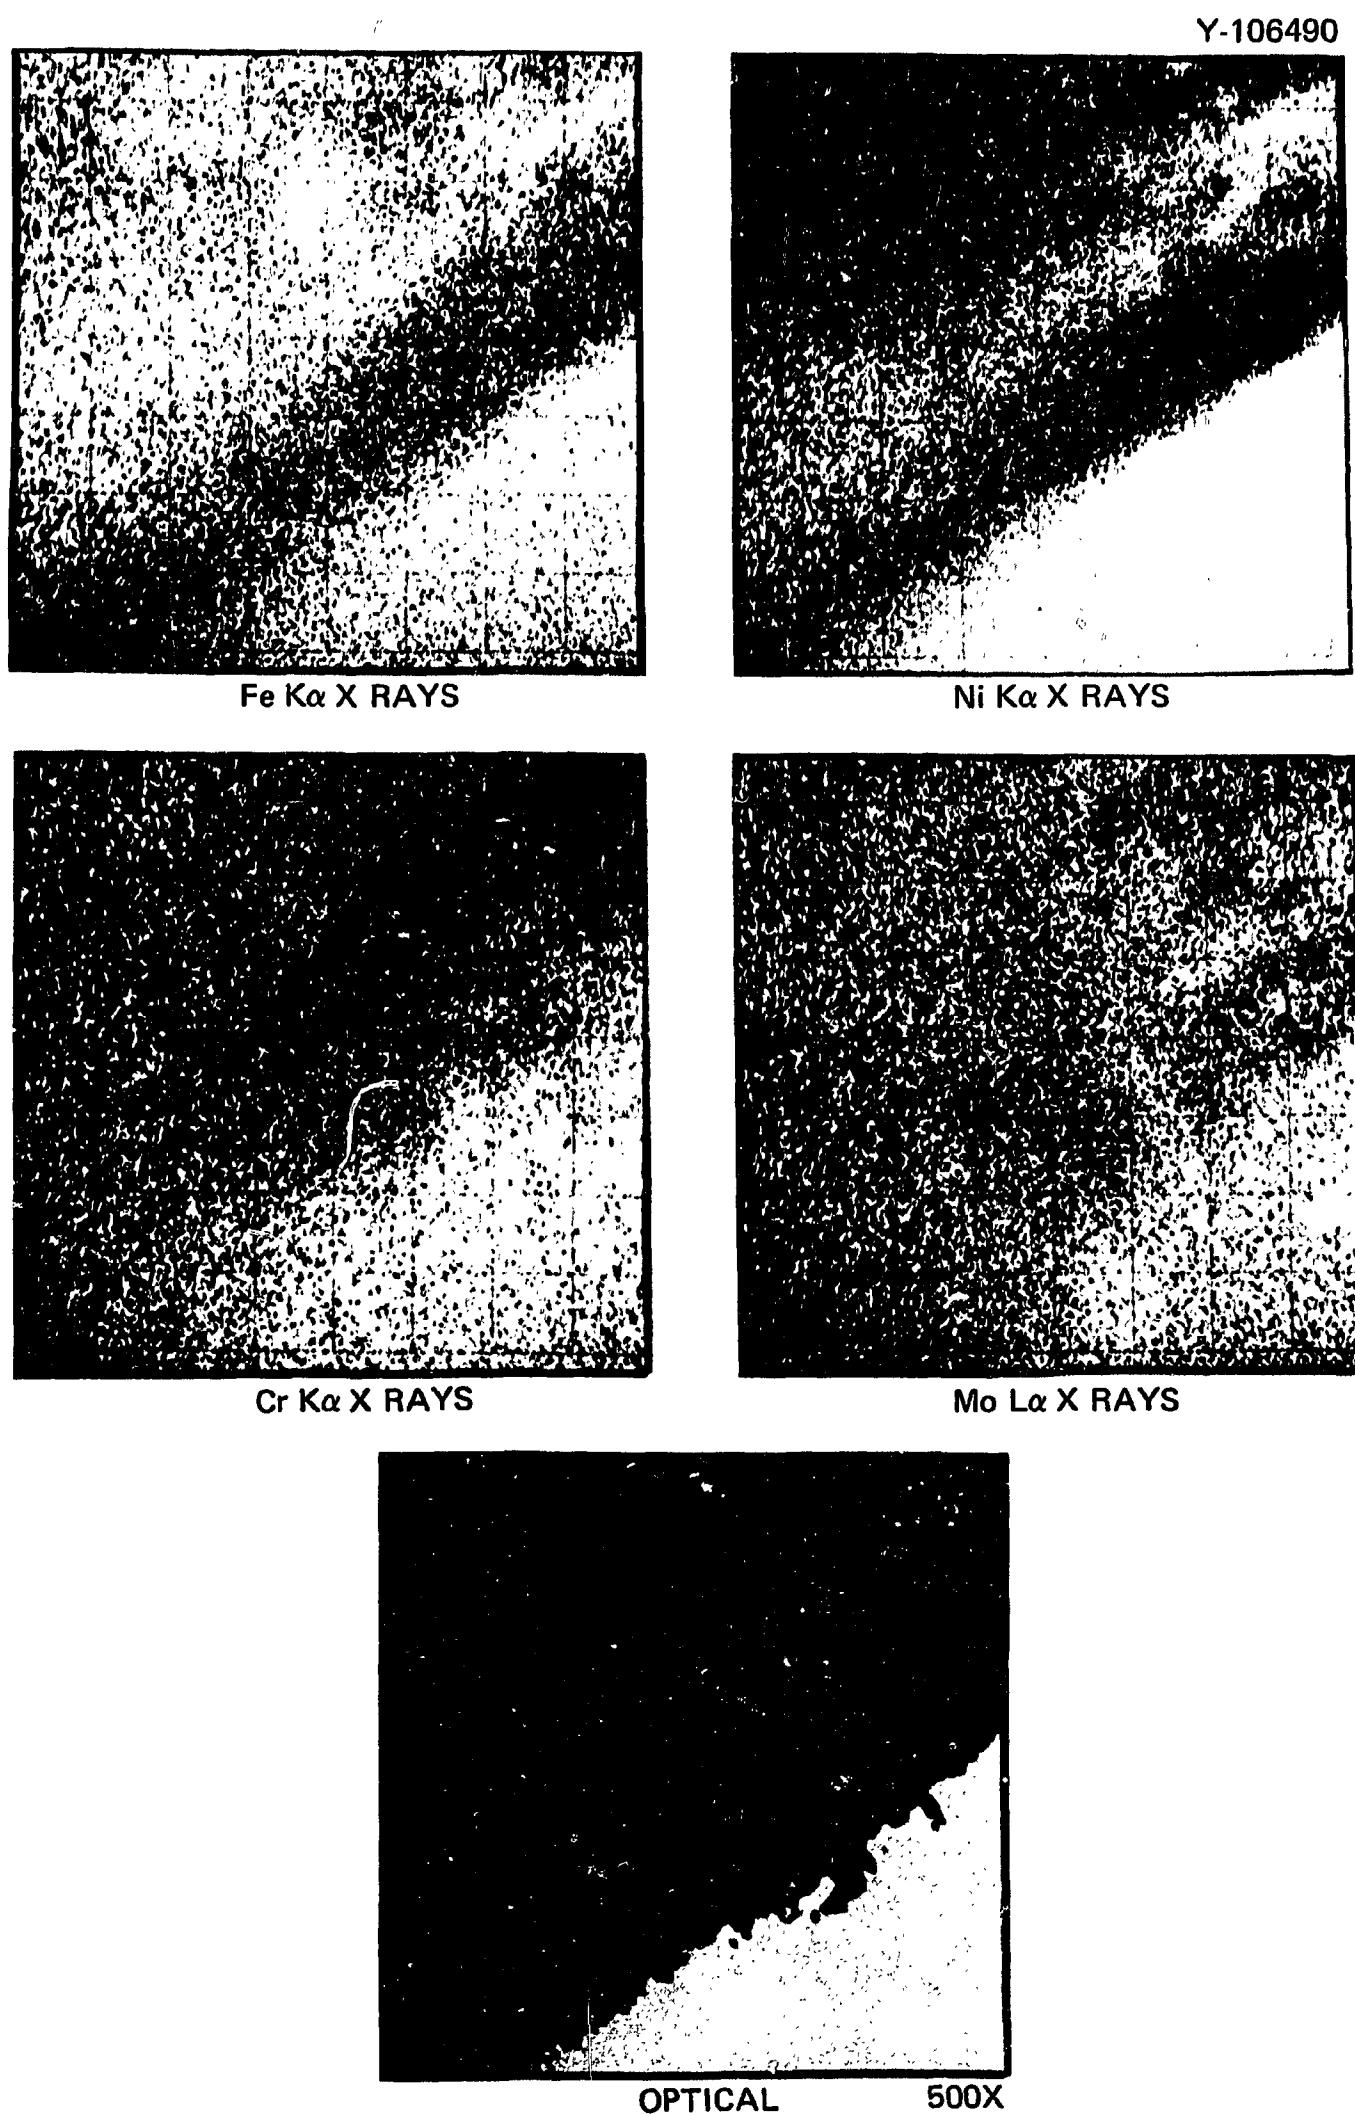
Fig. 45. X-ray displays from the surface deposit on a sampler cage rod immersed in fuel salt in the pump bowl. 400X.

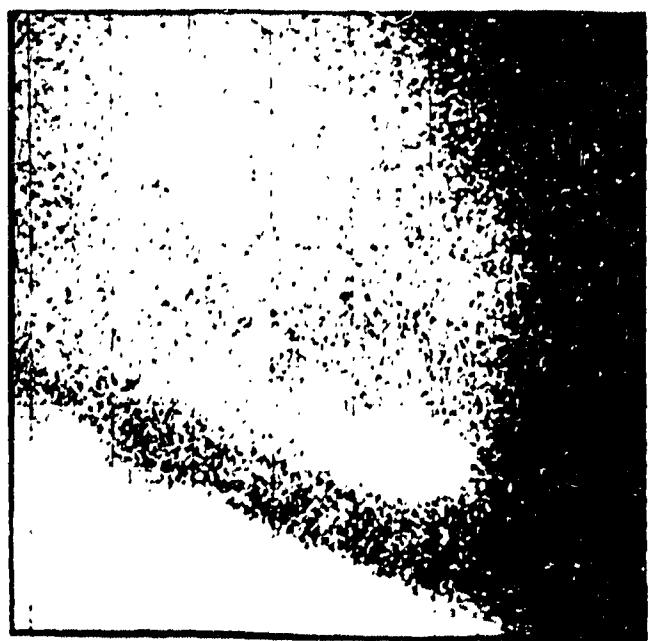
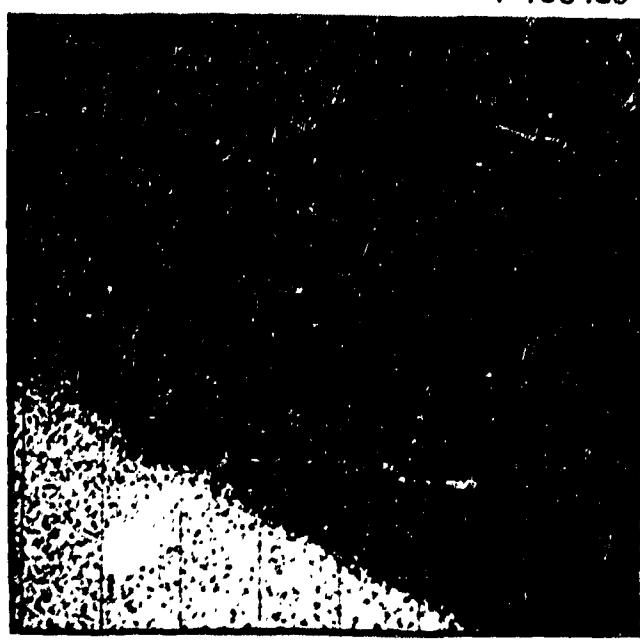
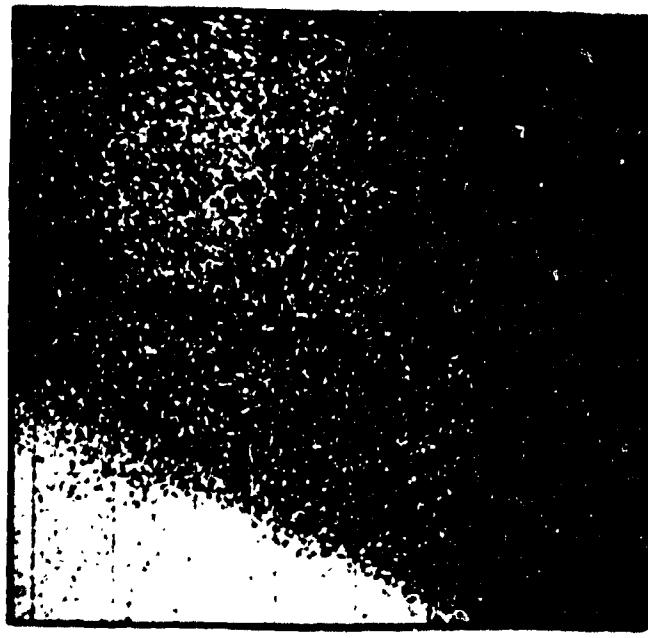
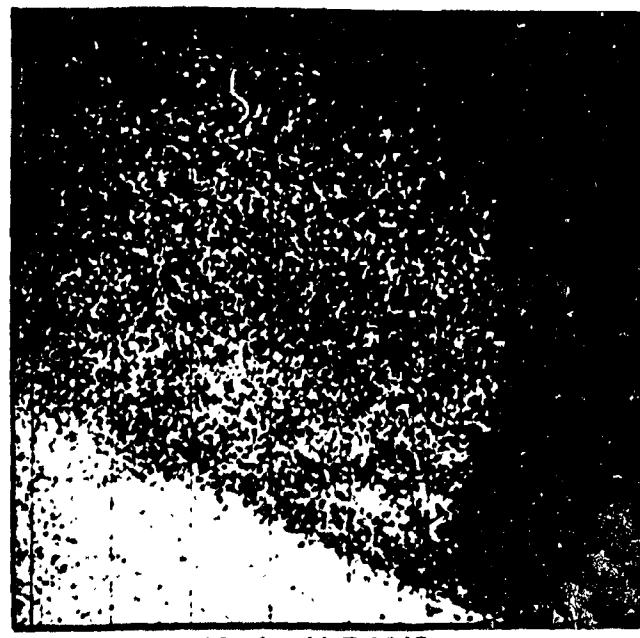
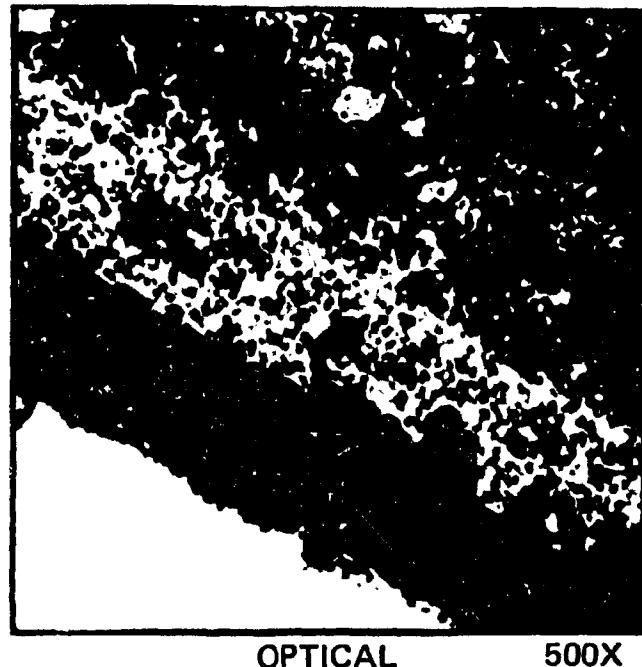
Fig. 46. X-ray displays from the surface deposit on a sampler cage rod immersed in fuel salt in the pump bowl. 400X.

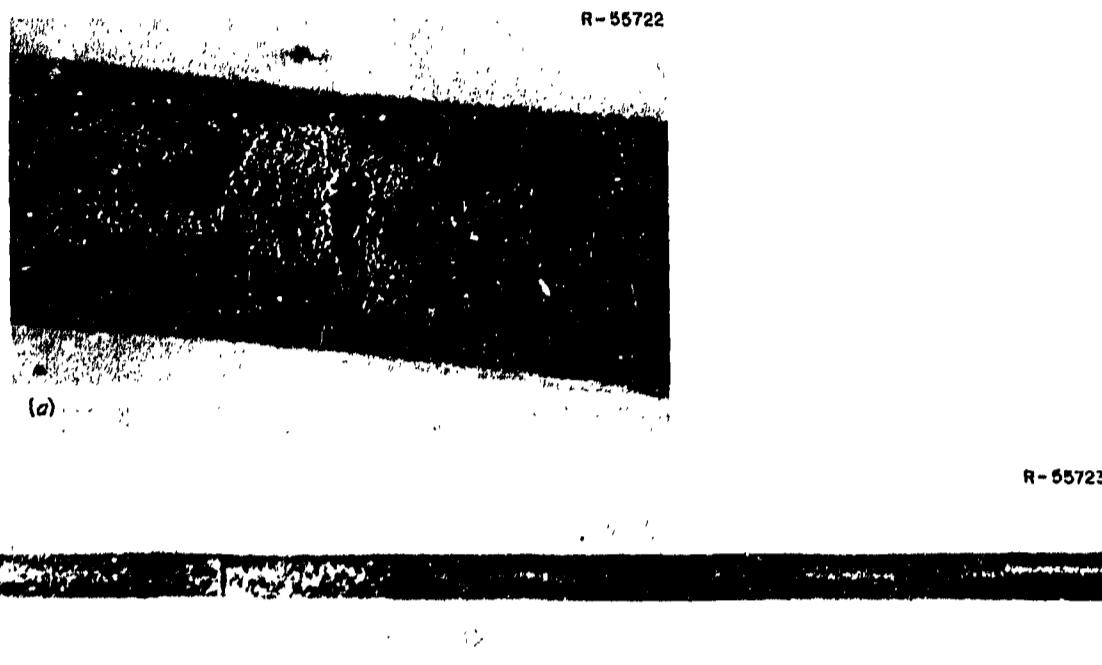
Fig. 47. Tensile-tested INOR-8 sampler cage rod from pump bowl. Rupture occurred near the average liquid-vapor interface. (a) Rupture area showing extensive surface cracking. (b) Composite of entire rod, with top at right. Rod diameter is  $\frac{1}{4}$  in.

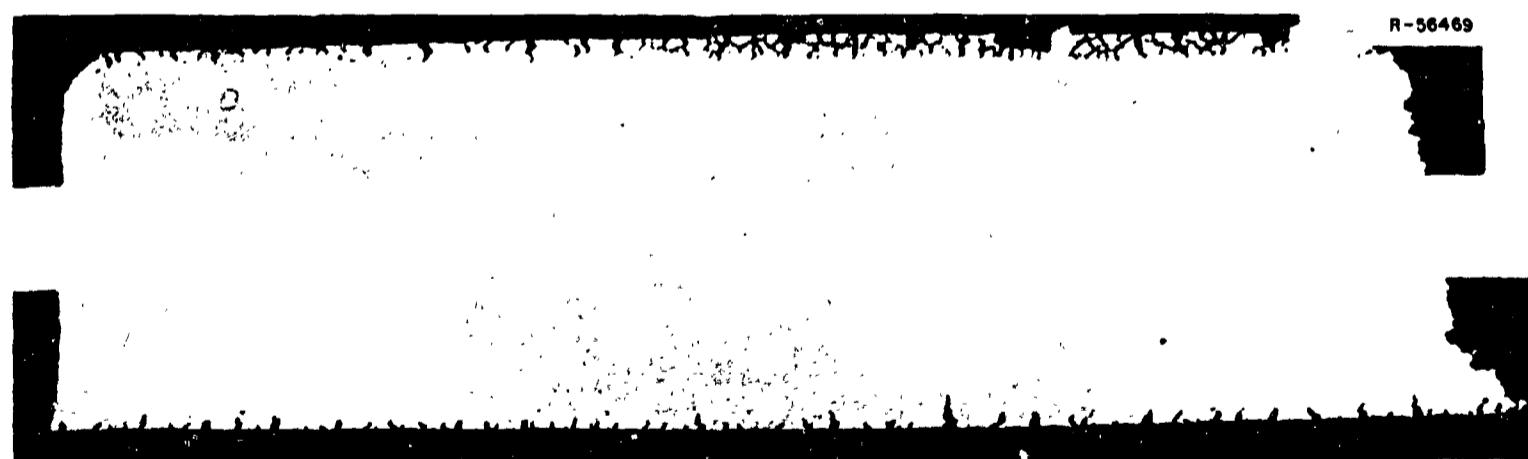
Fig. 48. Section of INOR-8 sample cage rod that was deformed at  $25^{\circ}\text{C}$ . 9.2X. The fracture (right) occurred at the salt-vapor interface. The rod is immersed further in the liquid from right to left. The length of the sample is 0.63 in.

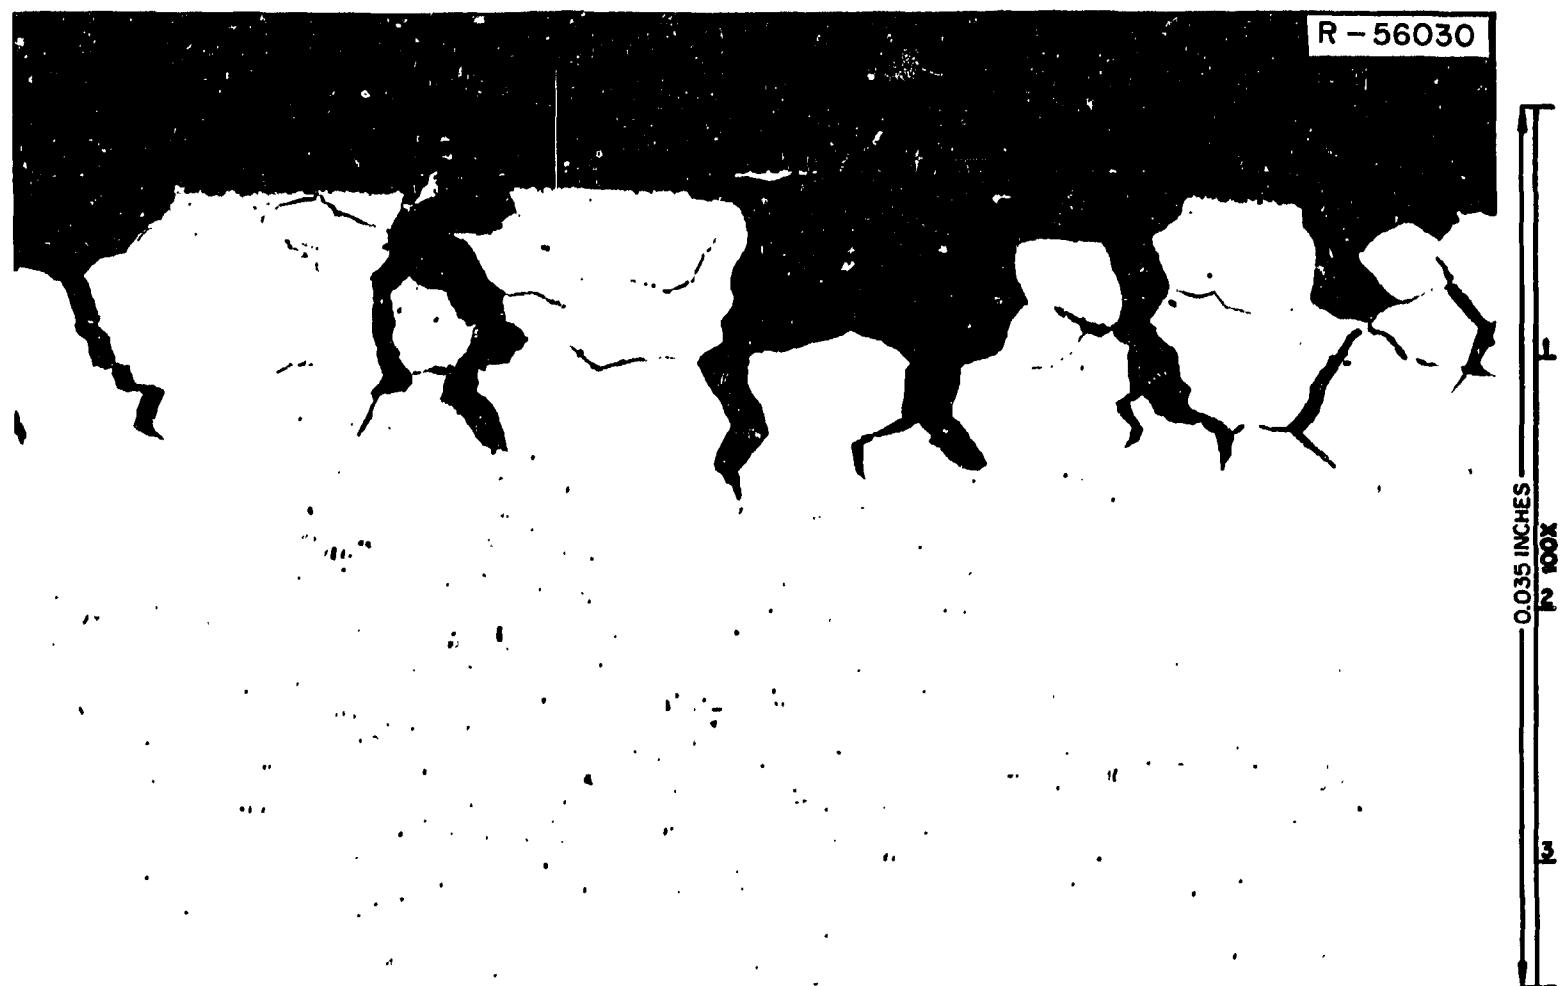
Fig. 49. Deformed INOR-8 sampler cage rod near the fracture. As polished.

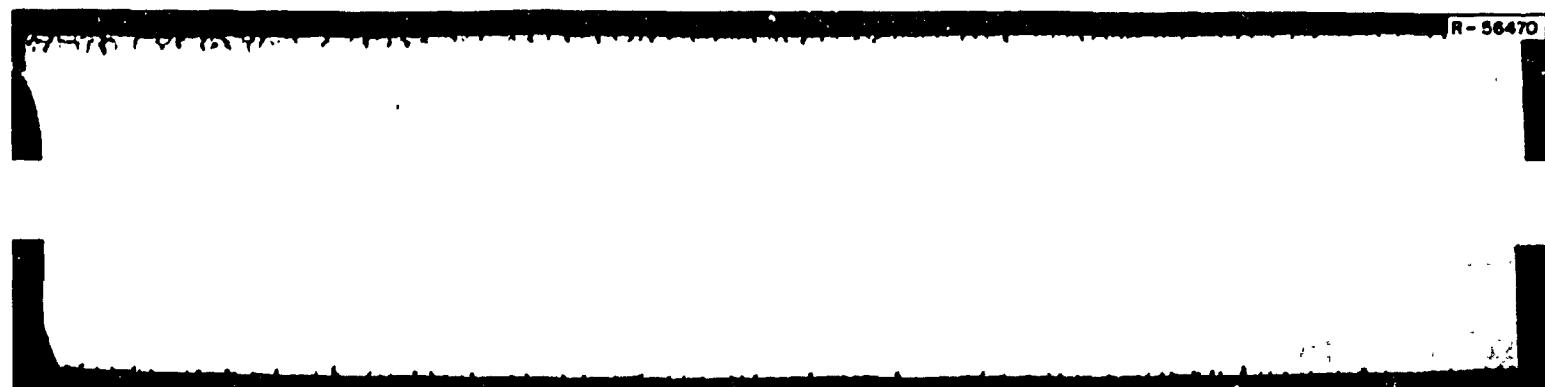
Fig. 50. Composite of photomicrographs of INOR-8 sampler cage rod strained at 25°C. 8.2X. Left end of sample was  $\frac{3}{4}$  in. from fracture. The rod progressed further into the vapor region from left to right. Sample length is 0.72 in.

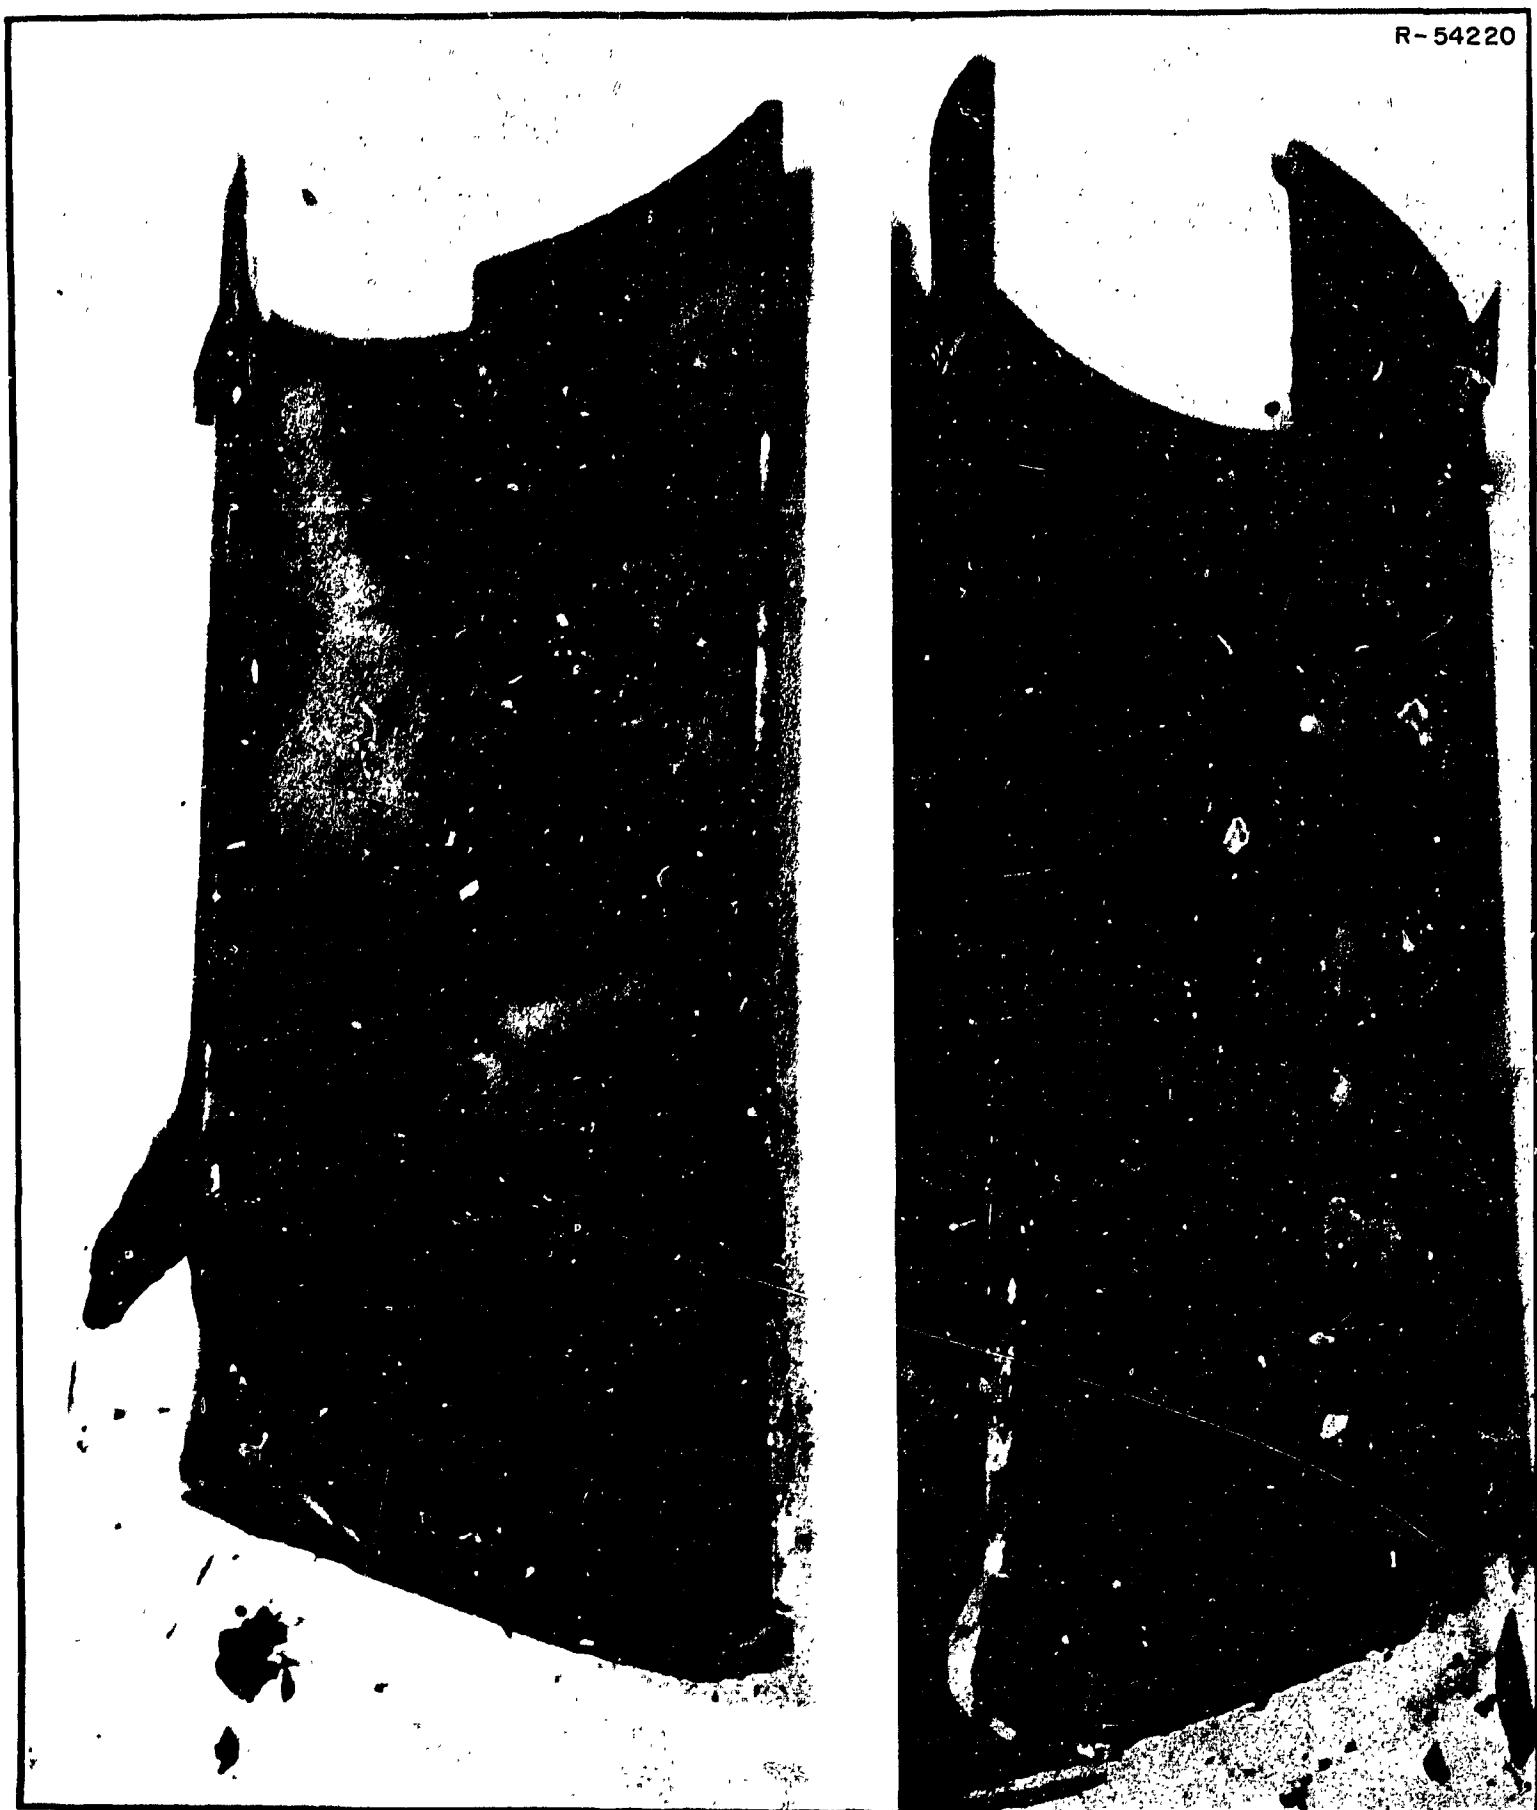
Figure 51 shows the mist shield after removal from the MSRE. The shield has been split to reveal the inside surface. Four specimens approximately 1 in. (vertical)  $\times$   $\frac{1}{2}$  in. (circumferential) were cut from the mist shield. Their locations were (1) outside the spiral and immersed in salt, (2) outside the spiral and exposed to salt spray, (3) inside the spiral and immersed in salt, and (4) inside the spiral and exposed primarily to gas. Bend tests were performed on these specimens at 25°C using a three-point bend fixture.<sup>30</sup> They were bent about a line parallel to the  $\frac{1}{2}$ -in. dimension so that the outer surface was in tension. The information obtained from such a test is a load deflection curve. The equations normally used to convert this to a stress-strain curve do not take into account the plastic deformation of the part, and the stresses obtained by this method become progressively in error (too high) as the deformation progresses.

**Fig. 51. Interior of INOR-8 mist shield. Right part of right segment overlapped left part of segment on left.**

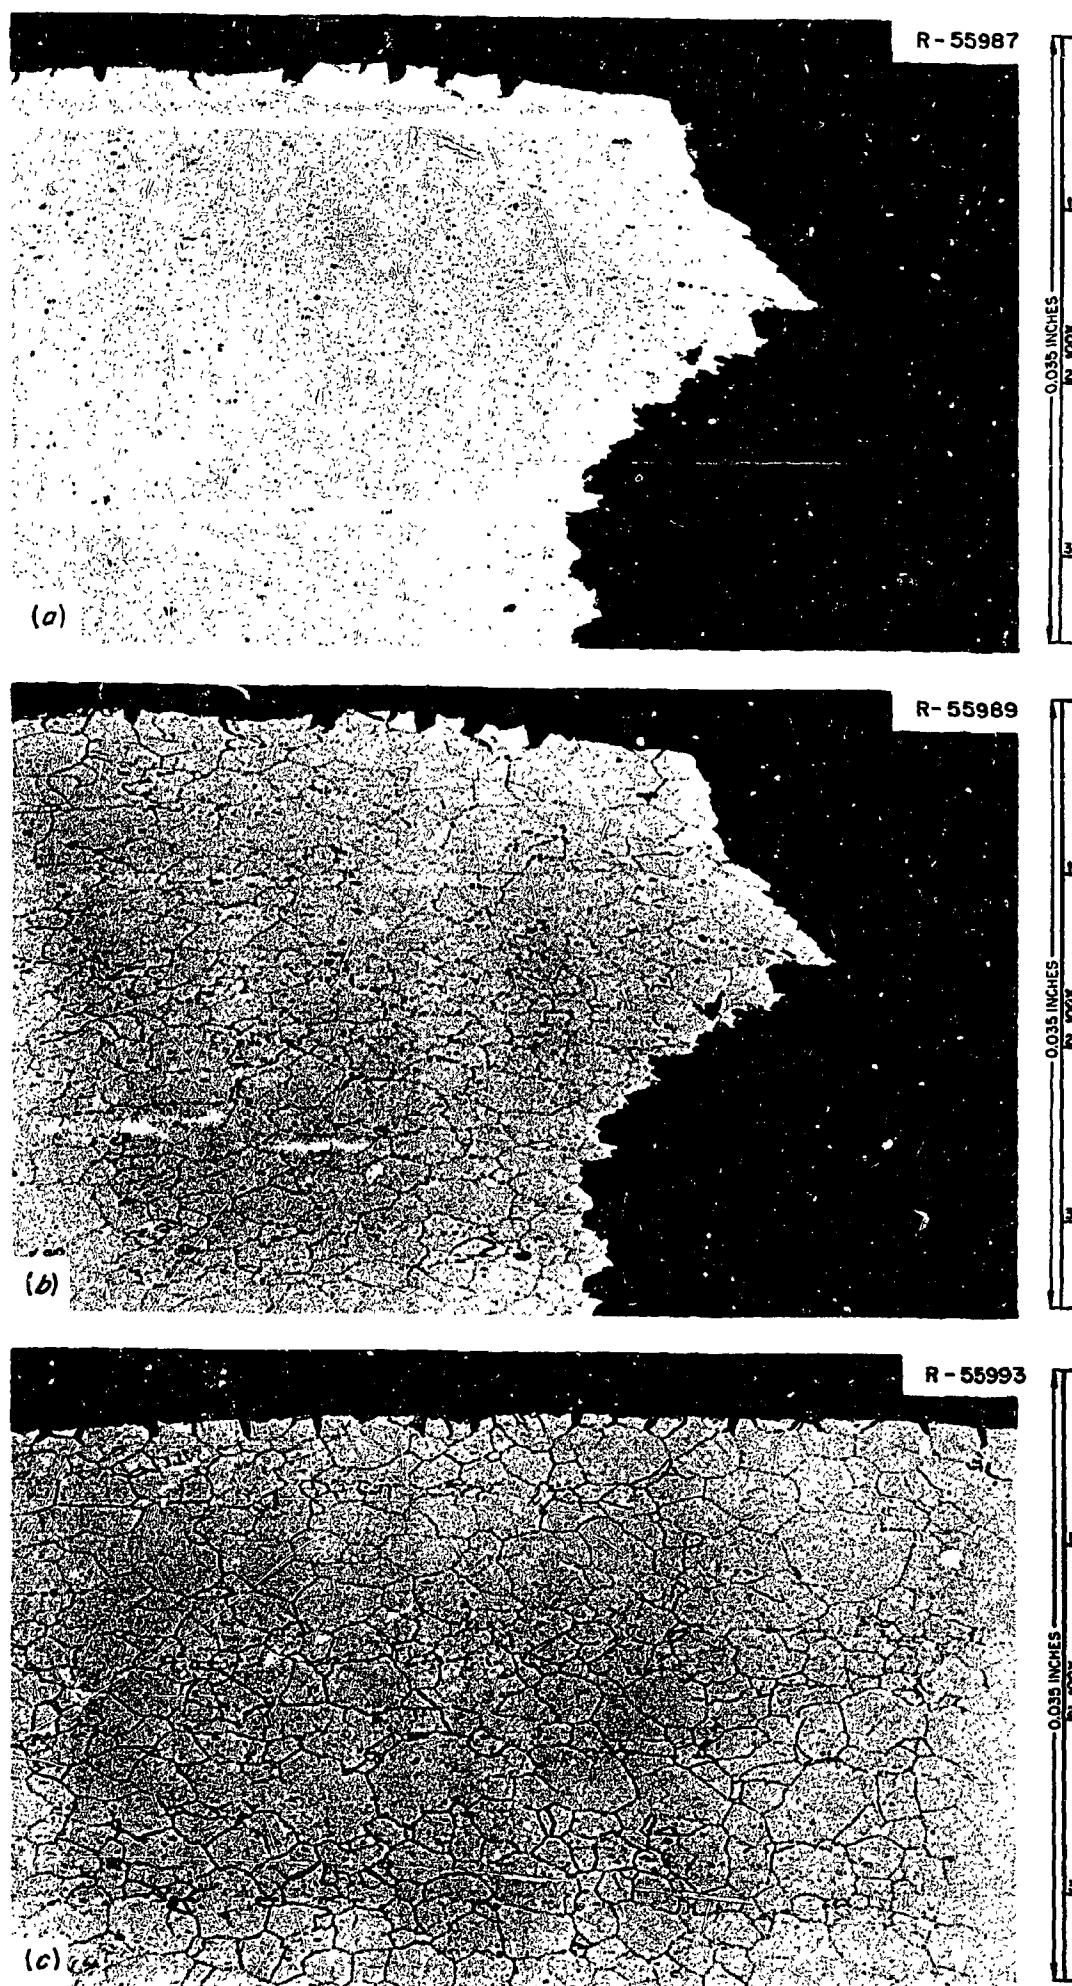
The bend samples of the mist shield were examined metallographically. Photomicrographs of the sample from the inside vapor region are shown in Fig. 52, and a composite of several photomicrographs is shown in Fig. 53. The edge cracks were intergranular and about 1 mil deep. The photomicrographs of the sample from the liquid region (Fig. 54) show that the cracks extended to a depth of about 8 mils. The composite photograph in Fig. 55 also shows the increased frequency and depth of cracking in the liquid region.

Fig. 52. Bend specimen of INOR-8 mist shield from inside vapor region. (a) Fracture and tension side, as polished. (b) Fracture and tension side, etched. (c) Tension side, etched. Etchant: aqua regia. Reduced 31%.

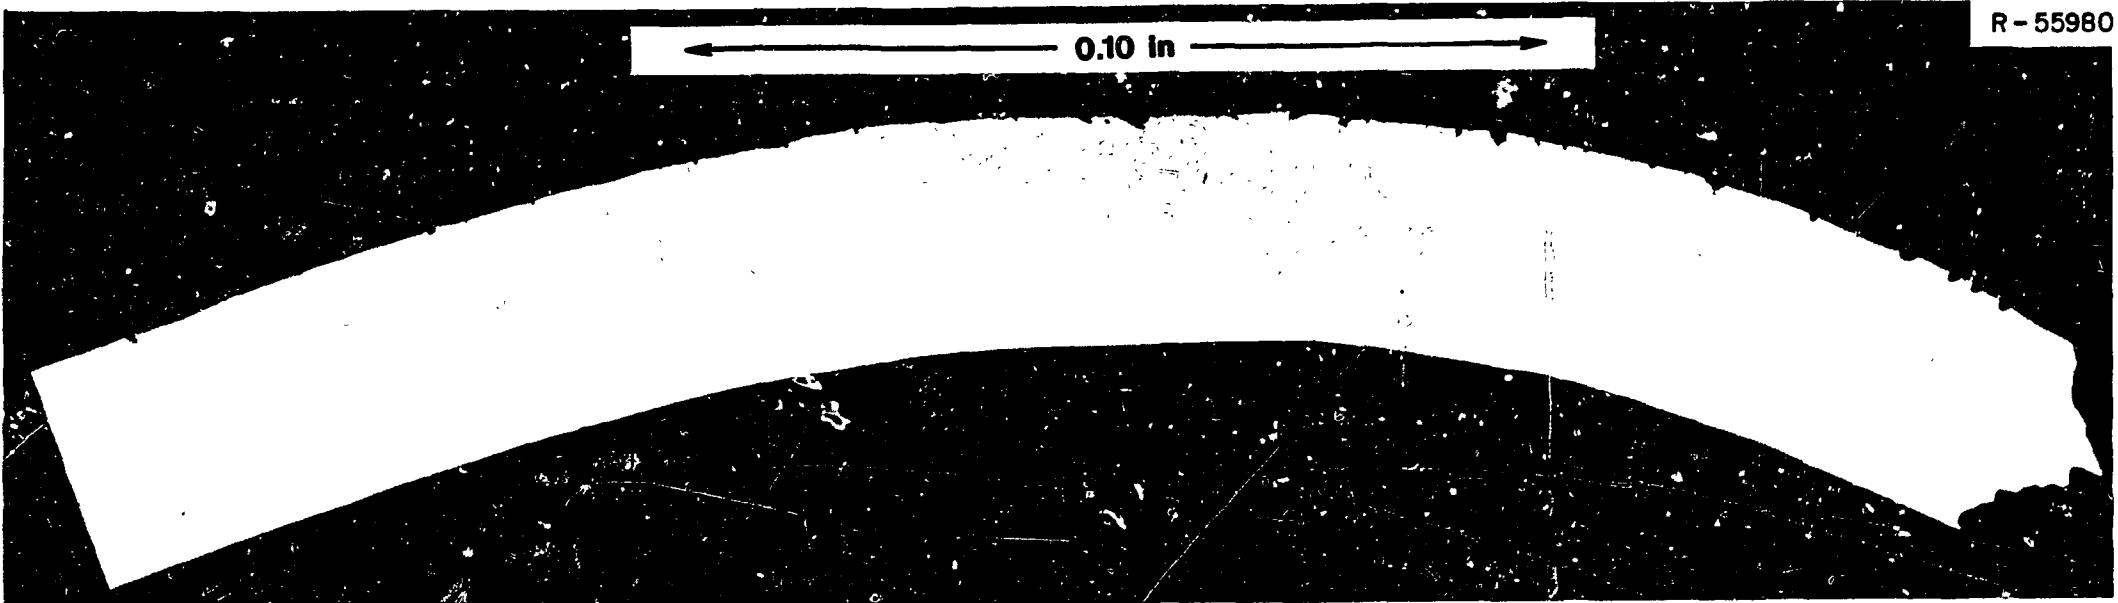
Fig. 53. Composite photograph of tension side of bend sample from inside vapor region of INOR-8 mist shield. Lower edge is not the compression side of the sample.
