POSTIRRADIATION EXAMINATION OF MATERIALS FROM THE MSRE

H. E. McCoy      B. McNabb

DECEMBER 1972

OAK RIDGE NATIONAL LABORATORY  
Oak Ridge, Tennessee 37830  
operated by  
UNION CARBIDE CORPORATION  
for the  
U.S. ATOMIC ENERGY COMMISSION

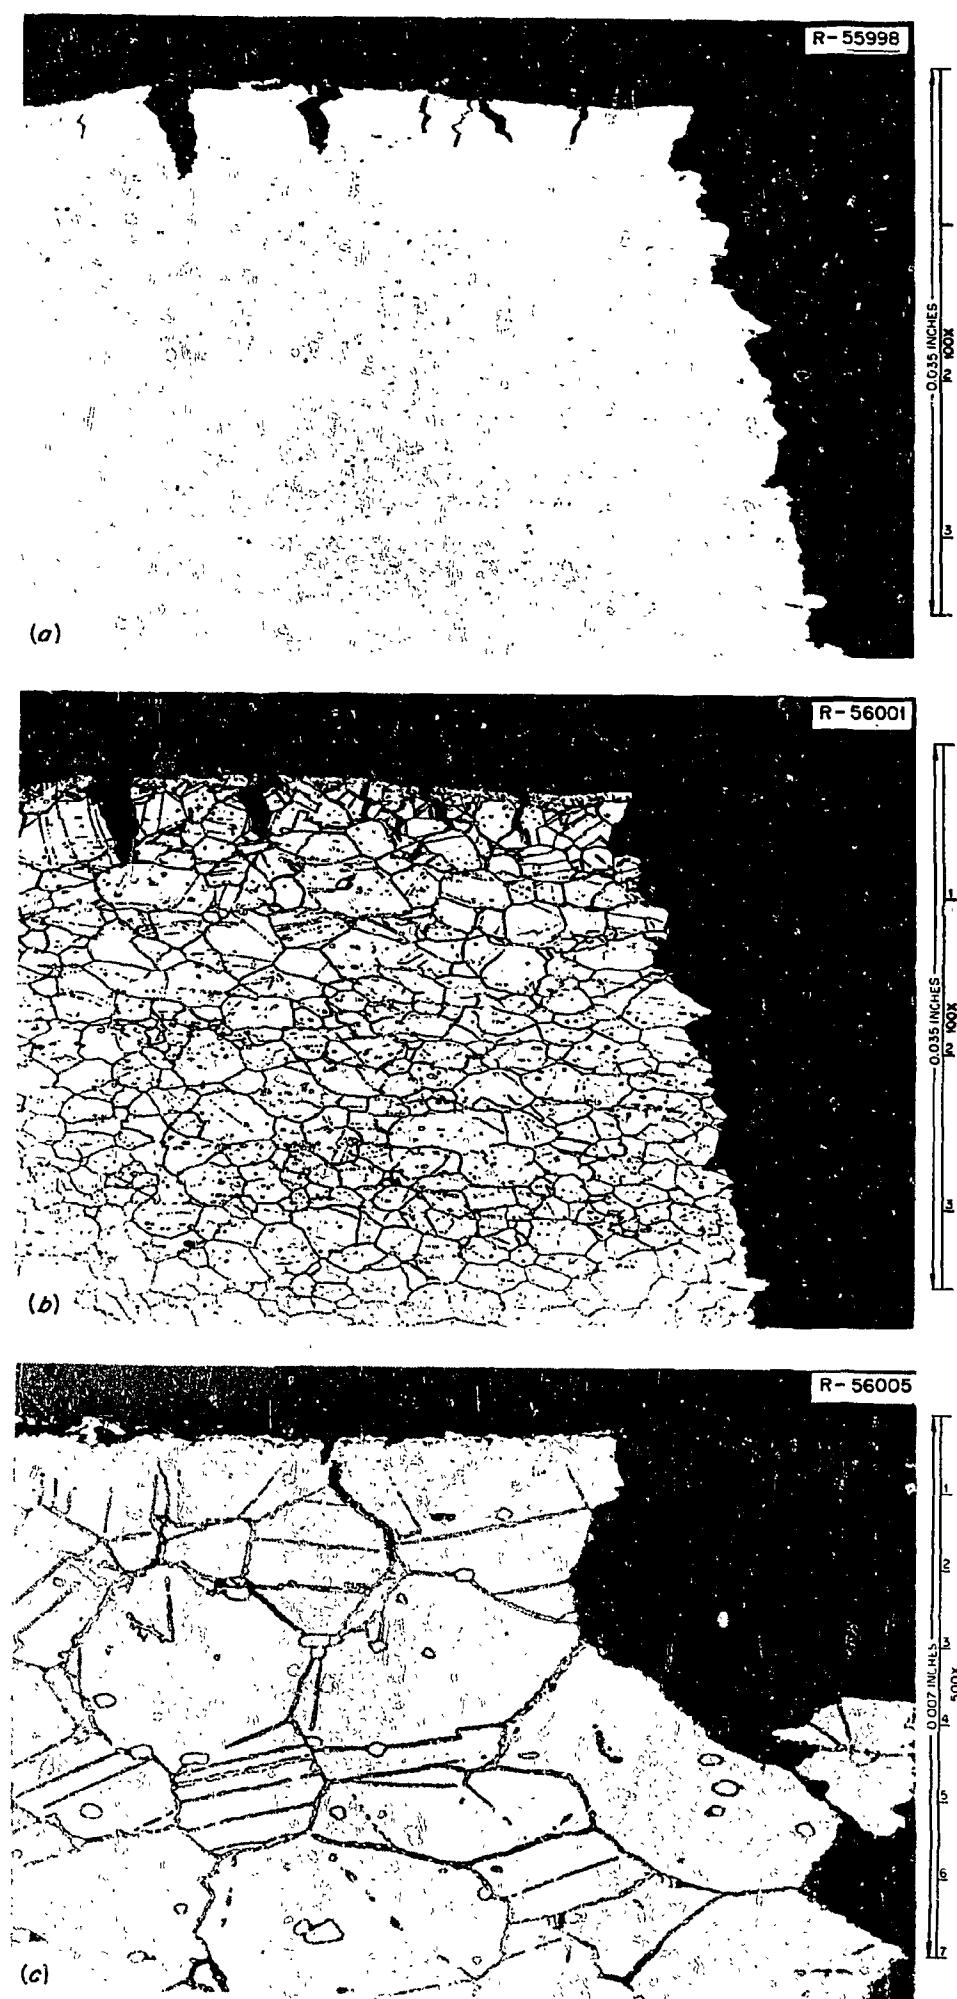
The bend samples of the mist shield were examined metallographically. Photomicrographs of the sample from the inside vapor region are shown in Fig. 52, and a composite of several photomicrographs is shown in Fig. 53. The edge cracks were intergranular and about 1 mil deep. The photomicrographs of the sample from the liquid region (Fig. 54) show that the cracks extended to a depth of about 8 mils. The composite photograph in Fig. 55 also shows the increased frequency and depth of cracking in the liquid region.

Fig. 54. Bend specimen of INOR-8 mist shield from inside liquid region. Fracture and tension side (a) as polished, (b) and (c) etched with aqua regia.

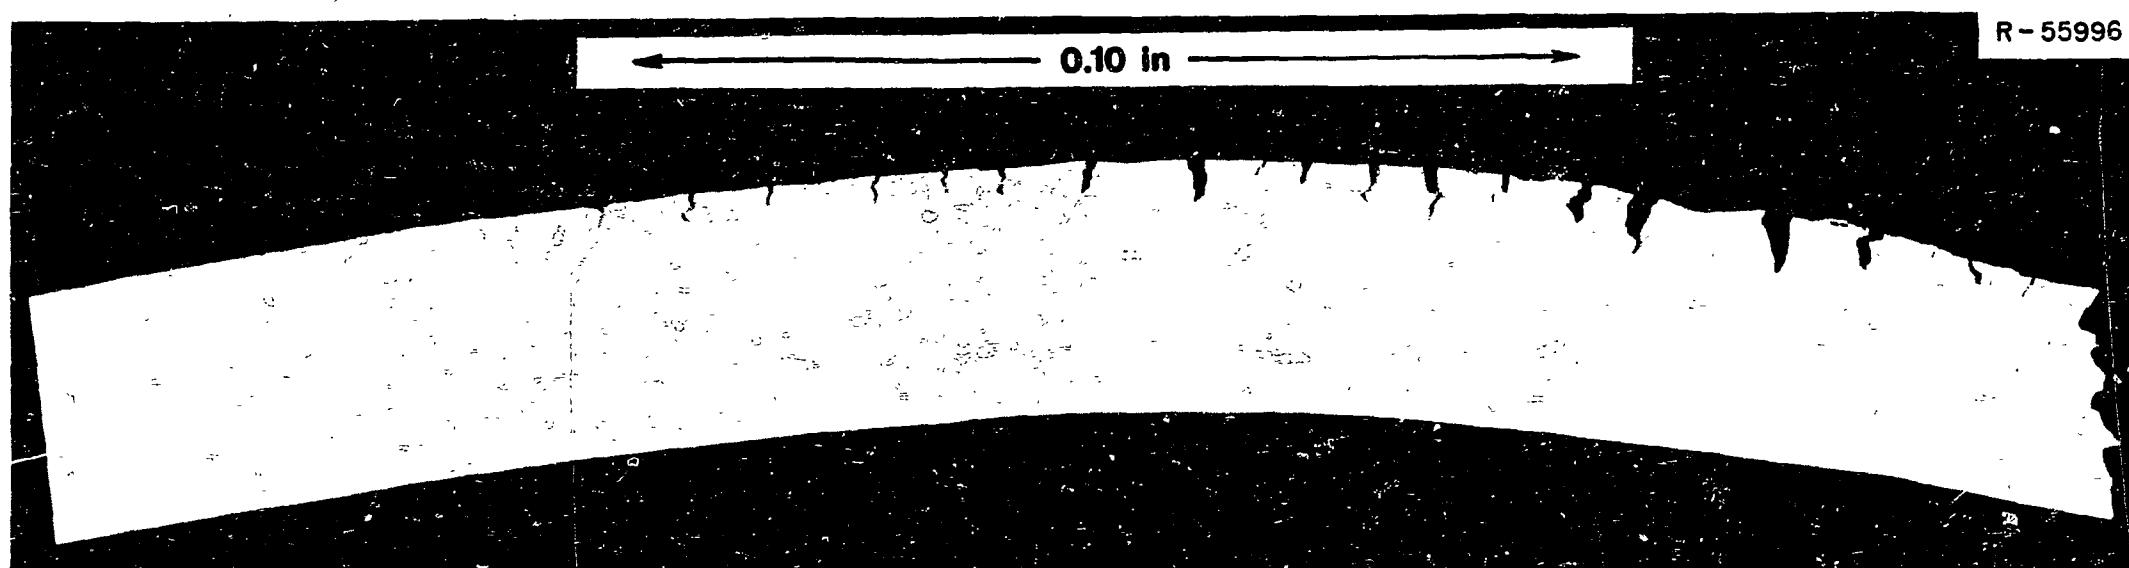
Fig. 55. Composite photograph of tension side of bend sample from inside liquid region of INOR-8 mist shield. Lower edge is not the compression side of sample.

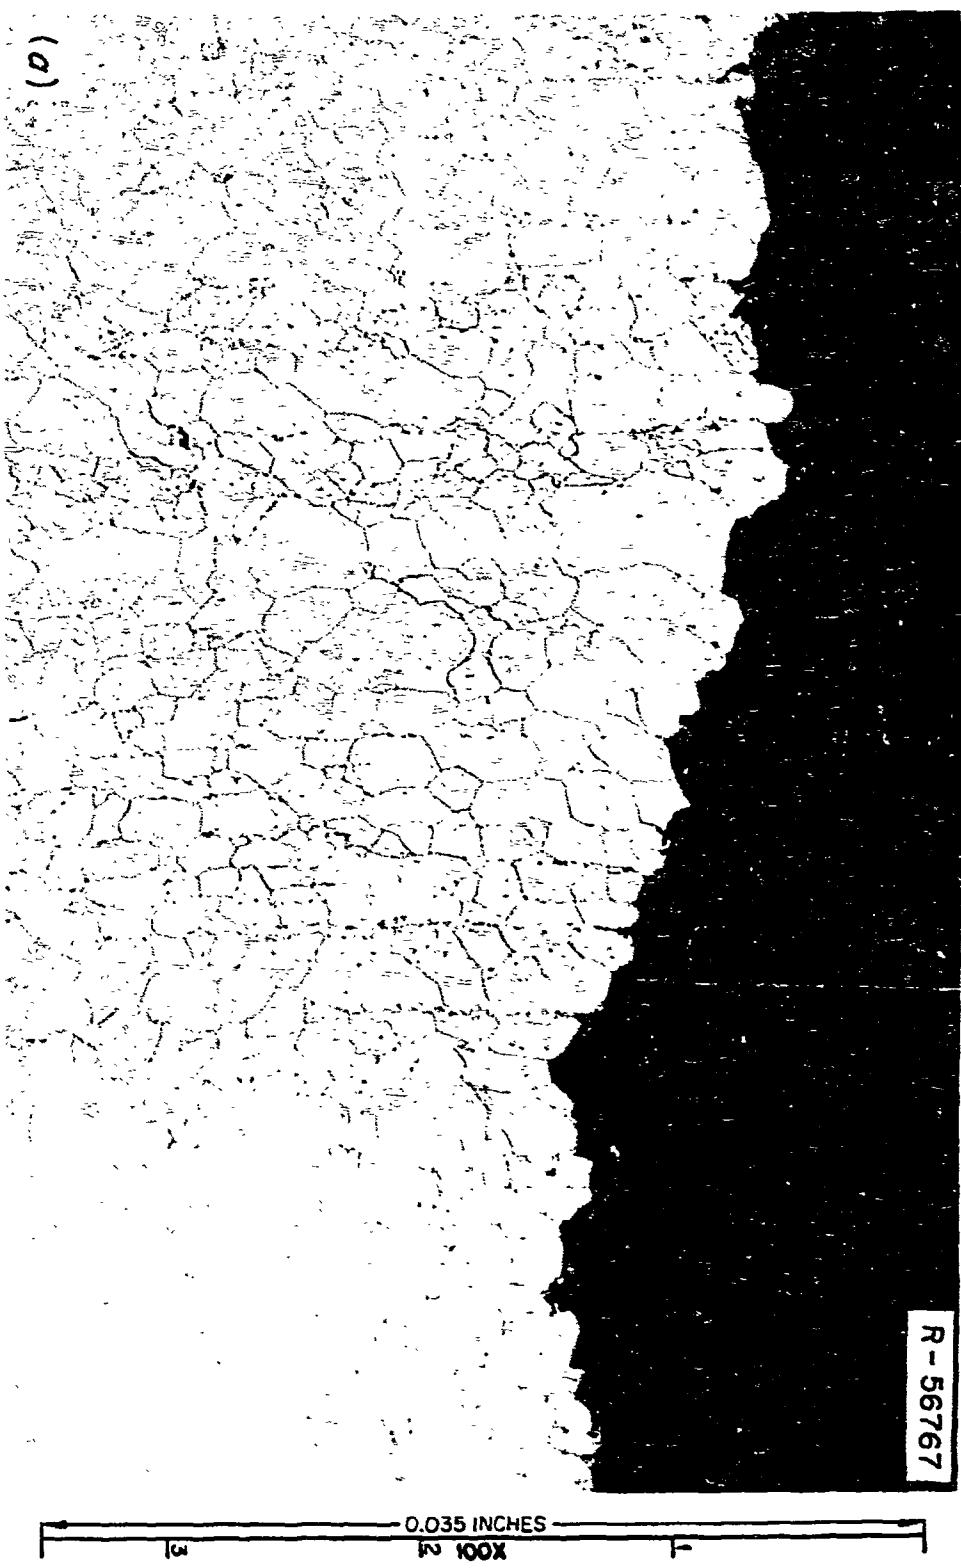
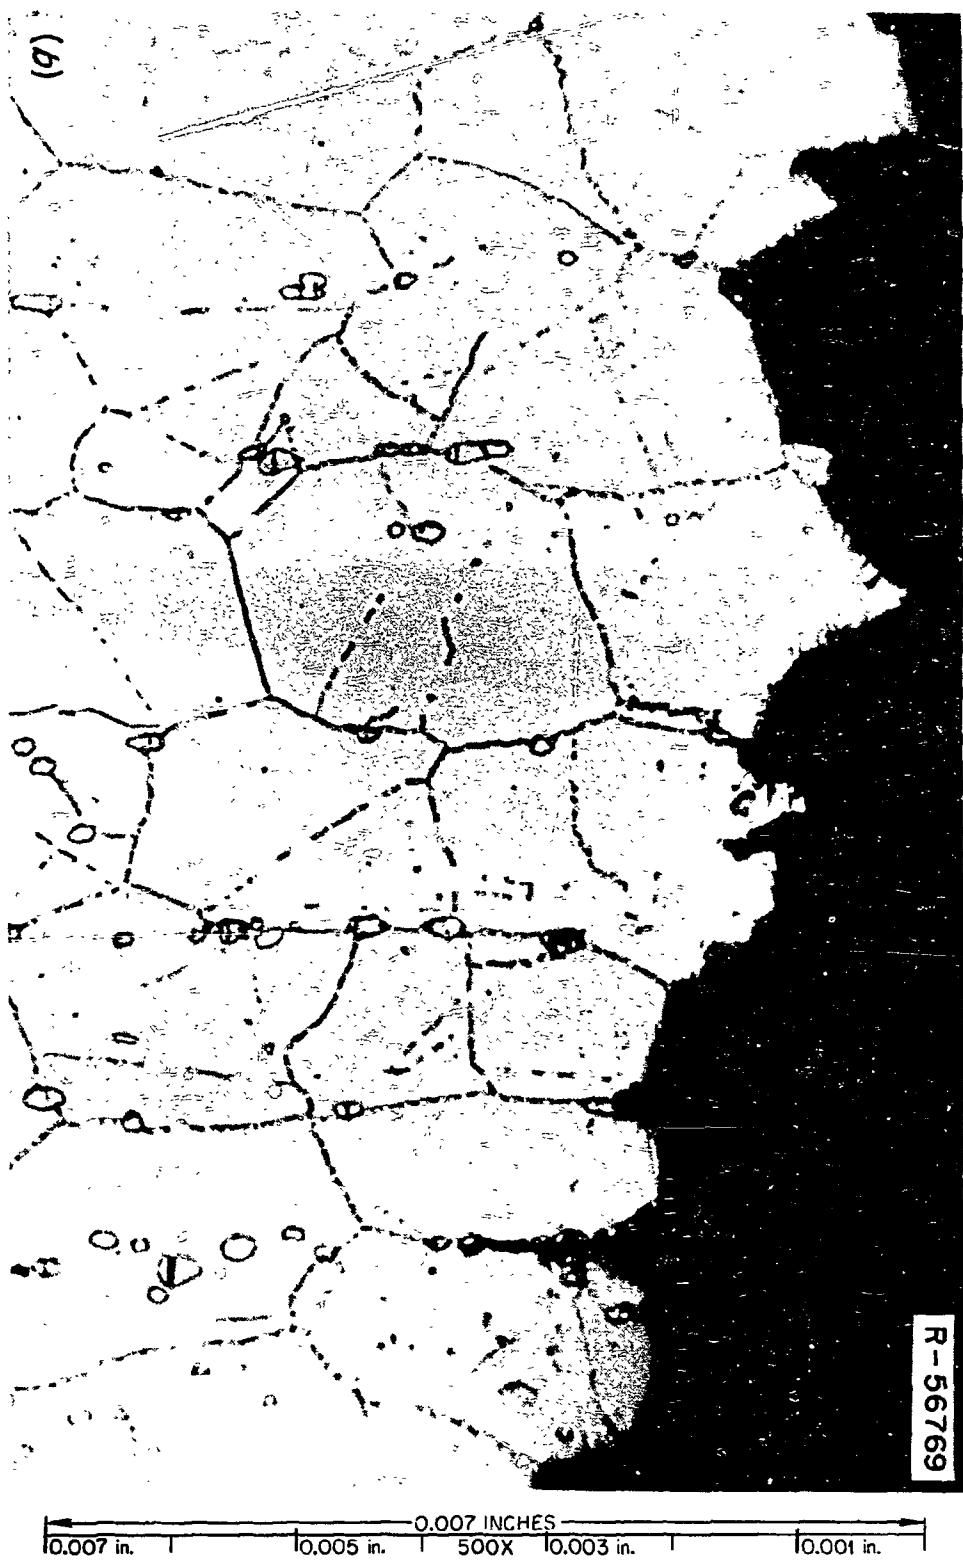
The sample from the outside liquid region was quite similar metallographically to that from the inside liquid region. Photomicrographs of the fracture and a typical region of the tension side near the fracture are shown in Figs. 56 and 57 respectively. A composite of several photomicrographs is shown in Fig. 58.

Fig. 56. Fracture of bend specimen from outside liquid region of INOR-8 mist shield. (a) 100X; (b) 500X. Etchant: lactic acid,  $\text{HNO}_3$ , HCl.

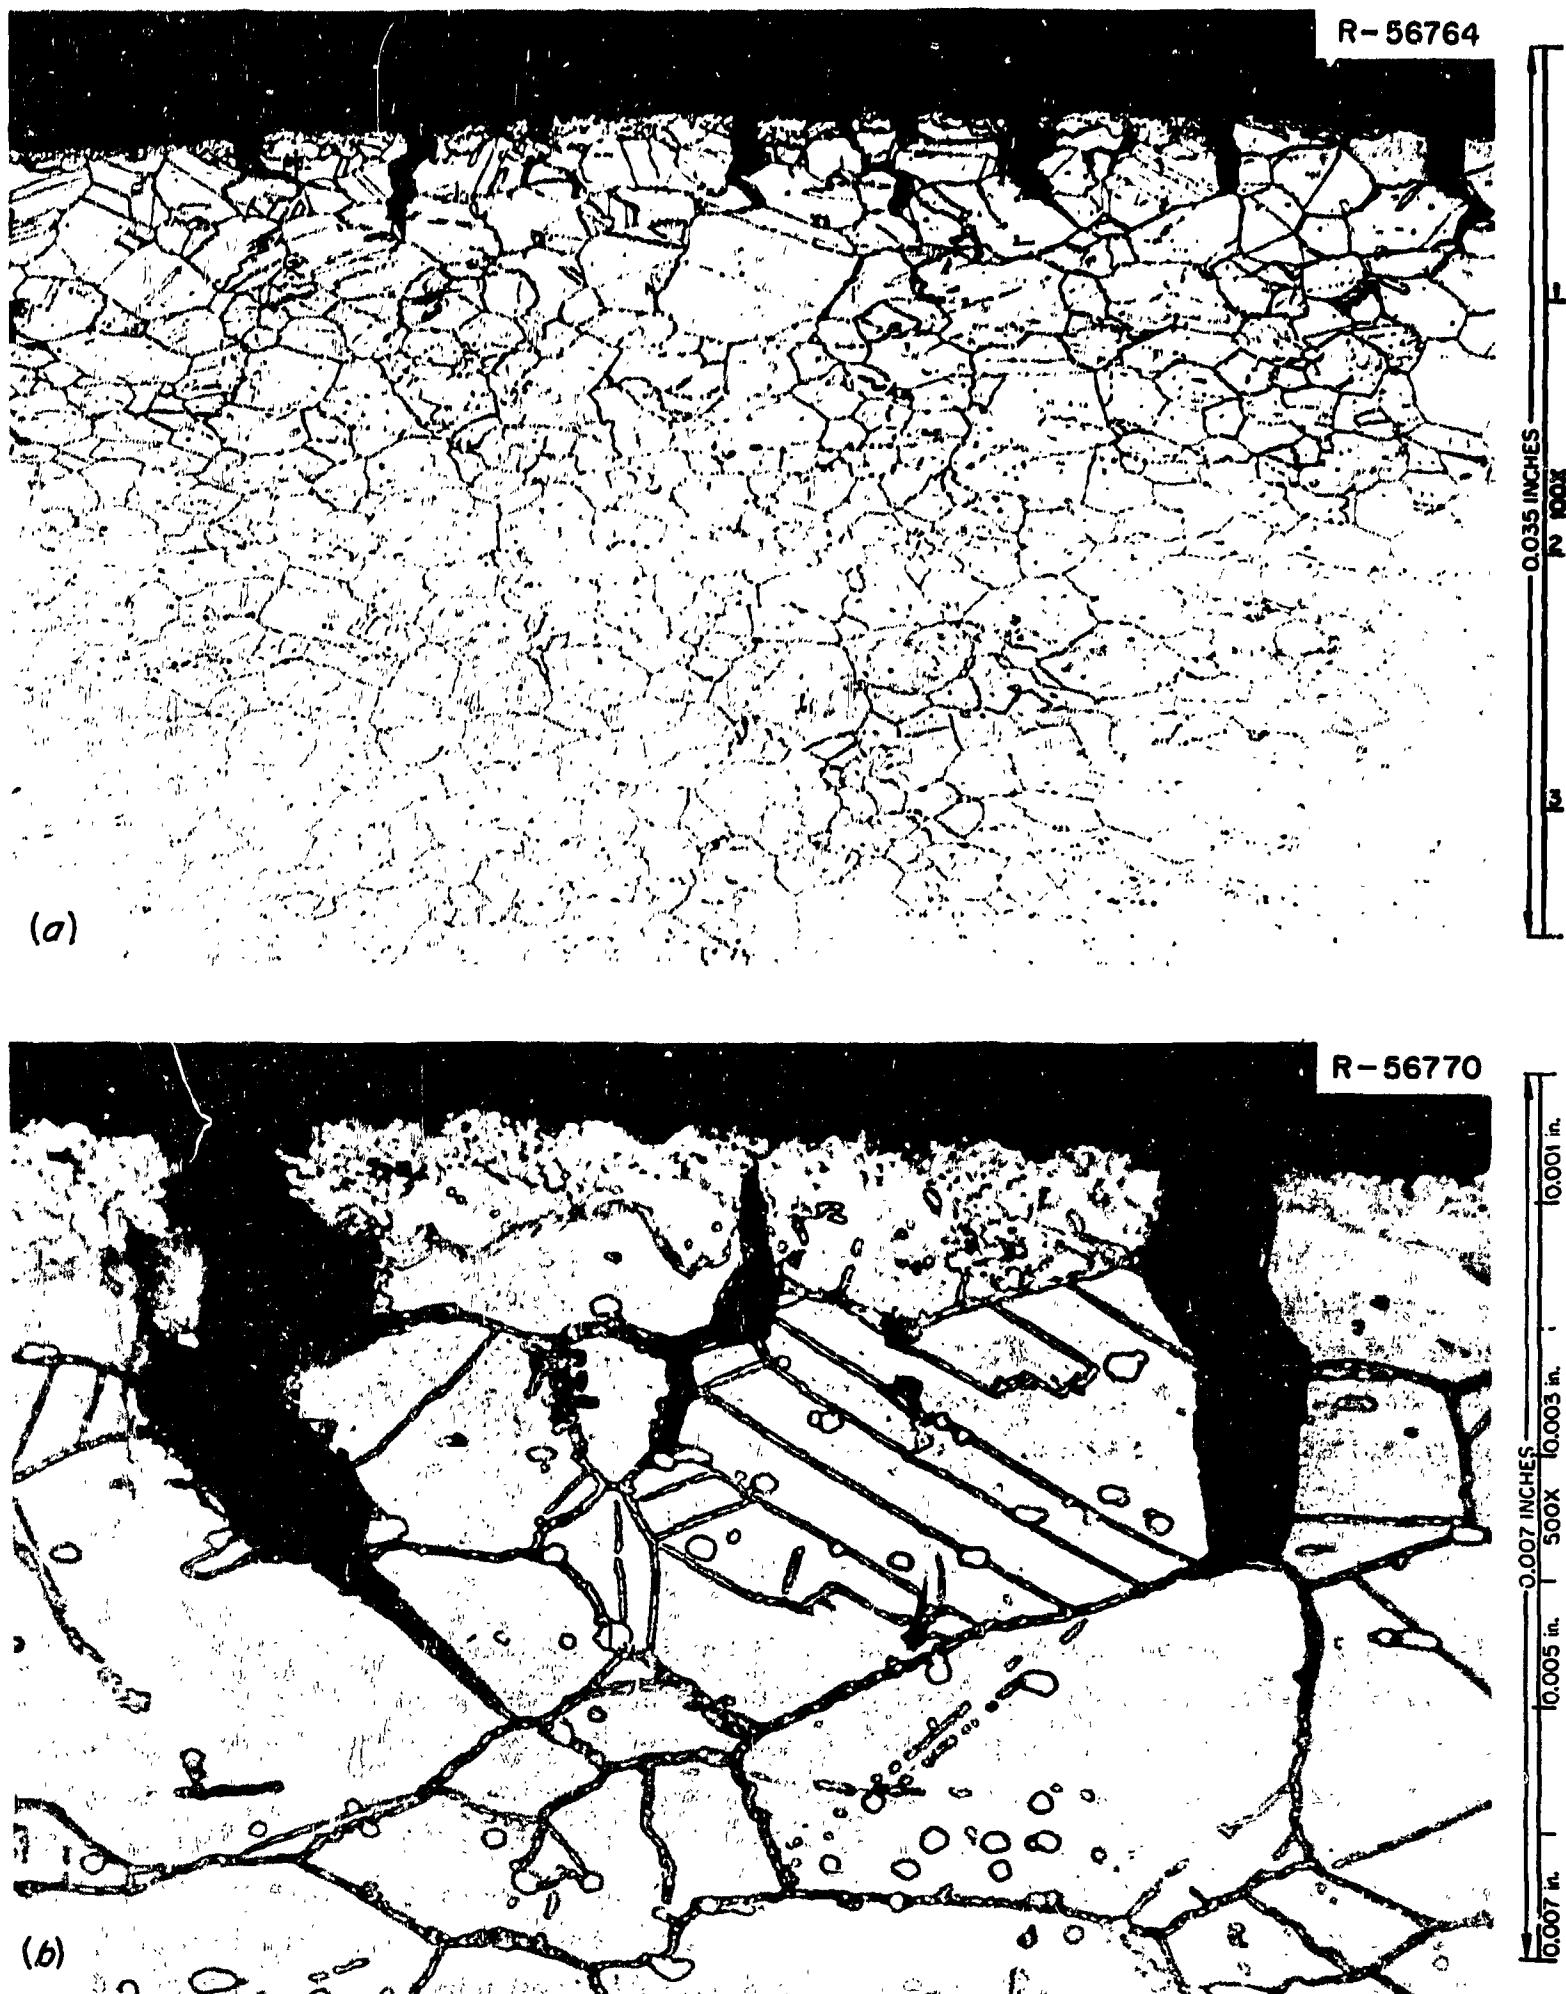
Fig. 57. Tension side near fracture of bend specimen from outside liquid region of INOR-8 mist shield. (a) 100X; (b) 500X. Etchant: lactic acid, HNO<sub>3</sub>, HCl.

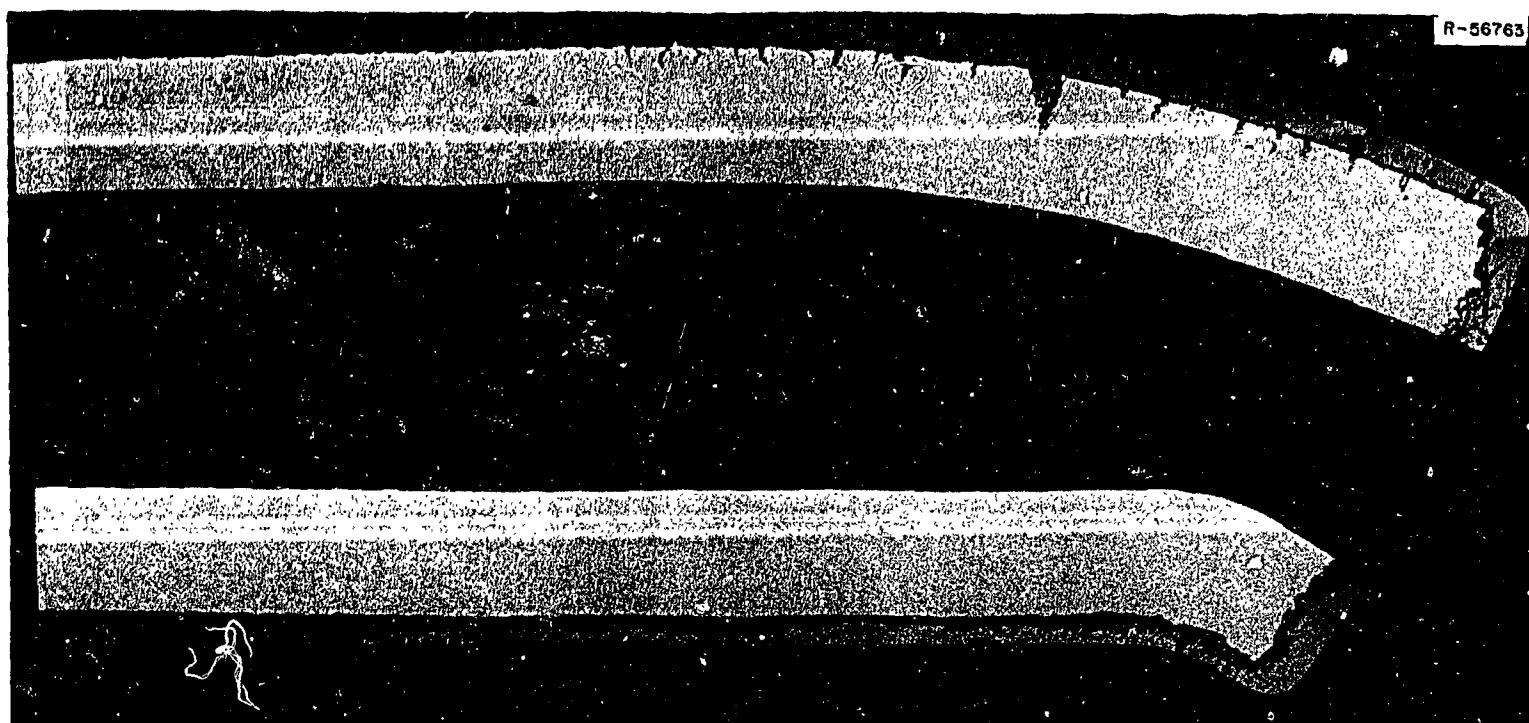
**Fig. 58.** Composite of several photomicrographs of bend specimen from outside liquid region of J' OR-8 mist shield. Top portion shows the tension side, and the lower portion shows the compression side. 24X. Reduced 44%.

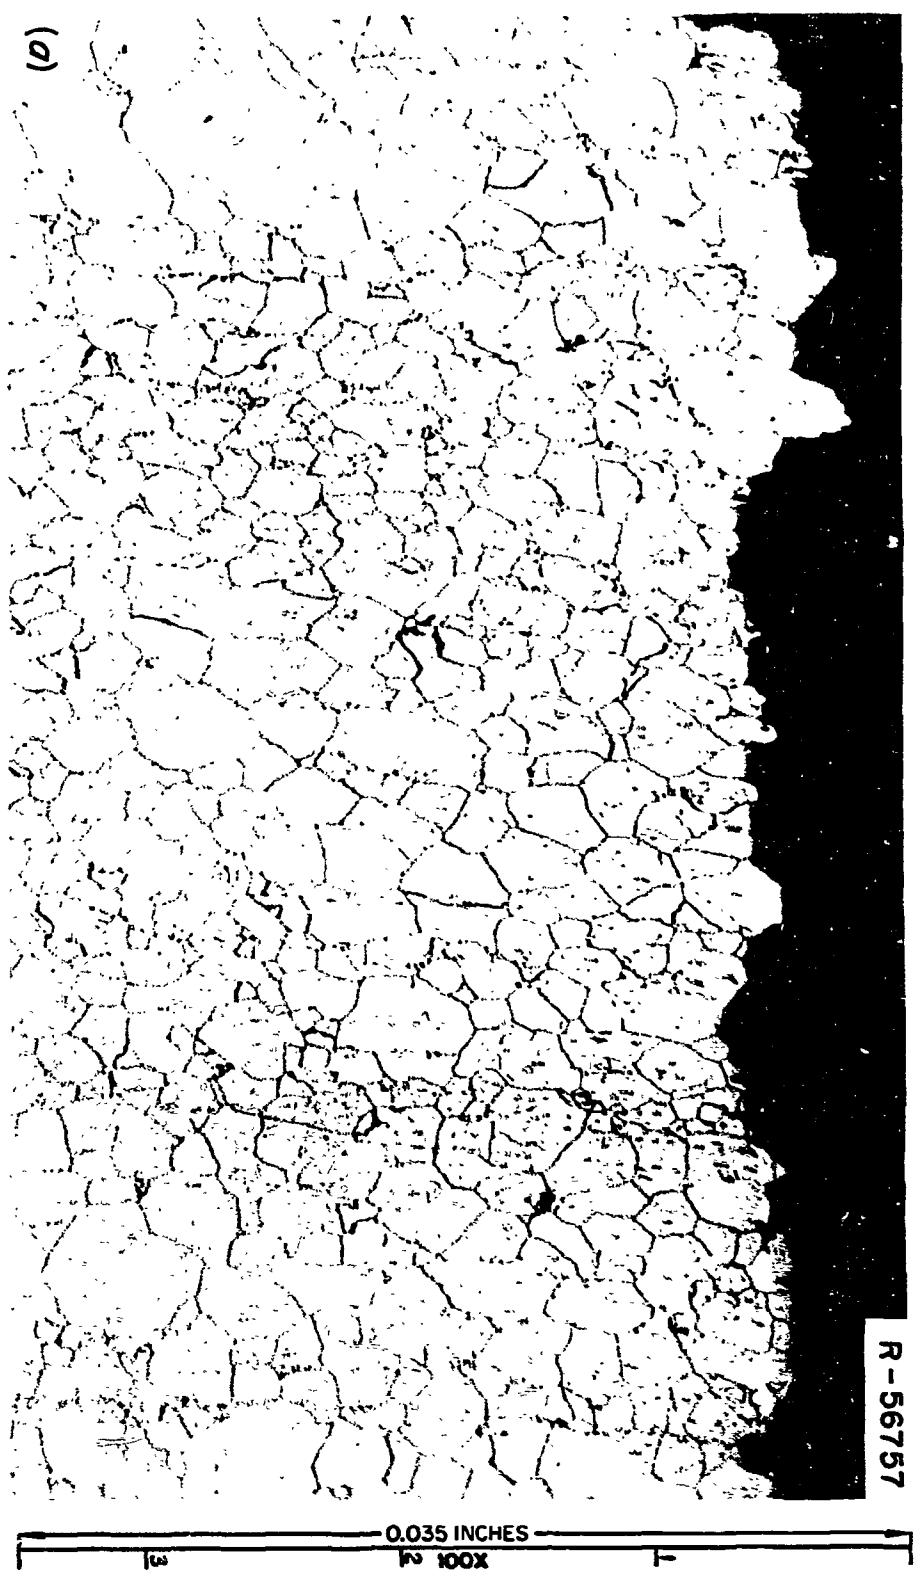
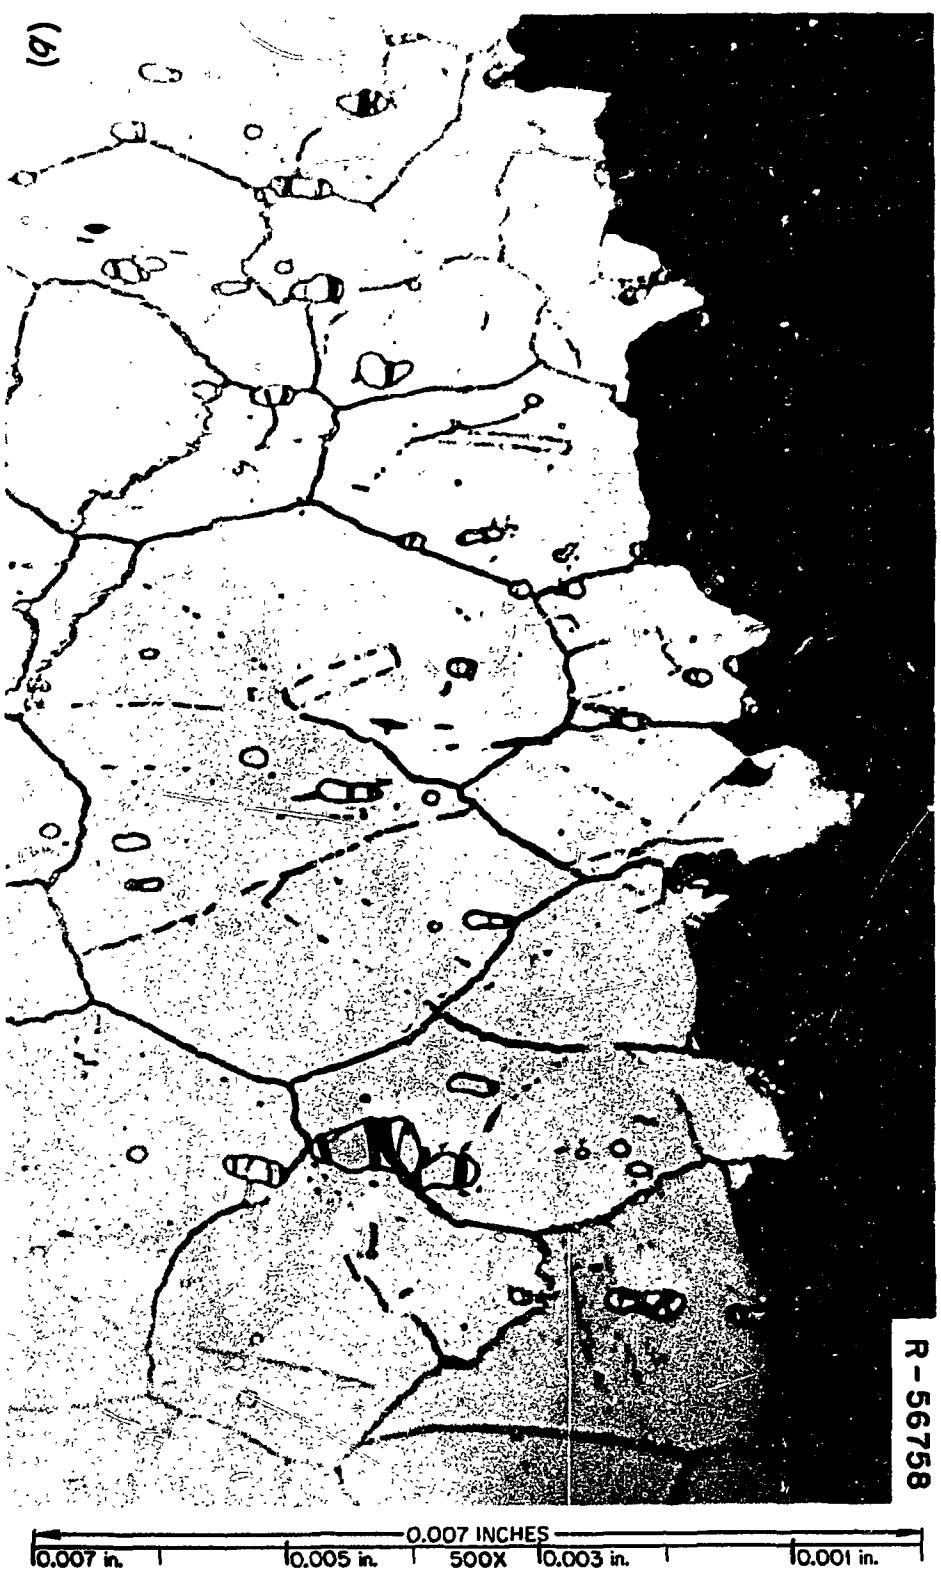
Photomicrographs of the outside vapor (salt spray) bend specimen at the fracture and on the tension side near the fracture are shown in Figs. 59 and 60 respectively. The composite of several photomicrographs in Fig. 61 shows that the cracks are not much deeper nor more frequent than in the liquid regions (compare Figs. 55, 58, and 61), but the tendency for grains to fall out is much greater. This is even more significant when one notes that the strain was the least in the sample from the outside vapor region (Table 7).

Fig. 59. Fracture of a bend specimen from outside vapor portion of INOR-8 mist shield. (a) 100X; (b) 500X. Etchant: lactic acid,  $\text{HNO}_3$ , HCl.

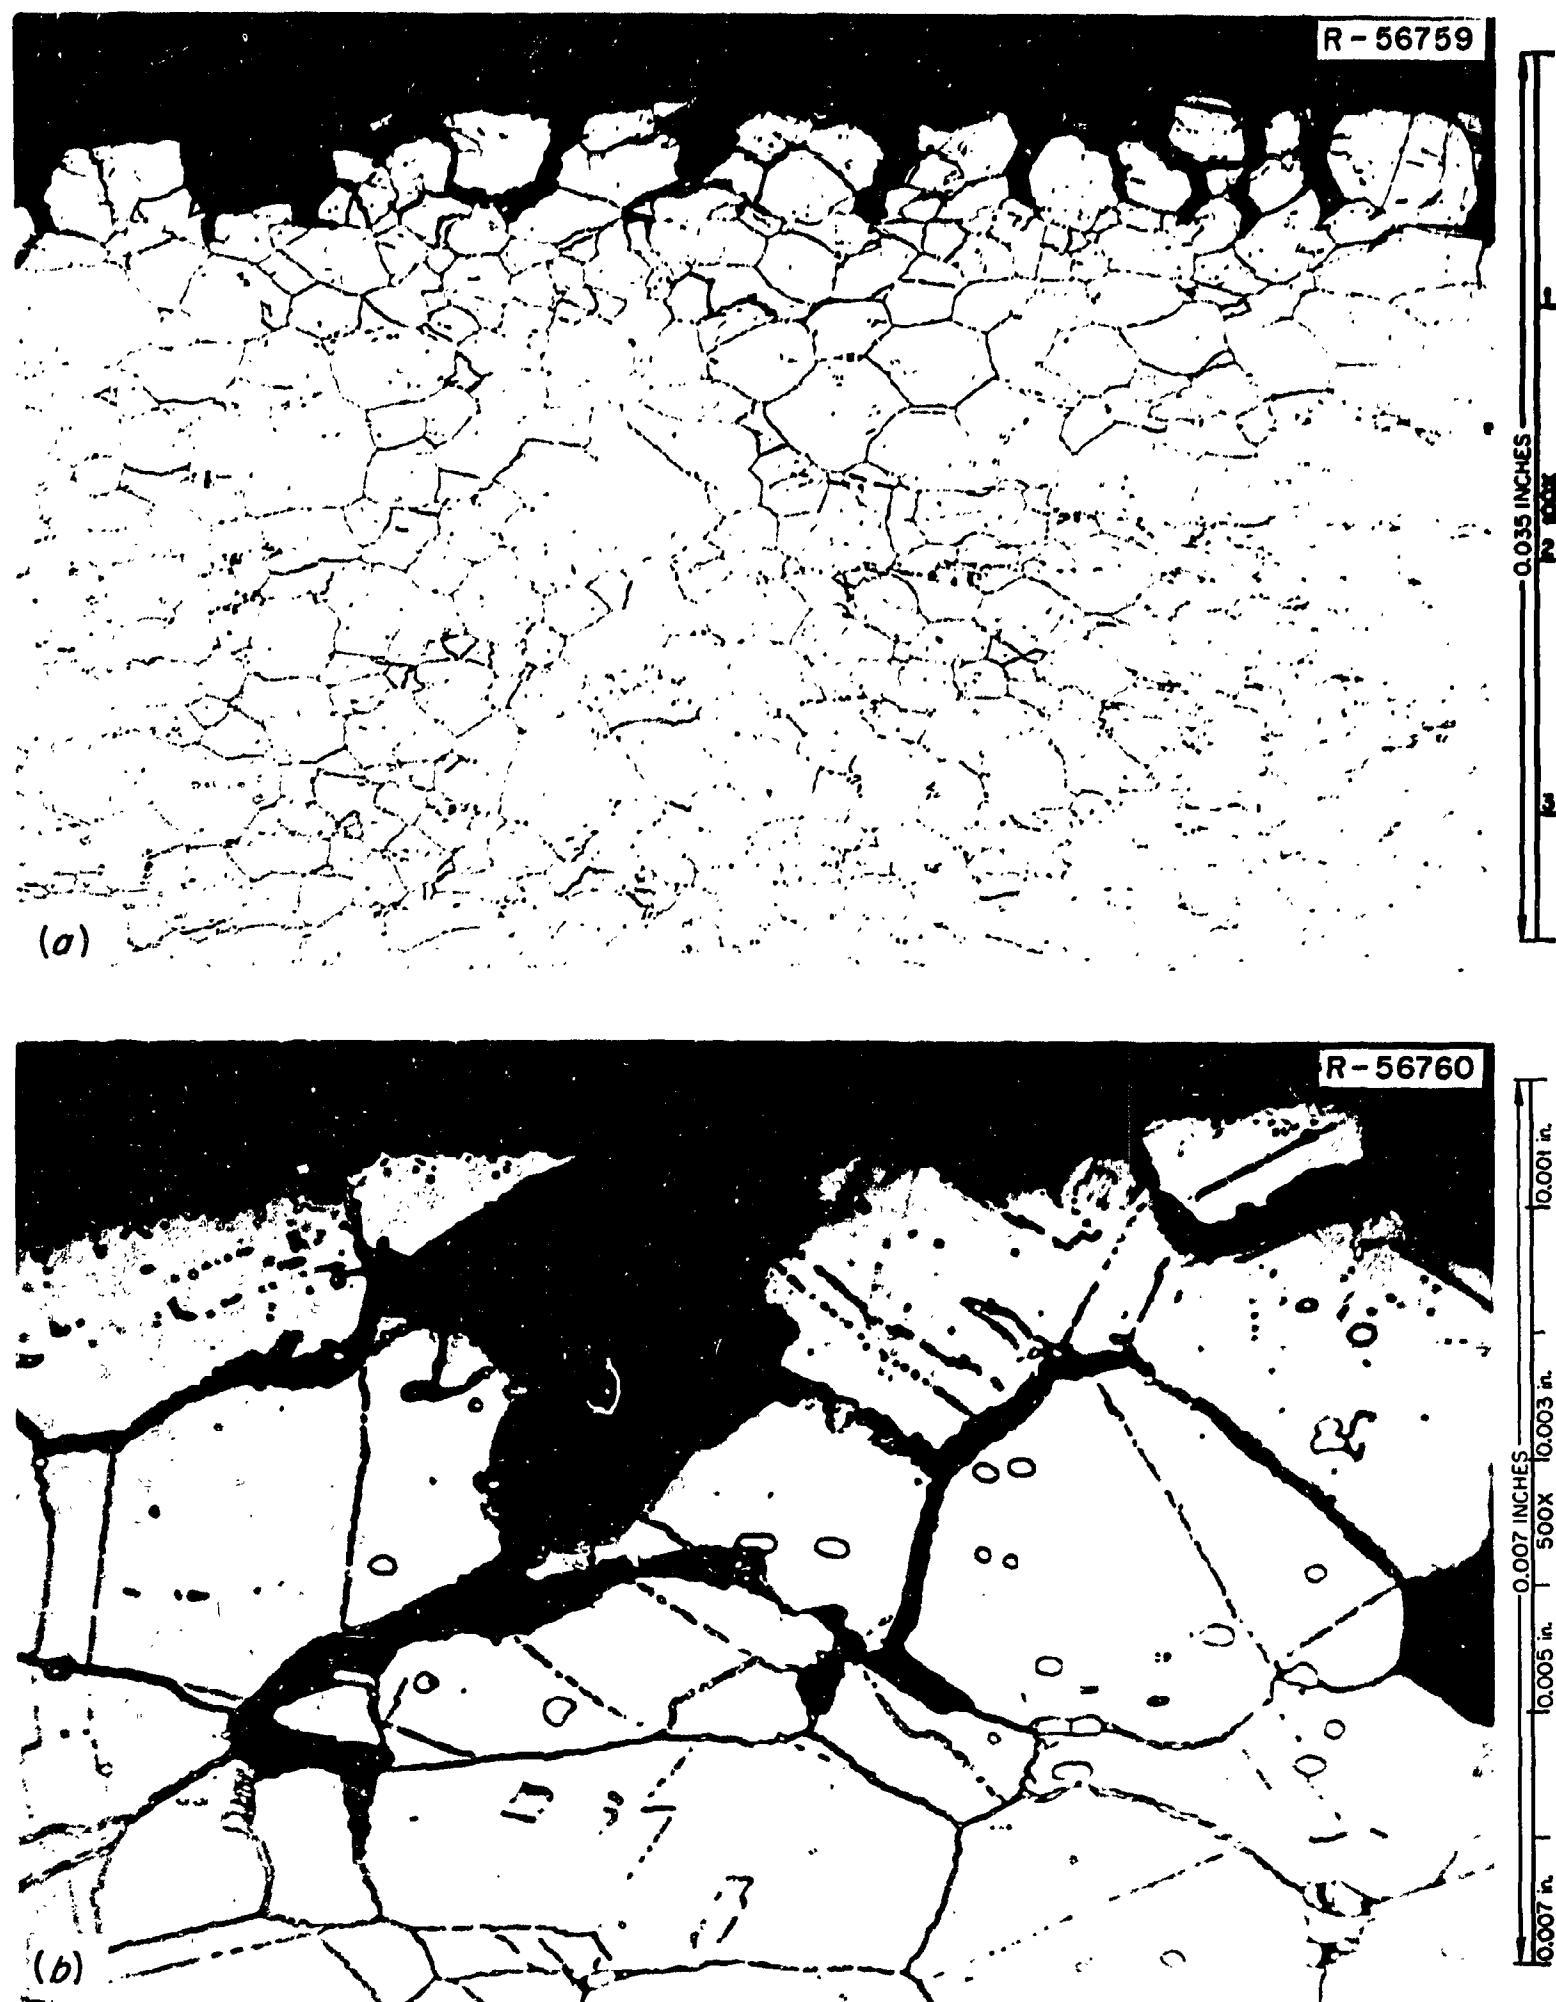
Fig. 60. Edge near fracture of bend specimen from outside vapor portion of INOR-8 mist shield. (a) 100X; (b) 500X.  
Etchant: lactic acid, HNO<sub>3</sub>, HCl.

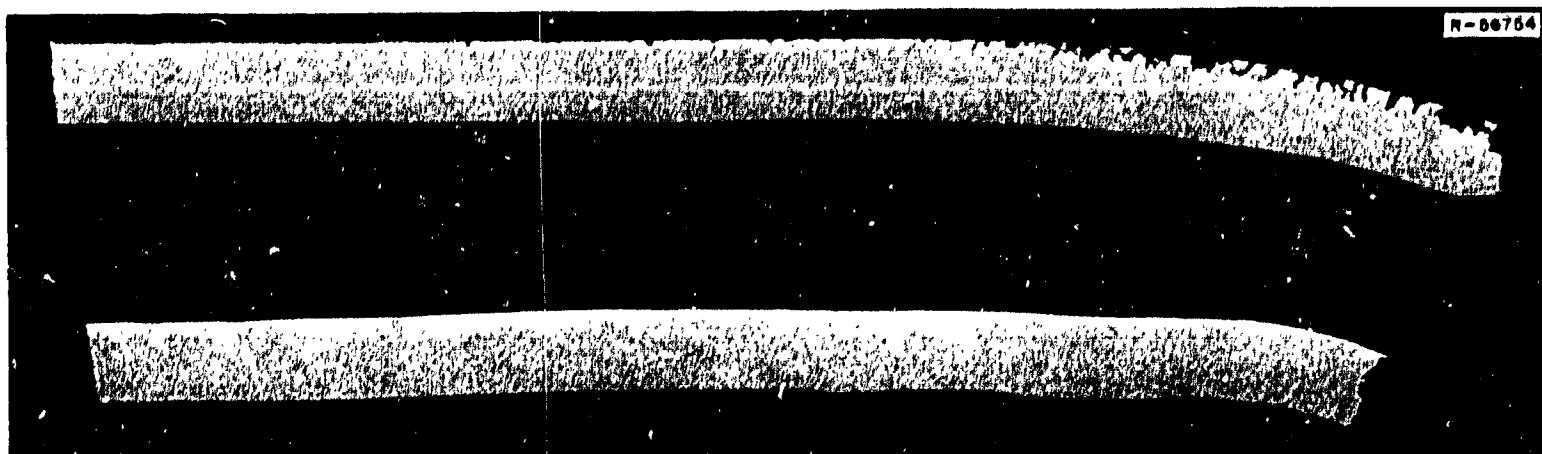
The reduced ductility of these samples remains unexplained. The maximum crack depth in the liquid region was only 8 mils, and it is quite unlikely that an 8-mil reduction in a sample thickness of 125 mils would cause much embrittlement. The embrittlement may have been partially due to the extensive carbide precipitation shown in Figs. 53, 55, 56, 58, and 59. However, the outside and inside of the shield received identical thermal treatments, but the samples from the outside had lower ductilities. Thus, attributing the embrittlement solely to carbide formation does not seem appropriate.

**Fig. 61. Composite of several photomicrographs of bend specimen from outside vapor region of INOR-8 mist shield. Top portion is tension side, and lower part is compression side. 15X. Reduced 44%.**

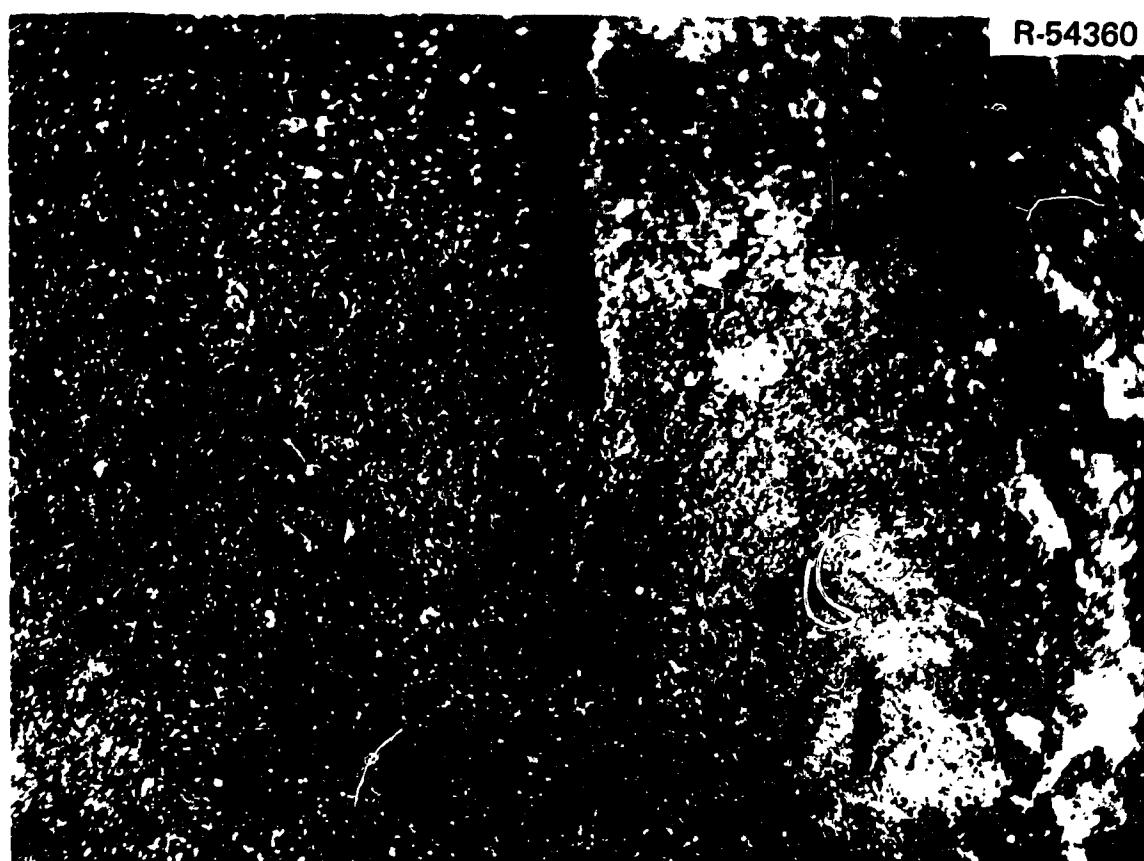
Fig. 63. Crack formed in copper sampler retrieved from pump bowl. Outer surface was coated with deposited material.

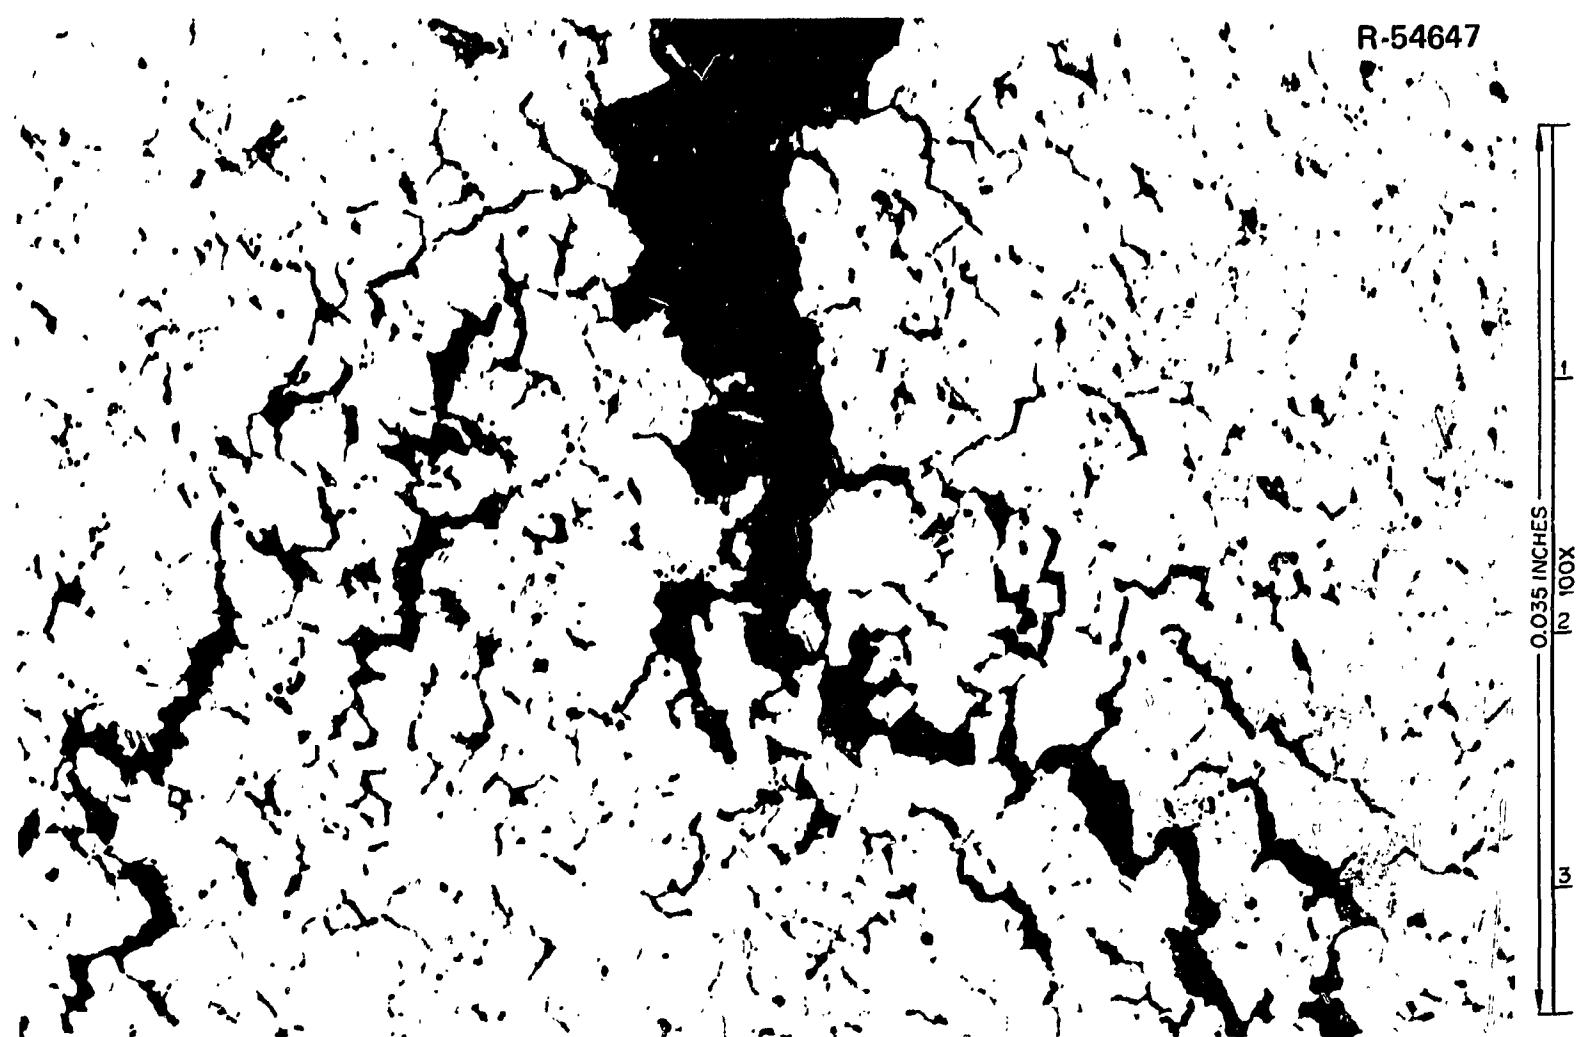
Fig. 64. Section of copper capsule showing extensive intergranular cracking.

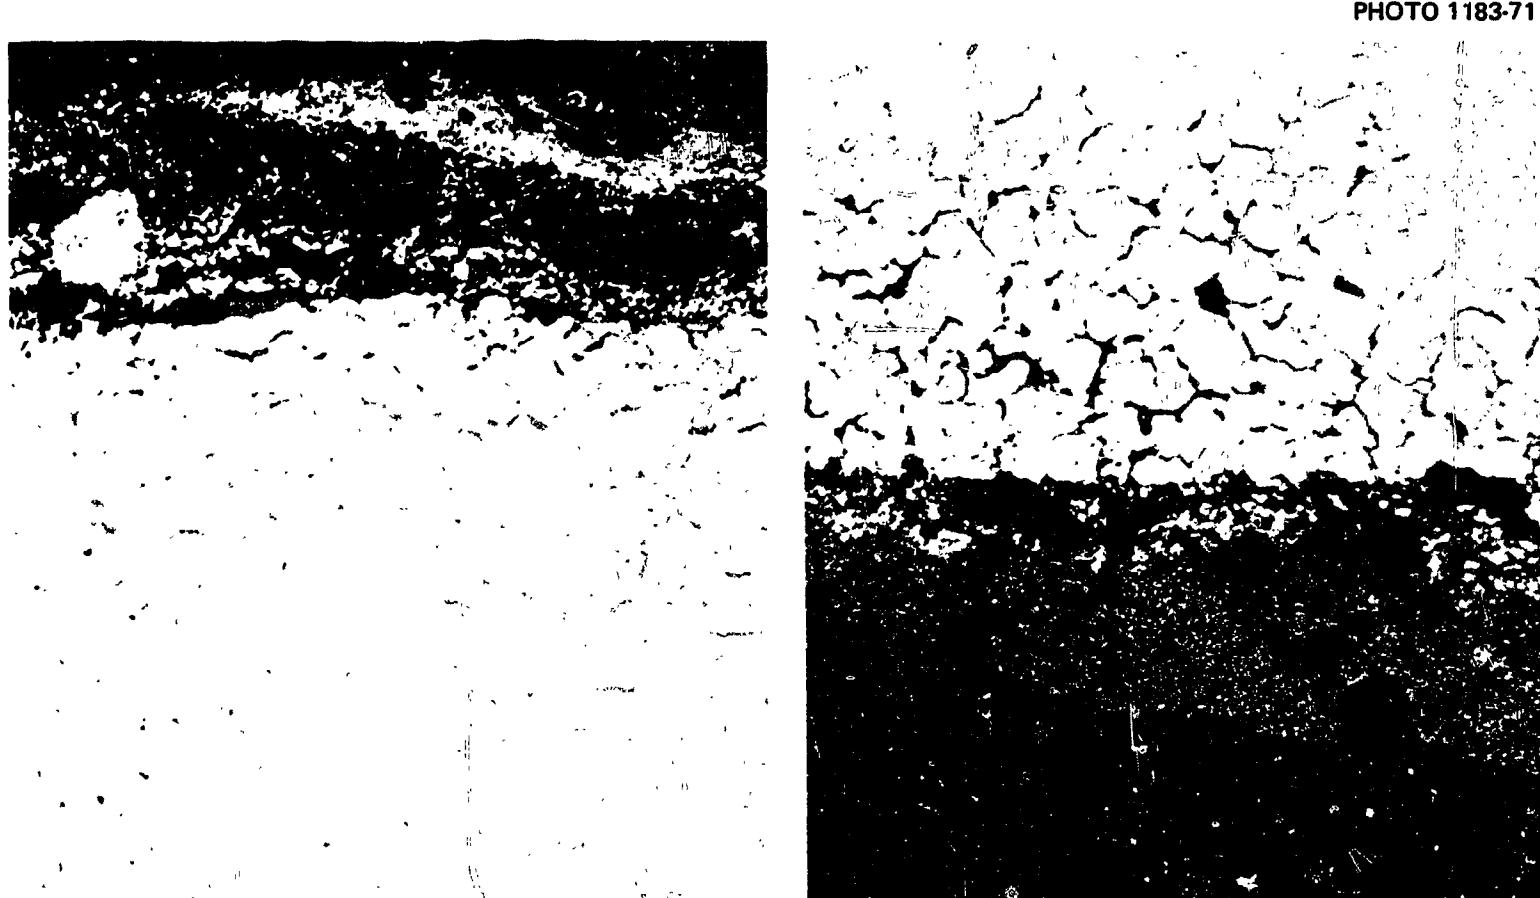
Figure 63 shows a cracked area of the sample capsule with some deposited material on the outside of the capsule. Figure 64 is a photomicrograph of the cracked area polished below the surface, showing the intergranular nature and extent of the cracks. Figure 65 is a photomicrograph of a cross section of the copper capsule, showing the thick deposit of material on both surfaces of the capsule.

Fig. 65. Photomicrographs of copper MSRE fuel sampler showing layers on outside surface (left) and inner surface (right).
