POSTIRRADIATION EXAMINATION OF MATERIALS FROM THE MSRE

H. E. McCoy      B. McNabb

DECEMBER 1972

OAK RIDGE NATIONAL LABORATORY  
Oak Ridge, Tennessee 37830  
operated by  
UNION CARBIDE CORPORATION  
for the  
U.S. ATOMIC ENERGY COMMISSION

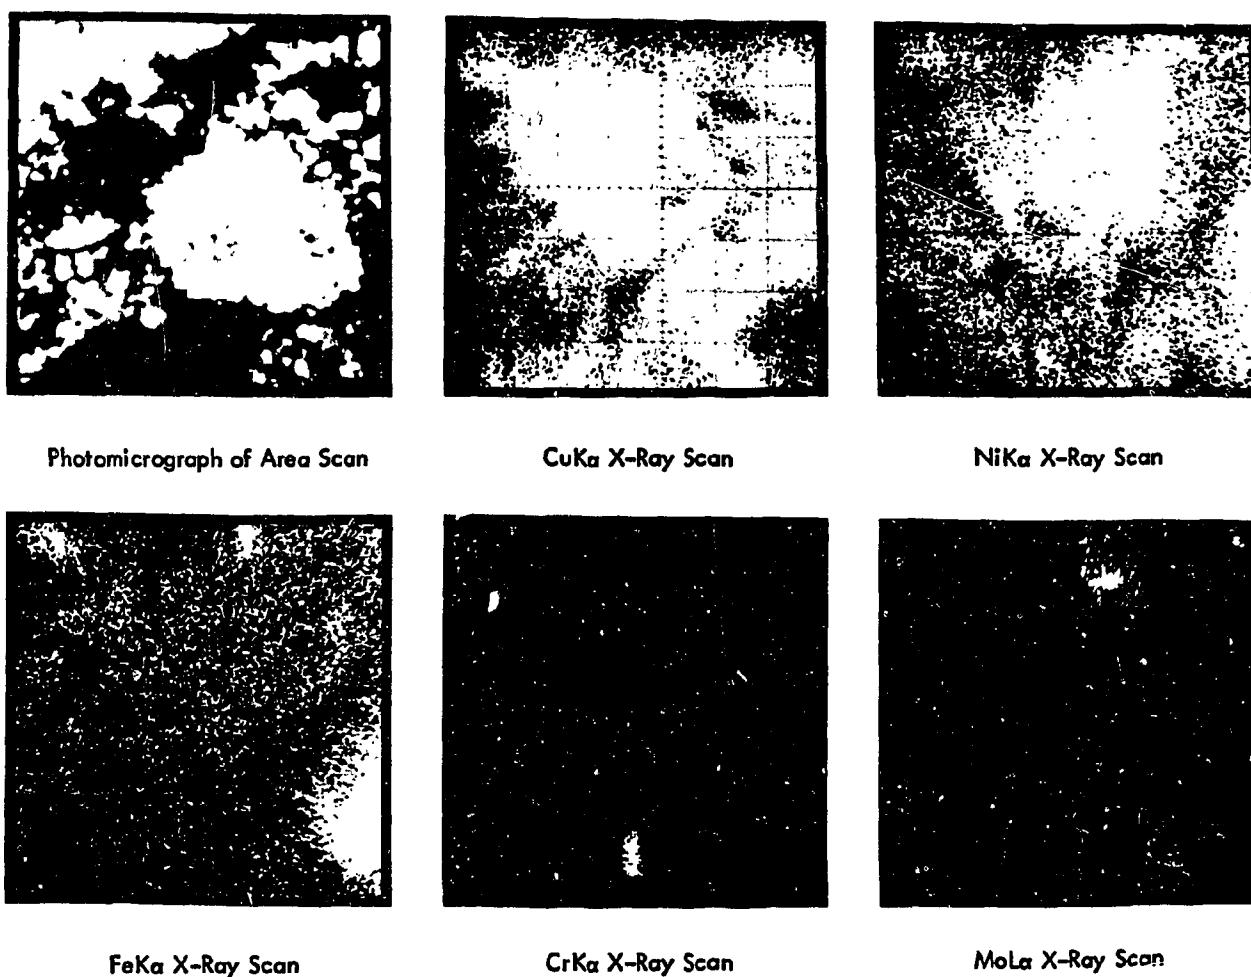
**Fig. 66.** Views of the surface of the copper sampler in the electron-probe microanalyzer. The upper left picture is an optical photomicrograph showing deposited metal crystals. The other pictures show the intensity of x-ray fluorescence for various elements. These displays are a mirror image of the first optical picture. Note that certain areas are enriched in Ni, Fe, Cr, and Mo. Some copper from the capsule is present in the deposited material. Approx 200 $\times$ .

An electron-probe microanalysis of the material in the grain boundaries and x-ray scans for the distribution of Ni, Fe, Cr, and Cu in the surface layer in the area around the large metallic particle on the outer surface were made. Figure 66 shows the distribution of these elements, and it appears that the surface layers were made up mostly of copper and nickel, with some areas containing high concentrations of chromium and molybdenum. The inner and outer surfaces of the capsule appear similar. The grain-boundary precipitate was only 28% Cu, and no other element could be detected. This observation indicates that the remainder is a light element, perhaps beryllium or lithium, that could not be detected by the instrument.

Although copper is generally accepted as being compatible with fuel salt, this capsule was severely embrittled in its 13,000-hr exposure to MSRE fuel salt. Heavy deposits quite similar to those noted on the sample cage and shield were present on the surfaces of the copper capsule. Some of the constituents of these deposits may have caused the embrittlement, but we were unable to identify the responsible element.

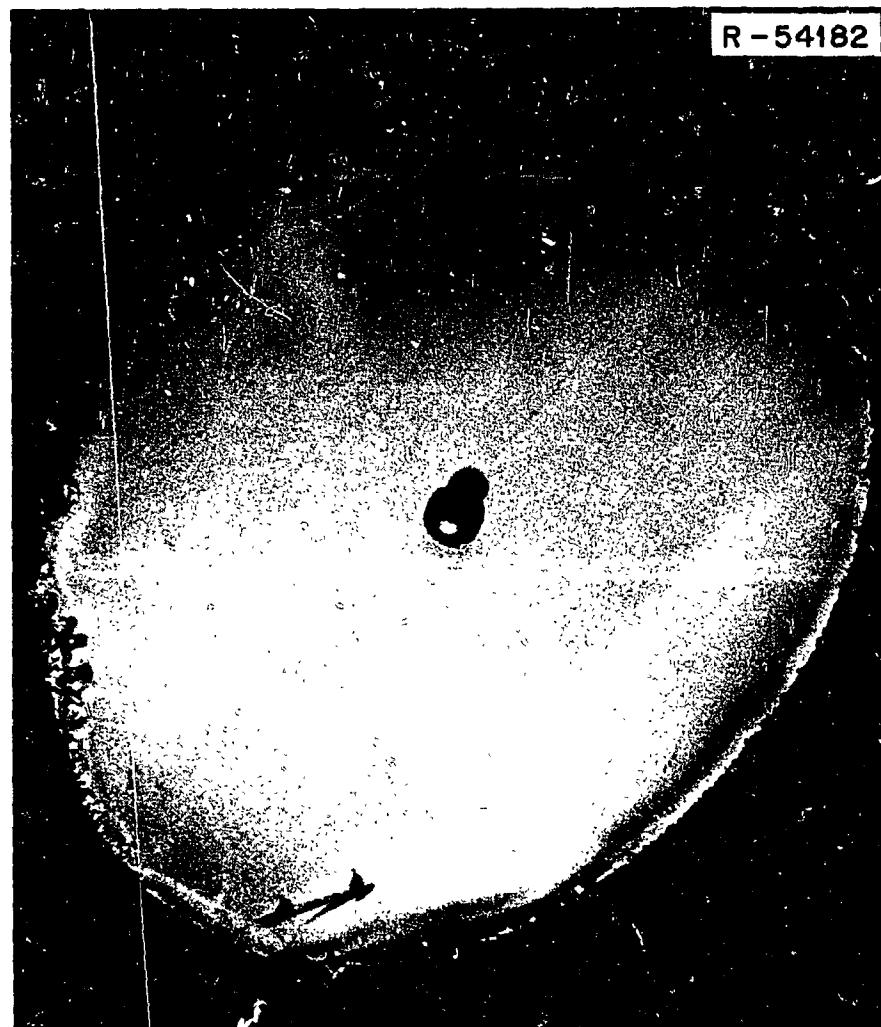
The heat exchanger was above 500°C for 30,807 hr and was exposed to fuel salt for 21,040 hr. An oval piece of the shell 10 X 13 in. was cut by plasma torch near the outlet end of the heat exchanger. This same cut severed a piece of one tube, and pieces of five others were cut by an abrasive wheel. These parts are shown in Figs. 68 and 69. The outside of the shell had a dark adherent oxide; the inside surfaces were discolored slightly and had a thin bluish-gray coating, probably caused by the plasma cutting operation. Some of this powder was brushed off and found by gamma scanning to contain  $^{106}\text{Ru}$  and  $^{125}\text{Sb}$ .

Fig. 68. Section 10 x 13 in. cut from the primary heat exchanger shell. The piece was cut with a plasma torch, and the center stud was used for guiding the torch.

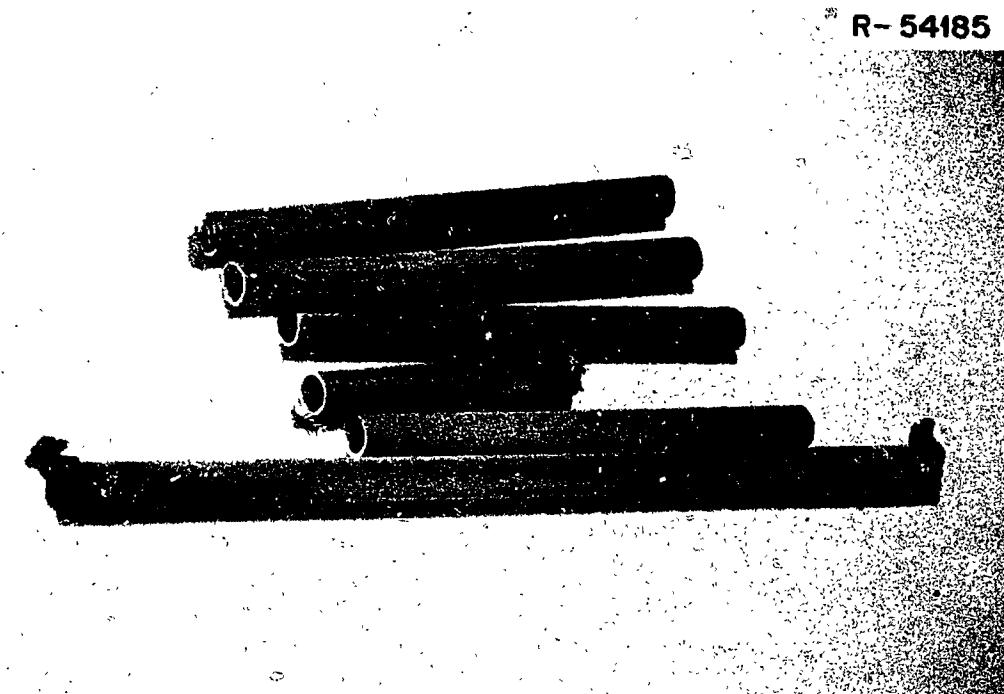
Fig. 69. The  $\frac{1}{2}$ -in.-OD INOR-8 tubes from the primary heat exchanger. The different shades arise from a dark film thought to have been deposited when the shell was being cut. The film was deposited on the side of the tubes facing the shell.

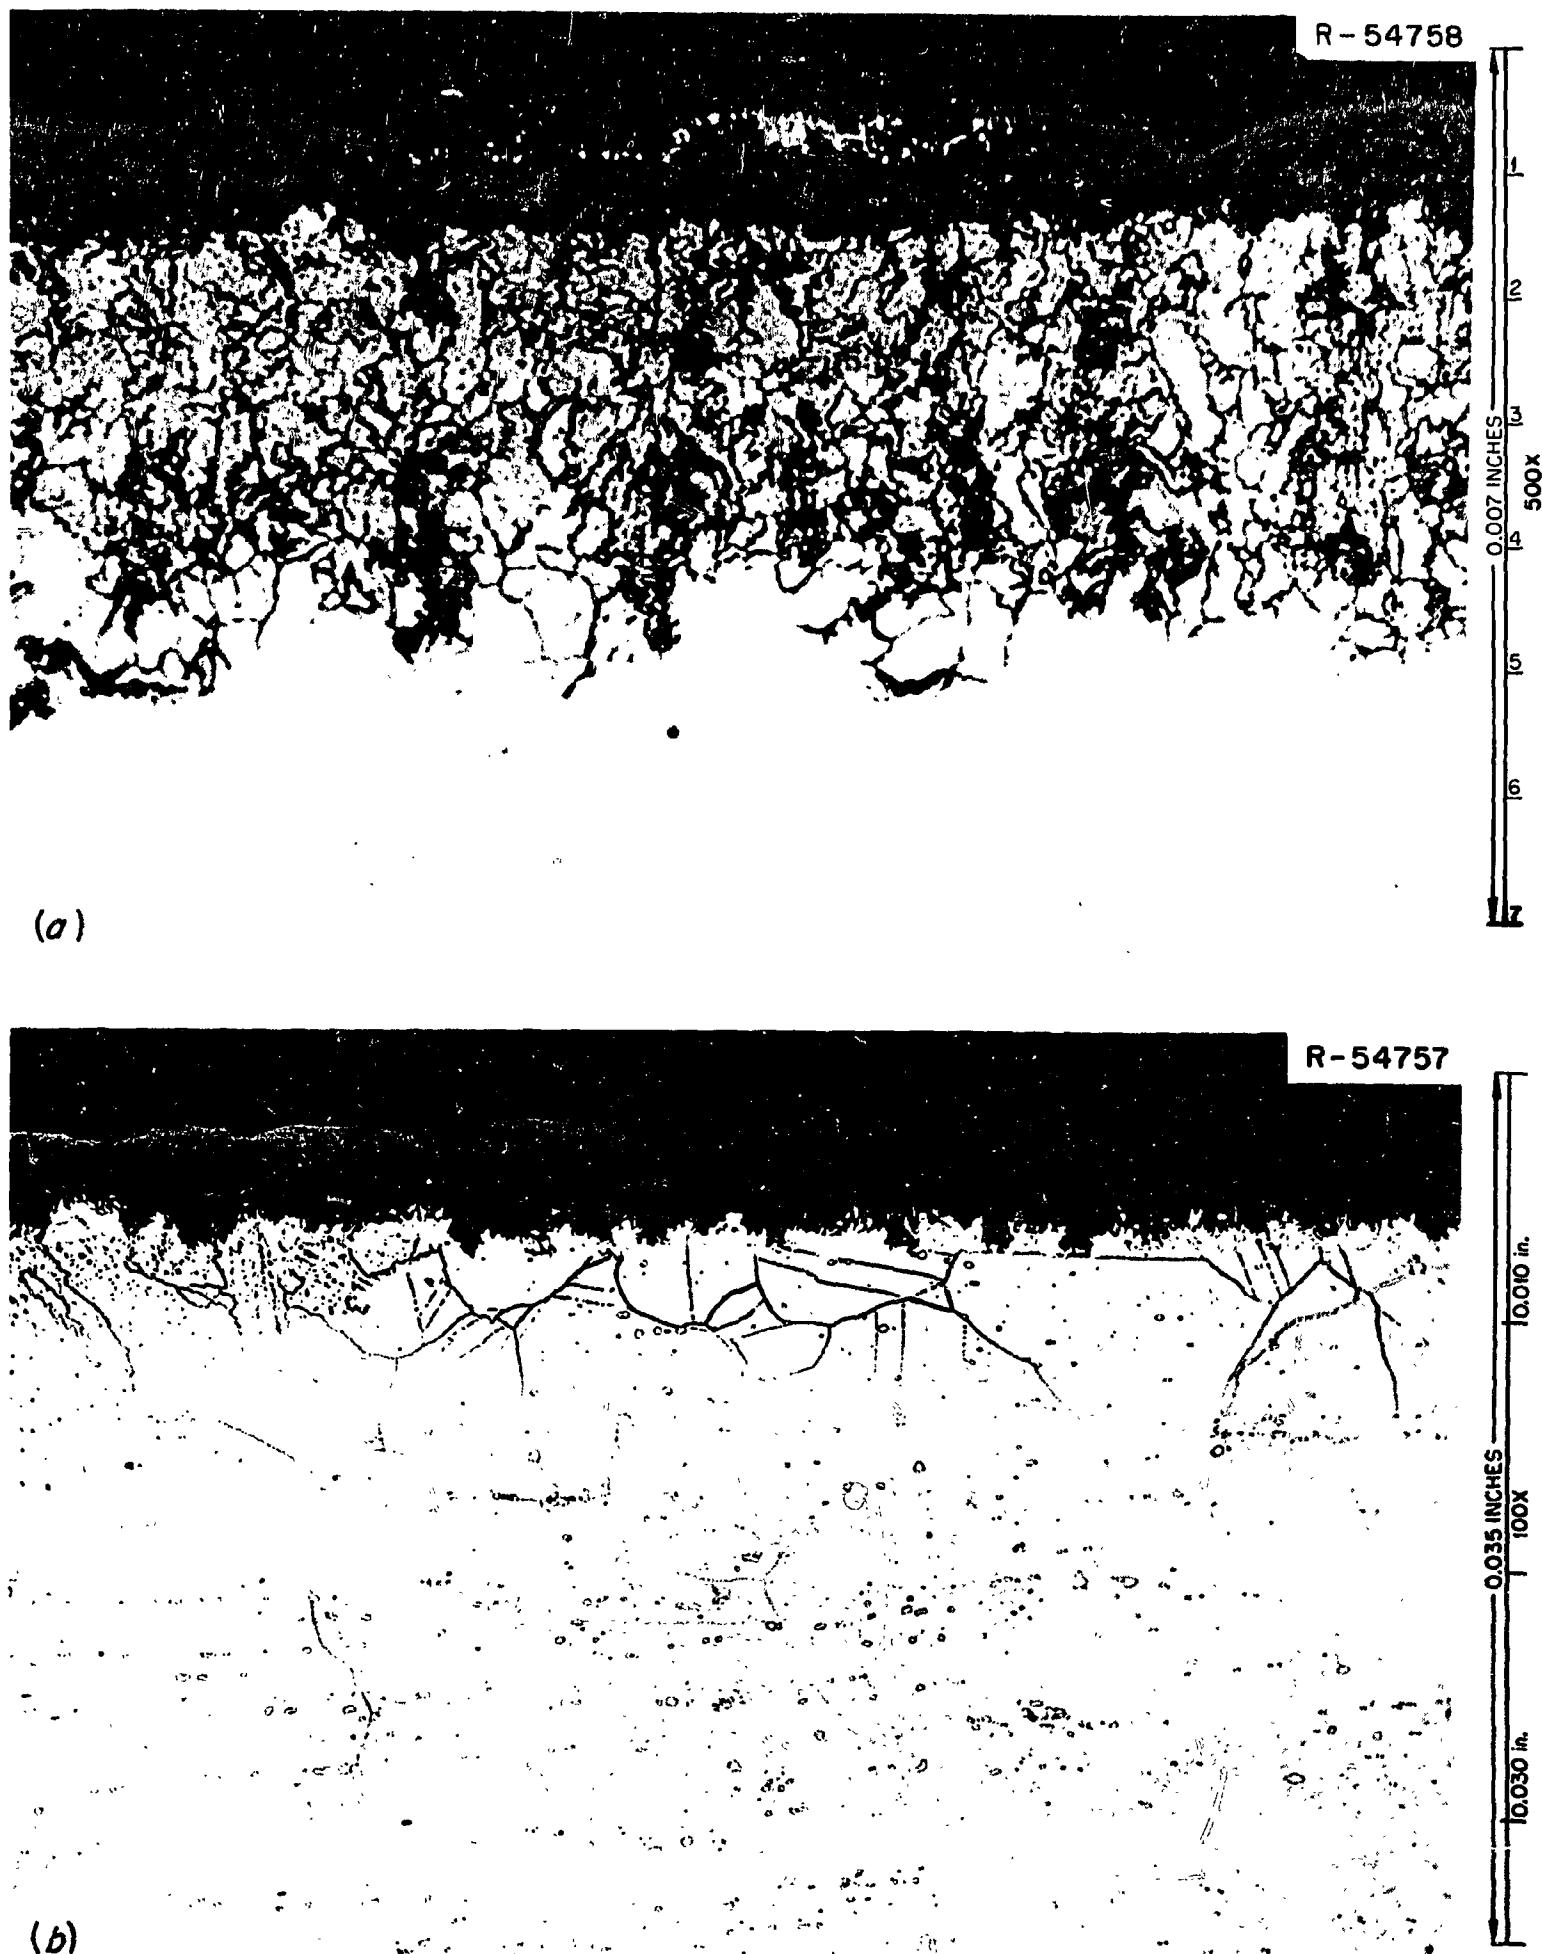
**Fig. 70. Outside edge of INOR-8 primary heat exchanger shell. This surface was exposed to 2 to 5% O<sub>2</sub> in nitrogen. (a) As polished, showing selective oxidation. (b) Etched view showing that metal in oxidized layer was completely removed. Etchant: aqua regia.**

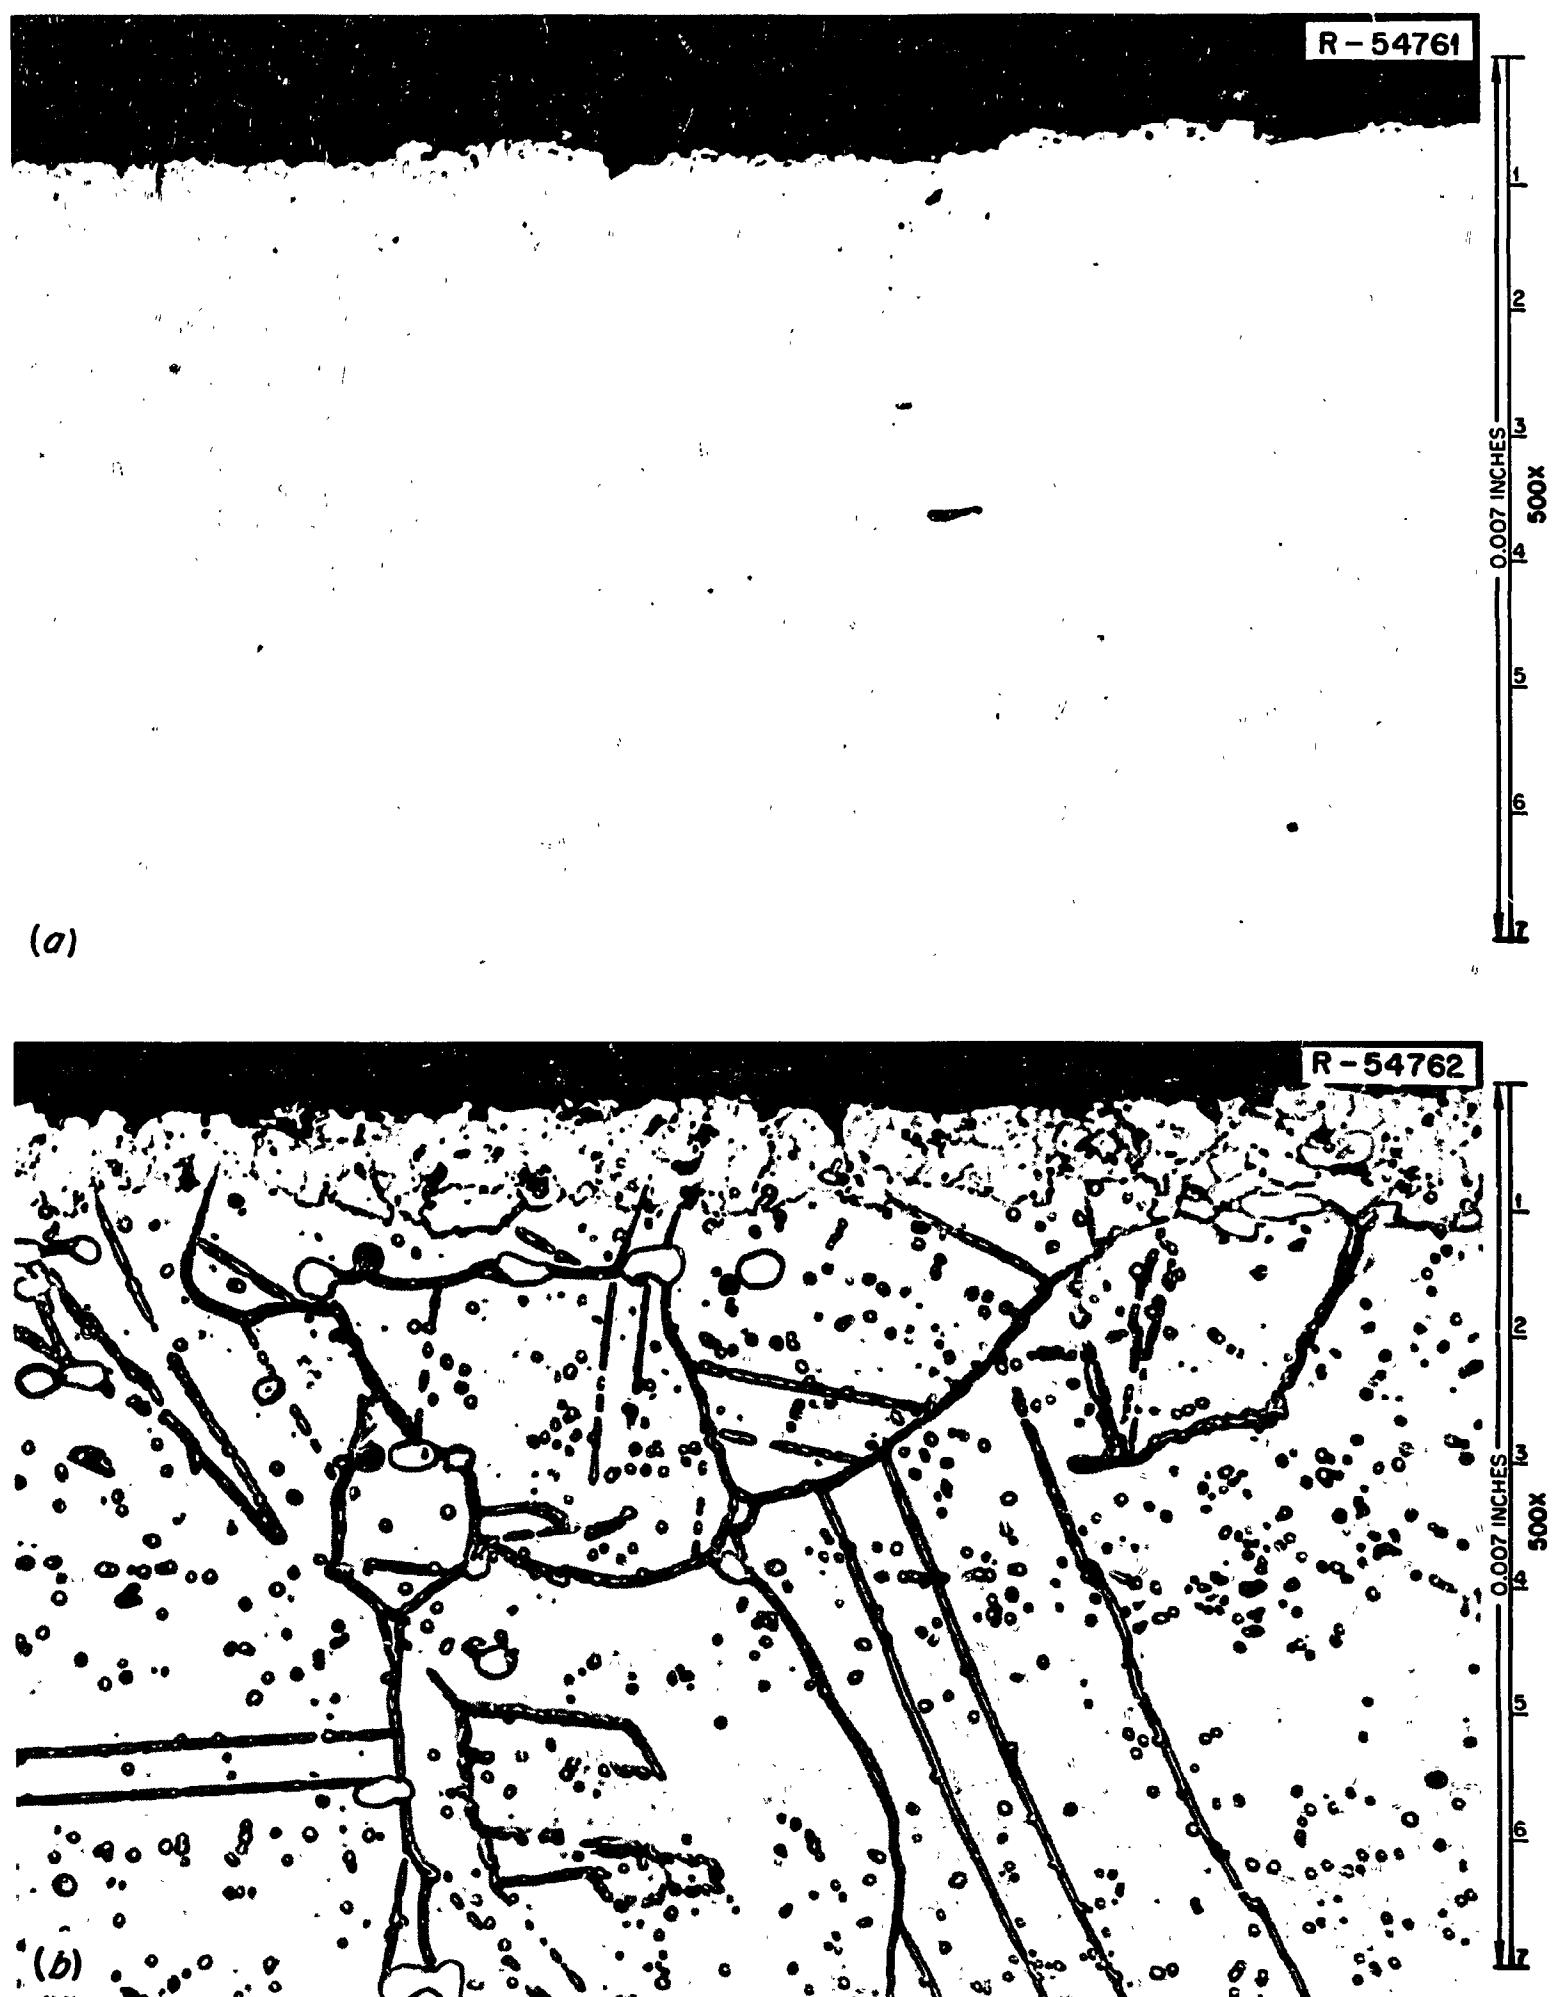
Fig. 71. Inside surface of INOR-8 primary heat exchanger shell. The surface was exposed to fuel salt, and the modified structure to a depth of about 1 mil is apparent. (a) As polished; (b) etched with aqua regia.

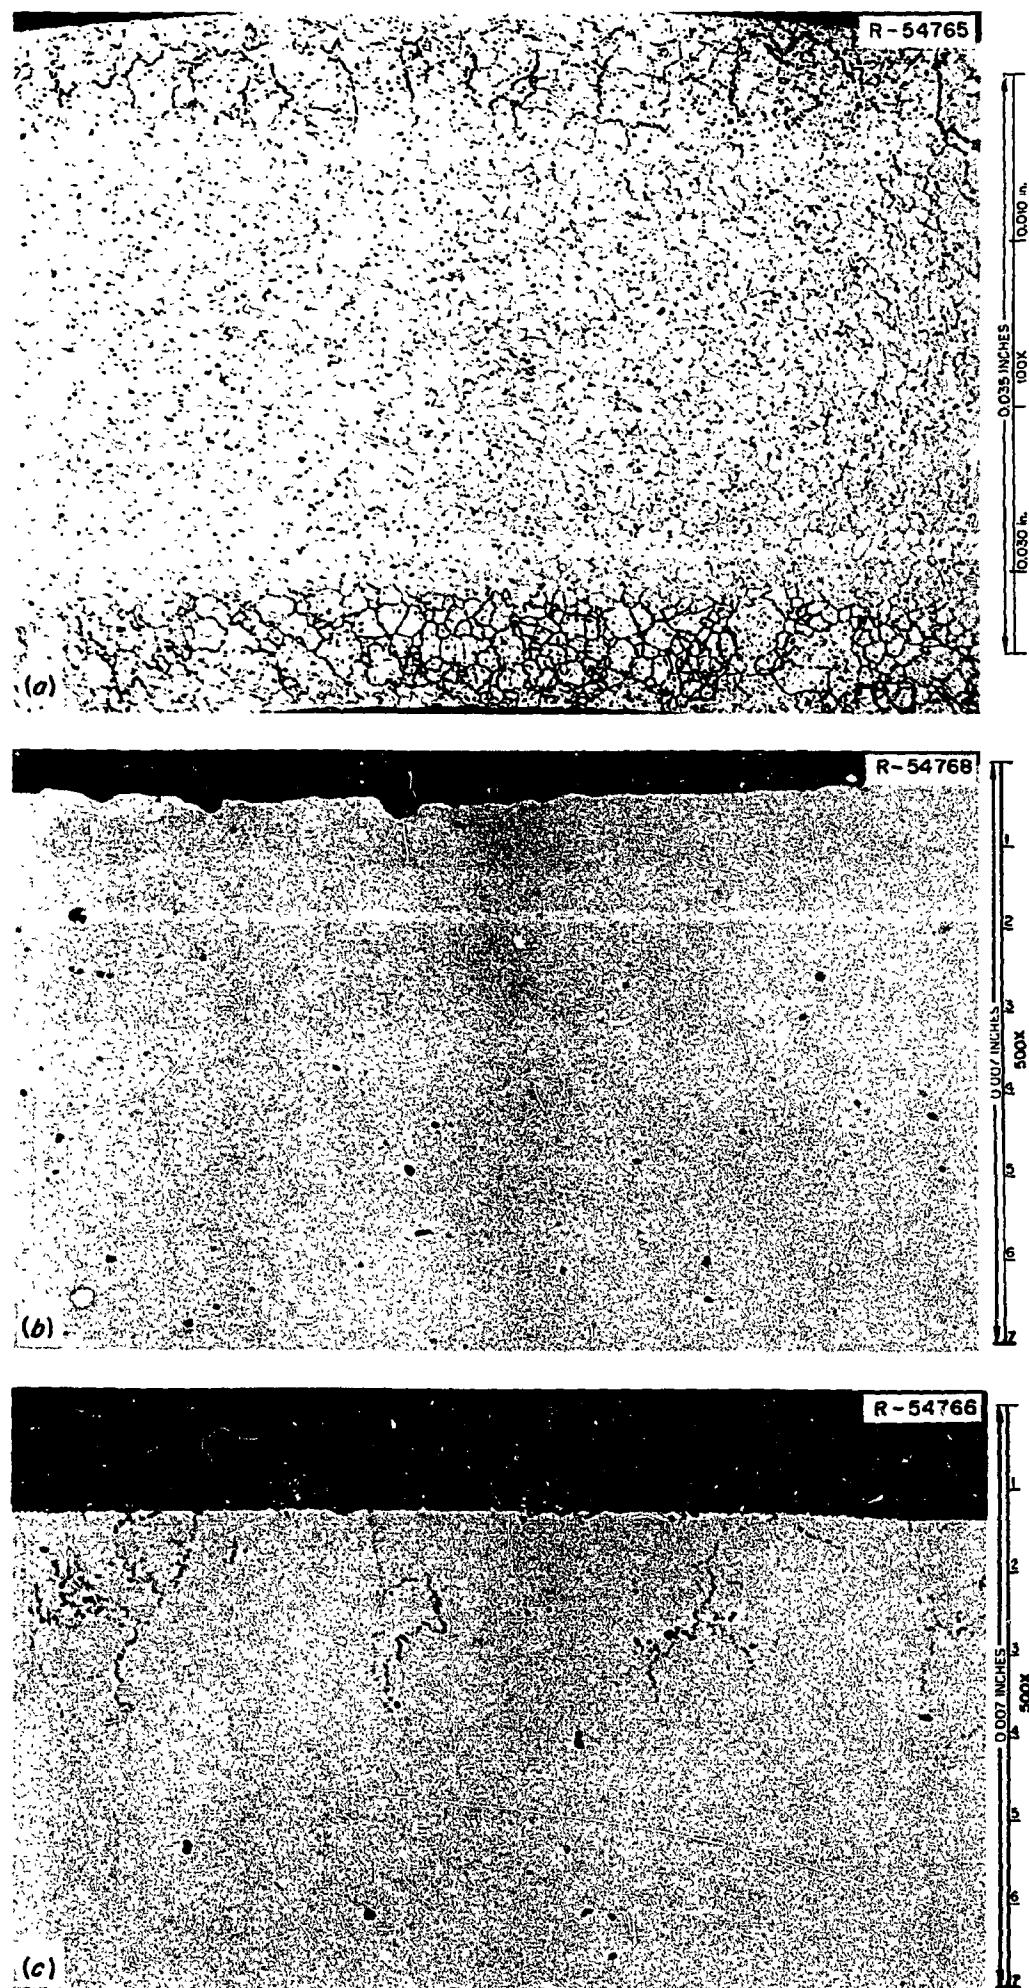
Photomicrographs of a typical cross section of the heat exchanger tubing are shown in Fig. 72. The overall view shows that both sides etch more rapidly than the center to a depth of about 7 mils. This is not unusual for a tubular product and is often attributed to impurities (primarily lubricants) that are worked into the metal surface during repeated steps of deformation and annealing. The higher magnification views in the as-polished condition show that grain boundary attack (or cracking) occurred on the surface exposed to fuel salt (outer) but not on the coolant side (inner). The temperatures under normal operating conditions were such that the fuel salt side would have been in compression.

Fig. 72. Cross section of INOR-8 heat exchanger tube. (a) Etched with glyceria regia. (b) Inside surface in the as-polished condition after exposure to coolant salt. (c) Outside surface in the as-polished condition after exposure to fuel salt. Reduced 34%.

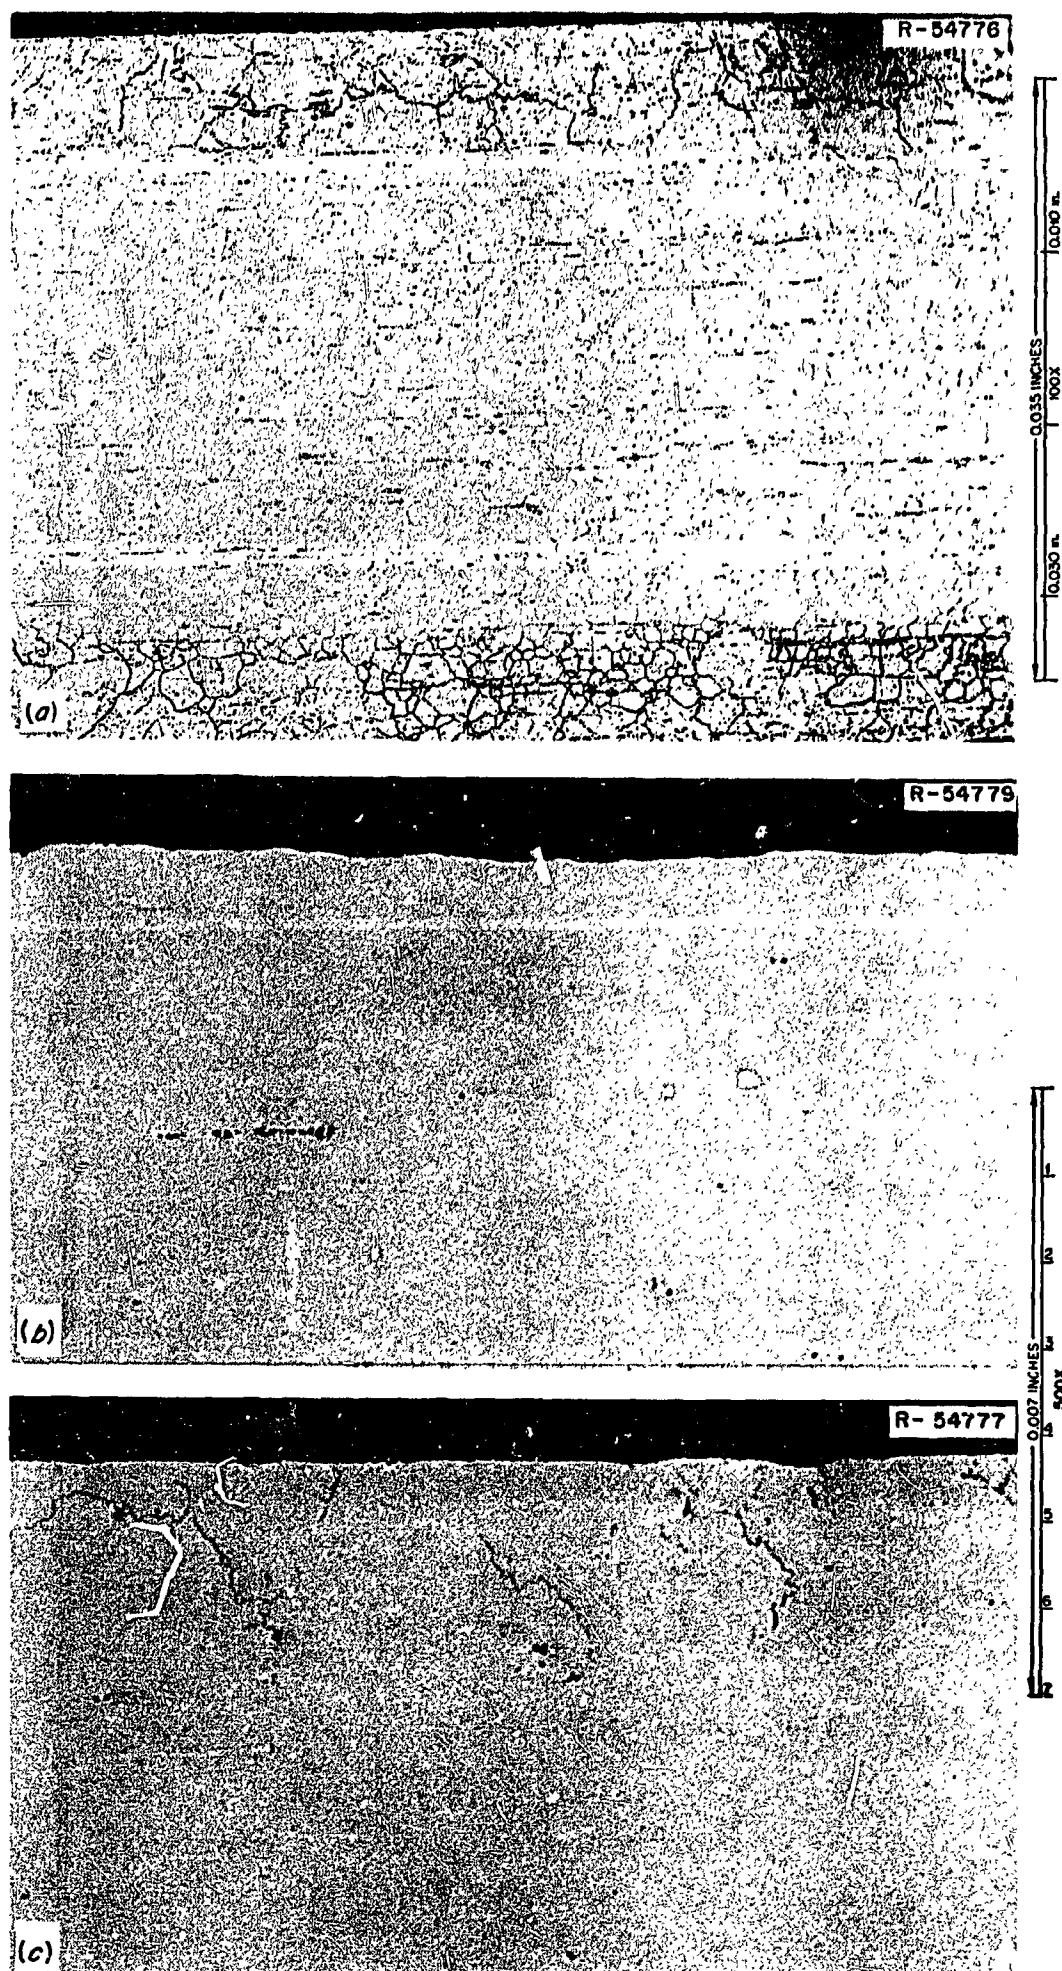
Similar photomicrographs of a longitudinal section of tubing are shown in Fig. 73. The features are quite similar to those discussed for Fig. 72. Both figures show some metallic deposits on the outside surface, which was exposed to fuel salt. These deposits are extremely small and could not be analyzed with much accuracy with the in-cell microprobe. However, they seemed to be predominately iron. Scanning across the tubing detected no concentration gradients of the major alloying elements in INOR-8.

**Fig. 73. Longitudinal section of INOR-8 heat exchanger tube. (a) Etched with glyceria regia. (b) Inside surface in the as-polished condition after exposure to coolant salt. (c) Outside surface in the as-polished condition after exposure to fuel salt. Reduced 31%.**

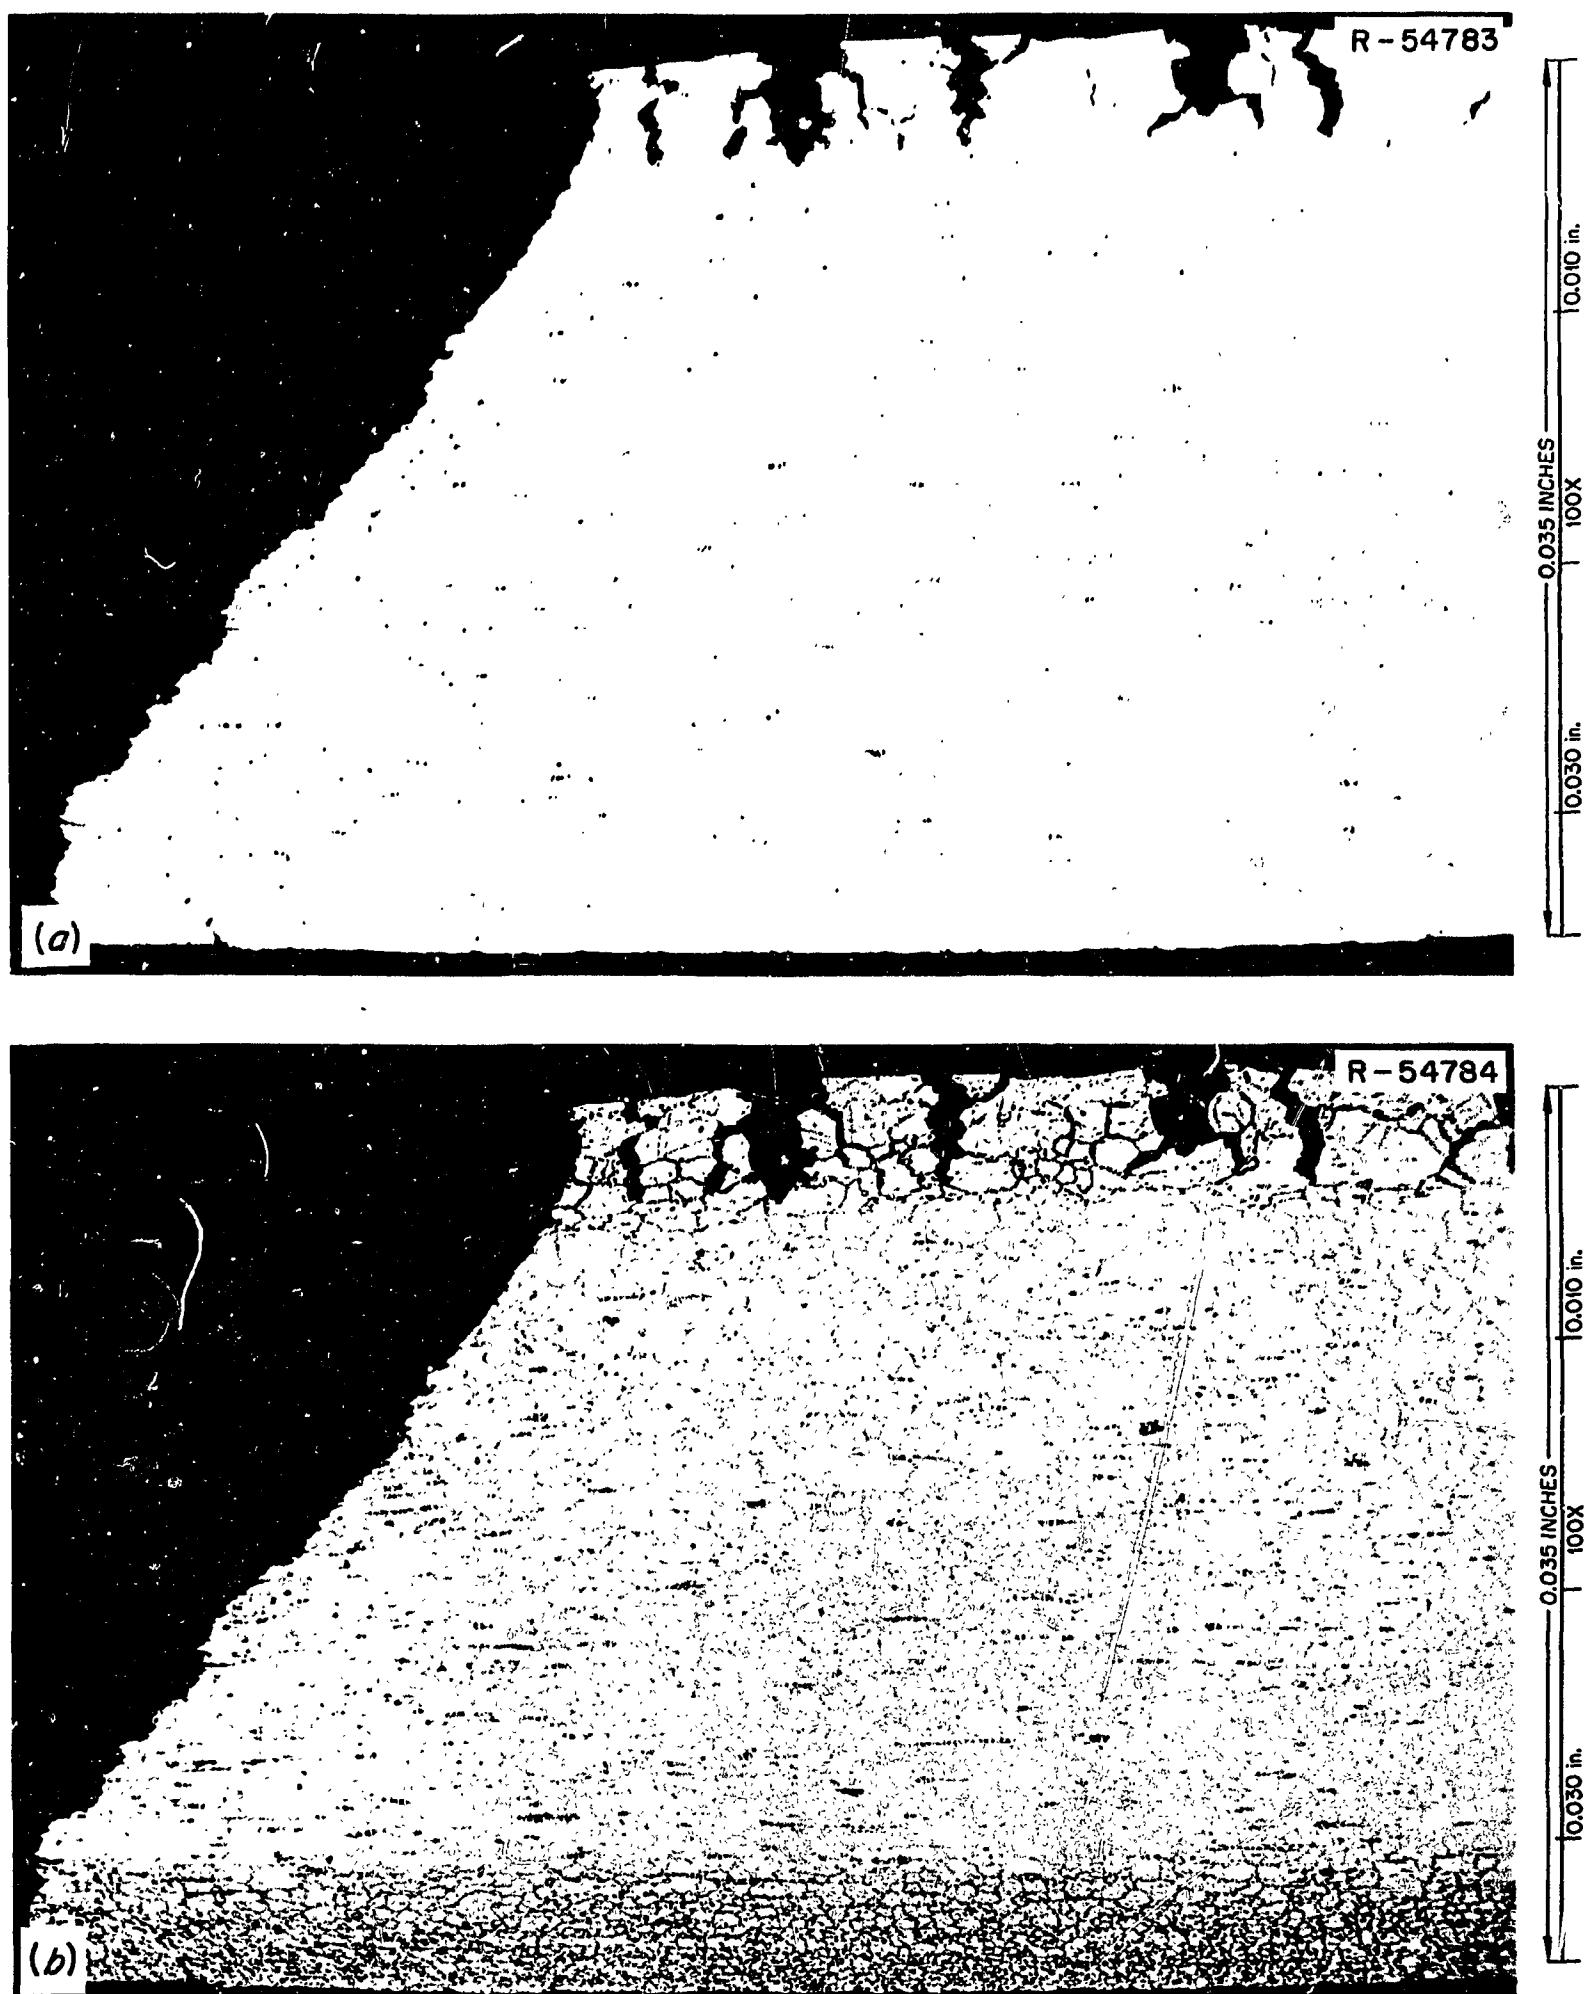
Photomicrographs of one of the tubes deformed at 25°C are shown in Fig. 74. Profuse intergranular cracks were formed to a depth of about 5 mils on the side exposed to fuel salt, but none were formed on the coolant salt side. Etching again revealed the abnormal etching characteristics near the surface, but whatever caused this abnormality did not result in grain-boundary embrittlement.

Fig. 74. INOR-8 heat exchanger tube deformed to fracture at 25°C. (a) As polished; (b) etched with aqua regia.

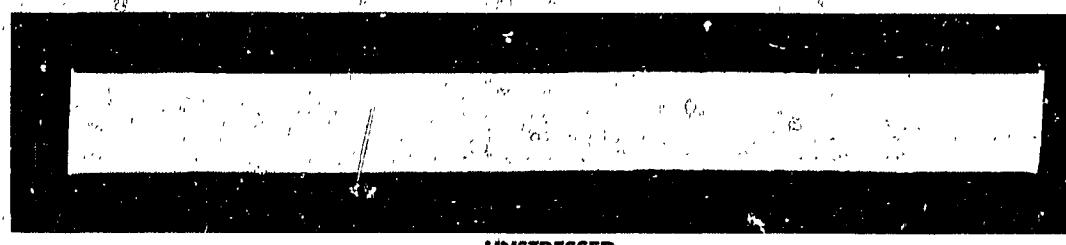
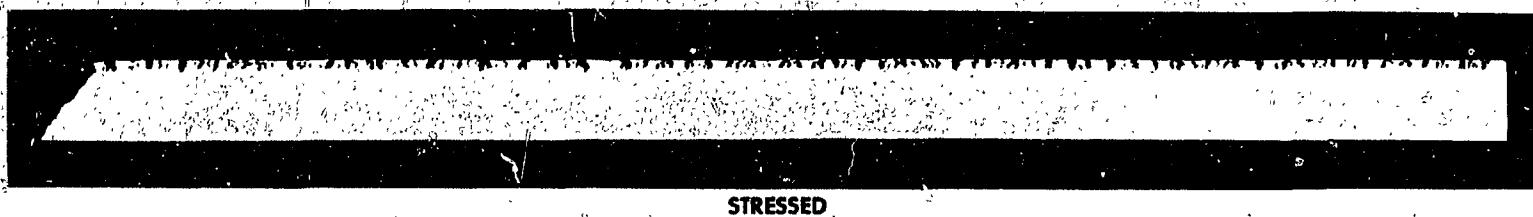
Unstressed and stressed sections of tubing were photographed over relatively large distances to get more accurate statistics on crack numbers and depths. Composite photographs of the two samples are shown in Fig. 75. The cracks are readily visible in the stressed sample but may not be apparent in

Fig. 75. Composite photographs of INOR-8 heat exchanger tubing before and after stressing. Width of unstressed sample is 0.042 in.

the unstressed sample. A higher magnification print used in making the composite is shown in Fig. 76; the cracks can be more easily seen. The stressed sample had 262 cracks per inch with an average depth of 5.0 mils. Two counts were made on the unstressed sample. In the first count only those features that unequivocally were cracks were counted. This gave a crack count of 228 per inch with an average depth of 2.5 mils. In another count, we included some features that were possibly cracks, and this gave a crack frequency of 308 per inch. Thus the number of cracks present before straining was about equivalent to that noted after straining. Straining did increase the *visible* depth. Some indirect evidence that the cracks were present initially and only spread open further during the tensile test was obtained from examination of the sample in Fig. 75. The sample length shown deformed 39% (Table 9), and the combined widths of the cracks account for 35% strain. Thus, the crack widths very closely account for the total strain and indicate that the cracks formed with little or no deformation and spread open as the sample was deformed.

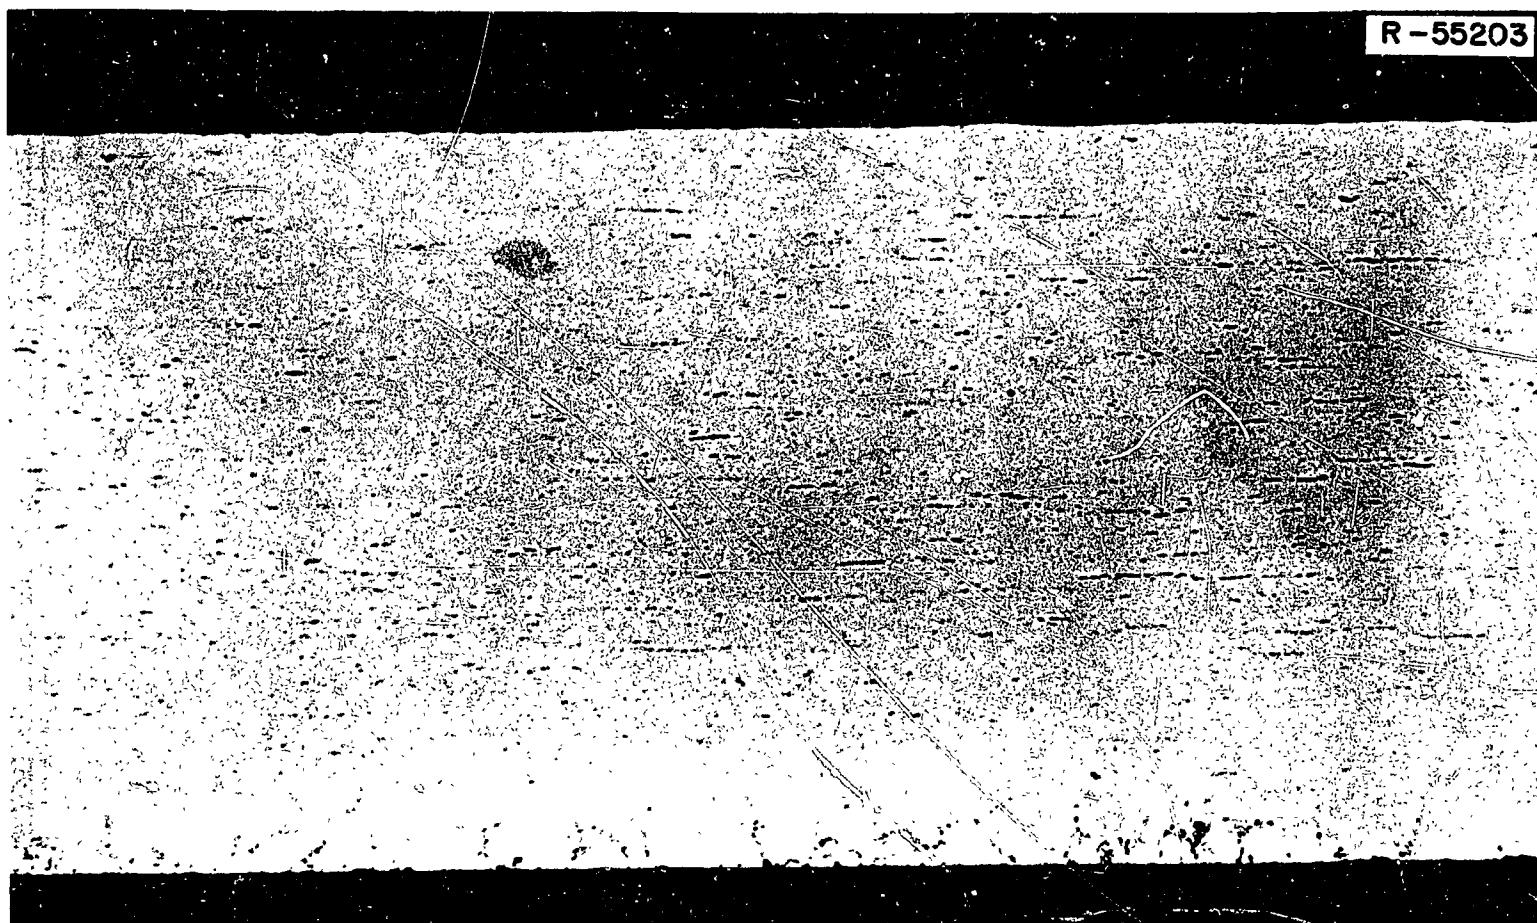
Fig. 76. INOR-8 heat exchanger tubing in the unstressed condition. The side with the small cracks was exposed to fuel salt, and the other was exposed to coolant salt.
