POSTIRRADIATION EXAMINATION OF MATERIALS FROM THE MSRE

H. E. McCoy      B. McNabb

DECEMBER 1972

OAK RIDGE NATIONAL LABORATORY  
Oak Ridge, Tennessee 37830  
operated by  
UNION CARBIDE CORPORATION  
for the  
U.S. ATOMIC ENERGY COMMISSION

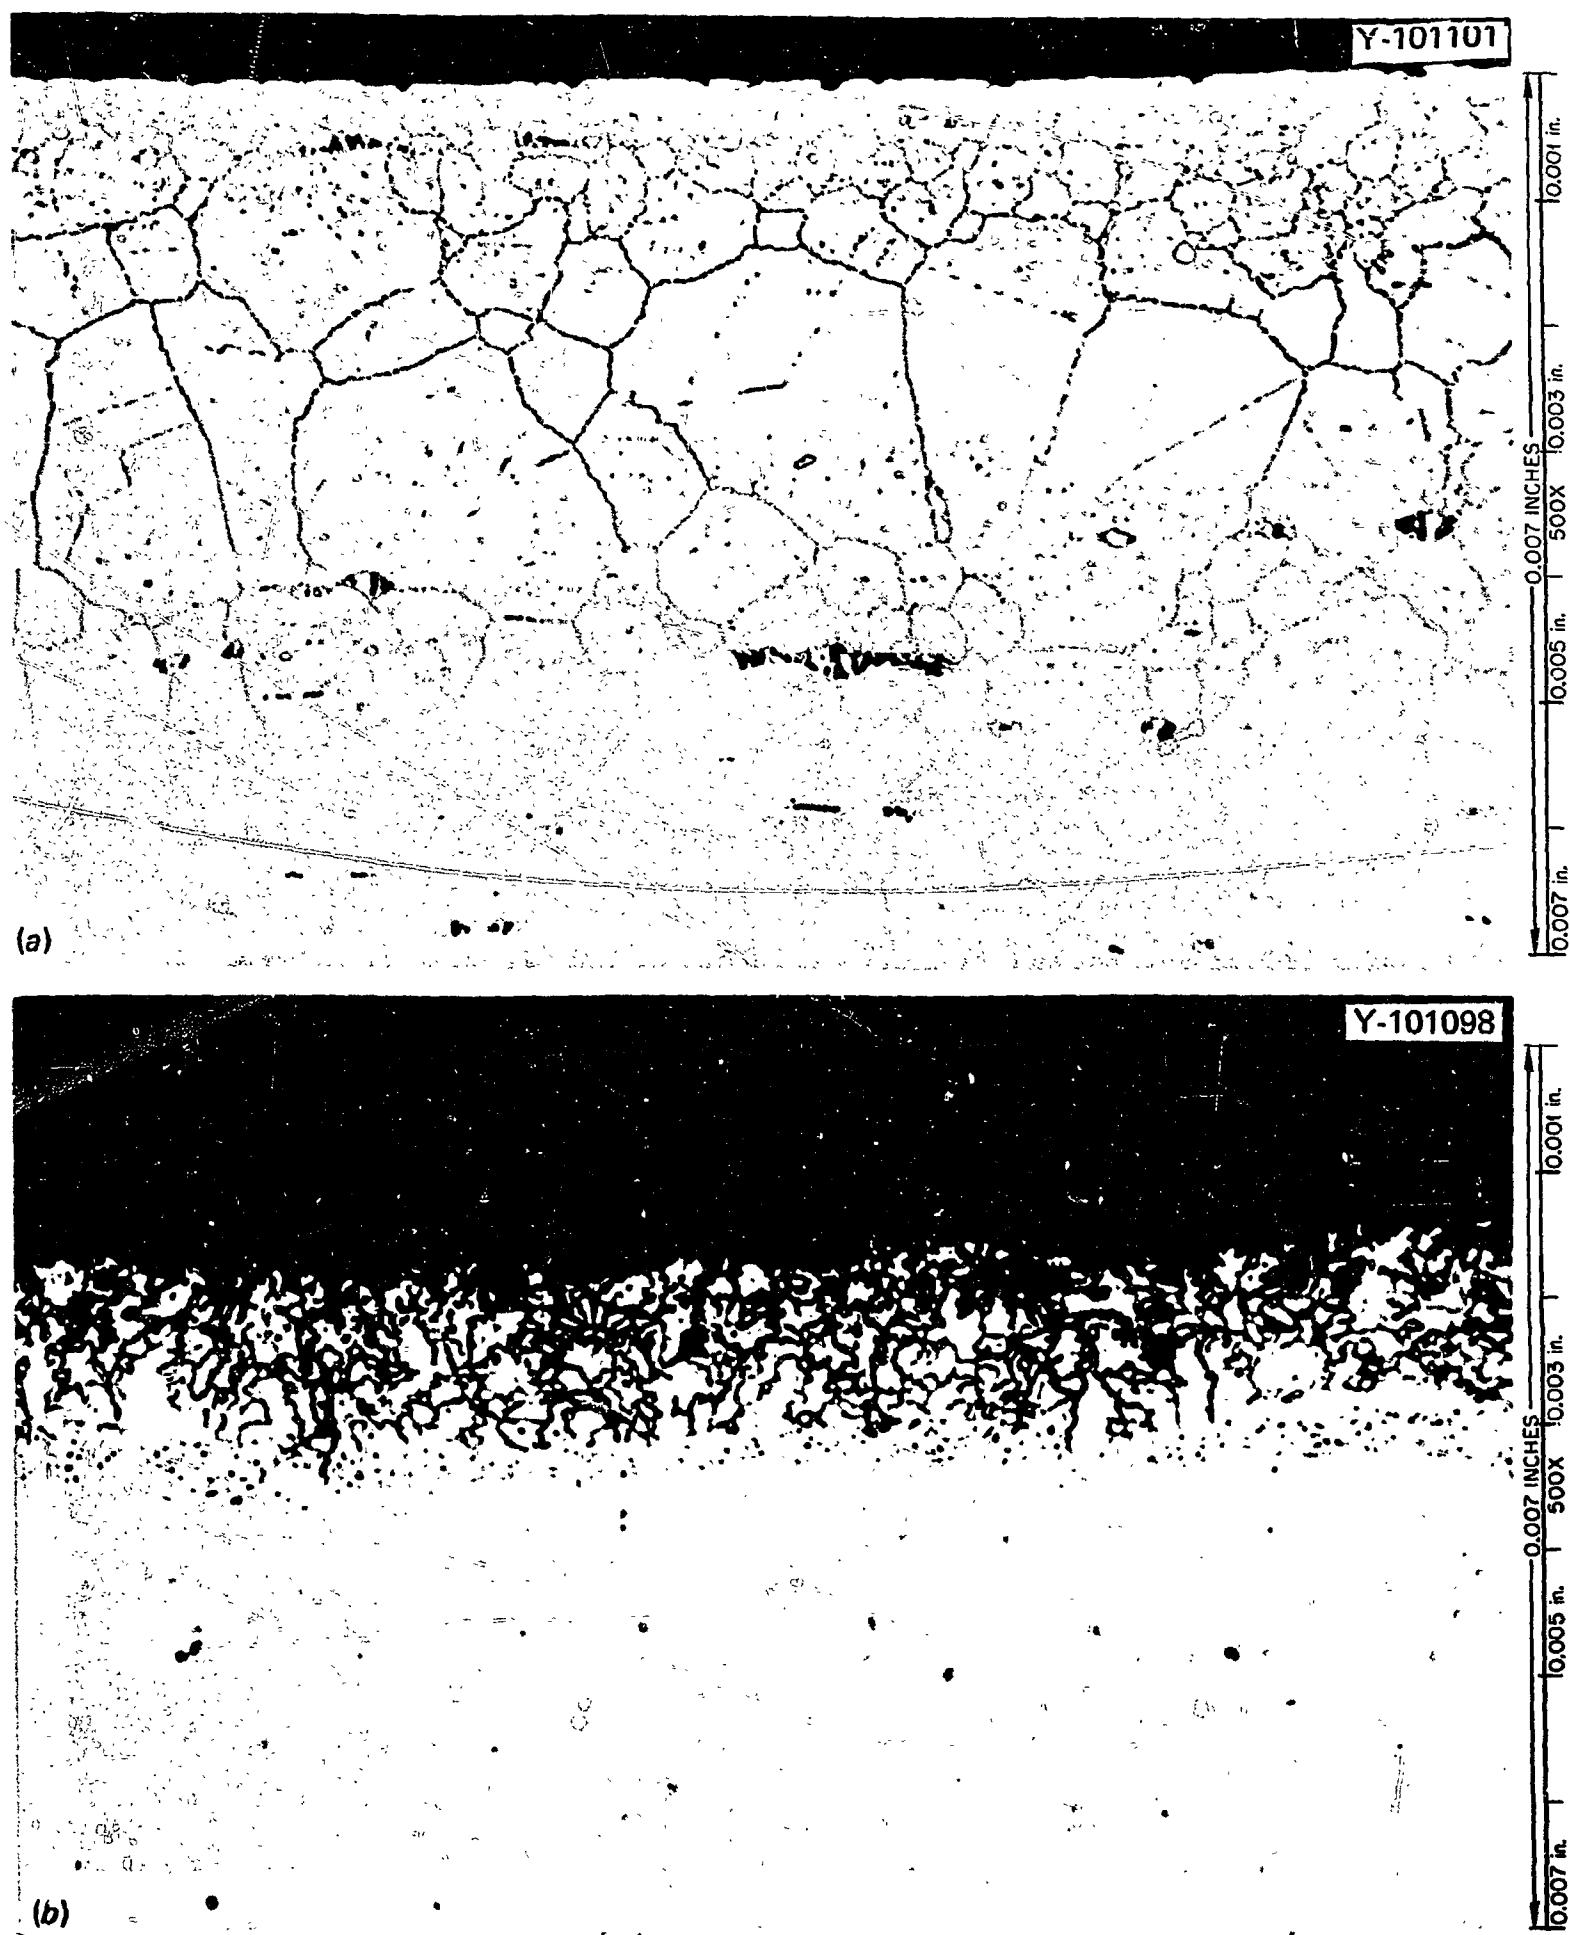
The microstructure of the tubing was altered two ways during service. The outside of the tubing was oxidized, and the inside of the tubing etched more rapidly to a depth of about 5 mils. These changes are shown in Fig. 80 for tubing at the inlet end and in Fig. 81 for the outlet end. The oxidation is not excessive, and the penetration of the oxide front is typical for nickel alloys with chromium content as low as that in INOR-8.

Fig. 80. Microstructures of a longitudinal section of INOR-8 tubing from the inlet end of the MSRE radiator. (a) Inside of pipe wall, etched with glyceria regia; (b) outside of pipe wall, as polished.

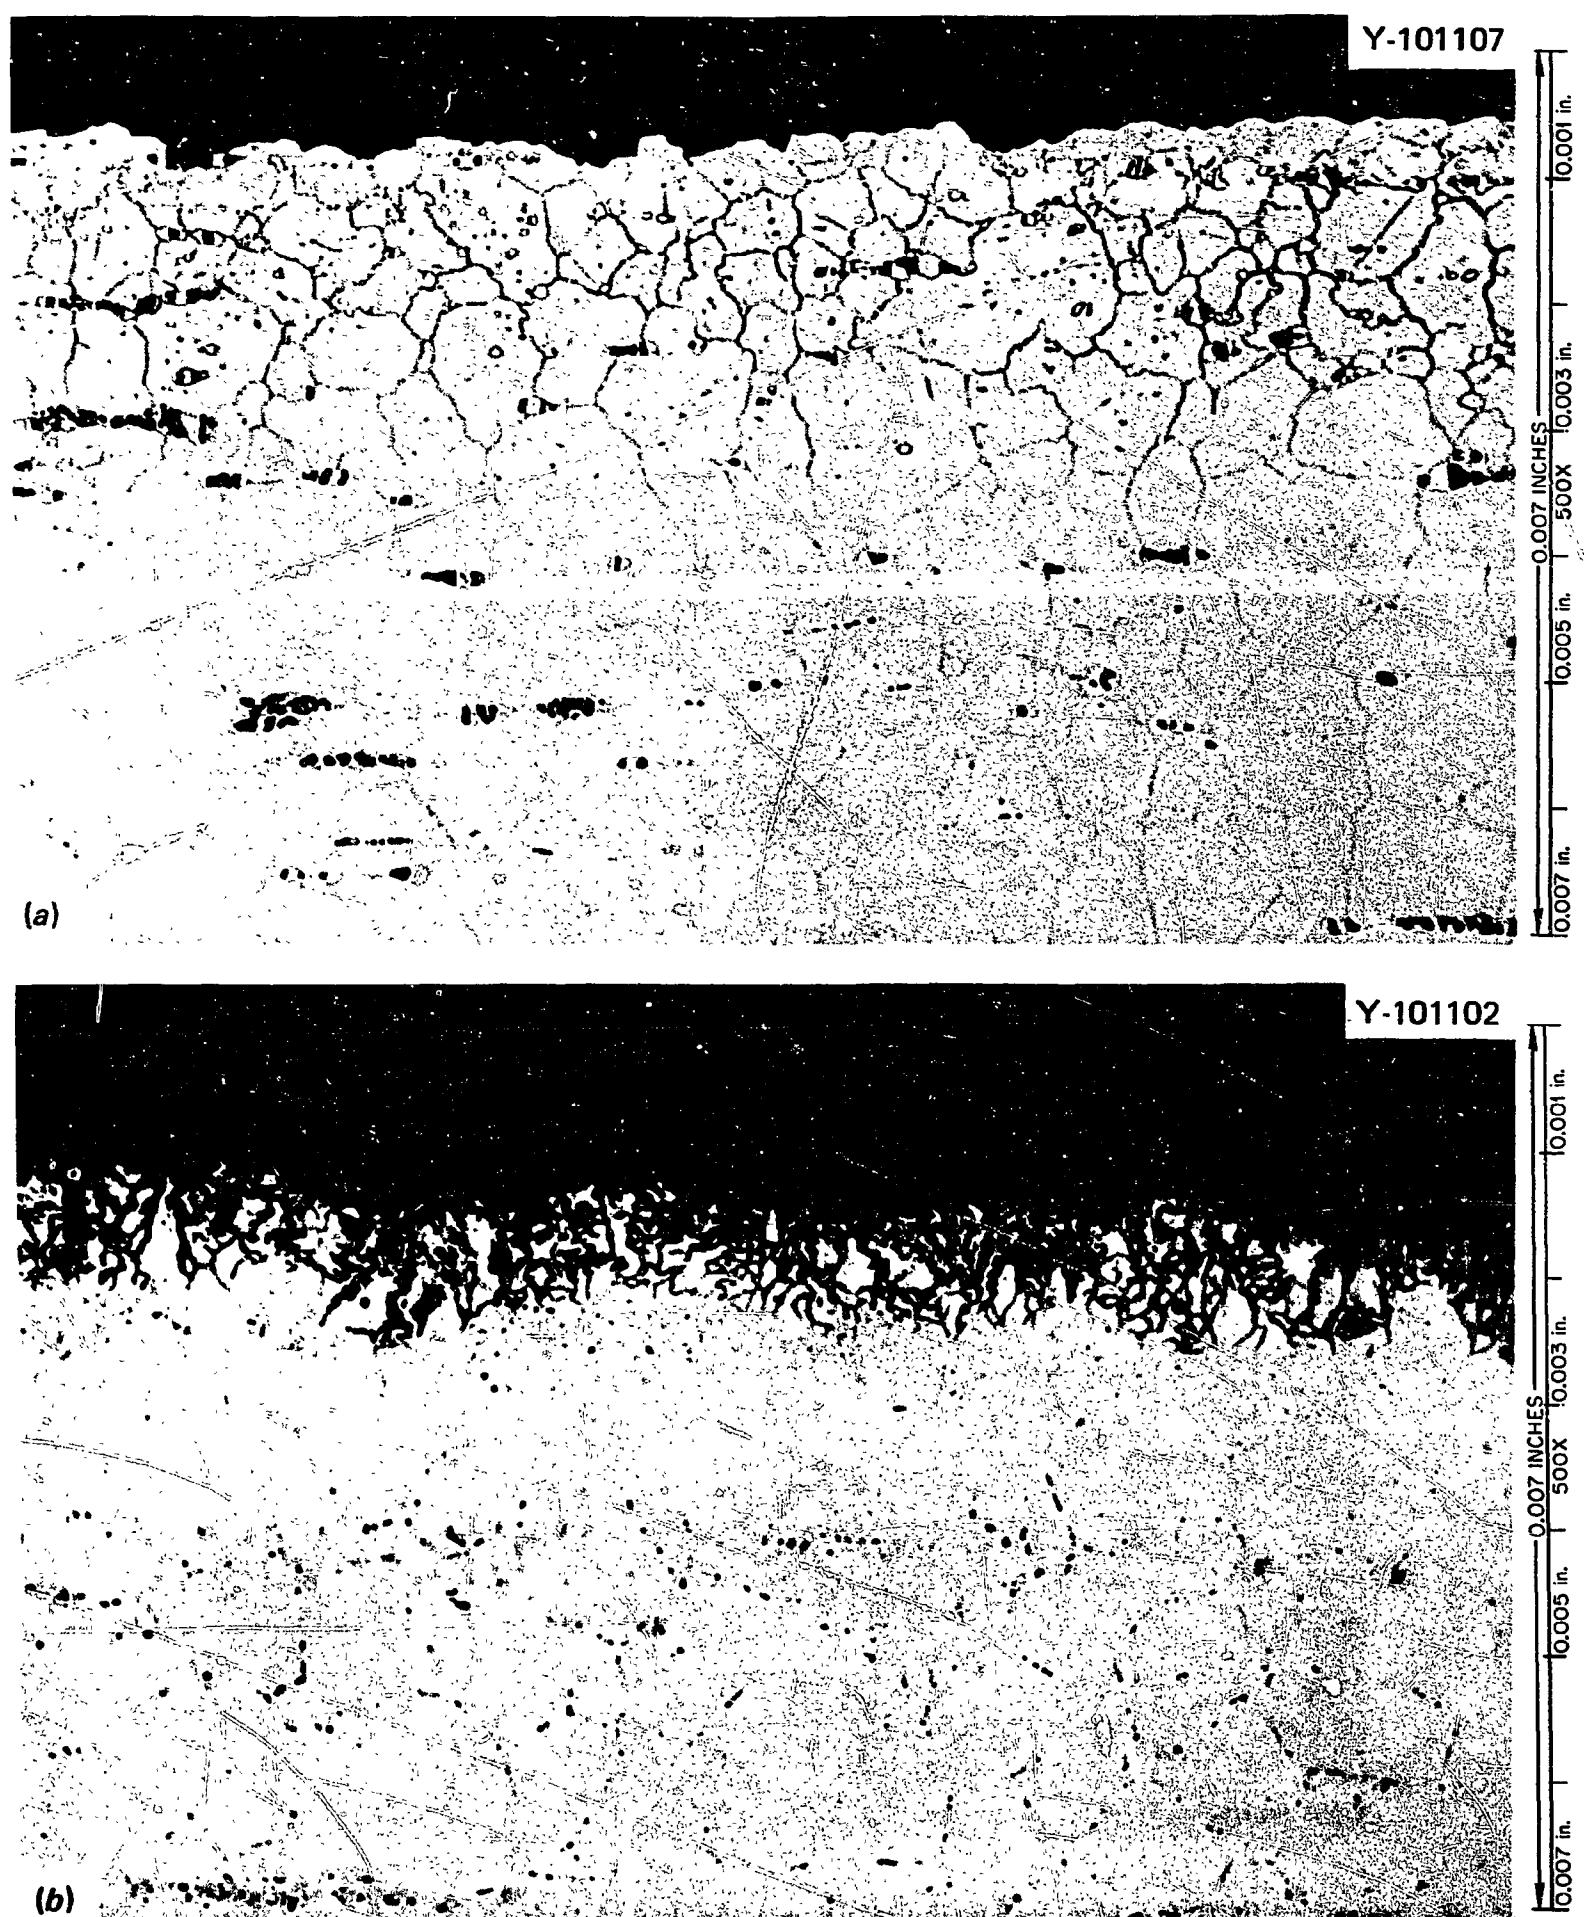
**Fig. 81. Microstructures of a longitudinal section of INOR-8 tubing from the outlet end of the MSRE radiator. (a) Inside of pipe wall, etched with glyceria regia; (b) outside of pipe wall, as polished.**

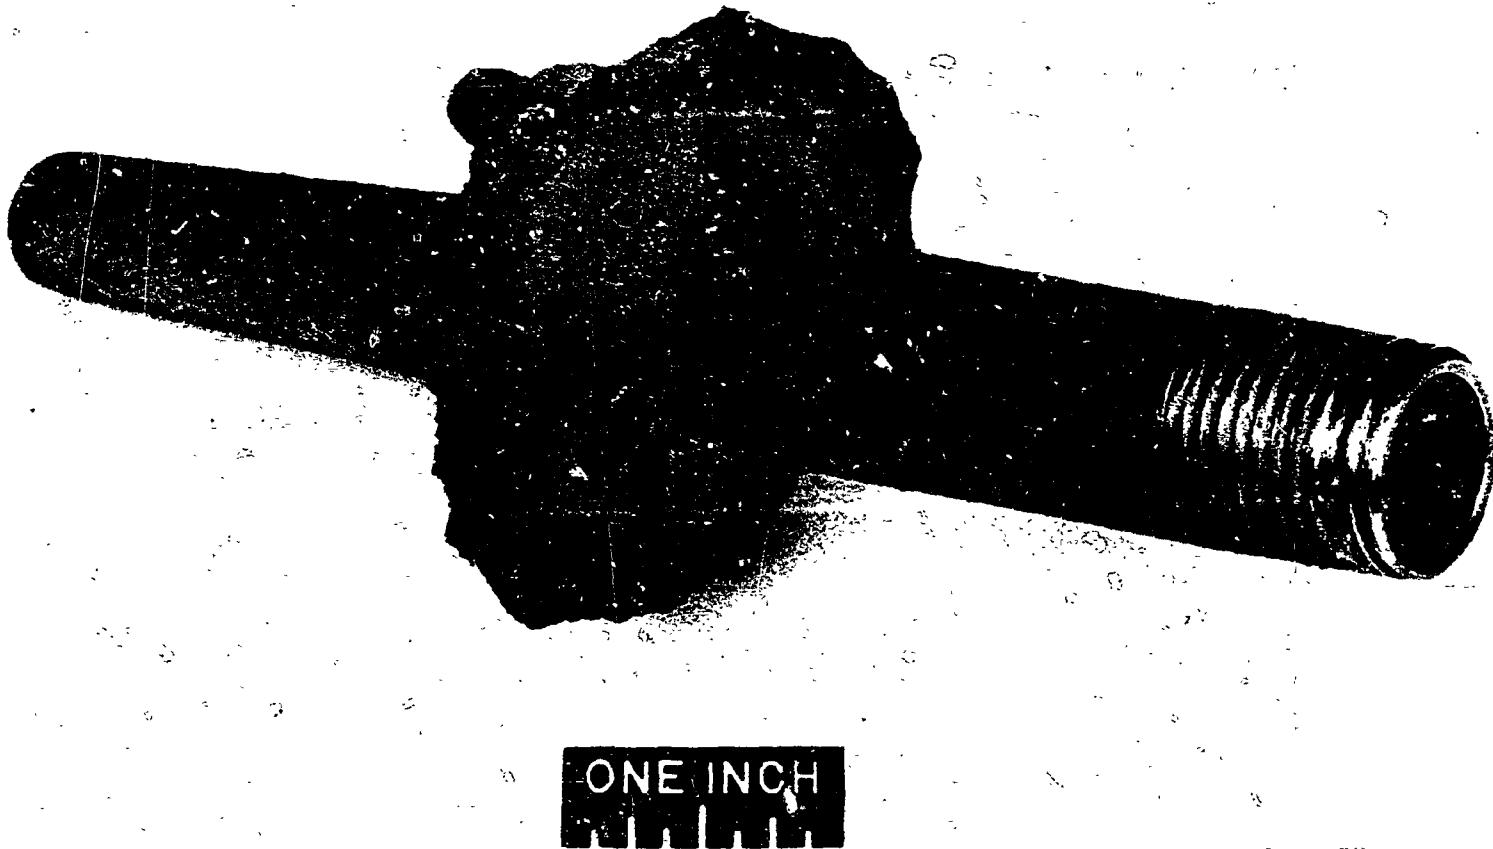
The inlet thermocouple well after it was cut off with a coated welding electrode is shown in Fig. 84. The oxidized appearance and the metal fragments on the part arose from the cutting operation. The circular piece of material is part of the 5-in. pipe wall. The thermocouple well was machined from bar stock and extended about 3 in. into the flowing salt stream. The cross-sectional view of part of the inlet well in Fig. 85 makes the geometry more evident. The pipe wall, the welds, and the thermocouple well are evident.

Fig. 84. INOR-8 thermocouple well removed from the inlet line to the radiator of the MSRE. Much of the discoloration and the fragments of metal resulted from cutting the part out with a coated welding electrode.

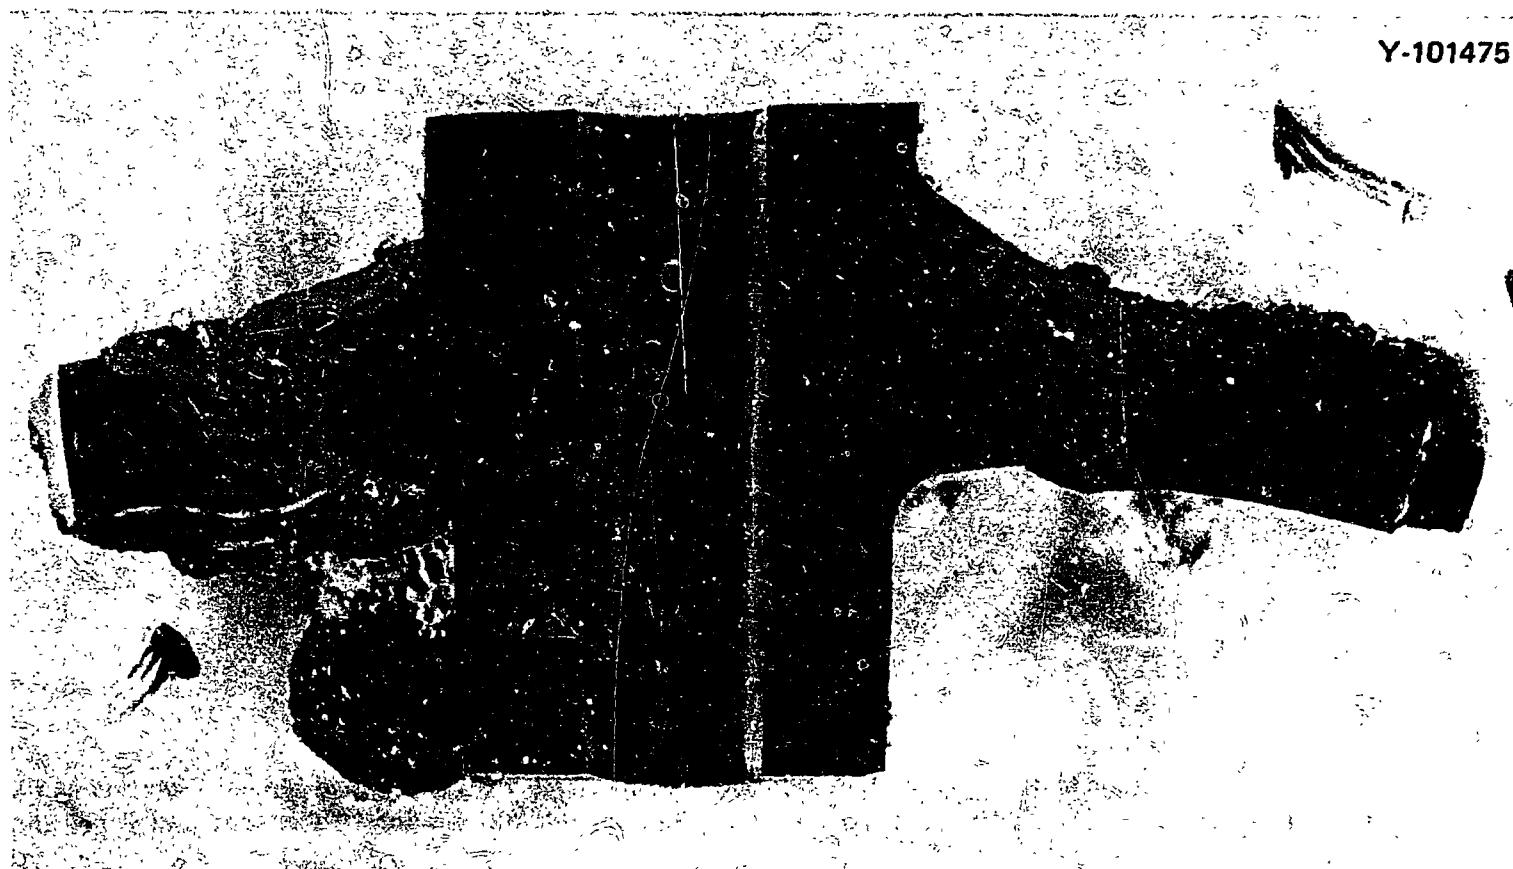
Fig. 85. Cross section of INOR-8 thermocouple well from the inlet line to the MSRE radiator. From left to right the components are the 5-in. coolant line, the weld, and the thermocouple well. The side having the most weld metal was exposed to air, and the other side was exposed to coolant salt.

Metallographic examination of the mounted cross section shown in Fig. 85 revealed that the weld had cracked on the salt side of the pipe. The cracks on both of the polished surfaces in Fig. 85 are shown in Fig. 86. In the worst case the cracks penetrated to a depth of about 3 mils. The remaining half of the well was cleaned by acid etching to remove the metal left from the cutting operation, and the weld was checked with dye penetrant. A photograph of the weld with dye still present is shown in Fig. 87. Note that the crack, as indicated by the dark color, extends almost completely around the weld. There is also an area where penetration of the root pass was incomplete. We propose that the cracks formed as the weld was made, because of the poor fit-up of the parts to be welded. The welds were not stress relieved, and the fact that the cracks did not penetrate further attests to the lack of stress and crevice corrosion by lithium-beryllium fluoride salts.

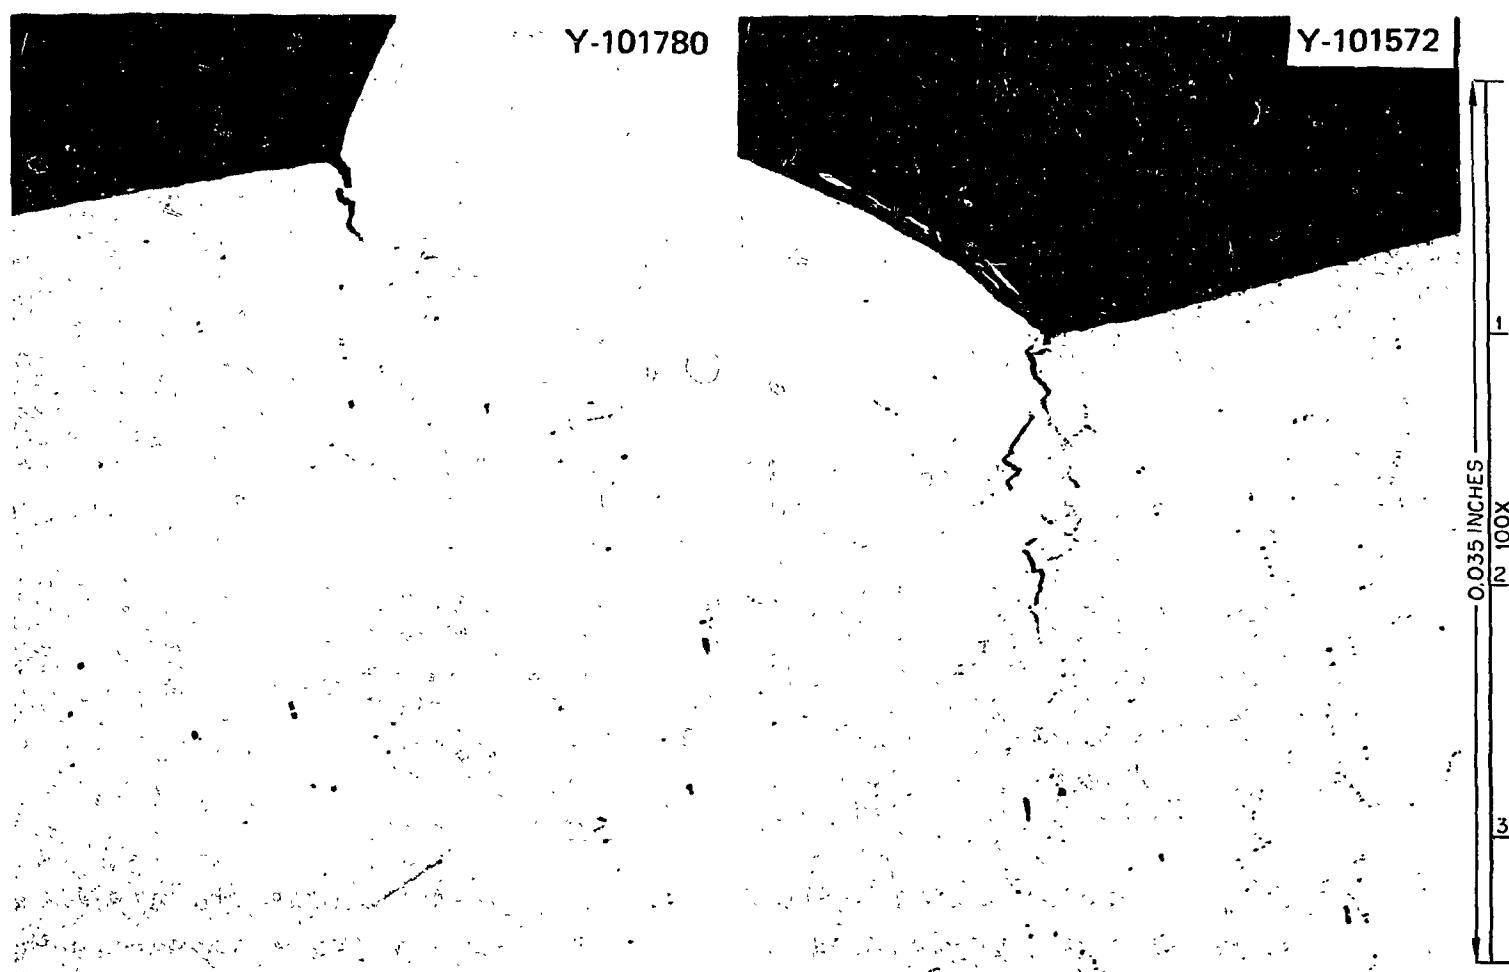
Fig. 86. Cracks in the root pass of the inlet weld. The cracks occurred at the fusion line and likely resulted from the poor fit-up of the parts. As polished.

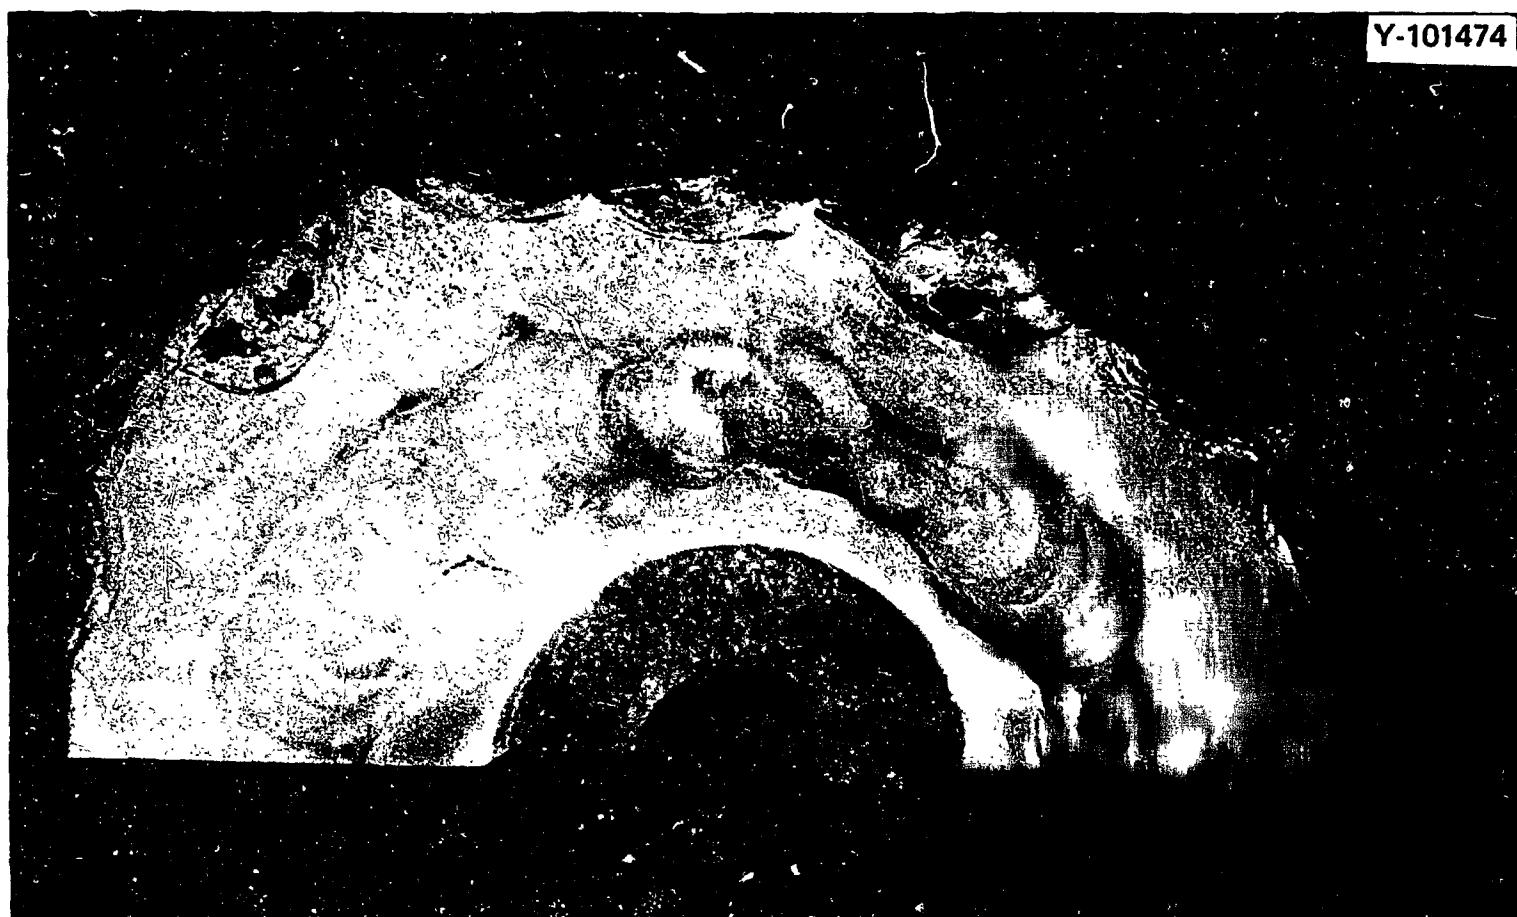
Fig. 87. Underside (salt side) of half of the INOR-8 thermocouple well from the inlet line to the MSRE radiator. The part was acid etched and coated with dye penetrant. Note the indication of a crack around most of the weld and an incomplete root pass region.

The cracked weld where the inlet thermocouple well was attached to the 5-in. pipe header likely resulted from poor fit of the parts during welding. The crack probably formed when the weld was being made, and it is encouraging that it did not propagate further during service.

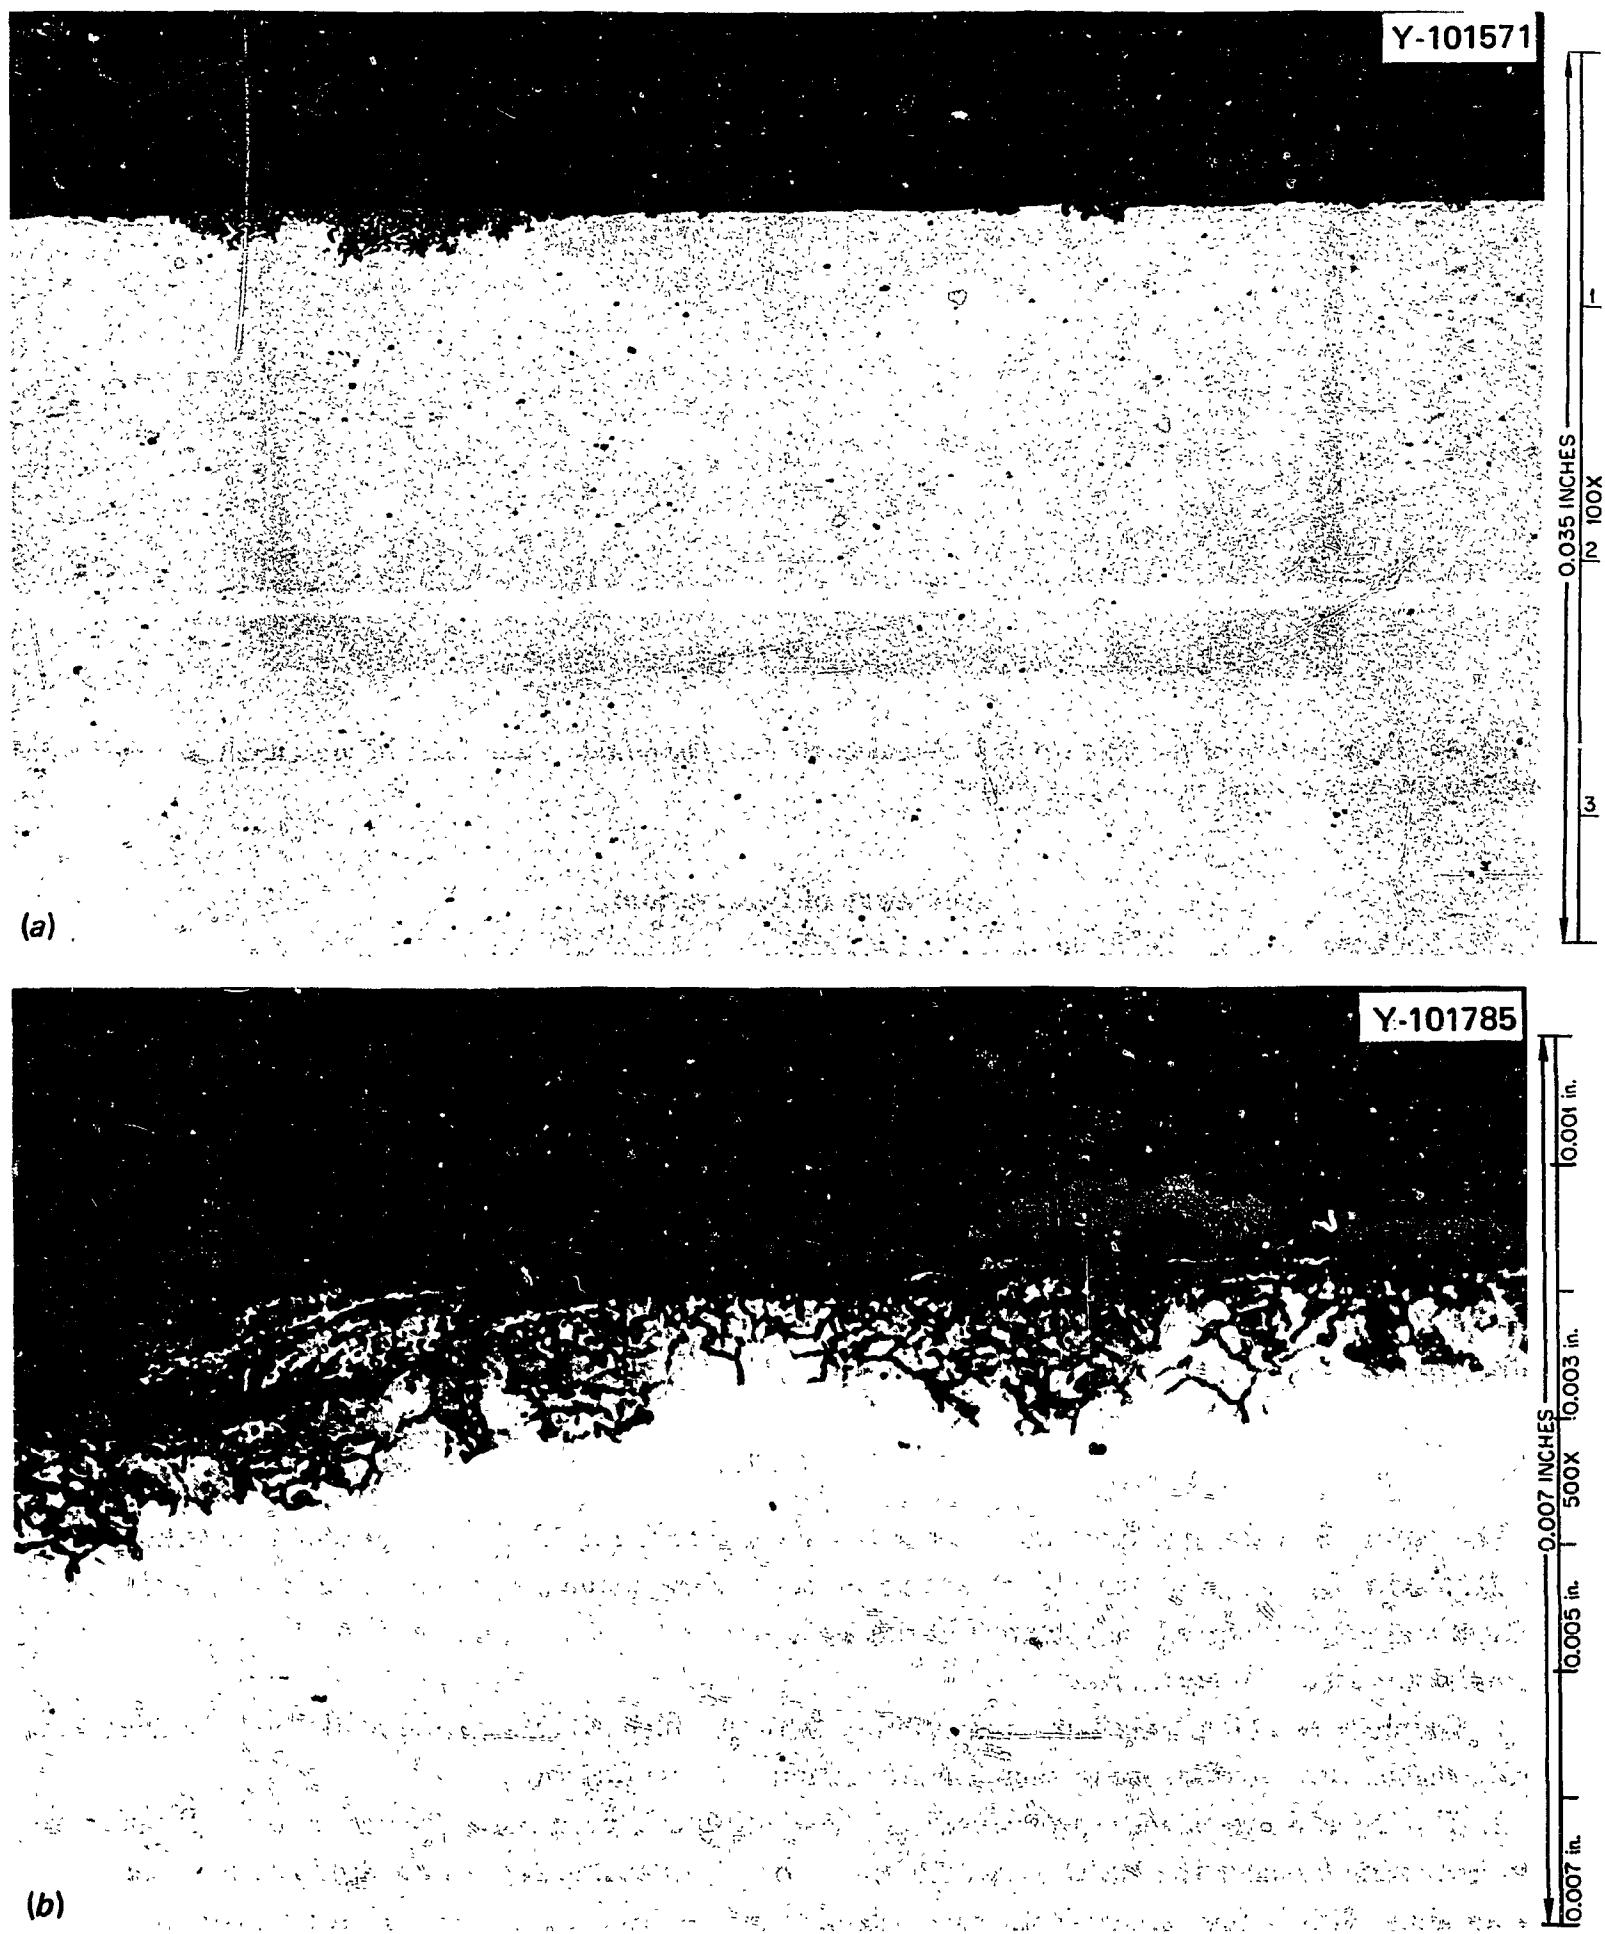
The outside surface of the 5-in. pipe was exposed to air and was oxidized. Figure 88 shows the spotty nature of the oxide and its maximum thickness of about 3 mils.

Fig. 88. Oxide formed on the outside of the 5-in. INOR-8 coolant line. As polished. (a) 100 $\times$ ; (b) 500 $\times$ .

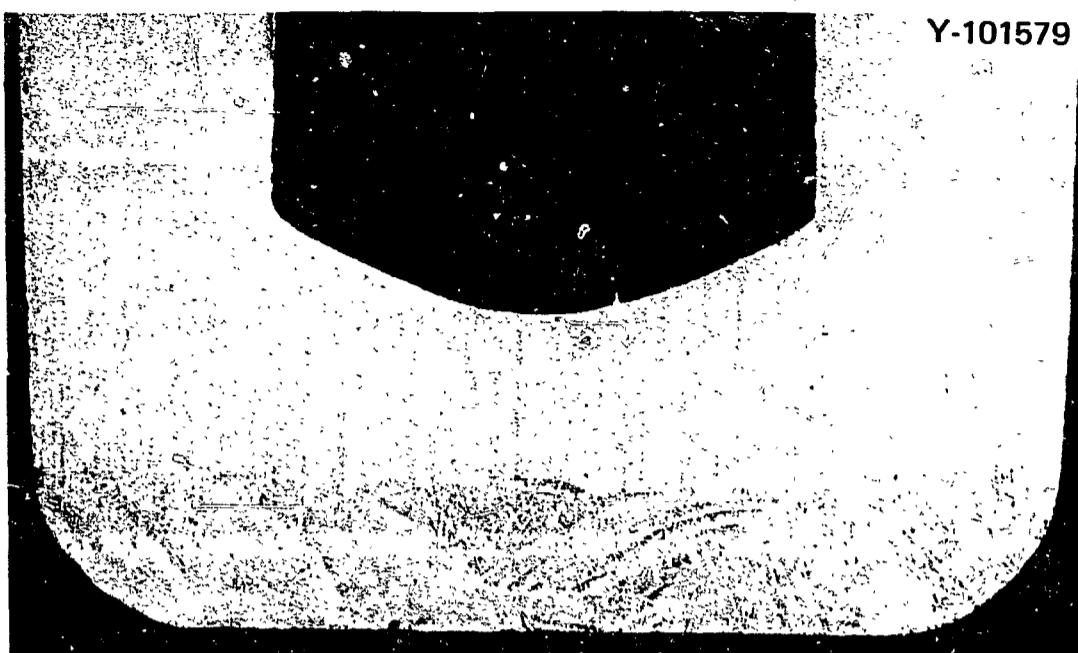
A cross section from the bottom of the well was examined. A macroscopic view of this section is shown in Fig. 89. The inside of the well was prepared by drilling, and the pointed shape of the drill is still apparent at the bottom. The weld metal deposit on the bottom was made to ensure that salt did not leak along the carbide stringers. The amount of oxidation was greater at the bottom of the well than further up. The transition to the thinner oxide about  $\frac{1}{8}$  in. from the bottom is apparent in Fig. 89. Figure 90(a) shows the oxide layer of about 5 mils at the bottom of the well, and Fig. 90(b) shows the abrupt transition about  $\frac{1}{8}$  in. from the bottom. Since lubricant would have been used during drilling, we suggest that this difference may have been due to the bottom of the well not being as clean as the sides.

**Fig. 89.** Cross section of the inlet INOR-8 thermocouple well. The outside was exposed to coolant salt, and the inside contained the thermocouple in air. 8X; as polished.

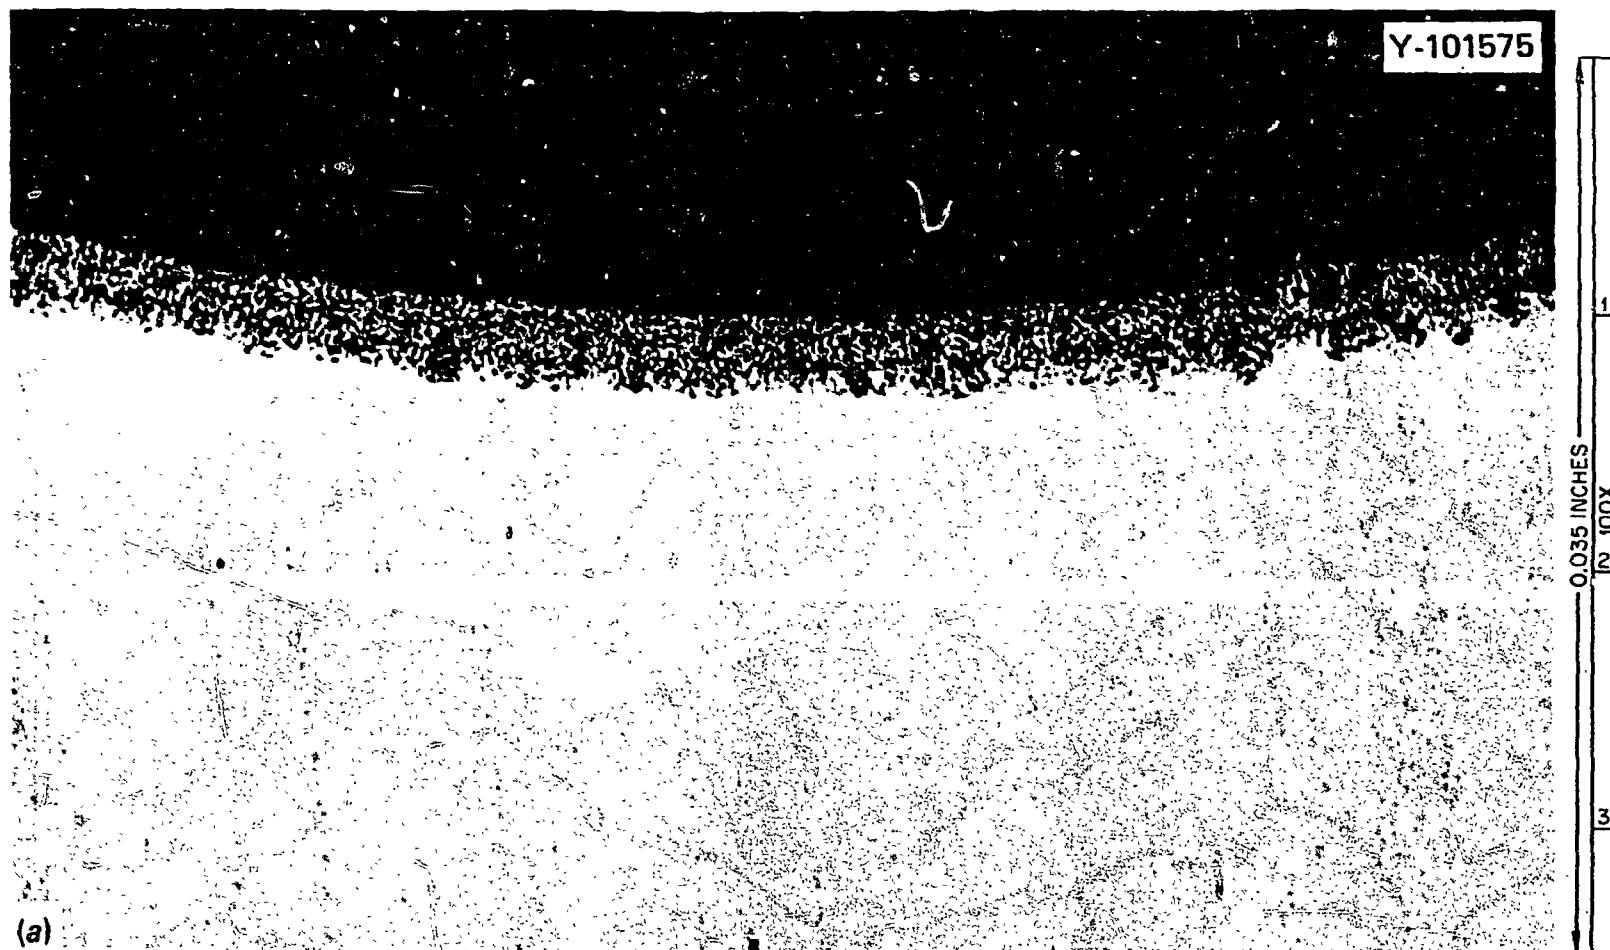
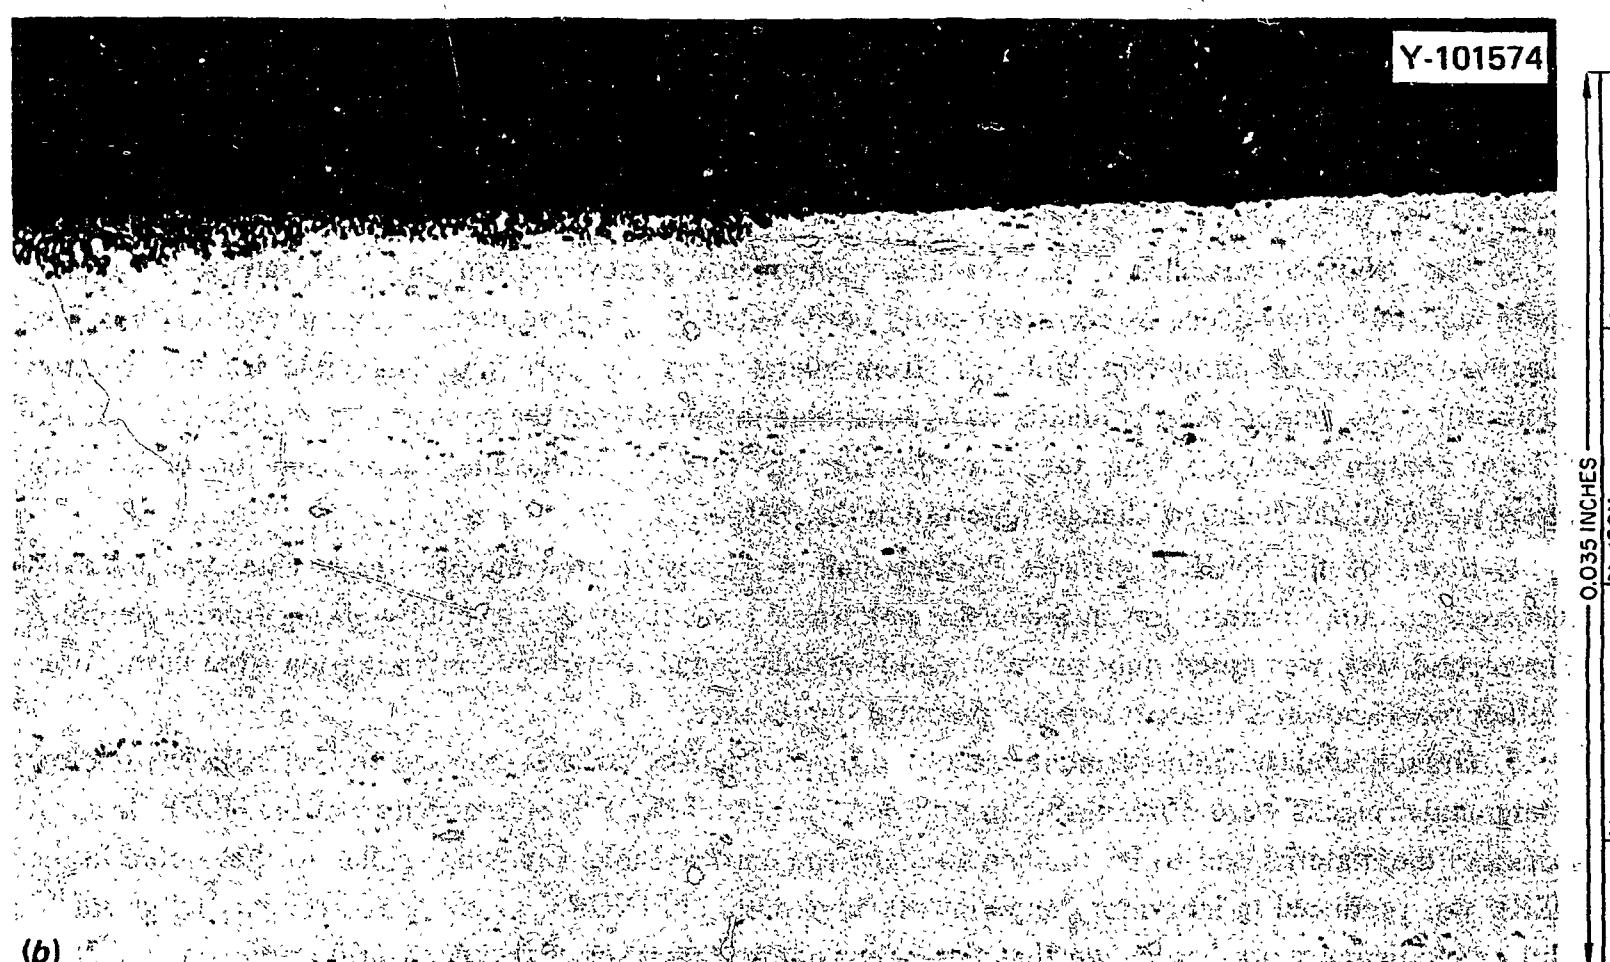
Fig. 90. Oxide inside the inlet INOR-8 thermocouple well. As polished. (a) At the bottom; (b) transition in depth about  $\frac{1}{8}$  in. from bottom of well.

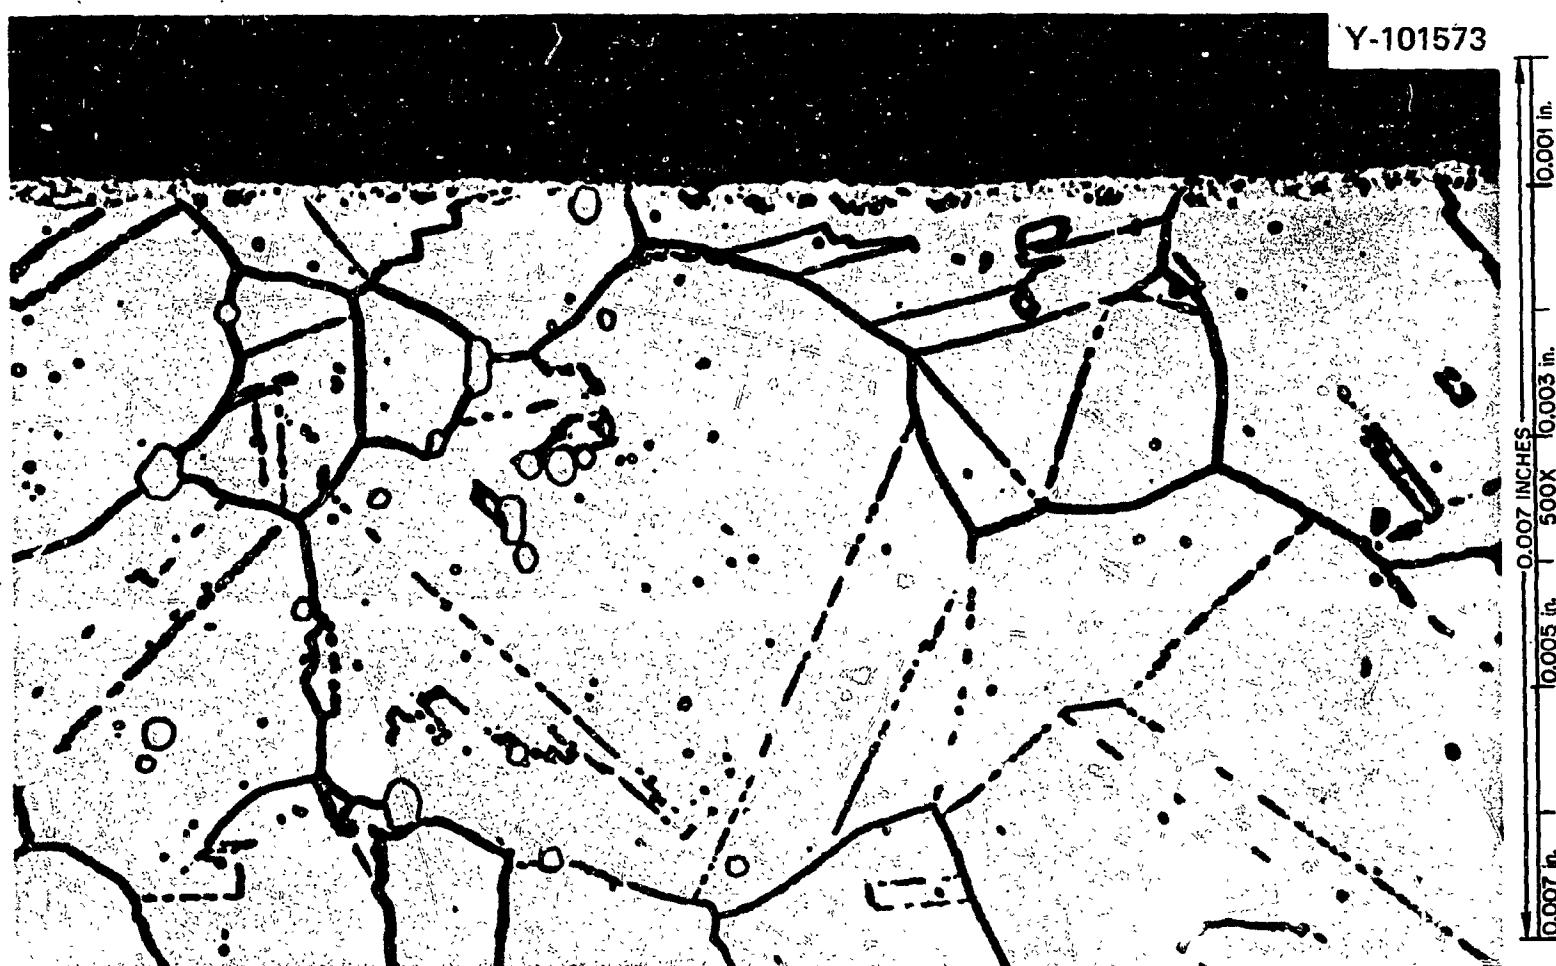
A further significant observation was that the surfaces of the well exposed to the salt looked quite similar to those of surveillance samples removed from the MSRE (Fig. 91). We have previously attributed this modified surface structure to cold working from machining and have shown that it can be produced in the absence of salt. The structure likely results from carbide forming on the slip bands produced by machining. Thus there is no evidence of corrosion of this part.

Fig. 91. The outside of the inlet INOR-8 thermocouple well that was exposed to coolant salt. Note the modified layer near the outer surface. Etchant: glyceria regia.
