# HOME INSPECTION REPORT

| Property Address: | 456 Oak Avenue, Portland, OR 97210 |
| Inspection Date: | 2025-10-25 |

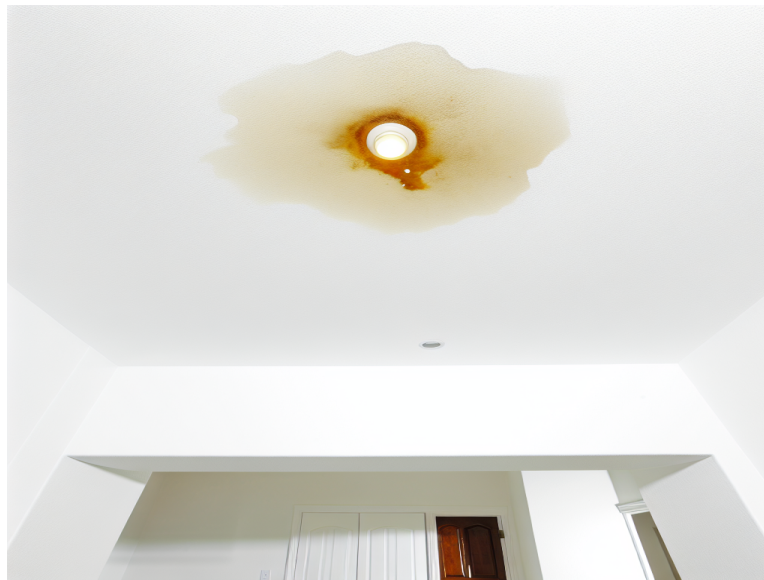
Photo: ceiling\_water\_stain.jpg (Timestamp: 30.0s)

### ■ ■ Water Stain on Master Bedroom Ceiling

**Location:** Master Bedroom Ceiling near Bathroom Wall

**Severity:** Moderate

A large brown water stain is visible on the ceiling near the bathroom wall in the master bedroom. The stain measures approximately 12-14 inches across and feels slightly damp to the touch, indicating a potential active leak from the bathroom above. This suggests a possible plumbing issue, such as a leak from the shower pan or fixtures.

Investigate the source of the leak, which may be from plumbing or roof issues. Repair the leak and replace any damaged materials to prevent mold growth. Recommend plumber inspection of shower pan and fixtures.

Recommend plumber inspection of shower pan and fixtures.

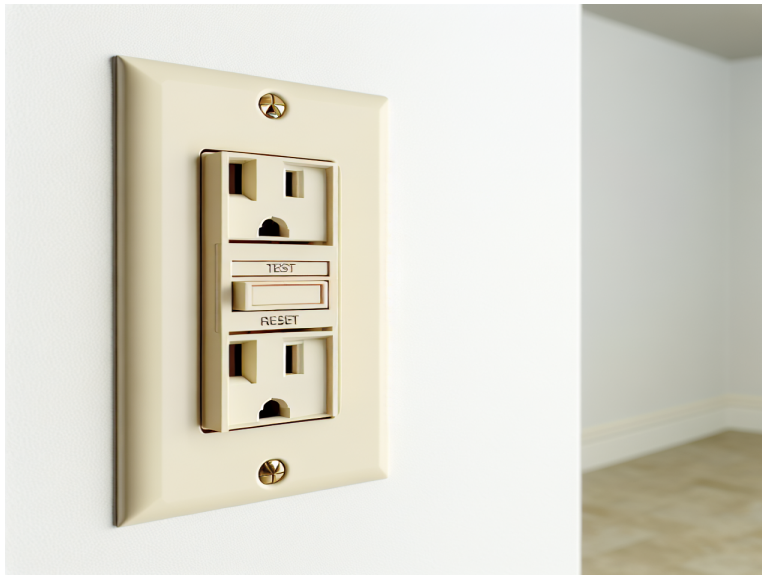
*Photo: gfc\_i\_outlet.jpg (Timestamp: 90.0s)*

### ■ Non-Functioning GFCI Outlet

**Location:** Bedroom, north wall

**Severity:** Safety Hazard

The GFCI outlet located on the interior wall appears properly installed with no visible defects in the photo. However, the inspector noted that the GFCI outlet in the bedroom on the north wall does not trip when the test button is pressed, indicating a malfunction. This is identified as a safety hazard because GFCI outlets are essential for shock protection.

GFCI outlets are required for shock protection.

Immediate replacement by a licensed electrician is recommended.

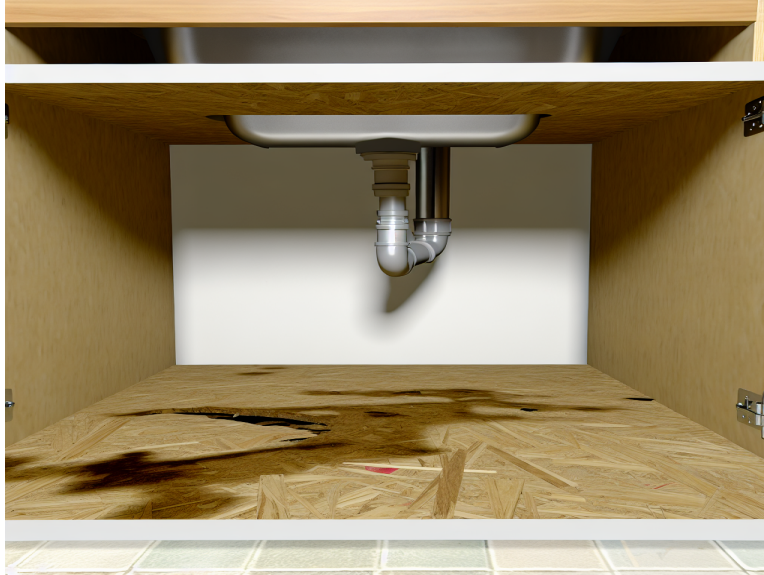
Photo: cabinet\_water\_damage.jpg (Timestamp: 145.0s)

### ■■ Water Damage and Potential Mold Growth Under Kitchen Sink

**Location:** Kitchen - Under Sink Cabinet

**Severity:** Moderate

The under-sink cabinet in the kitchen shows signs of water damage, including warping and discoloration of the plywood base, as well as potential mold growth. The inspector noted that the

particle board cabinet bottom is warped and discolored, indicating past water intrusion. Although the supply lines appear dry at the moment, the damage suggests there was a leak at some point.

Inspect and repair any leaks in the plumbing. Replace the damaged plywood to prevent mold growth and structural issues. Conduct a mold assessment and remediation if necessary.

Homeowner should monitor this area.

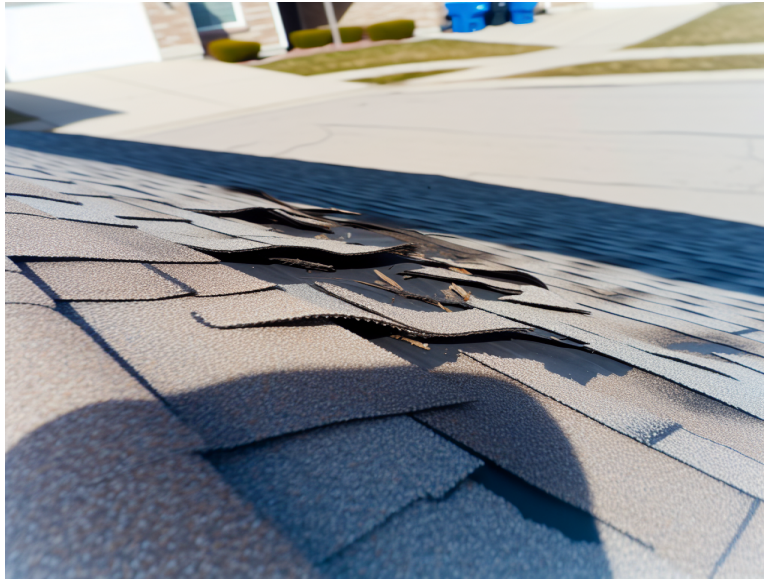
*Photo: roof\_shingle\_damage.jpg (Timestamp: 200.0s)*

■■ Damaged and Aging Shingles

**Location:** Roof - North Side

**Severity:** Moderate

The roof on the north side shows several asphalt shingles that are lifted and appear to be damaged, likely due to wind or improper installation. The inspector noted significant age-related wear on the south-facing slope, with curling, cracking, and granule loss, and recommended roof replacement within 2-3 years.

Replace damaged shingles on the north side to prevent water infiltration and further roof damage. Consider roof replacement within 2-3 years due to overall age-related wear.

Inspector recommends roof replacement within 2-3 years due to significant age-related wear.

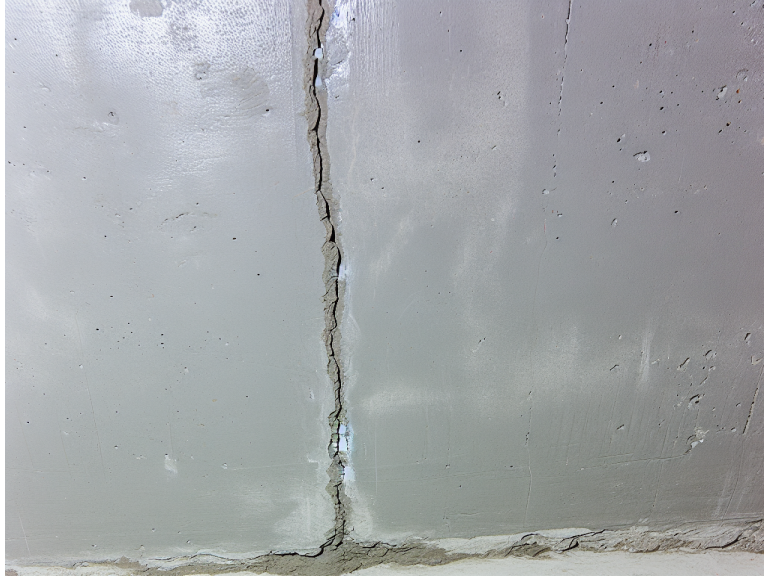
Photo: foundation\_crack.jpg (Timestamp: 250.0s)

### ■■ Vertical Crack in Basement Concrete Wall

**Location:** Basement Wall, East Side

**Severity:** Moderate

A vertical crack approximately 6 feet in length and 1/8 inch in width is visible in the concrete wall of the basement on the east side. This crack may indicate settling or structural stress, and there is some moisture staining around the crack. It is recommended to consult a structural engineer to assess the cause and recommend repairs. Monitoring the crack for any changes in size or shape is advised.

Consult a structural engineer to assess the cause and recommend repairs. Monitor the crack for any changes in size or shape.

This needs monitoring and potential structural engineer consultation.

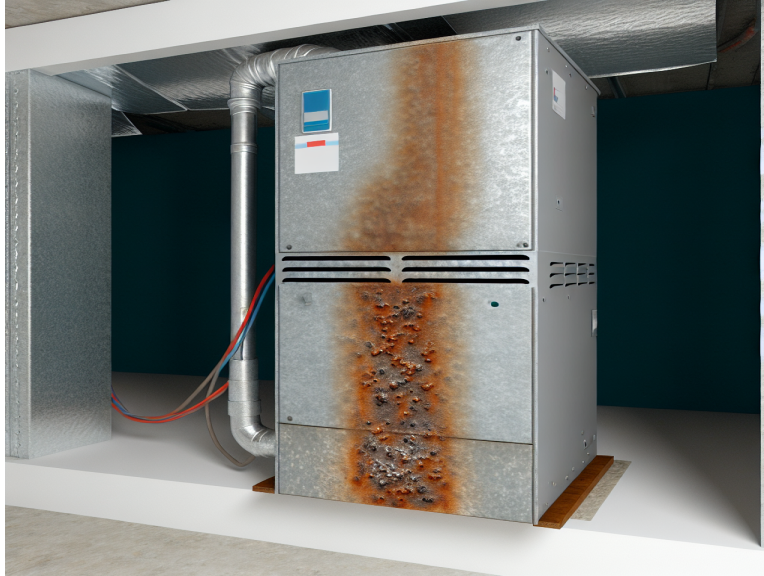
*Photo: hvac\_rust.jpg (Timestamp: 300.0s)*

### ■ ■ Severe Rust on Furnace

**Location:** Utility Room - HVAC Area

**Severity:** Major

The furnace in the utility room's HVAC area exhibits significant rust and corrosion on the exterior casing, particularly on the front panel. This rust indicates potential moisture issues and could compromise the structural integrity of the unit. The furnace is approximately 18 years old, which is nearing the end of its typical lifespan. While it is currently functional, the homeowner should budget for replacement in the near future.

Immediate evaluation by a licensed HVAC technician is recommended to assess the extent of the damage and determine if repair or replacement is necessary. Homeowner should budget for replacement in the near future.

While currently functional, homeowner should budget for replacement in the near future.
