## Case Study: University Center

#### Executive Summary

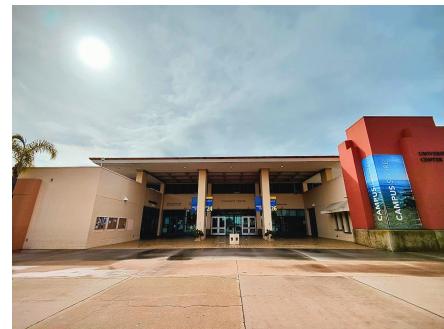
*The view of the University Center from outside the main entrance on the main floor.*

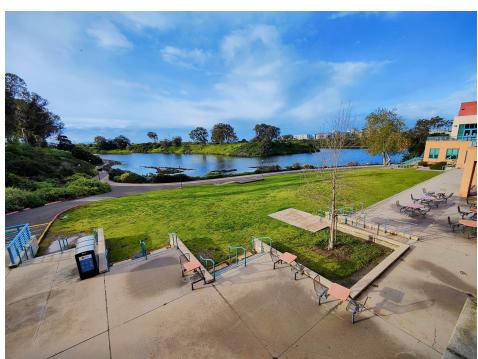
One way the design of the building site protects this area is with the Lagoon Lawn behind the building, which lies directly between the building and the lagoon. The lawn facilitates water absorption to prevent stormwater runoff from contaminating the lagoon. This protection design prevents pollutants and trash from flowing into the lagoon during storms. Additionally, large sections of the building roof are painted white to reduce the heat island effect, thereby minimizing the effect on microclimates.

*The view of the Lagoon Lawn and the campus Lagoon from the UCen.*

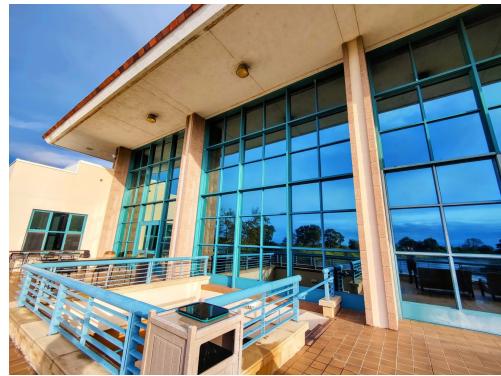
The UCen takes advantage of the direct sunlight it receives throughout the day by balancing the amount of sunlight used for natural lighting and heating. This practice minimizes energy usage during the day. A large array of south-facing windows on the main floor allow in a comfortable amount of light, removing the need for artificial lighting. Multiple large skylights throughout the building bring natural light into the second and third floors, and high ceilings allow sunlight to radiate further.

*An assembly of tinted windows on the UCen's main floor facing the south side with a large awning.*

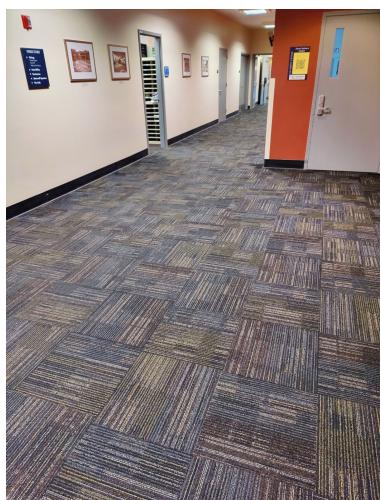
The UCen prioritizes sustainability in this category through its restaurants. Every eatery offers cutlery made out of biodegradable materials. This includes biodegradable plastic and paper containers. Additionally, some parts of the building are floored with carpet tiles, which are beneficial since individual tiles can be removed instead of the entire carpeting when replacement is needed. The third floor was also recently renovated, which removed asbestos from the building insulation.

*An array of carpet tiling on the main floor of the University Center.*
