# Need for a Multi-Sensor Monitoring Approach for Embankment Failures: Lessons Learned from the Edenville Dam Failure

**Key Terms:** *Embankment Failure, Edenville Dam, Synthetic Aperture Radar, Persistent Scatterer Interferometry, Soil Moisture Index*

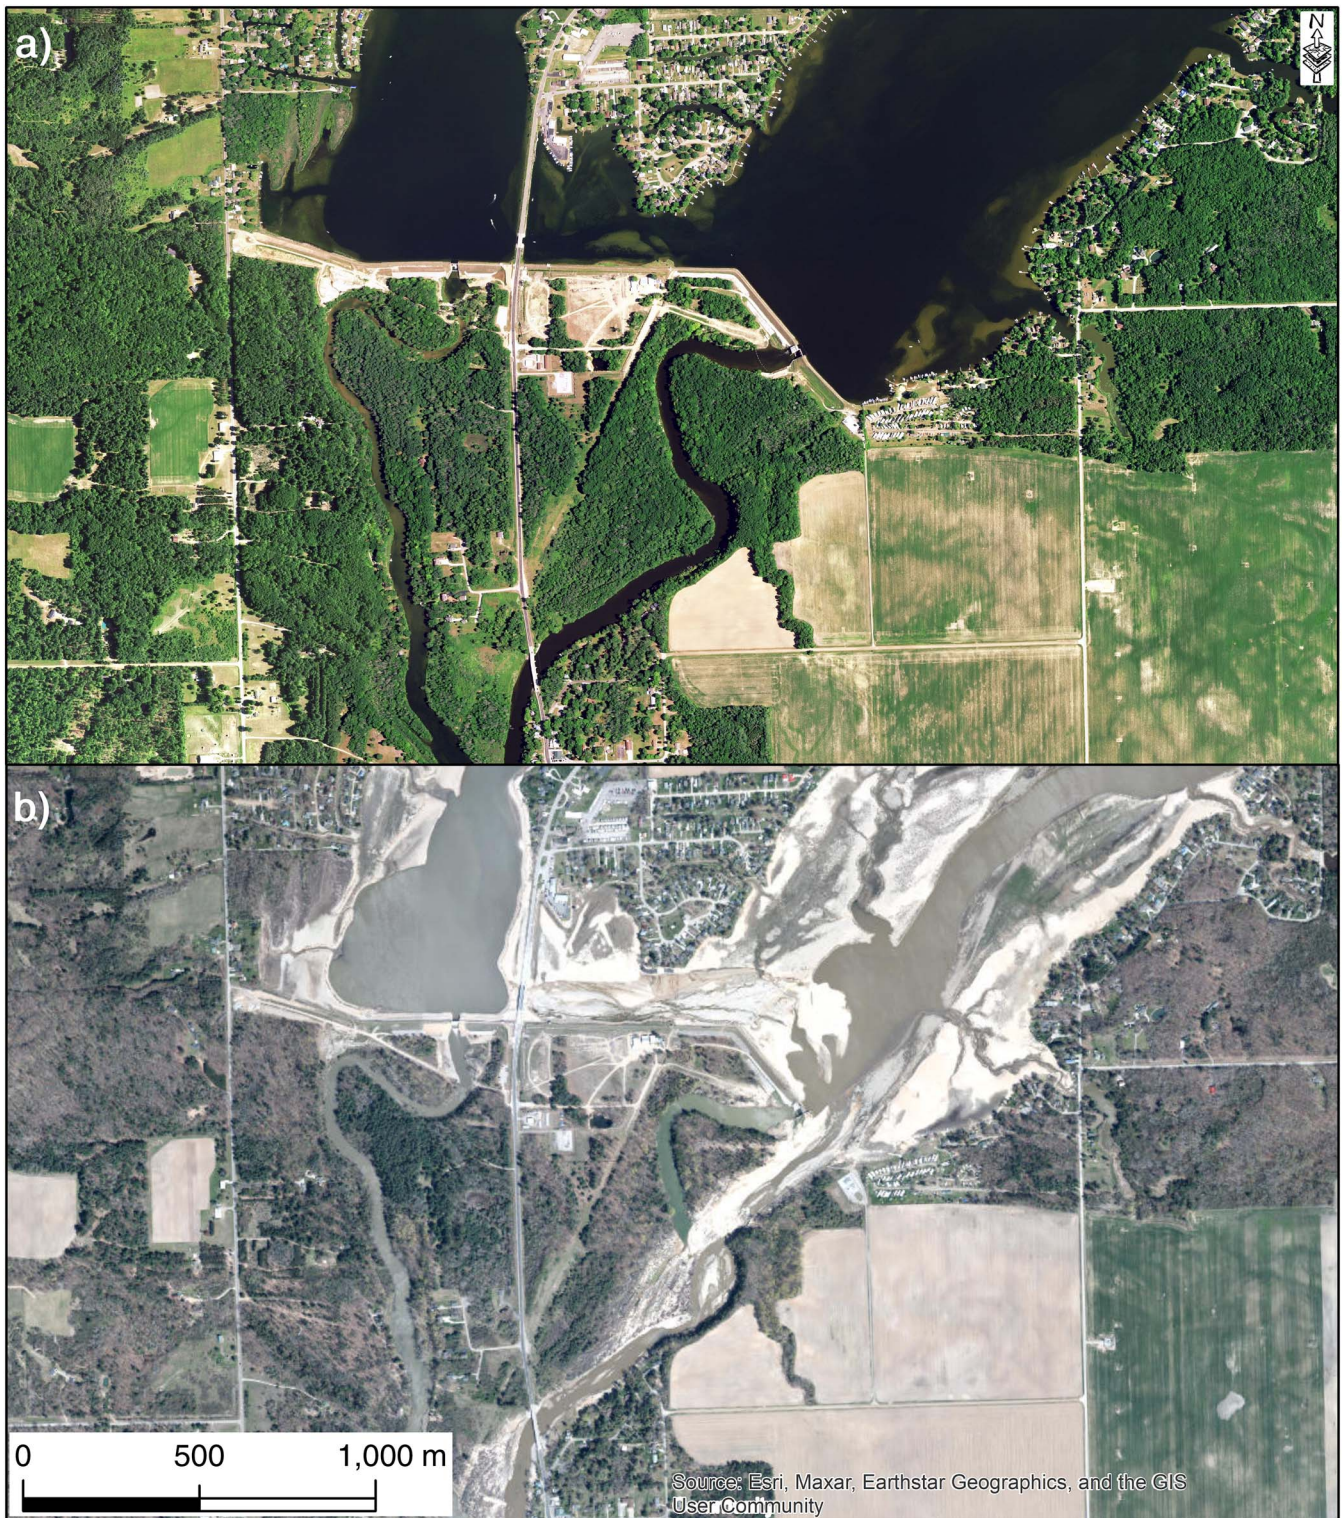
Figure 3. (a) Pre-failure and (b) post-failure imagery of the Edenville Dam. The approximate failure location where the depression was observed is shown in red. (Pre-failure imagery: NAIP image; post-failure imagery: ArcGIS world imagery.)

was emptied. Figure 3 presents a pre- and post-failure comparison of the Edenville Dam. It was also reported that the downstream embankment slope was not uniform and was over-steepened in areas, and a bulging feature

was present in a 2017 light detection and ranging (LiDAR) survey. A slope stability model showed a low factor of safety (1.08) for a rotational slide when modeled with the reservoir level at the time of failure.
