## Summary of Decommissioning and Contaminated Water Management

February 28, 2019

Secretariat of the Team for Countermeasures for Decommissioning and Contaminated Water Treatment

# Progress Status and Future Challenges of the Mid- and Long-Term Roadmap toward Decommissioning of TEPCO Holdings' Fukushima Daiichi Nuclear Power Station (Outline)

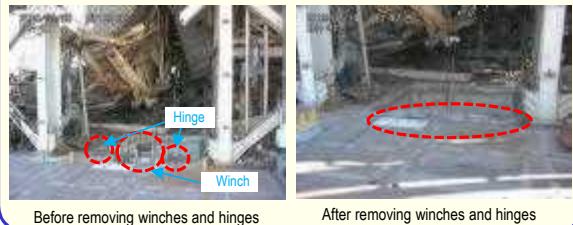
Before removing winches and hinges

After removing winches and hinges

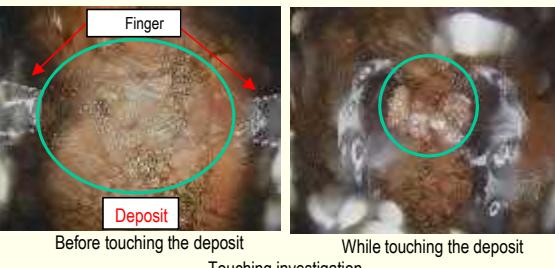
Before touching the deposit

While touching the deposit

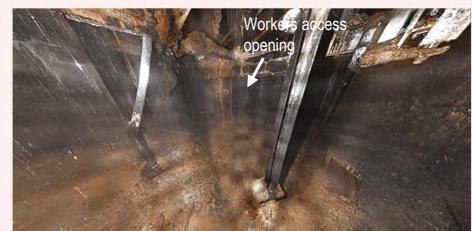
- The results of this series of investigations confirmed fallen and deformed gratings and a quantity of deposit inside the pedestal.
- On January 19, 2018, the status below the platform inside the pedestal was investigated using an investigative device with a hanging mechanism. From the analytical results of images obtained in the investigation, deposits probably including fuel debris were found at the bottom of the pedestal. In addition, multiple parts higher than the surrounding deposits were also detected. We presumed that there were multiple routes of fuel debris falling. Obtained data were processed in panoramic image visualization to acquire clearer images.

- On February 13, 2019, an investigation touching the deposits at the bottom of the pedestal and on the platform was conducted and confirmed that the pebble-shaped deposits, etc. could be moved and that hard rock-like deposits that could not be gripped may exist.

- In addition, images, etc. would help determine the contour and size of the deposits could be collected by moving the investigative unit closer to the deposits than the previous investigation.
