## Aviano Campus

### Facility Condition Assessment Report

| Date of Assessment | 21-Jan-2020 |

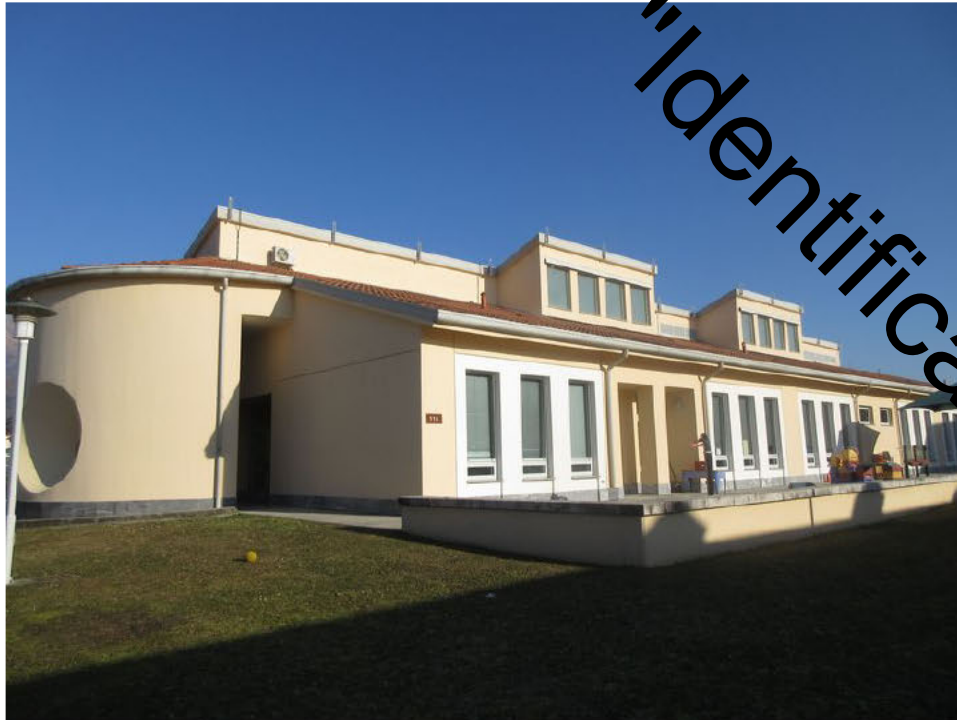
YEAR BUILT: 2005

AREA (SF): 20,049

TOTAL DEFICIENCIES: \$0

| BUILDER(TM) METRIC | | SCORE |
|---|---|---|
| Facility Condition Index | FCI: | 100 |

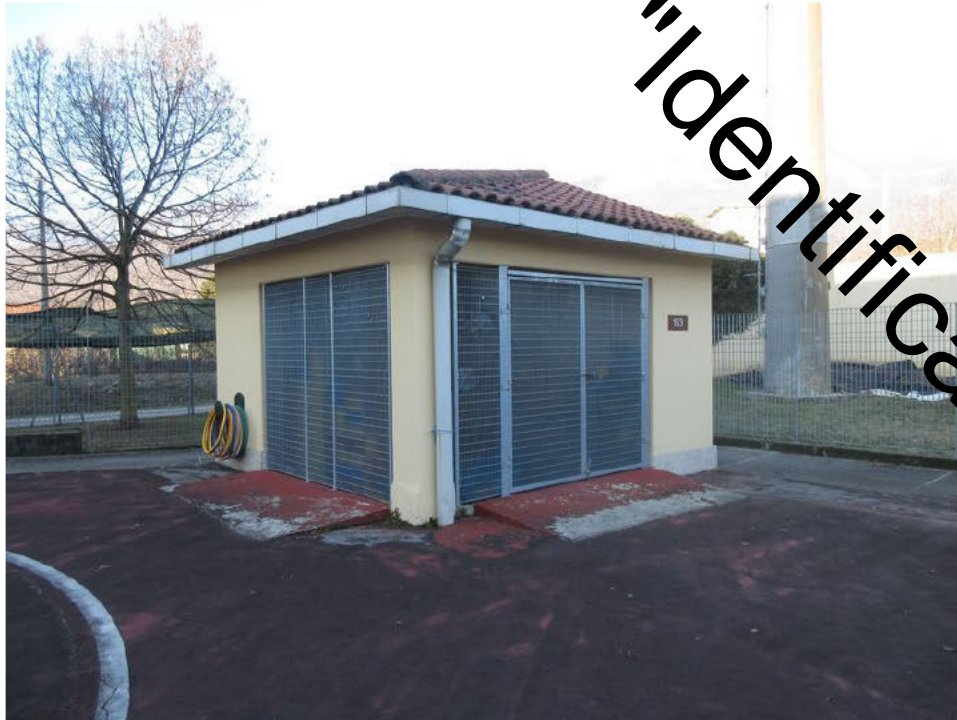
## 153 - Aviano ES Bldg 153

YEAR BUILT: 2002

AREA (SF): 203

| BUILDER(TM) METRIC | | SCORE |
|---|---|---|
| Facility Condition Index | FCI: | 100 |
