# Livorno Elementary/Middle School

## Facility Condition Assessment Report

| Date of Assessment | 07-Jan-2020 |

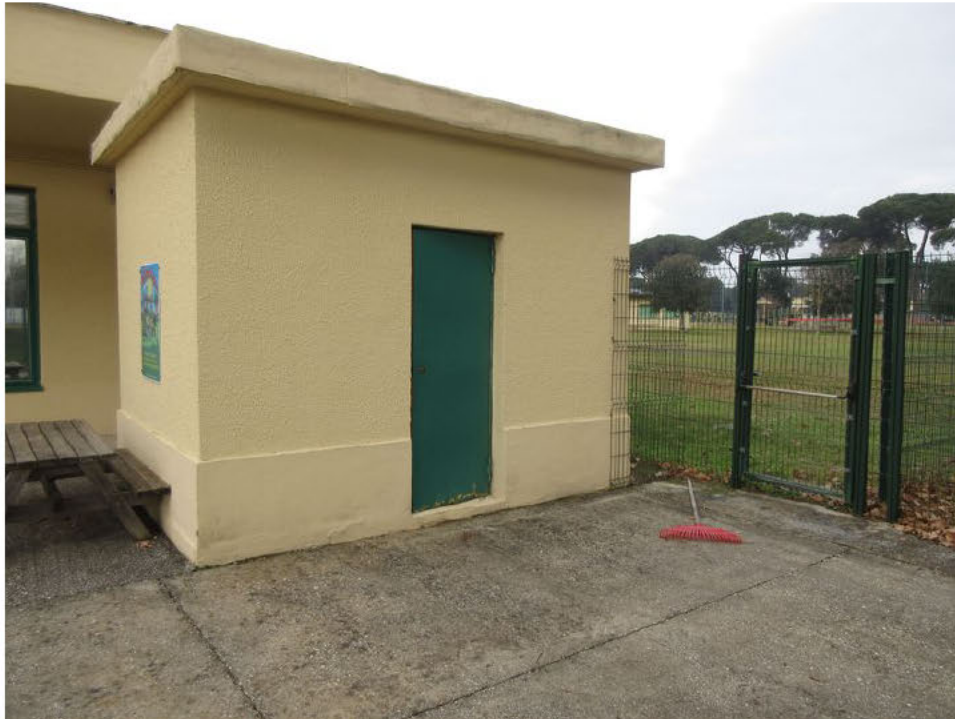
## 200 - Livorno ES/MS Bldg 200

TOTAL DEFICIENCIES: \$0

| BUILDER(TM) METRIC | | SCORE |
|---|---|---|
| Facility Condition Index | FCI: | 100 |

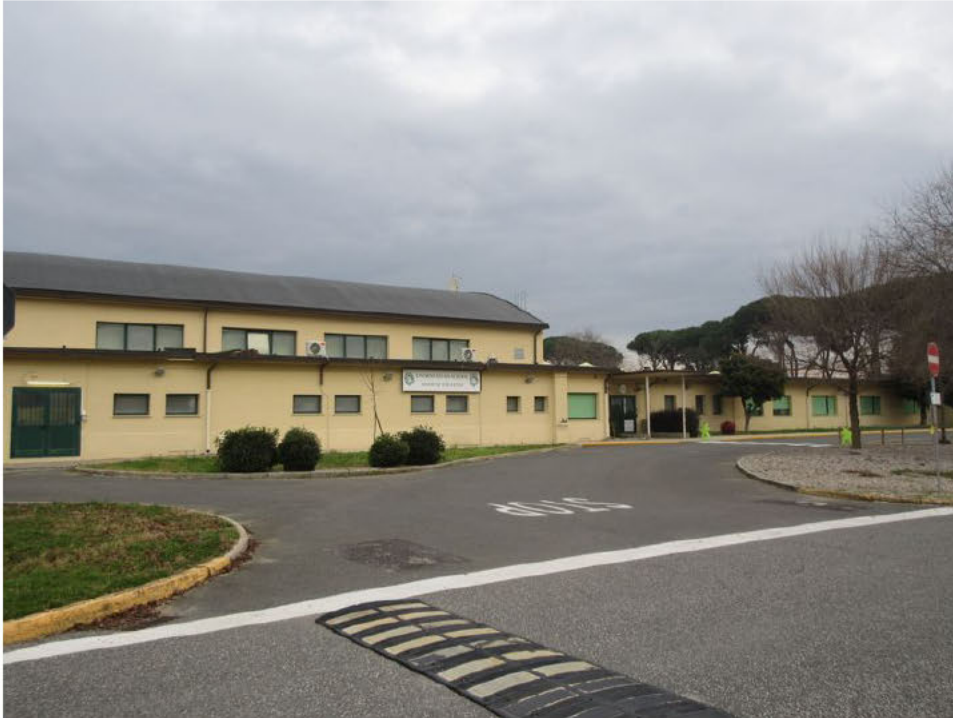
## 201\* - Livorno ES/MS Bldg 201\*

TOTAL DEFICIENCIES: [REDACTED]

| BUILDER(TM) METRIC | | SCORE |
|---|---|---|
| Facility Condition Index | FCI: | 82 |
