## Executive Summary — Plant Equipment, Unit Installation & Ductwork

| PROJECT<br>The Garema Hotel (5-Star), ACT | PRINCIPAL CONTRACTOR<br>TP Dynamics | MECHANICAL CONTRACTOR<br>Climatech | SITE SUPERVISOR<br>Keith Morgan |

## Works Summary Report 02

THE GAREMA HOTEL · 20-26 AUG 2026

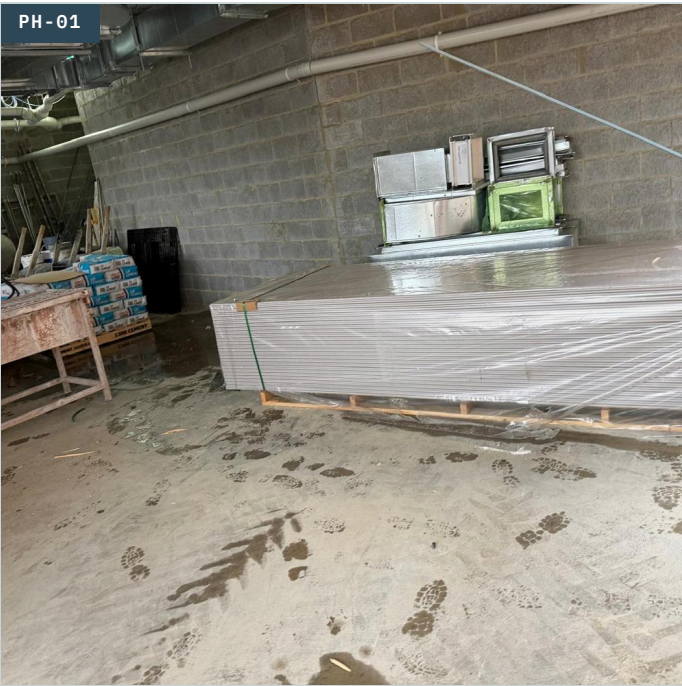
PH-01

Basement material store

Ductwork, motorised and volume control dampers and plenum boxes received, checked and staged clear of access routes prior to distribution to work fronts.

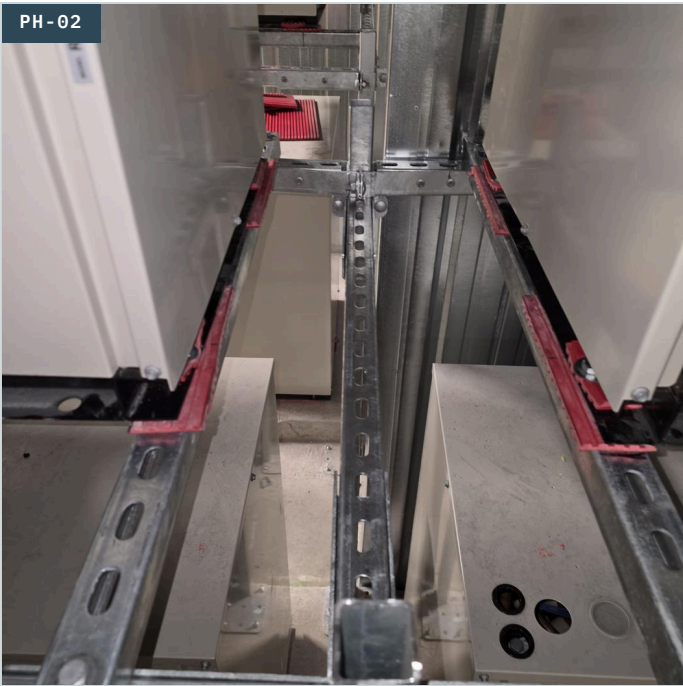
PH-02

Support frames — plant area

Galvanised unistrut trapeze and goal-post frames installed to slab and soffit, cross-members bolted and levelled to suit the unit footprints and the services above.

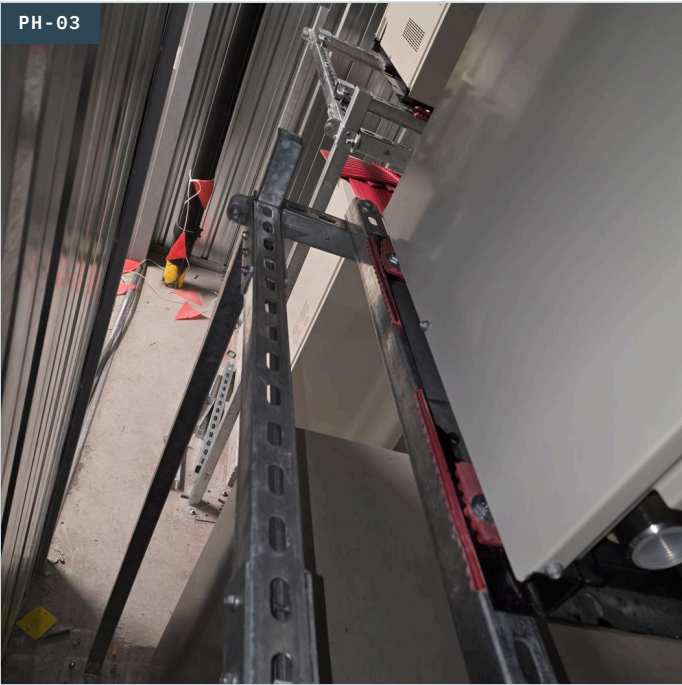
PH-03

Frame run — typical arrangement

Repeating frame arrangement set out to a common line and level so units, duct connections and access clearances stay uniform across the run.

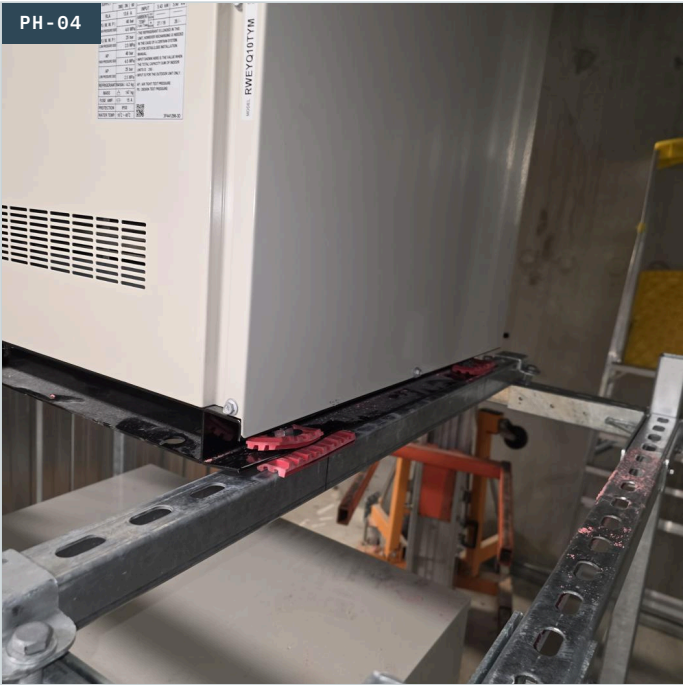
PH-04

Daikin RWEYQ10TYM module set

Water-cooled VRV heat pump module (Ser. E001506) positioned, aligned and seated on the support frame, nameplate left visible for commissioning and asset records.

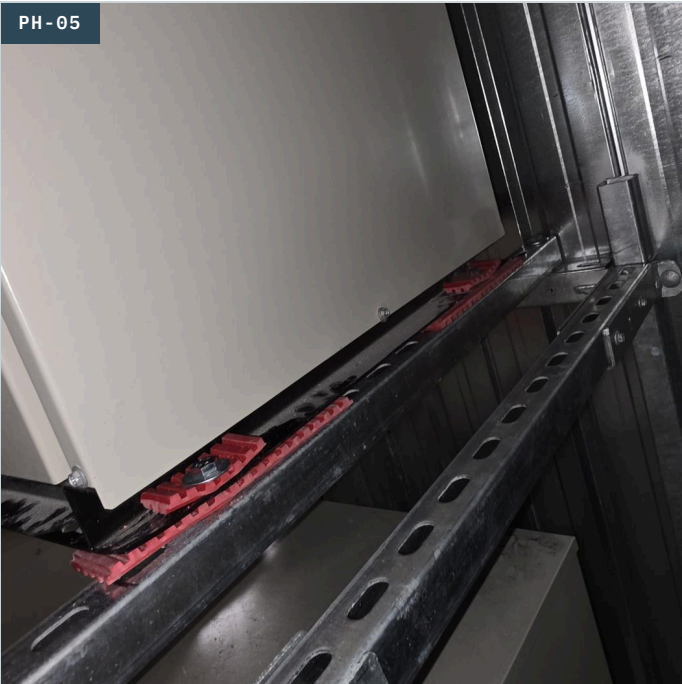
PH-05

### Anti-vibration pads at unit base

Continuous rubber AV pads fitted between the unit base rail and the steel support so the unit bears fully on the isolator — an acoustic requirement for the guest floors.

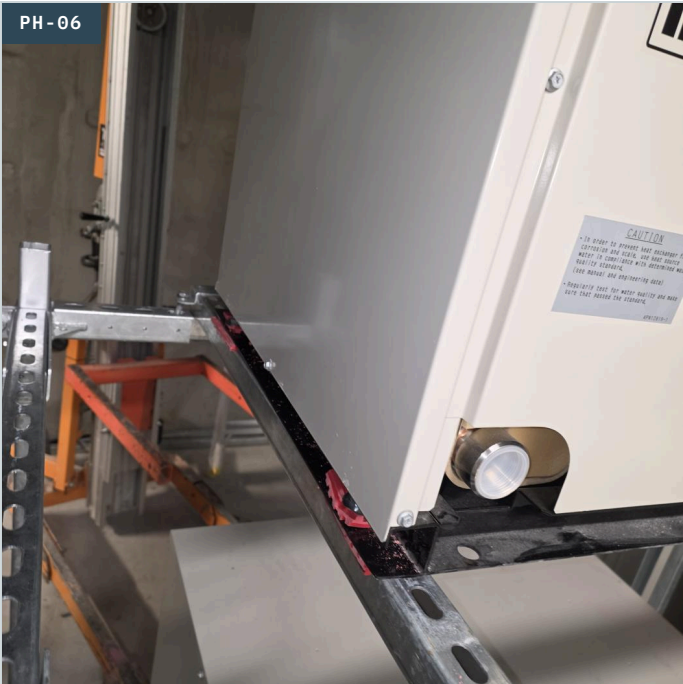
PH-06

### Condenser water connection presented

Unit set with condenser water connections capped and presented clear of the frame for connection by the hydraulic trade; manufacturer water-quality label retained.

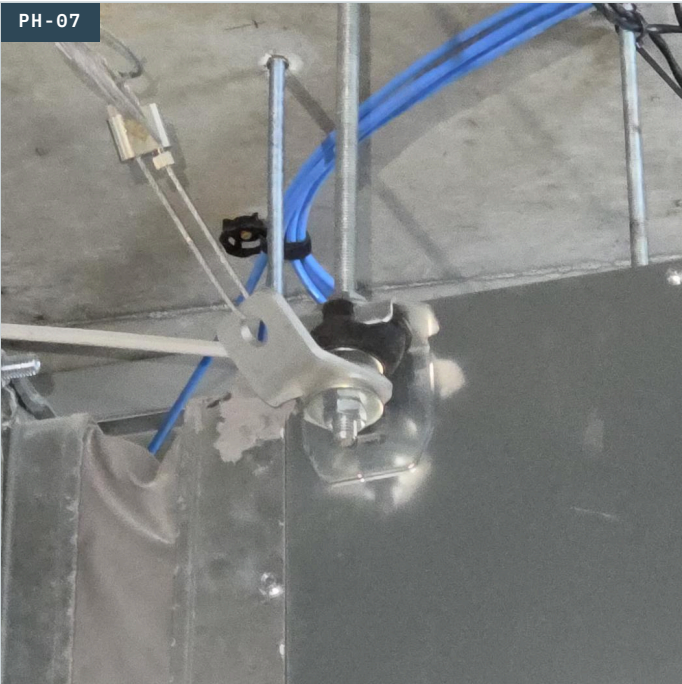
PH-07

### Support bracket fixed and tightened

Wall bracket bolted off and tensioned, with refrigerant and control cabling dressed and secured to saddles clear of the duct face and the access zone.

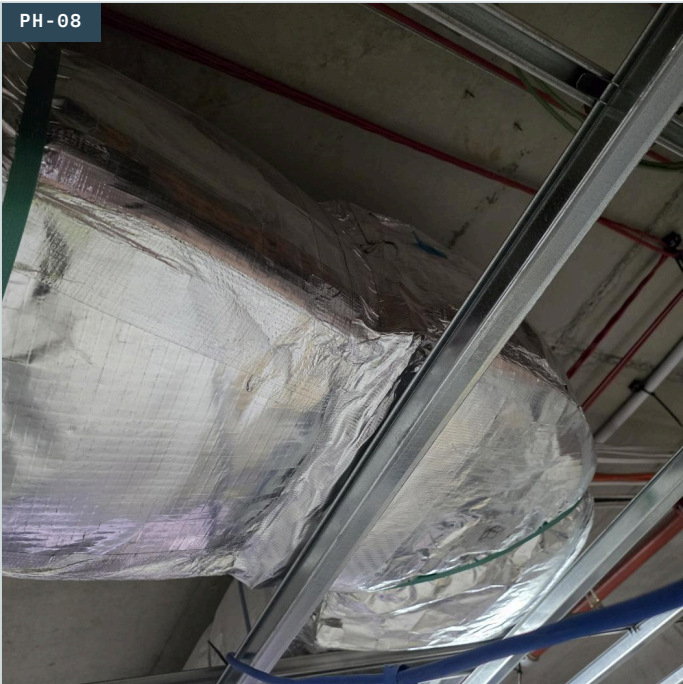
PH-08

### Insulated duct transition installed

Insulated rectangular duct and transition to spiral installed and supported on unistrut, set out to clear the hydraulic and fire services running above.

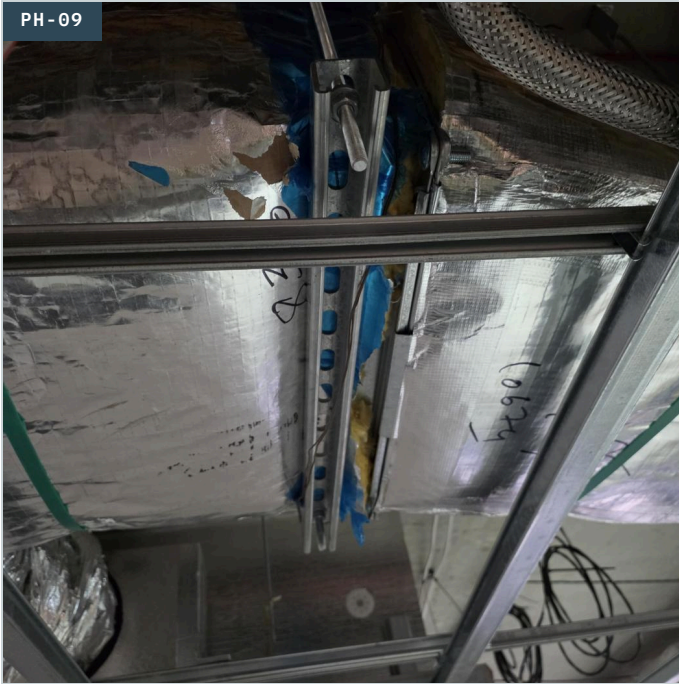
PH-09

Existing soffit anchors continue to be found stripped or not holding load, and have been marked on the slab — compliant circled OK, defective marked X (PH-14). Replacement with HKD drop-in anchors is recommended before further hanging.
- Vibration isolation** — units set on AV pads or hangers; final levelling to be re-checked after connection by others.
  - Insulation** — insulation disturbed by supports temporarily made good; permanent reinstatement to be programmed (PH-09).

### Riser duct and damper set

Riser duct supported on threaded rod and unistrut with damper set in position; insulation and vapour barrier temporarily made good at the support penetration.

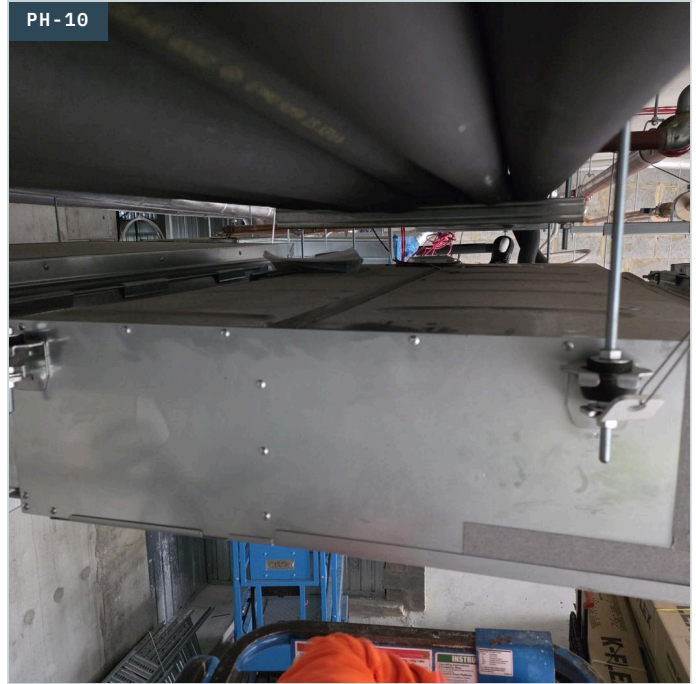
PH-10

### Plenum box hung to soffit

Plenum / attenuator box hung from the concrete soffit on threaded rod with rubber-in-shear AV hangers, flexible connection fitted at the duct joint.

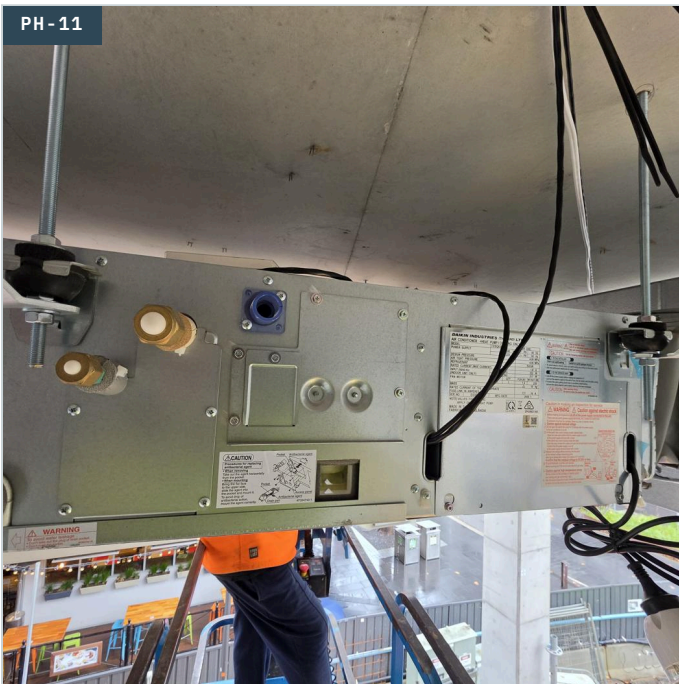
PH-11

### Ducted FCU hung and presented

Daikin FXSQ-series ducted fan coil hung on four threaded rods with AV hangers; refrigerant flares, drain socket and electrical entry left accessible for connection.

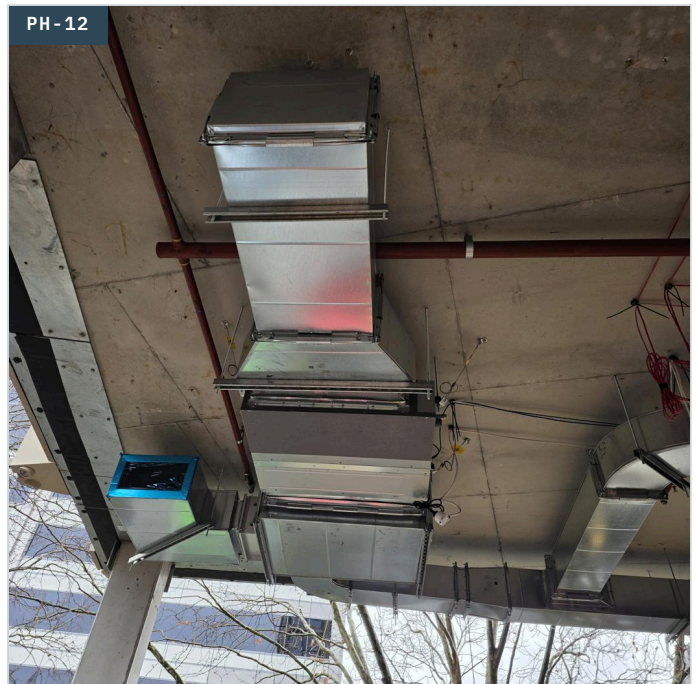
PH-12

### Duct run and boxes to drawings

Duct run with plenum, filter box and spiral connections installed to the issued mechanical set, with open ends protected pending the following connection.

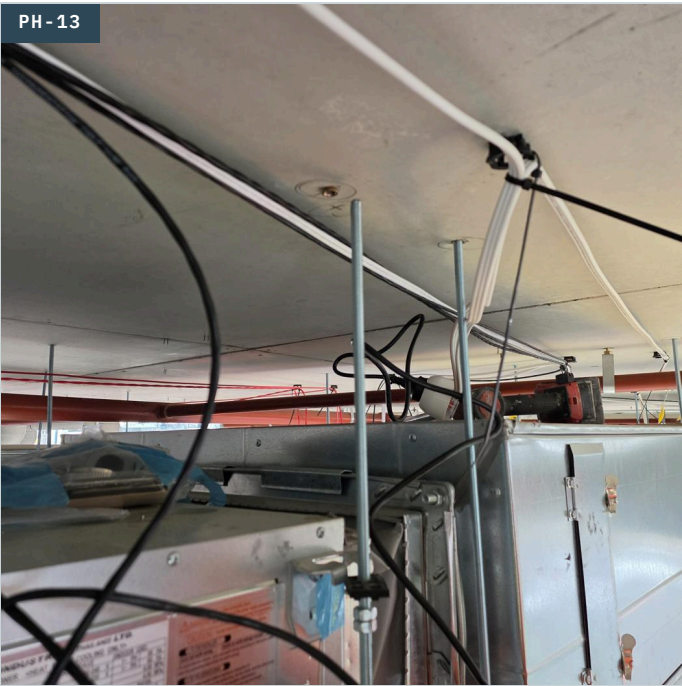
PH-13

Cabling and drain presented at unit

Control and power cabling dressed to the hanger line and drain line set to fall, with safety wires fitted to the hung equipment.

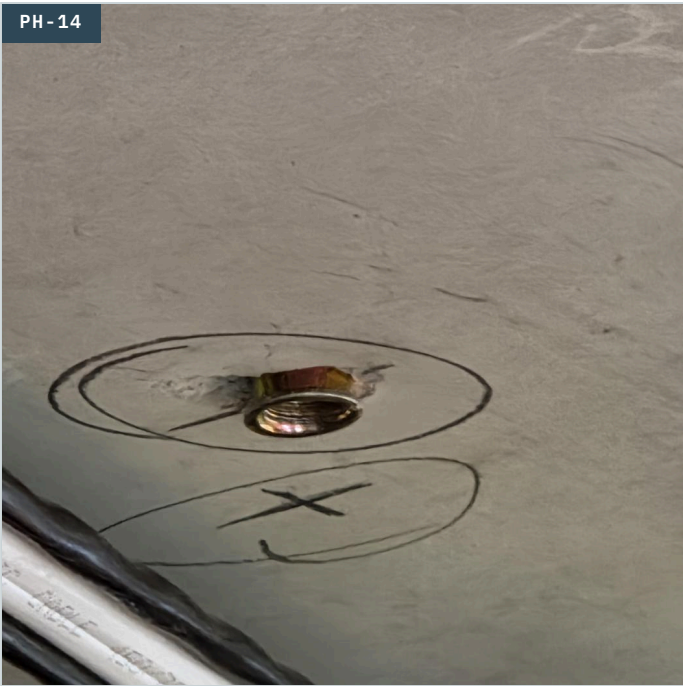
PH-14

Anchor inspection marked on slab

Existing soffit anchors inspected and marked in place — compliant anchor circled OK, adjacent defective anchor marked X. Replacement with HKD drop-in anchors recommended.

- Complete plenum hanging and flexible connections at remaining floors; replace defective soffit anchors with HKD drop-ins, subject to direction.
- Continue insulated duct runs, damper sets and access panels; progressive sign-off.

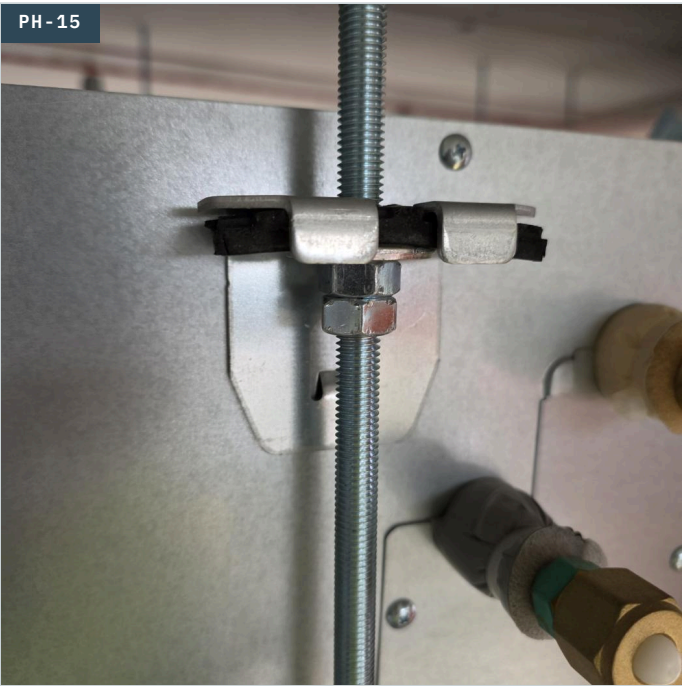
PH-15

AV hanger detail at unit bracket

Threaded rod hanger double-nutted at the unit bracket with rubber isolation pad between clamp and bracket — typical detail applied across the hung equipment.

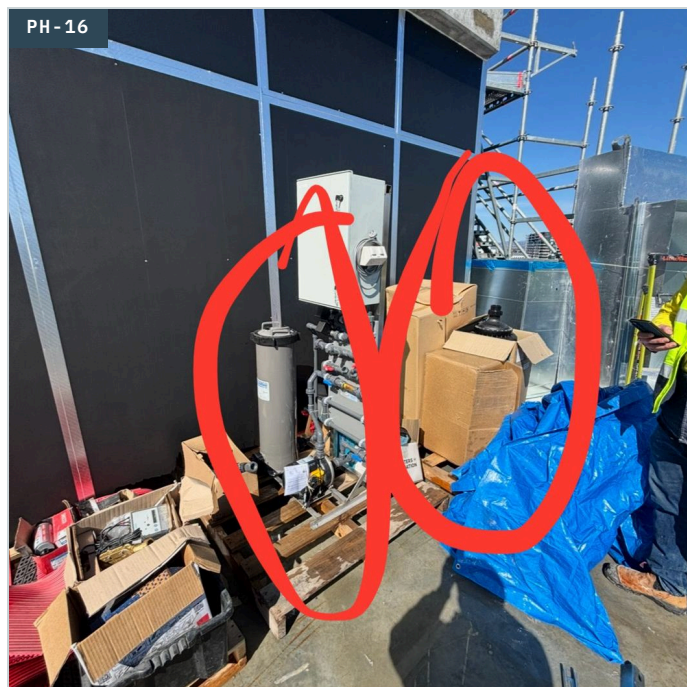
DIRECTION

### Items marked for relocation

Filtration skid, control panel and associated cartons at the Ground Floor store, marked up by the site supervisor for transfer to the rooftop store.

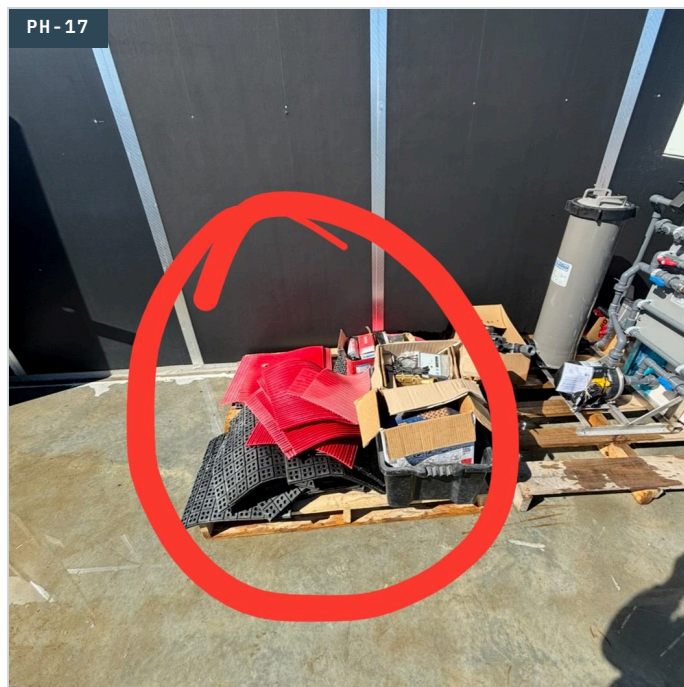
DIRECTION

### Pallet marked to remain in place

Pallet of protection matting and fixings marked by the site supervisor to stay at the Ground Floor store and be covered on site rather than relocated.

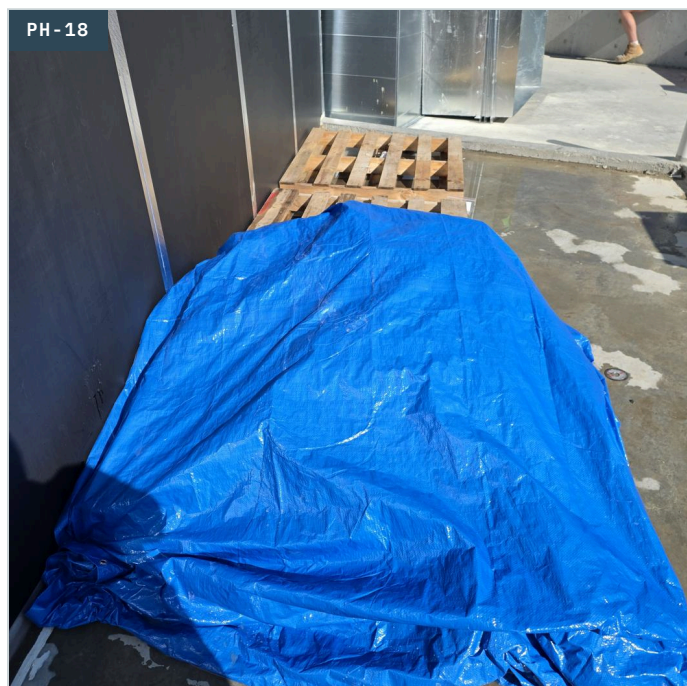
RELOCATION

### Material relocated to rooftop

Marked items transferred to the rooftop and set down in the agreed storage location, clear of the ductwork run and the access route along the wall.

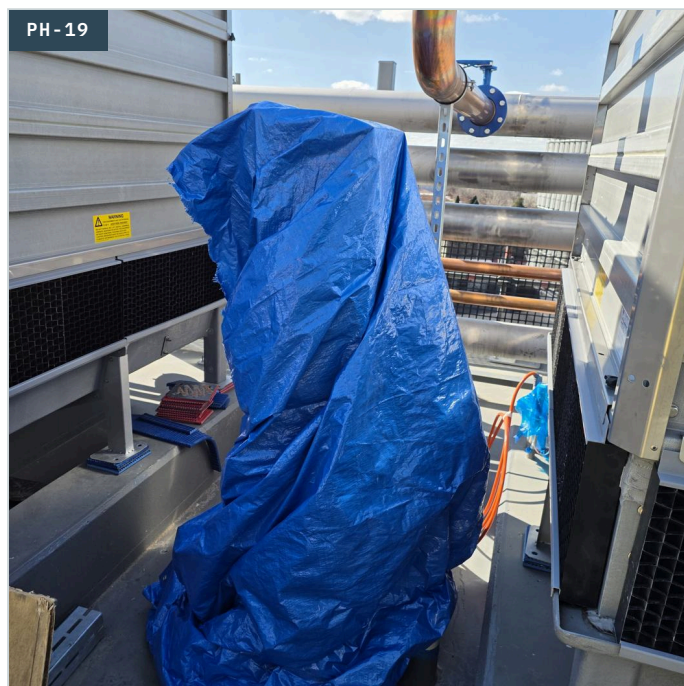
PROTECTION

### Stored plant covered on rooftop

Relocated plant covered with tarpaulin on the rooftop deck, clear of the cooling tower platform, the condenser water pipework and the walkway.

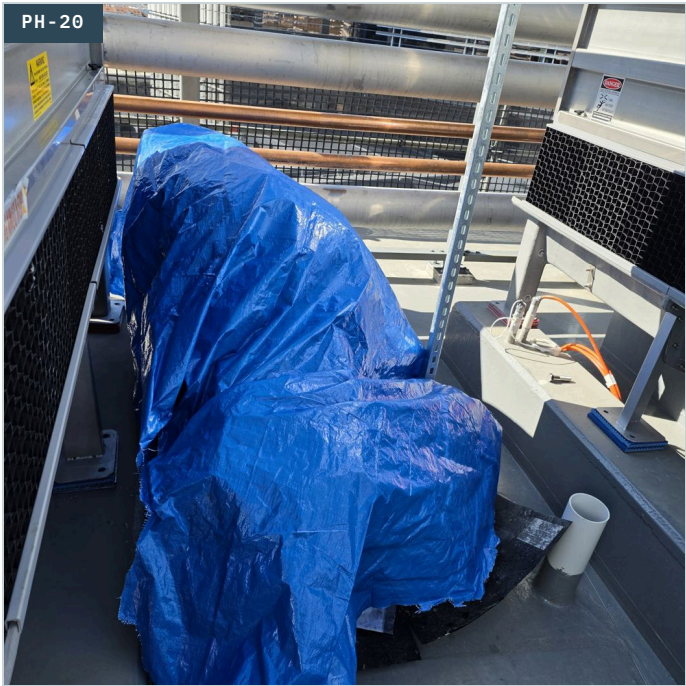
PROTECTION

Second pallet covered and secured

Balance of the relocated material covered and weighted down against wind exposure on the open rooftop, clear of plant access and grated walkways.

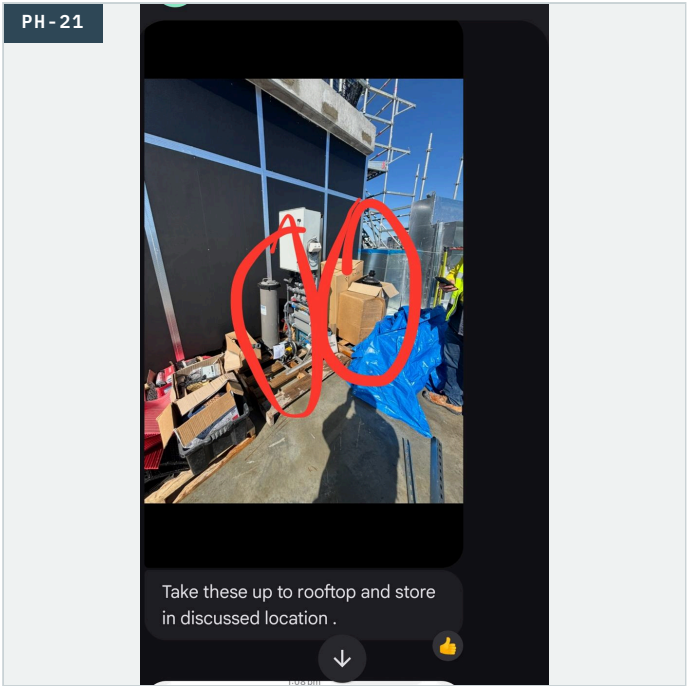
DIRECTION

Supervisor direction — rooftop transfer

Instruction received from Climatech on 26/08: the marked items to be taken up to the rooftop and stored in the agreed location. Works completed same day.

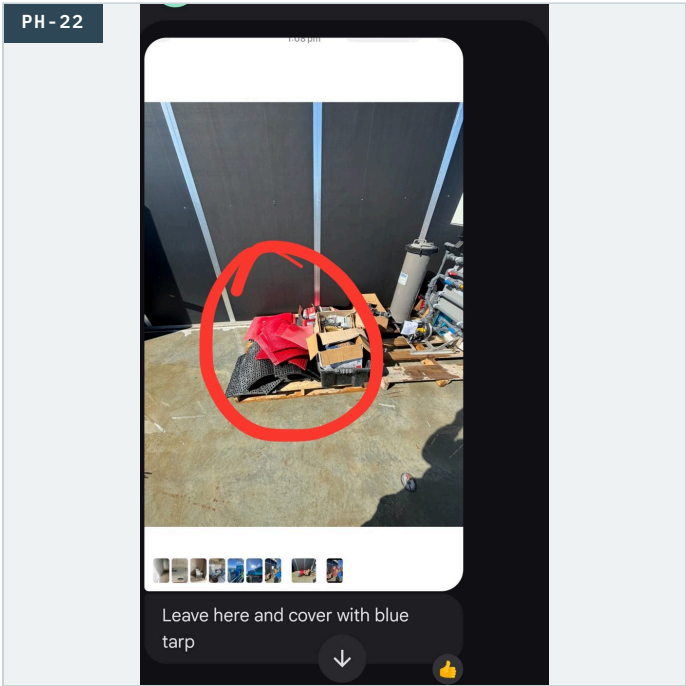
DIRECTION

Supervisor direction — cover in place
