Giuseppe Cazzaniga, Liutaio

Bernareggio, July 2009 - June 2012

Restoration of a Brescian style double bass

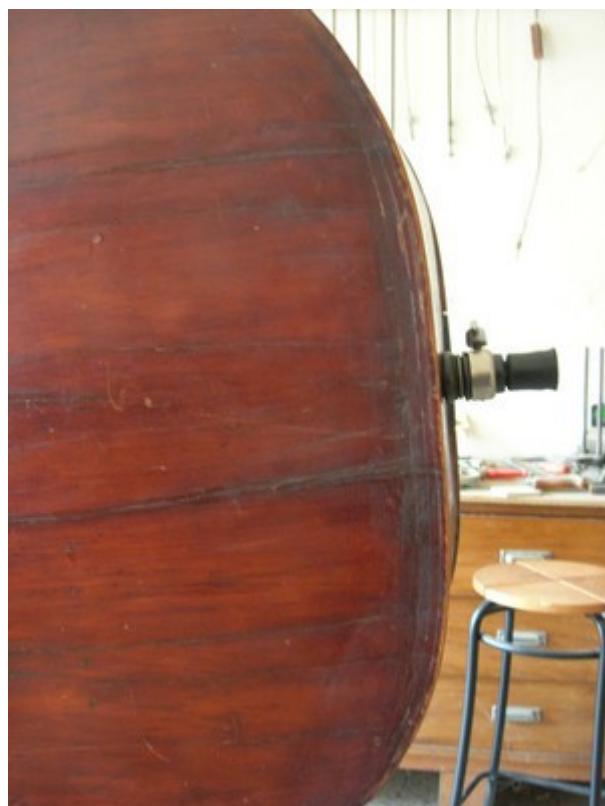
The lower curves of the back have been modified, next to and on the sides of the lower block, for a length of about 45 centimetres, with a replacement of the edge and purflé, of a maximum width of 20 millimetres

The glueing surface of the ribs to the back in this area has been lowered by 5 millimetres

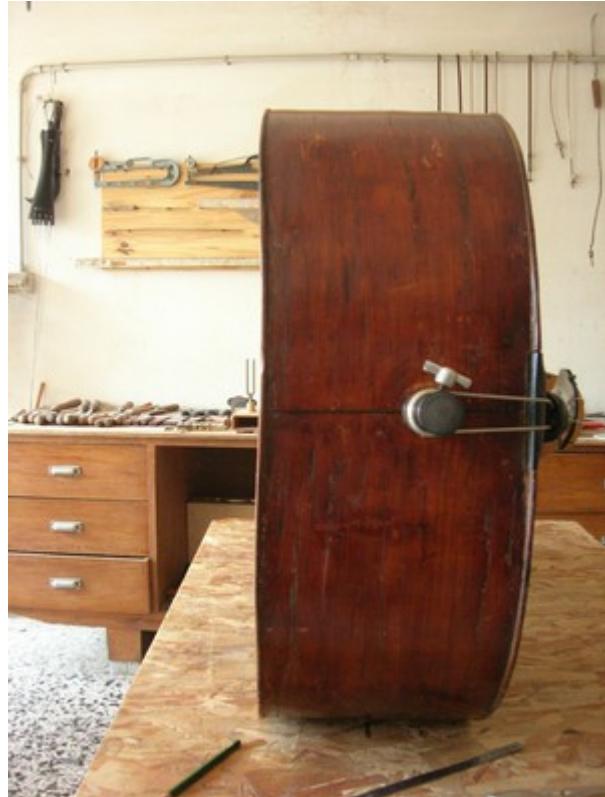
The endpin hole is not in the middle point of the ribs' height but more towards the top.

It is possible that the ribs and lower block have been planed down, and the lower part of the back rebuilt, to repair the damages caused by resting the back edge of the instrument on the floor while playing, or because of the removal of a "clog" used for the same reason, and that in the beginning there was an end button instead of an endpin.

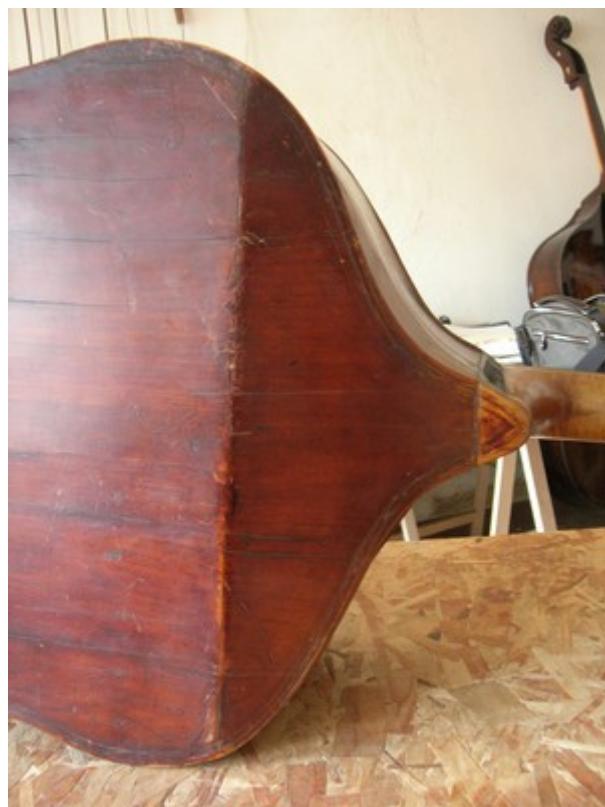
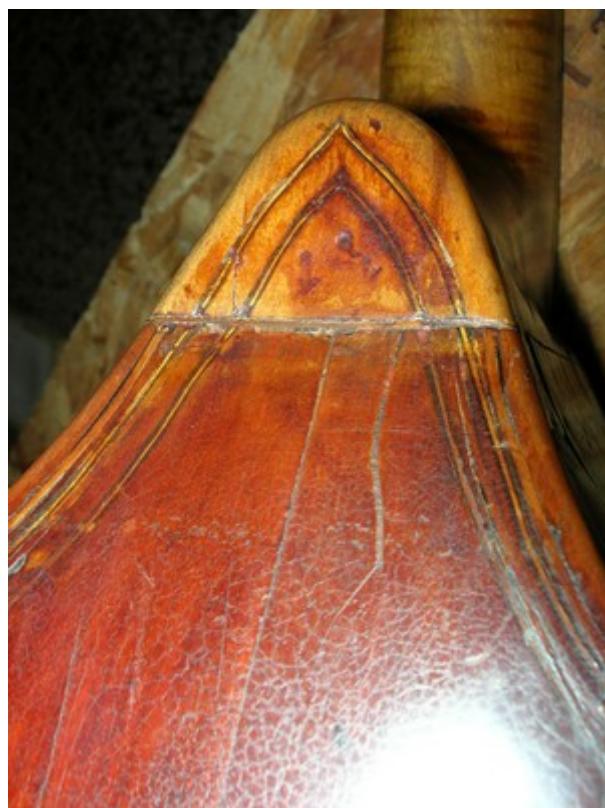
The width of the back has been decreased, as proved by the old purfling beside more recent ones, from the back button to the maximum width of the upper bouts.

The width of this reduction is of about 5 millimetres per side. The back button has been cut transversely and rebuilt.

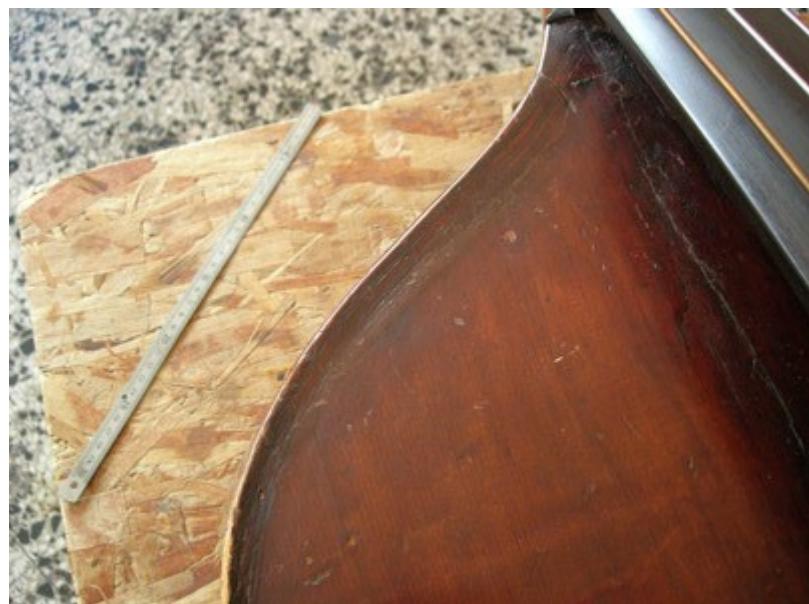
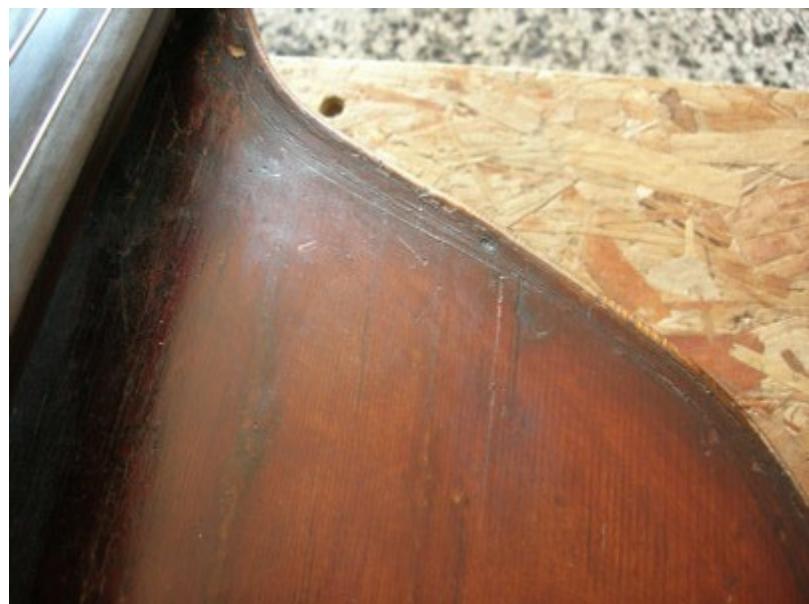
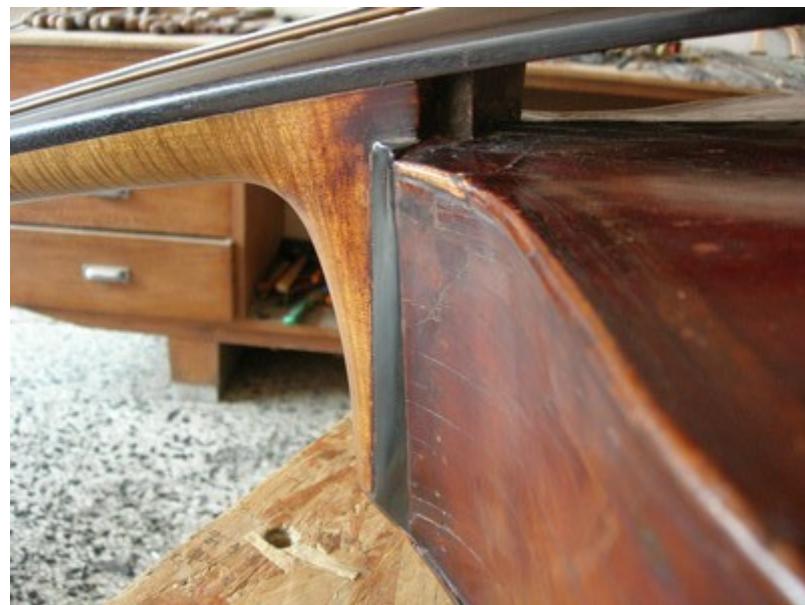
In the same area the top has been widened with two additions of the edge and purfling.

On the G side, the addition has a maximum width of 17 millimetres and a length of about 180 millimetres.

The two additions, and some fillings as well, cover the highest point of the top.

On the neck's sides, to complete the body's outline, there are two ebony columns.

It seems that the upper part of the body has been modified to bend the shoulders ribs, by widening the top plate and tightening the back.

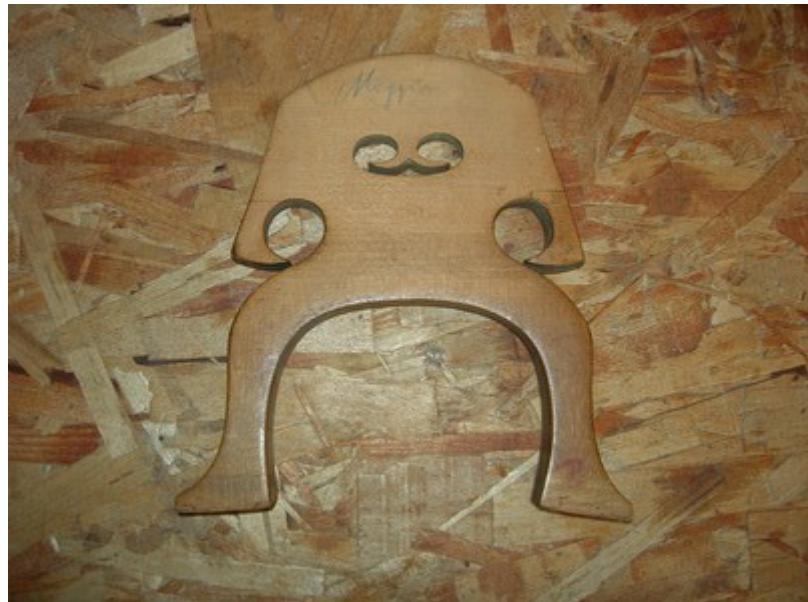
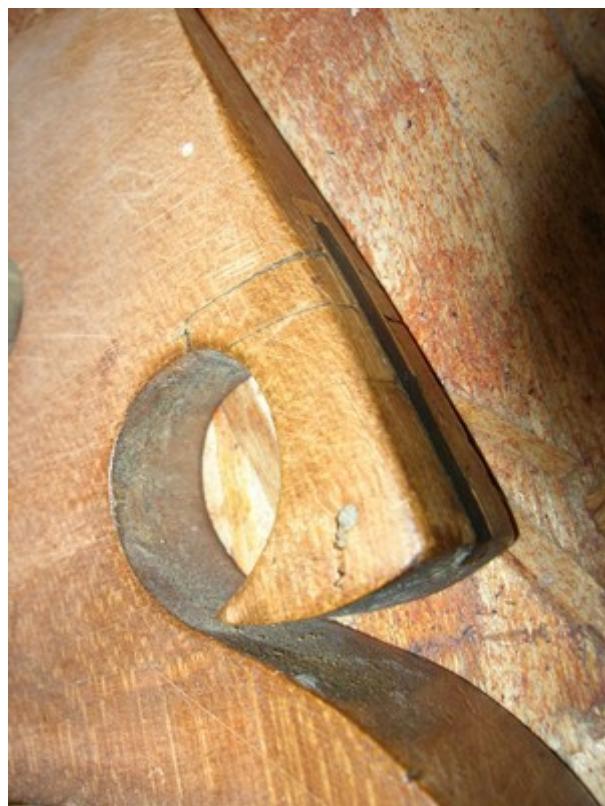
The bridge is deformed and has been repaired on the E side with an ebony plate, where it was fractured and eaten by woodworms.

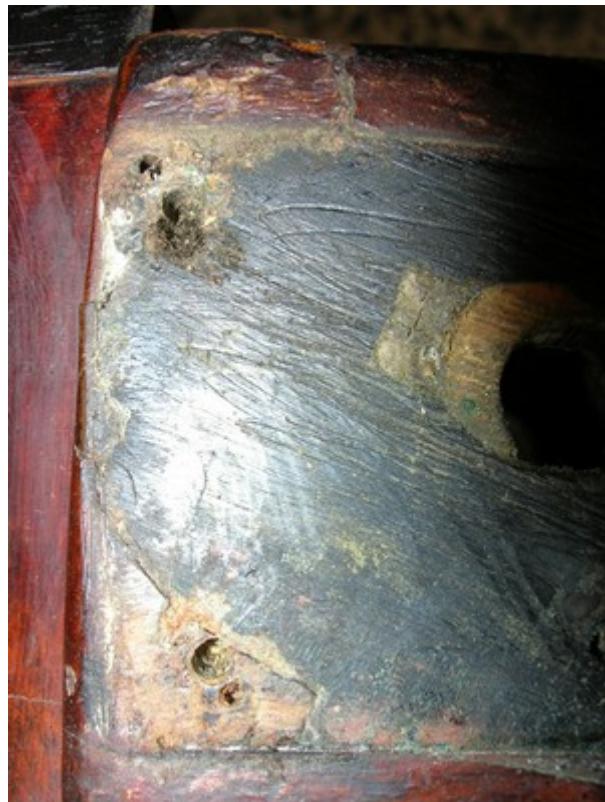
Under the plates there are two ebony and filler replacements, where a previous set of tuning machines for four strings were inlaid in the pegbox.

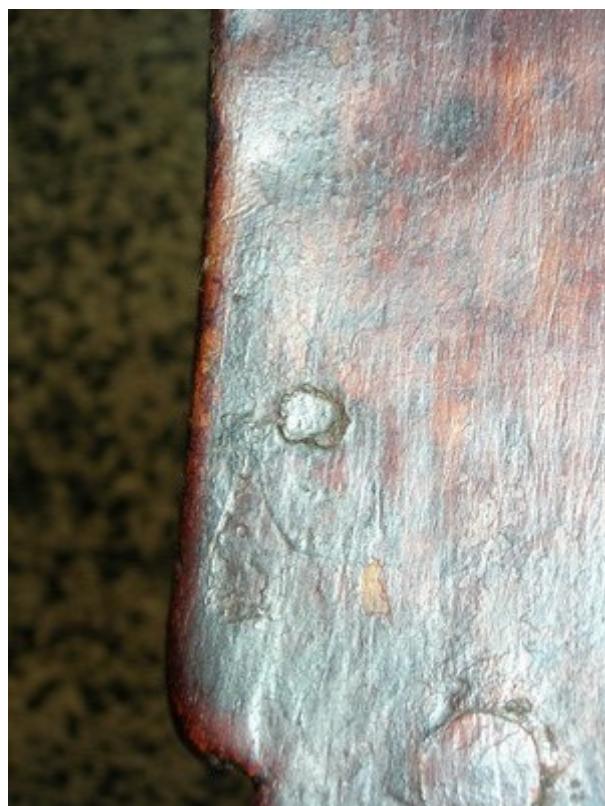
On the back of the pegbox it is possible to see three filled holes, that might be left from a previous set of three machines with retaining pins.

I will be able to get better informations on the previous stringing when I will repair the pegbox by removing the ebony and filler from the walls in order to make new additions.

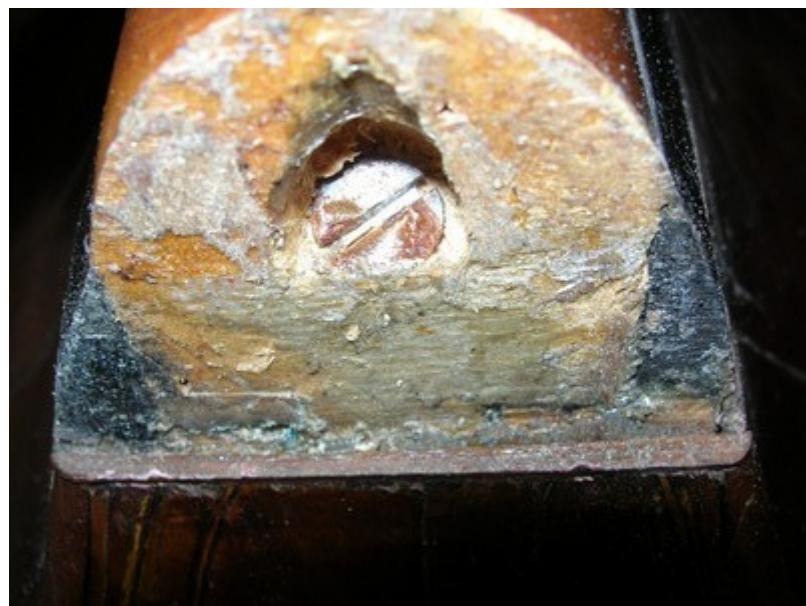
Under the non original back button there is a metal screw inserted diagonally between neck and upper block

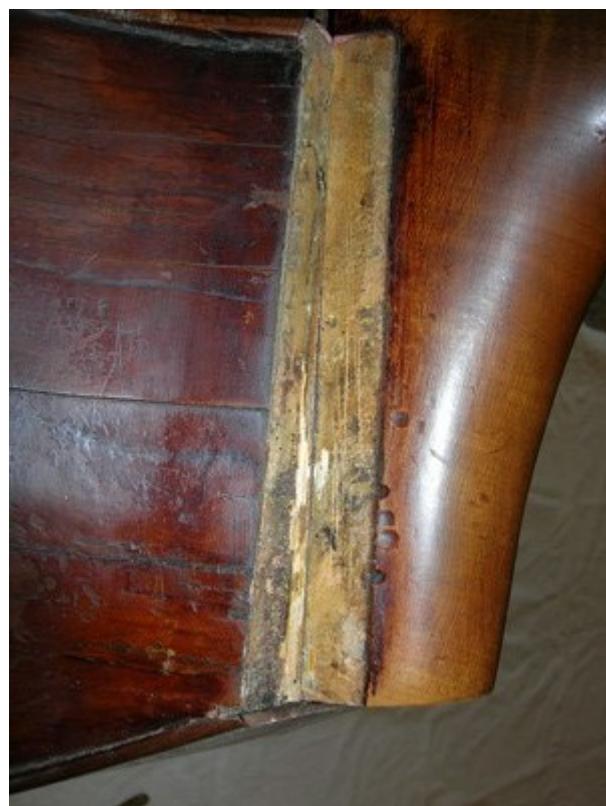
On the G side a wedge has been inserted to block the dovetailed neck fitting.

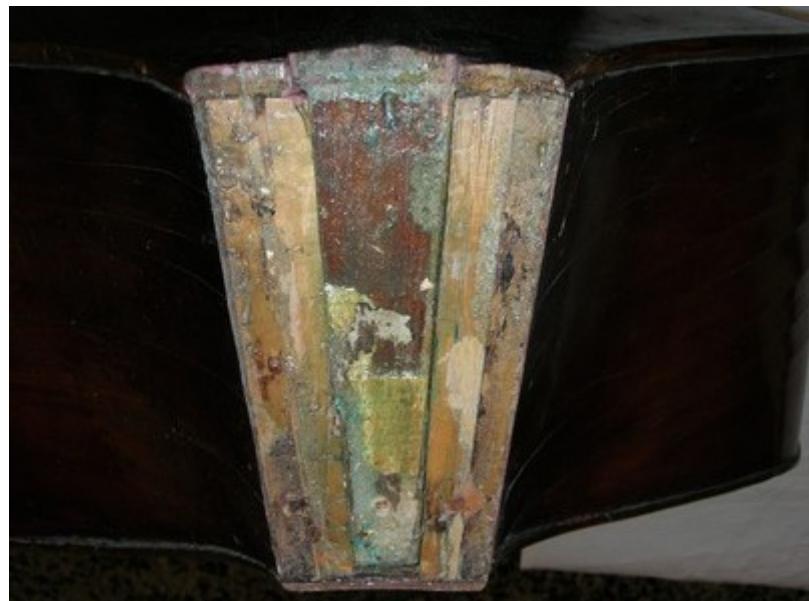
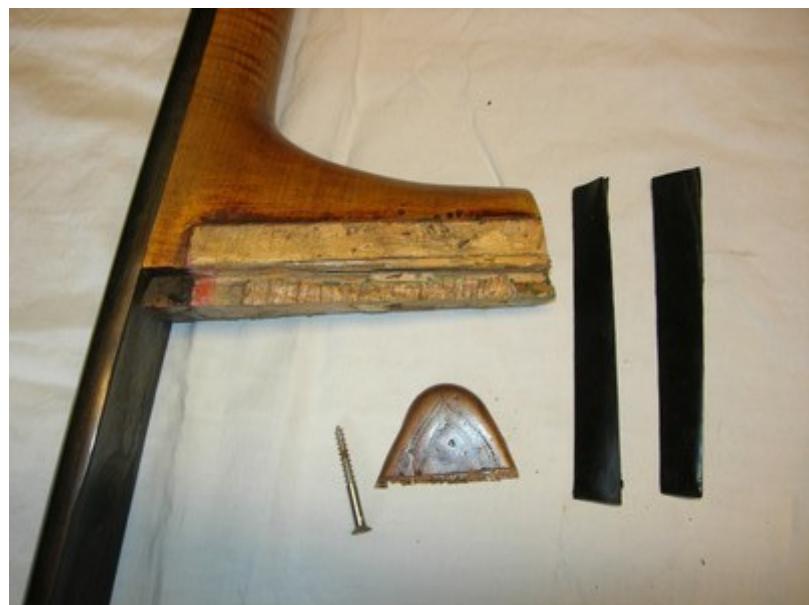
Various replacements are glued to the upper block both on the sides and back of the dovetail, with different woods (walnut, maple, spruce). There are three screws as well.

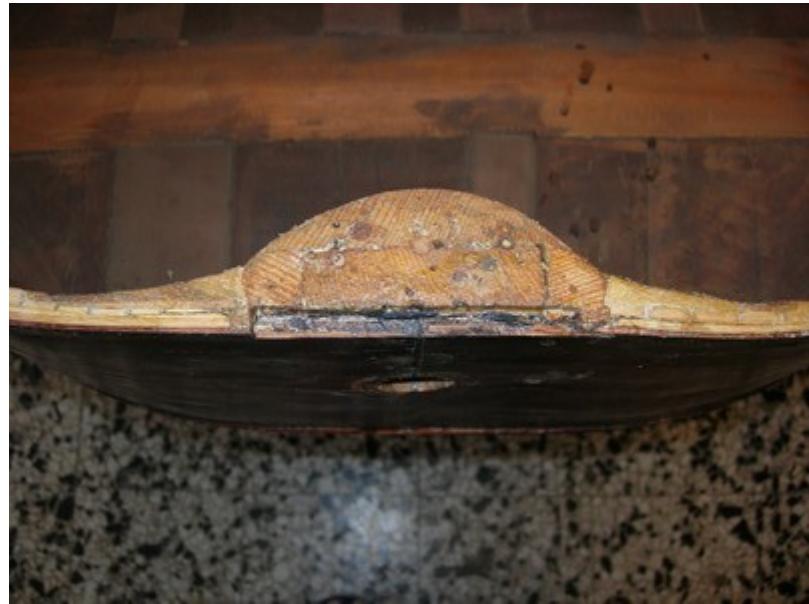
The upper rib on the E side has been repaired with three large ash doublings with transversal fiber, and some splints.

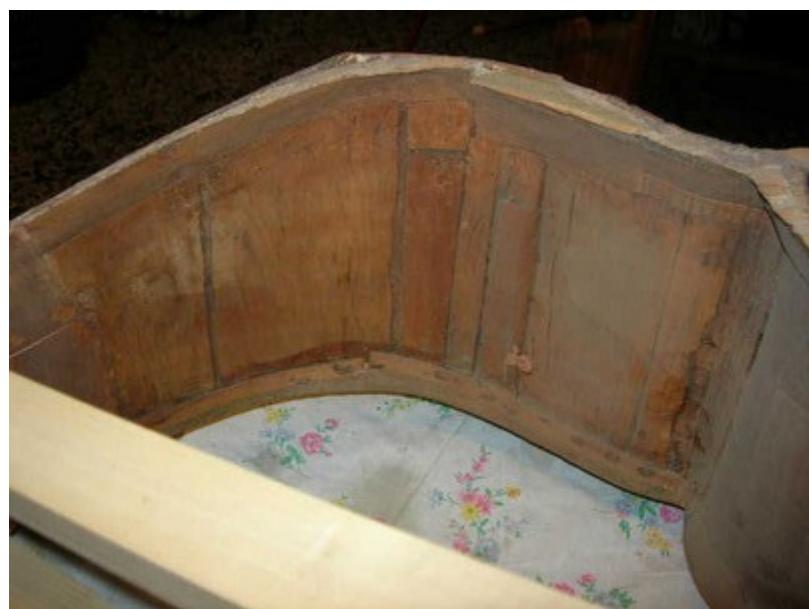
The rib shows a large number of cracks on the entire surface, and worm damages on the back side between the corner and the middle, which have been filled.

I clean the rib of all the restorations and take the linings off. I then glue a set of 1,7 millimetres thick poplar splints.

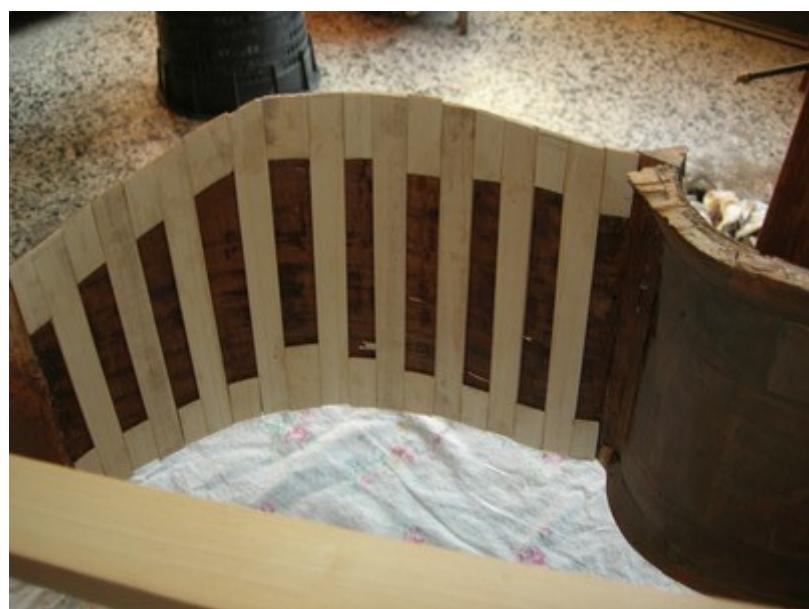
The upper rib of the G side shows many cracks as well, repaired with a large ash doubling and other small ones, with transversal fiber.

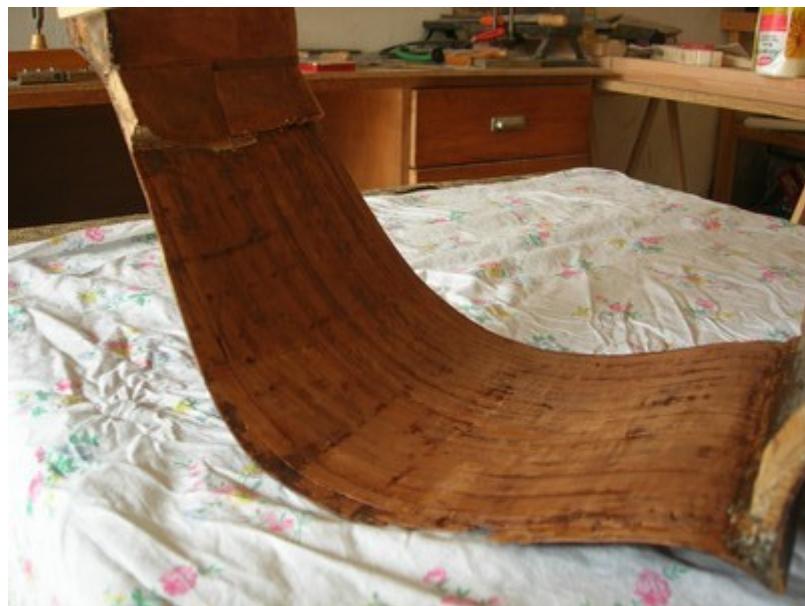
The rib is between 1,8 and 2,3 millimetres thick.

I glue a set of 1,7 millimetres thick poplar splints, with fiber running perpendicularly to the rib.

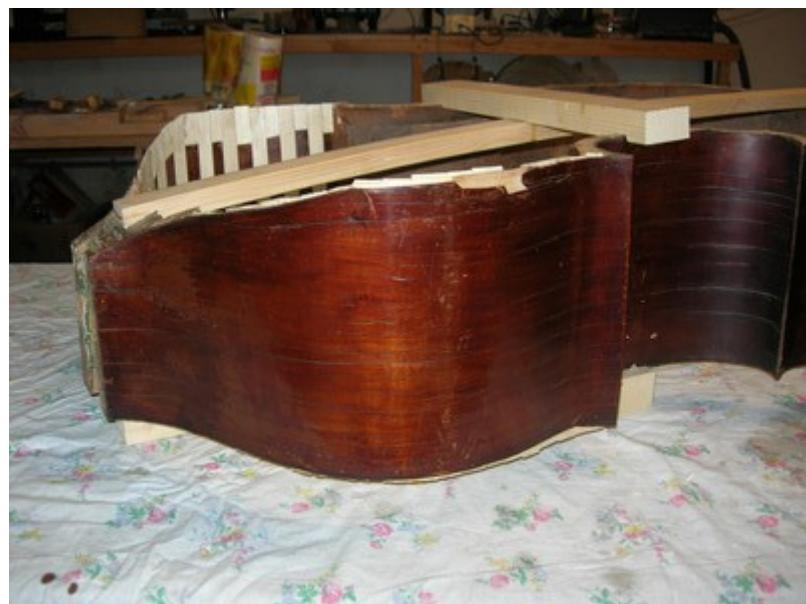
The lower rib on the E side shows cracks on the entire surface, repaired with ash doublings, that cover the whole rib towards the lower block.

There are three spruce splints as well, two of them covering the ash doubling.

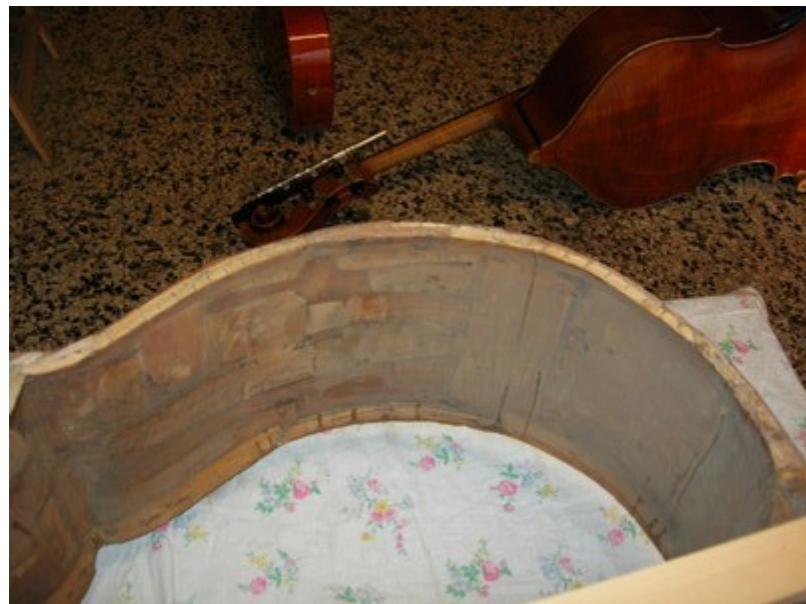
The lower corner on the back side has been replaced.

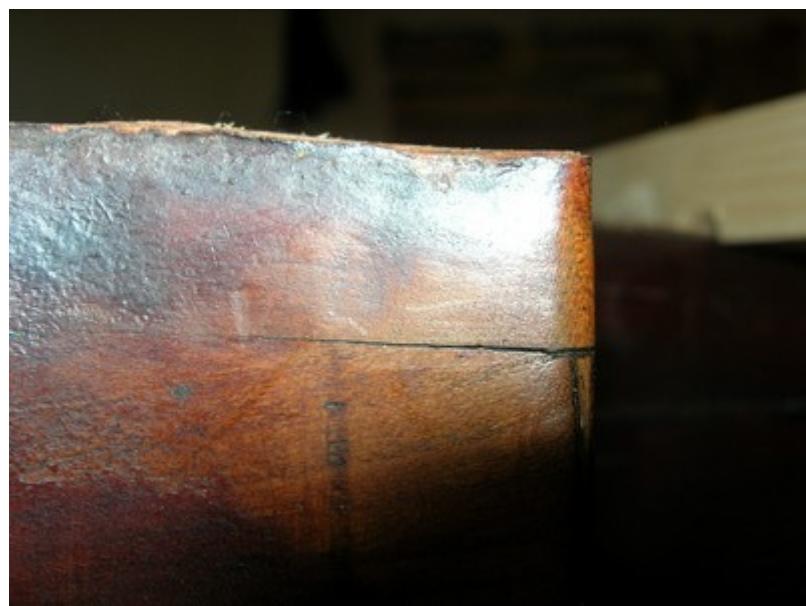
There is a small replacement in the center of the rib as well.

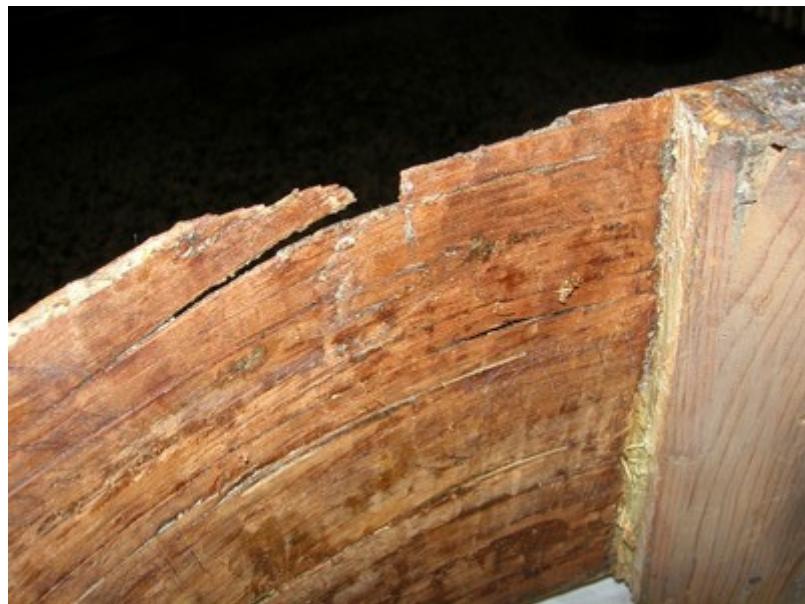
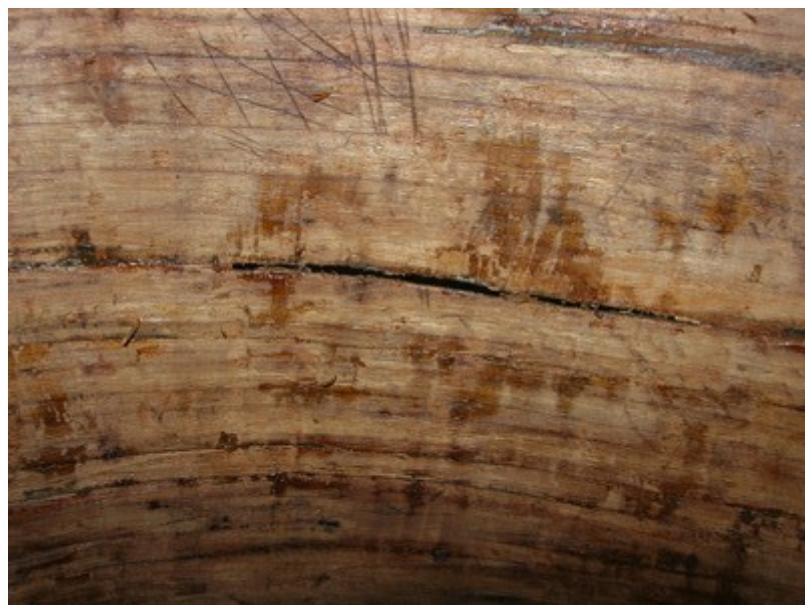
During the cleaning process two missing parts can be seen along the glueing surface on the back side, at the lower block and towards the corner.

The missing parts were filled with wood and filler.

The glueing surface between ribs and back has been lowered, probably during the replacement of the lower edge of the back.

In order to rebuild the missing section, I glue a set of poplar splints longer than the current height of the rib.

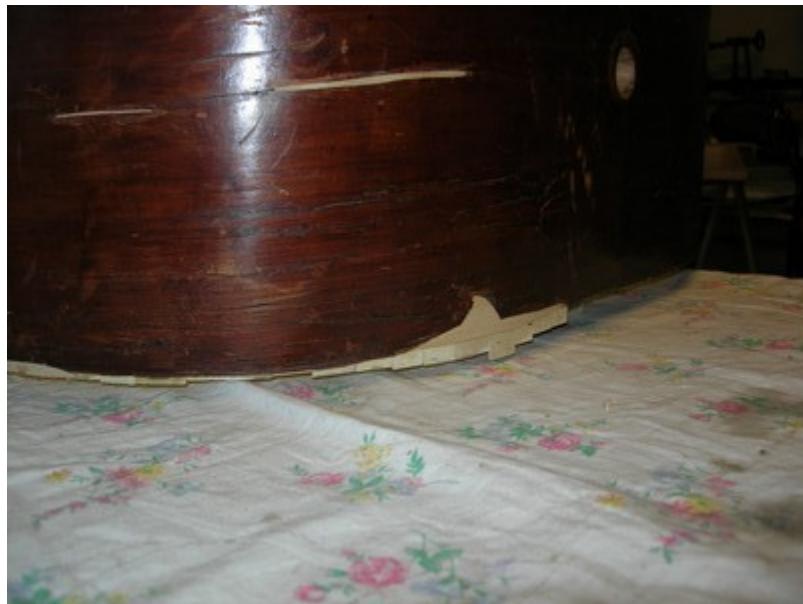
The lower rib on the G side shows many cracks, repaired with ash doublings and with three large splints of linden wood.

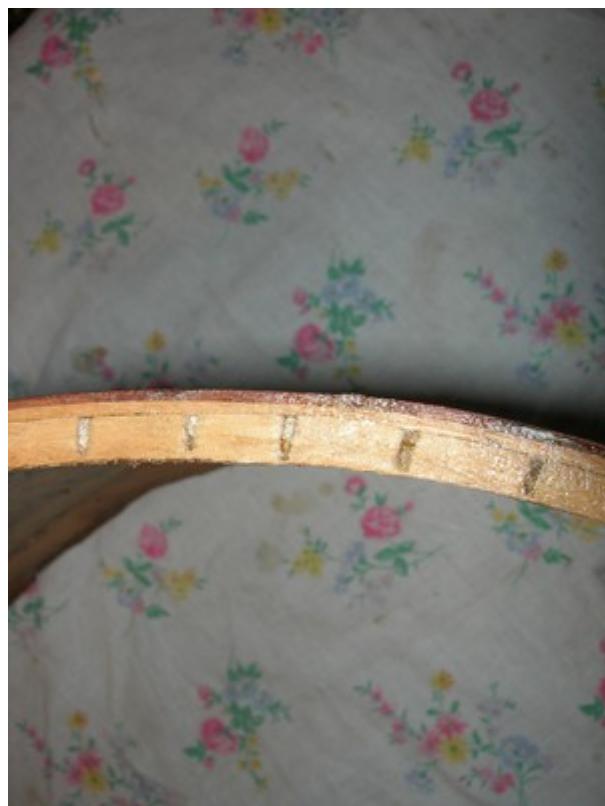
A part of the rib on the back side is missing and filled with putty.

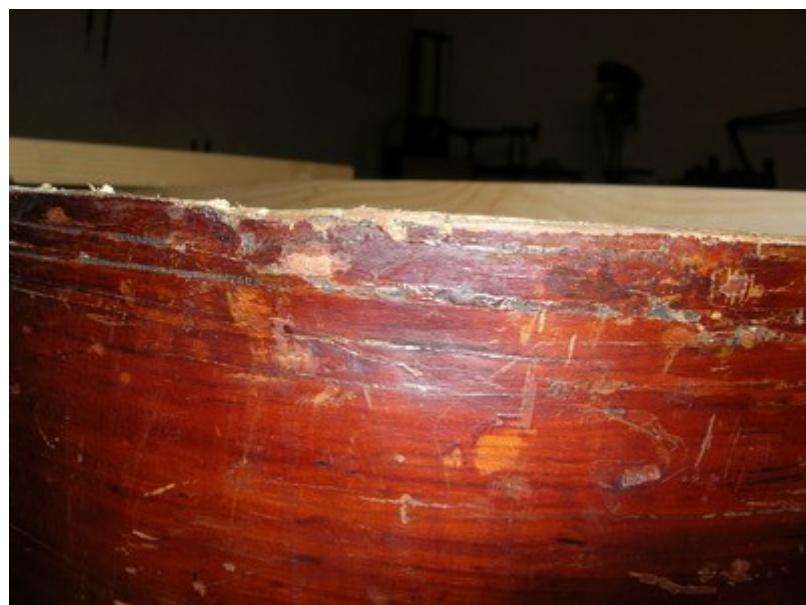
The glueing surface of the back to the ribs next to the lower block has been lowered.

Once the rib is cleaned, I make the poplar splints higher than the rib, to rebuild the missing part.

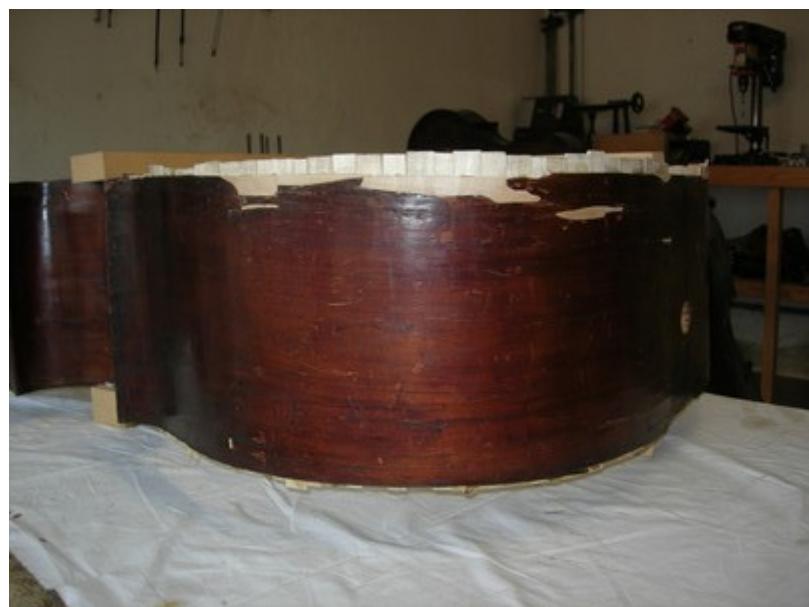
The upper block might be partially original. It is currently made of four different layers of wood, two side grafts, wedges and fillings.

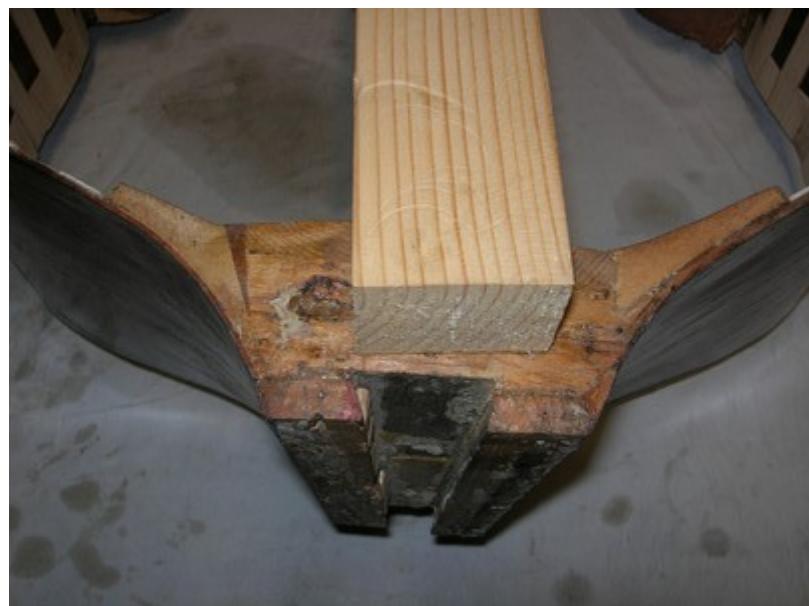
The external layer is screwed to the inner ones, and is not original. It is made of walnut, and forms the cheeks of the dovetail neck fitting.

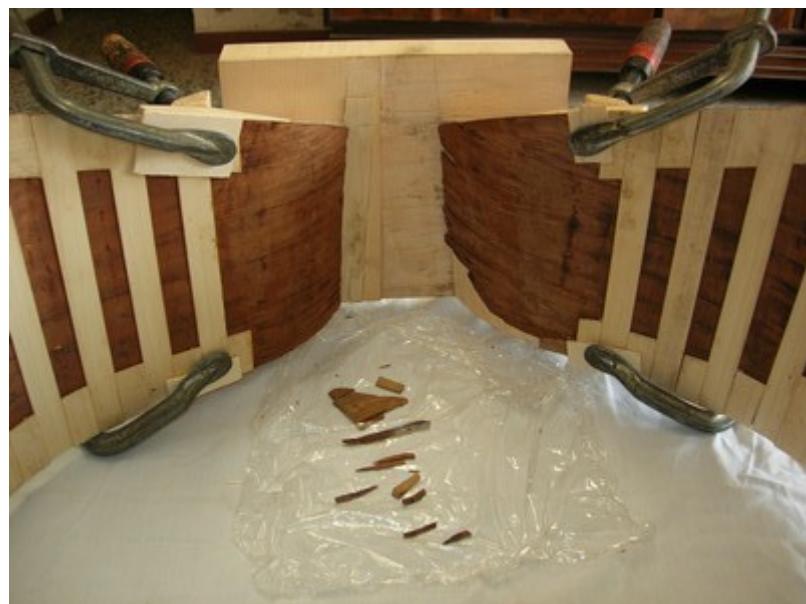
During the cleaning of the ribs, two replacements on the bass side get unglued, and some splinters break off.

The two middle layers of the block, with the fiber running perpendicularly to how it is commonly used, are glued to the ribs by the endgrain, and have three holes.

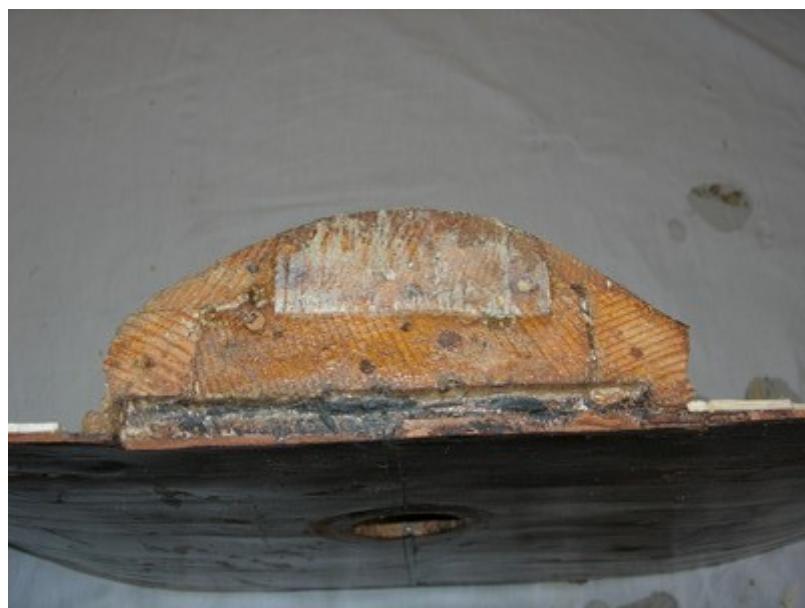
The lower block might be original as well.

It is made of four pieces of spruce, with the grain running in different directions, but all perpendicularly to the ribs

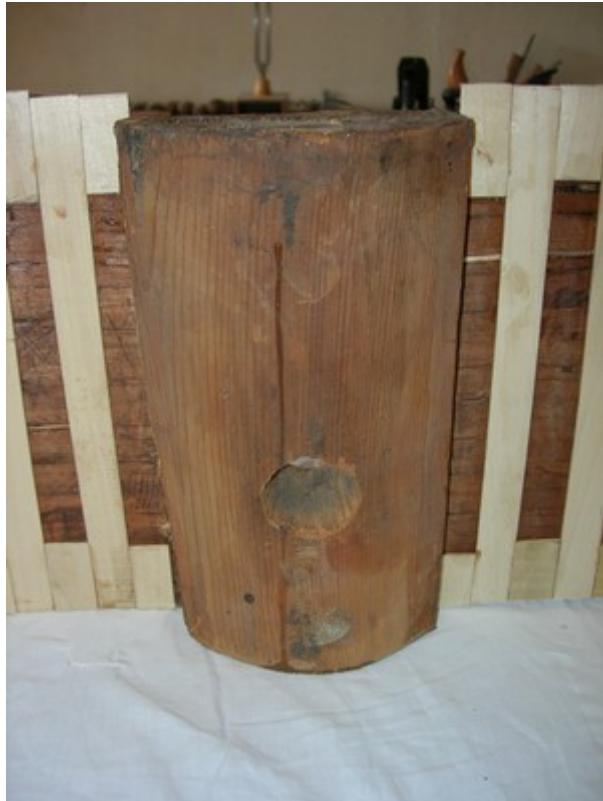
The endpin hole is off center in respect to the height of the ribs

If the hypothesis is that the instrument was played with the back edge resting on the floor, maybe with a protective "clog", it would make sense to think that an end button was used rather than an endpin, and would have been placed more towards the top, so it would not touch the floor.

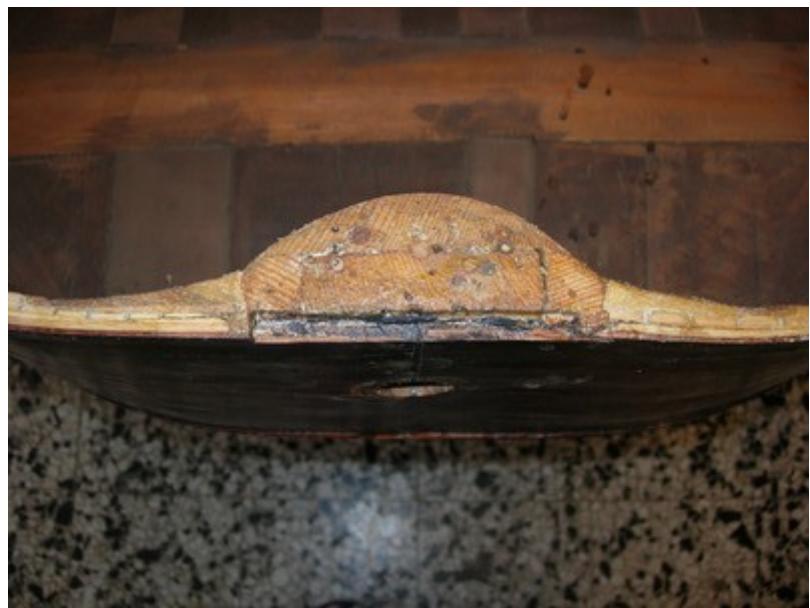
An ebony inlay at the lower ribs' joint suggest that the block has been detached and reglued , maybe to shorten the ribs

The block has been cut on the sides in order to put two lateral reinforcements in linden wood.

I decide to make a new block, for solidity, and to have one of the right height.

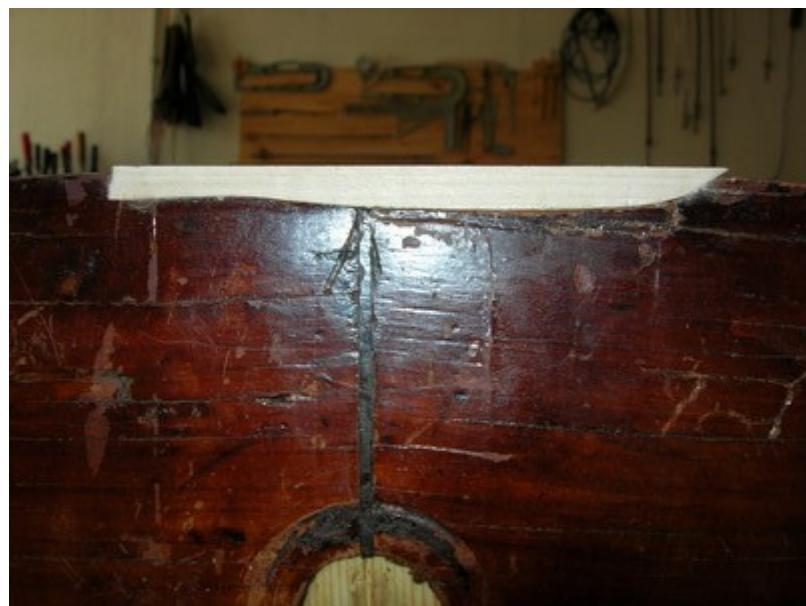
I glue the new one. The ribs are missing a part next to the top, where the saddle was partially fitted into the block.

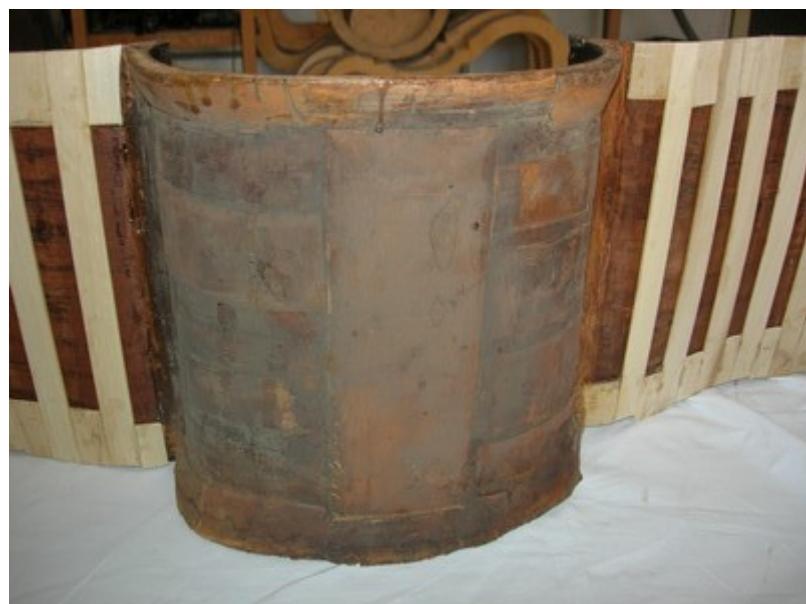
The G side C bout has been repaired with some ash doublings and a large spruce splint in the middle.

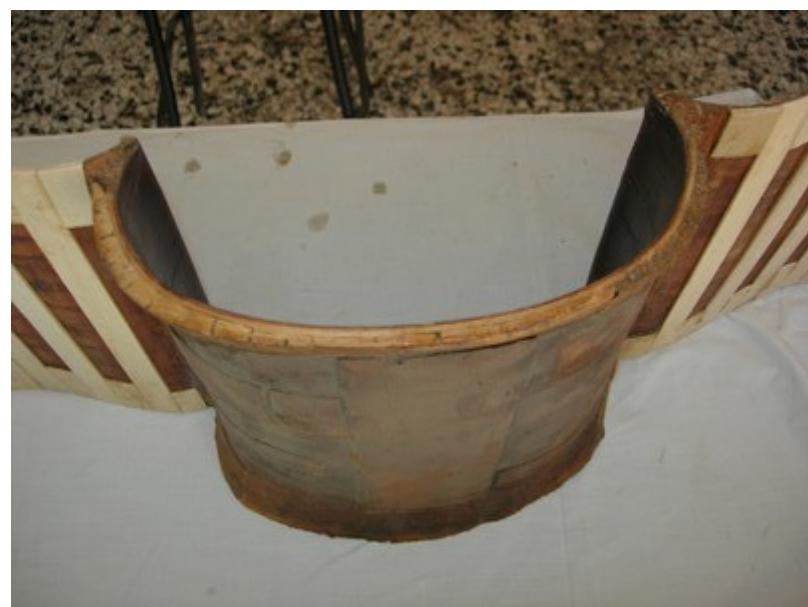
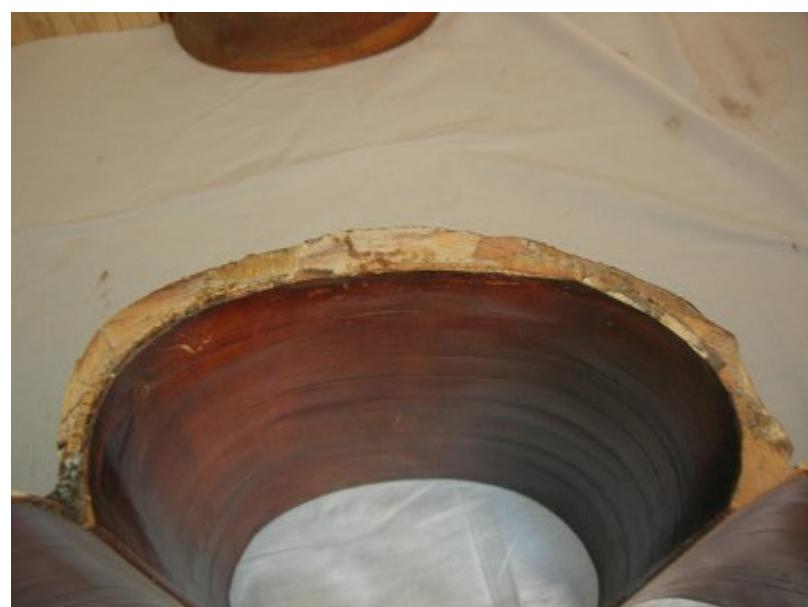
Covering two straight fiber linings, there are others in linden wood; the top one is cut and bent, the back one cut to shape.

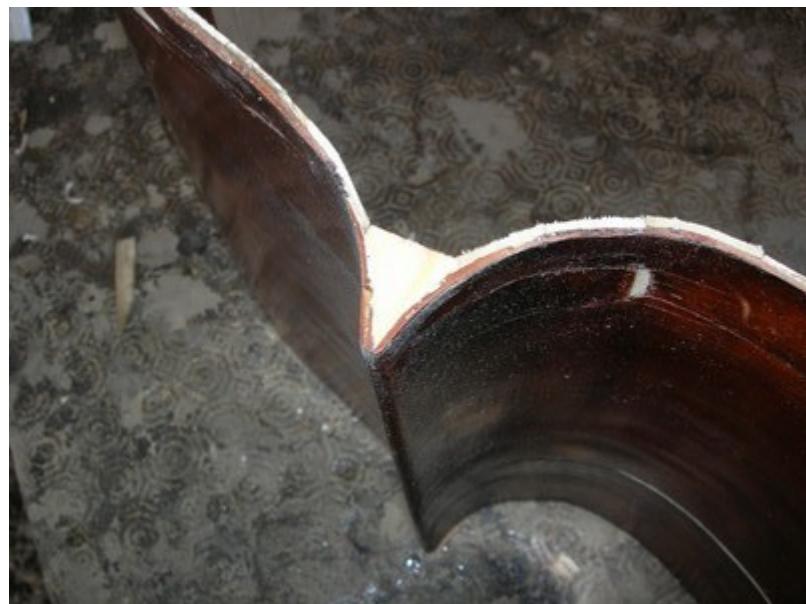
On the back side, the corner blocks are lower than the ribs.

I rebuild the missing parts and two replacements on the lower corner.

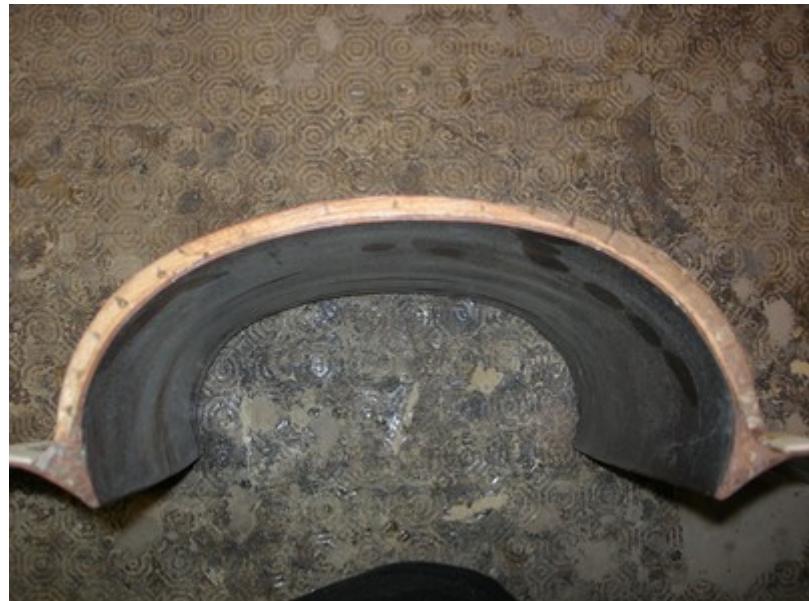
On the top side a straight fiber lining is covered by a second one, cut and bent.

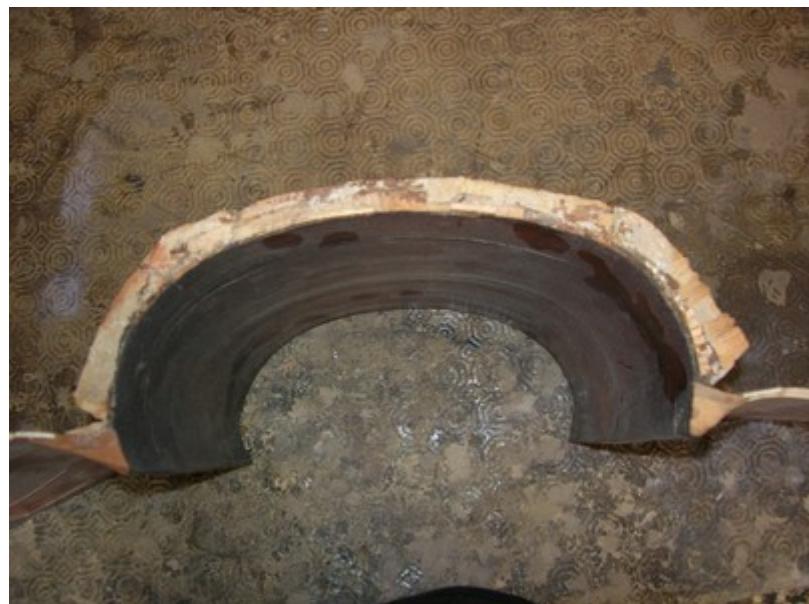
On the back side the covering one is in three pieces, cut to shape.

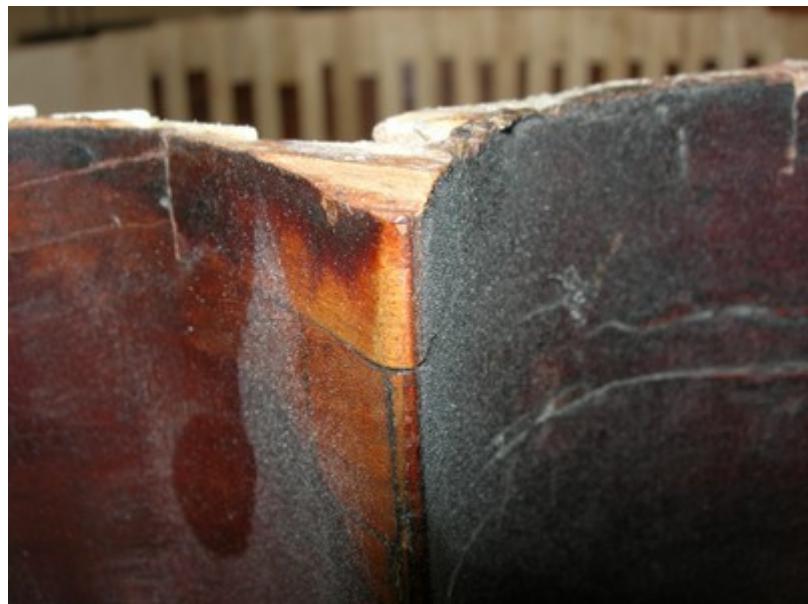
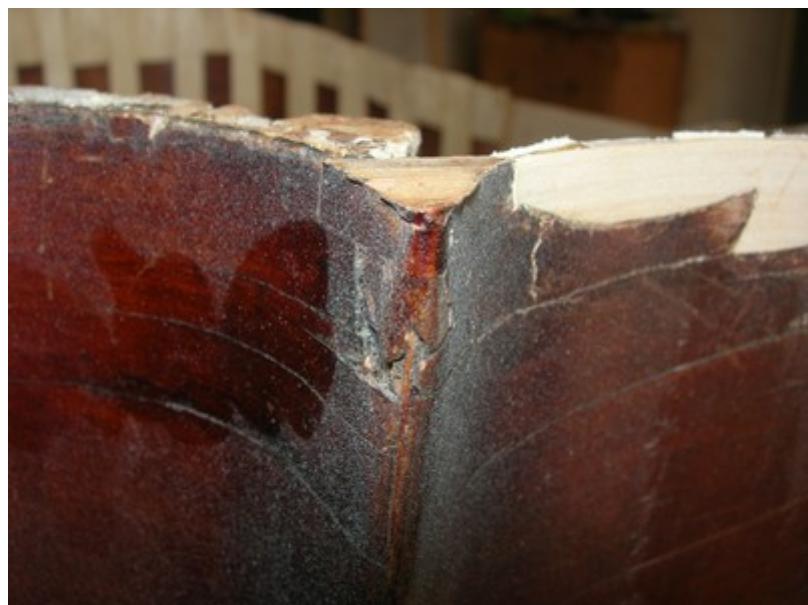
The back corners have been replaced. Here too, it is possible that the blocks were lower than the ribs.

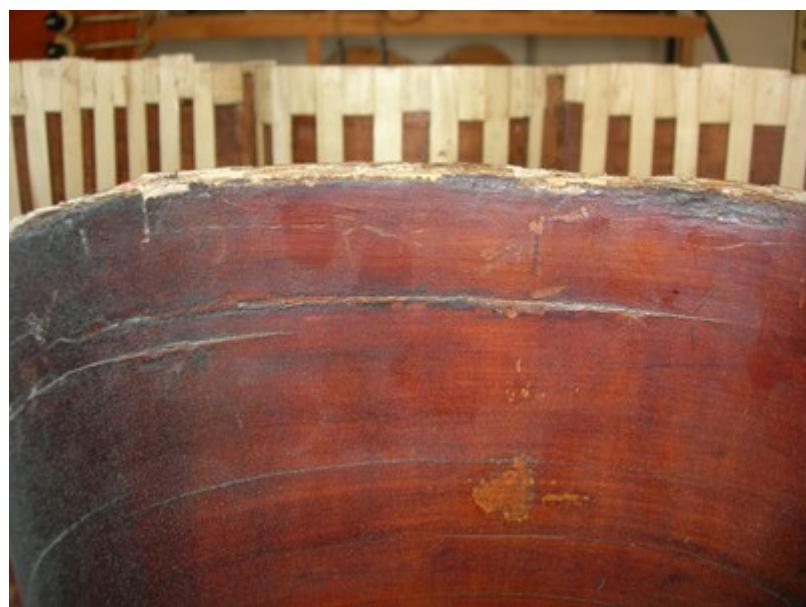
In proximity to the glueing surface on the back side, there is a rectangular replacement, and part of the edge is missing and filled.

At about 35 millimetres from the edge there is a reconstruction meant to fill a crack.
