Giuseppe Cazzaniga, Liutaio

Bernareggio, July 2009 - June 2012

Restoration of a Brescian style double bass

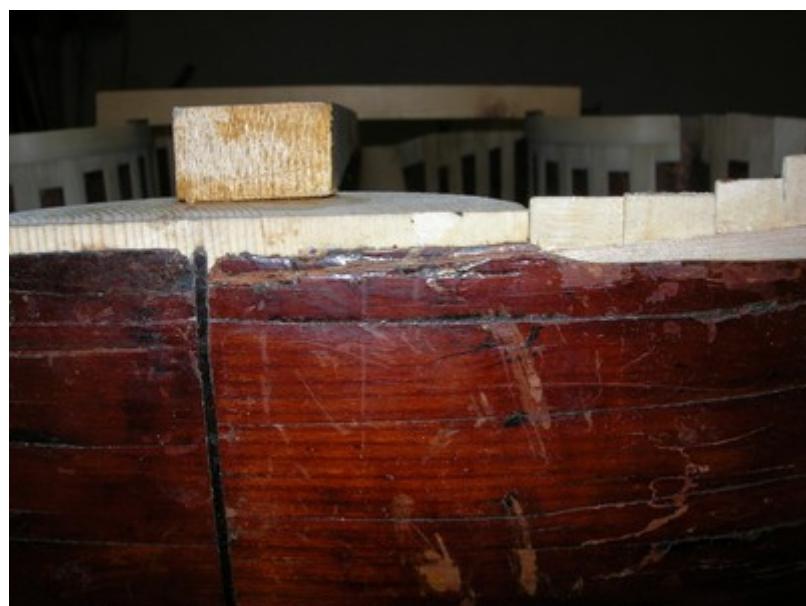
The ribs have been lowered next to the lower block on the back side as well.

In this area I kept the lower block, splints and doublings higher.

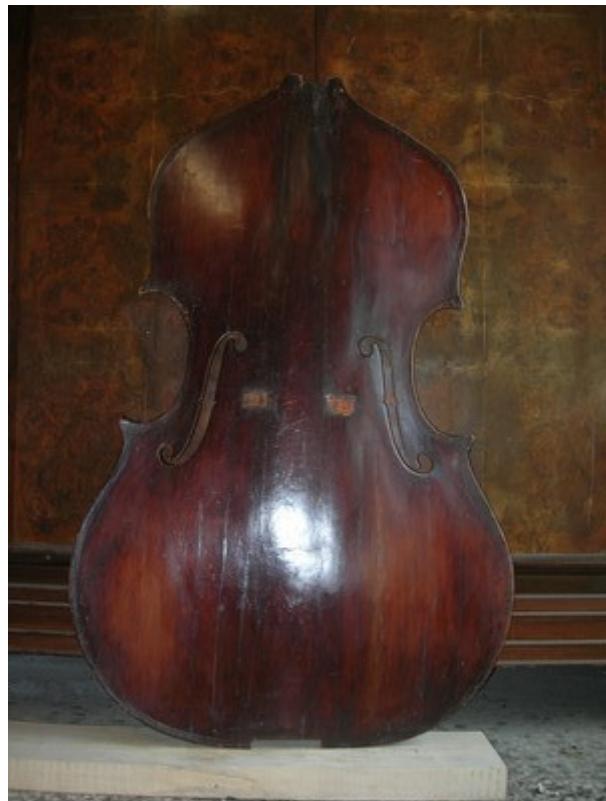
The whole surface on the front is heavily cracked,

It is also very deformed, presenting an extensive weakening of the bass side, a swelling of the lower treble side, cuppings under the bridge's feet, in particular under the G foot

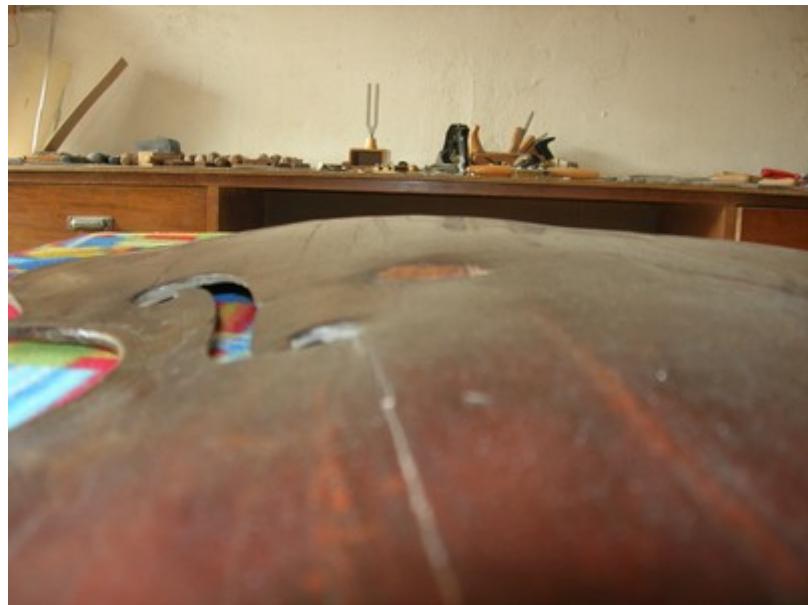
Edge works and purfling replacements are evident both on the lower and upper block's sides.

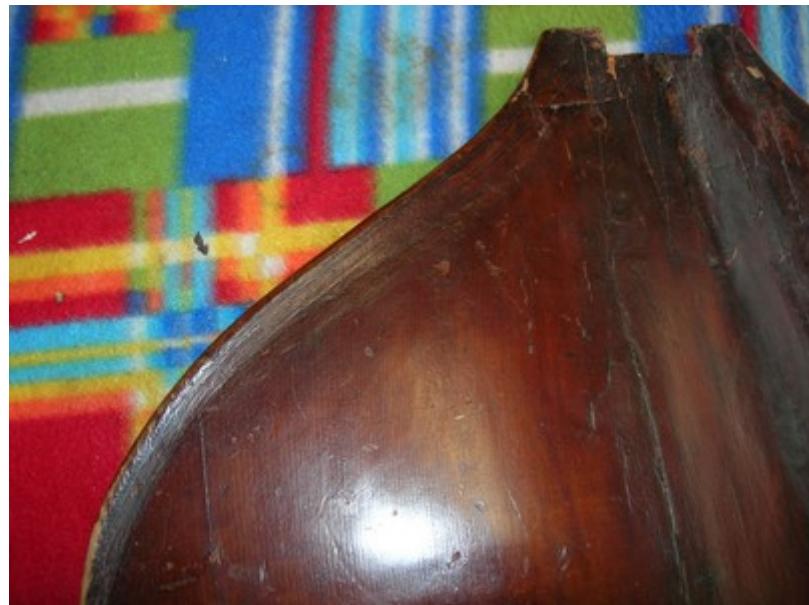
I have doubts on the lower part of the C bouts as well. I will have a clearer view after I clean the varnish and remove the edge doubling from the inside.

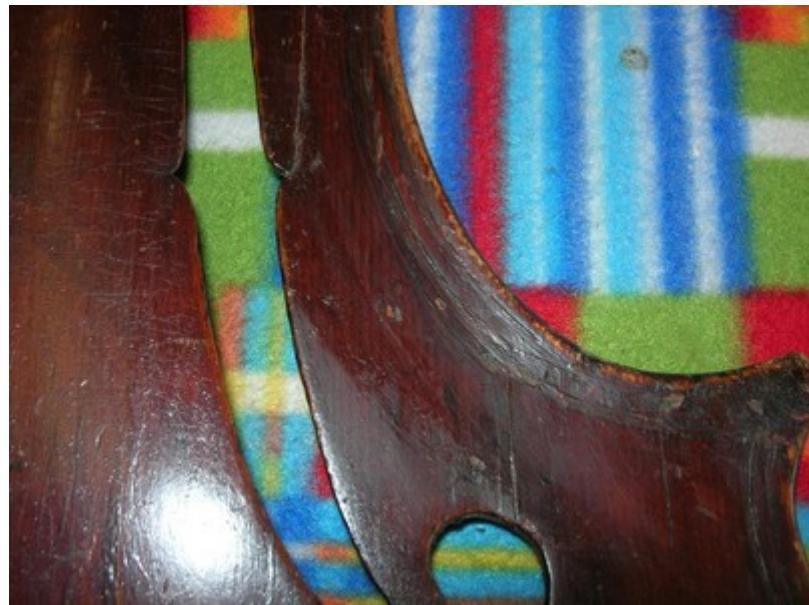
The varnish is dirty, with red brown retouchings and fillings, specially near the bass bar, where there are evident woodworm damages.

There are no open worm holes though.

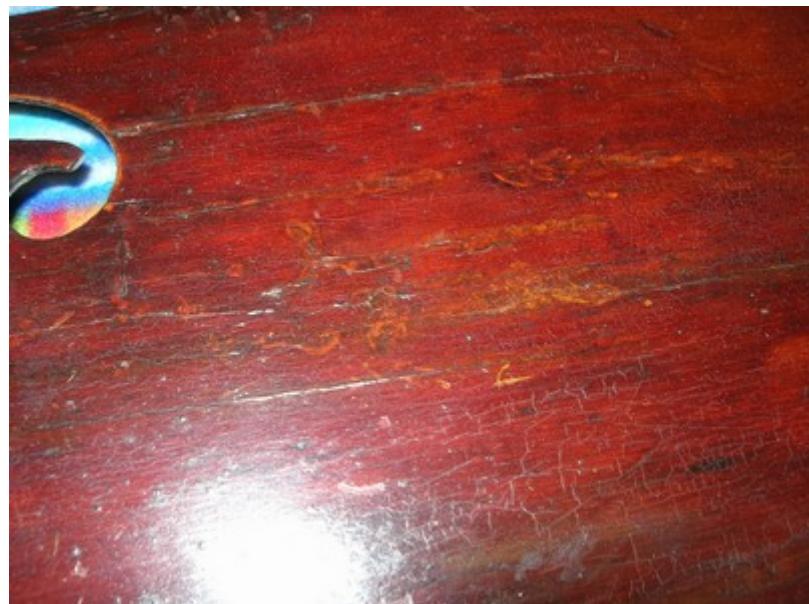
From an inside view, there are repairs by at least three different hands

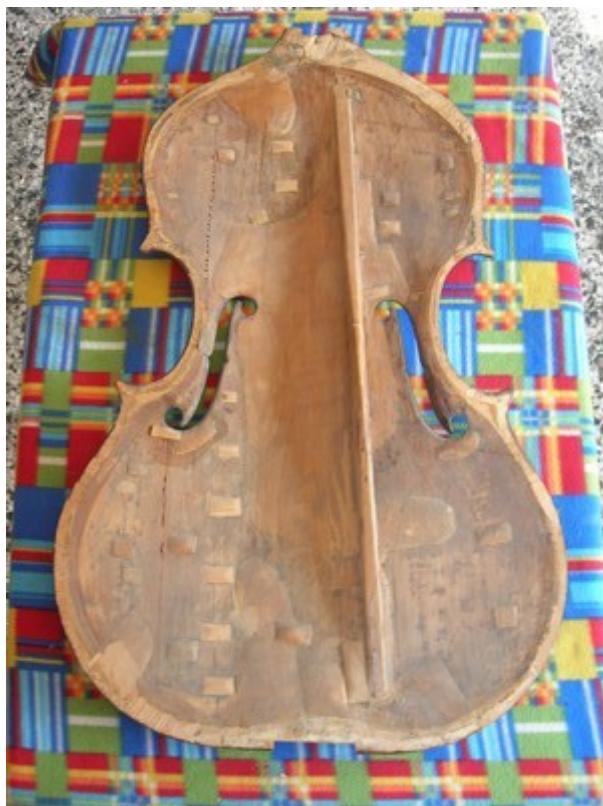
The entire edge has a spruce doubling, which has been glued with the fiber running perpendicularly to it.

At the lower edge, this doubling is glued over another (previous?) one.

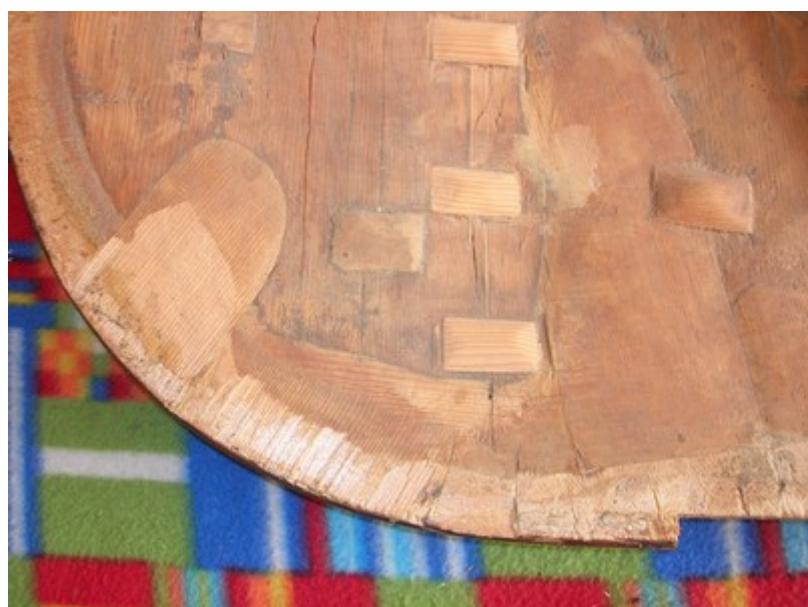
In some areas, upper and lower bouts on the treble side, lower bout on the bass side, at the lower block, the doubling extends inside the top.

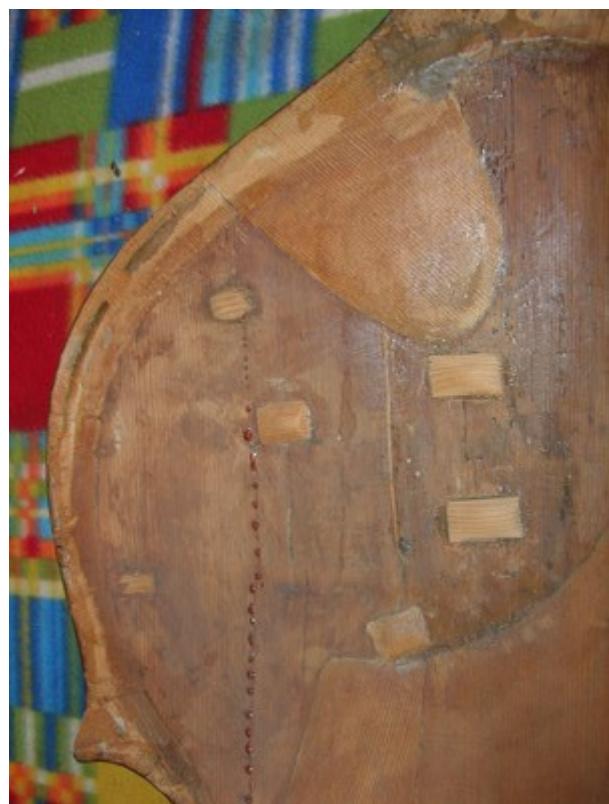
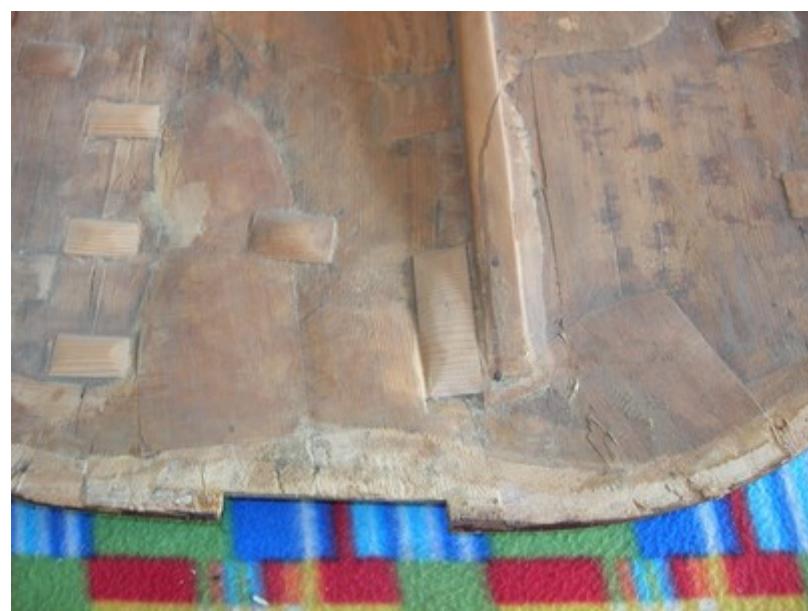
The bass bar, which is very long, conical, well shaped, is glued to a large doubling in the middle part of the top, and to reinforcements with perpendicular fiber at the edges. (the grain of the central doubling which is made of multiple pieces, goes in various directions).

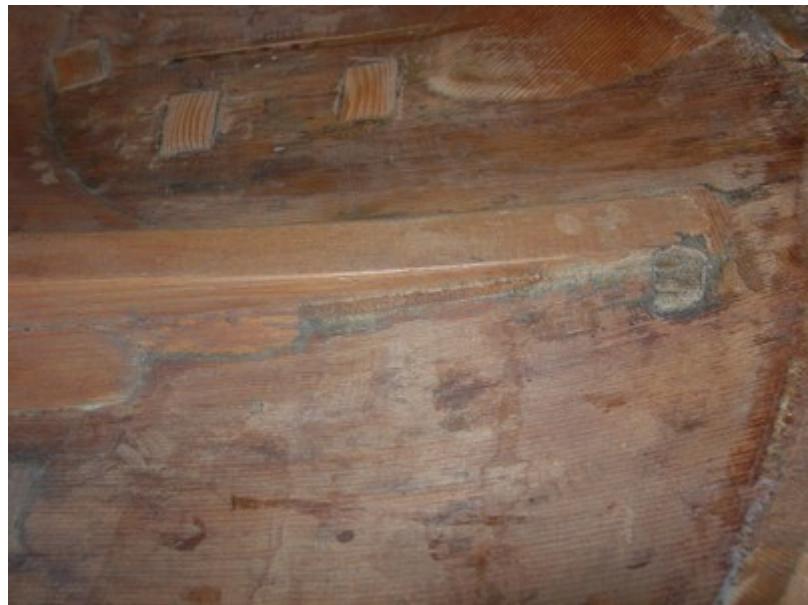
The thickness of the non doubled parts, without considering irregularities, shows a thick area near the edge, ranging from 4,5 to 6 millimetres, up to 7,5 in the C bouts area, and a relatively thick area at the edges of the bass bar, between 6 and 7 millimetres, while thin areas can be found between the bass bar and the edges, till a minimum of 2,8 millimetres.

The edge of the f holes has been bevelled from the inside, so that from the outside it shows a thickness more or less regular and of an average of about 4 millimetres.

In order to have proper sustaining during the removal of the doublings, and to correct the deformations, I need to make a mould of the front.

To do so, I plane down the bass bar, which I will replace, to lay the top on a flat surface.

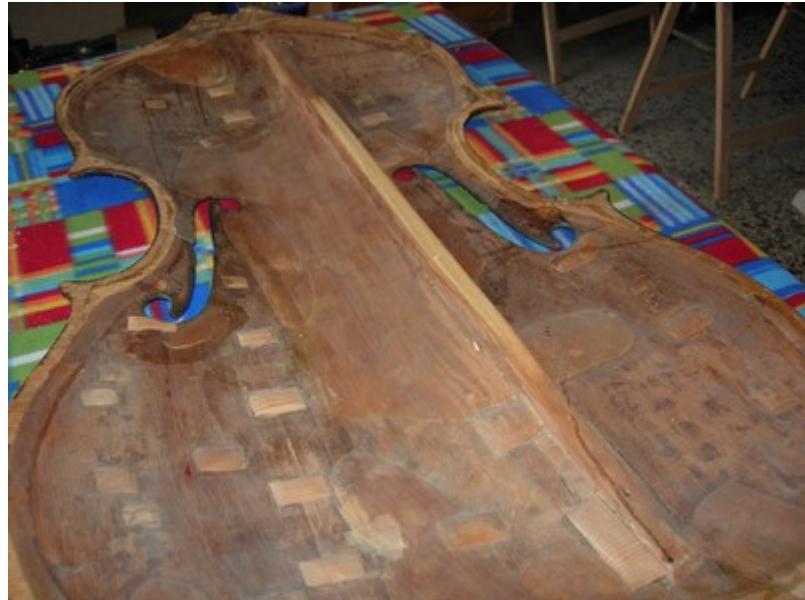
I notice, with no surprise considering the ribs, that the edge of the top is not flat but curves lengthwise, with the C bouts being the highest point.

Doublings, replacements and deformations might have been a cause for it, but is more likely that the curve was given to the ribs by planing them to follow an original curve of the top's carving.

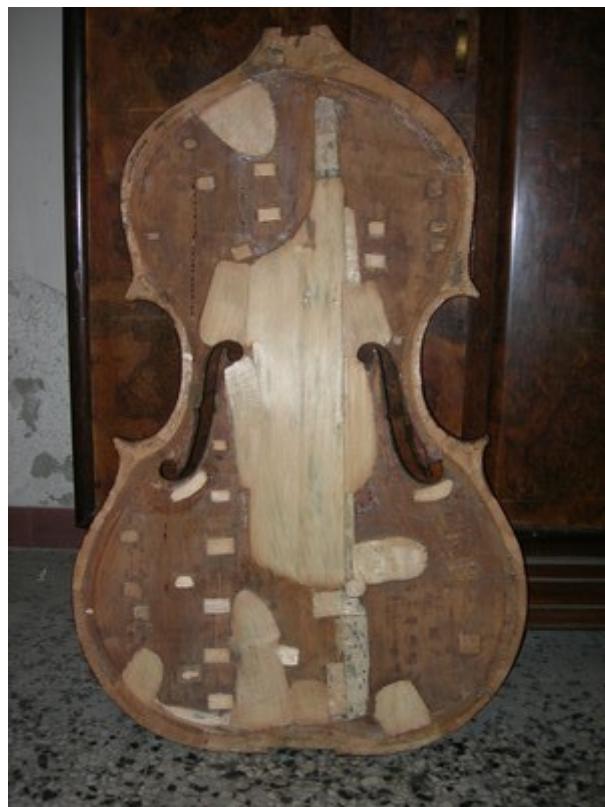
While doing this, I notice that the edge doublings and their extensions toward the inside are older than the ones in the middle of the front, where the wood used seems less oxidized.

There is a second doubling in the lower center of the top, older than the one covering it.

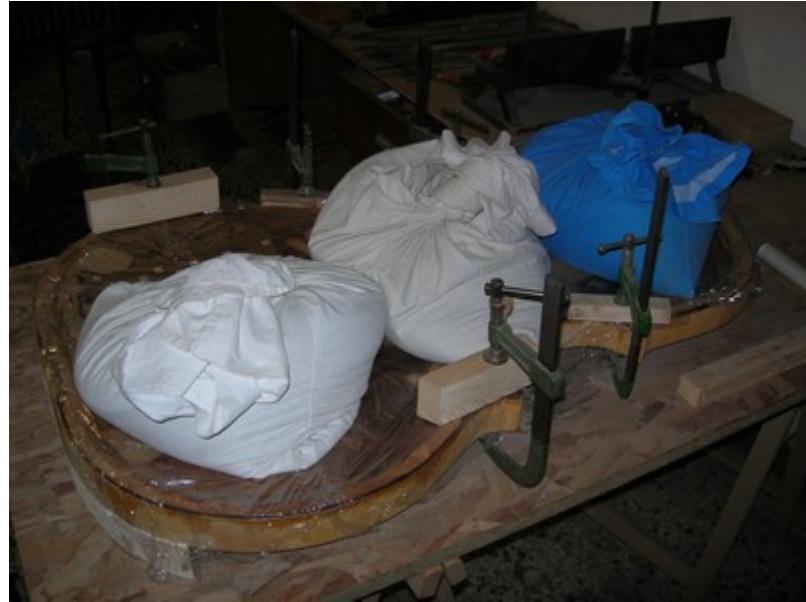
The top takes an acceptable shape in about two months. The area under the bridge's treble foot remains slightly cupped, and it will need more time to get in shape before the making of the central doubling.

Then I press the top against the modified mould, moisturizing it and using sand bags as weights, while clamping the edges down when they rise up.

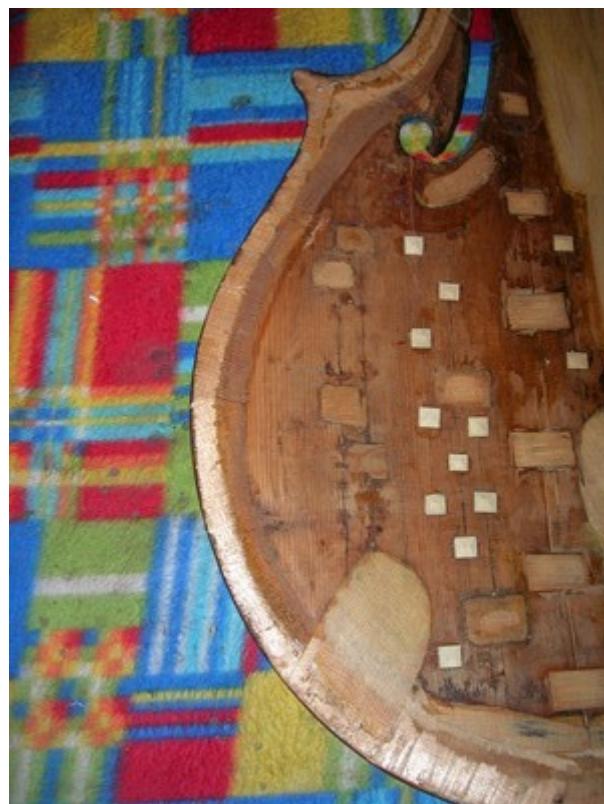
By doing so, I can see that the edge had been replaced in the lower part, at the widest part of the bout and at the corner, where I see a wooden pin.

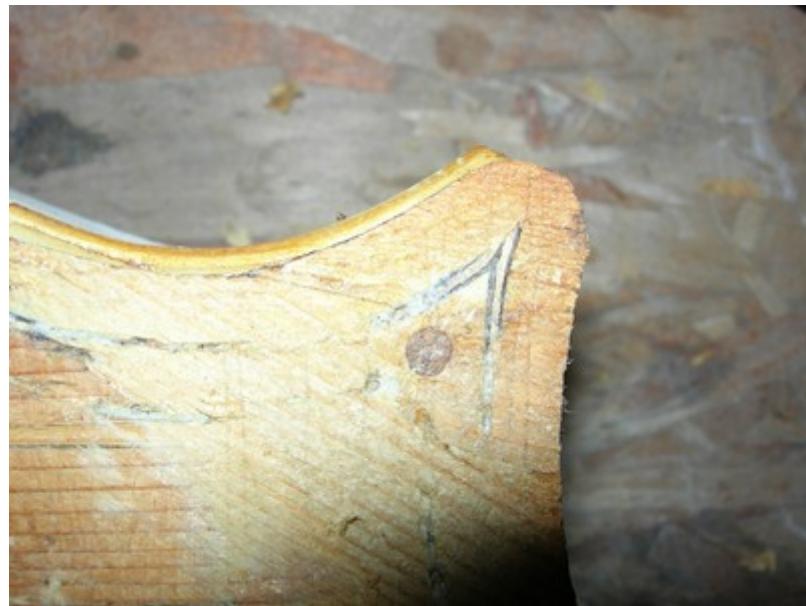
The outer purfling has been partially replaced or reglued with white glue.

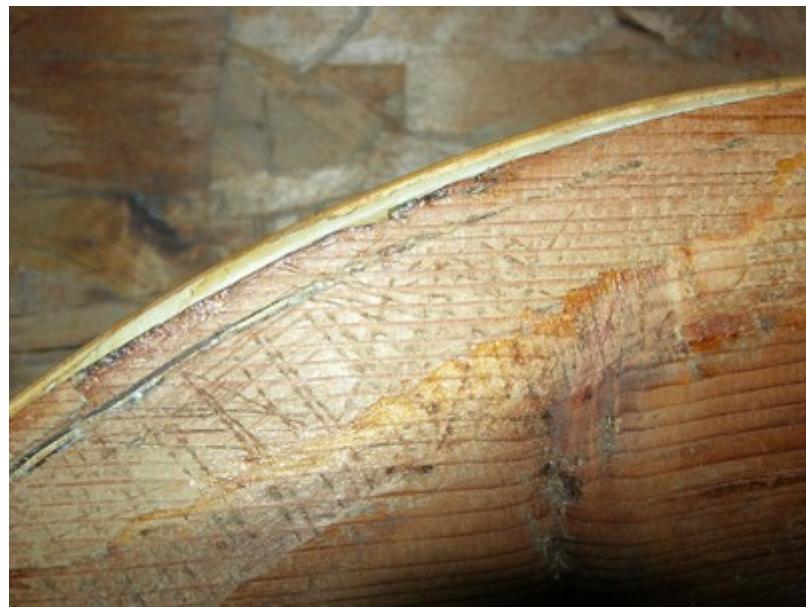
The doubling's extension towards the inside, in the lower part, has been inserted in the plate with a straight joint.

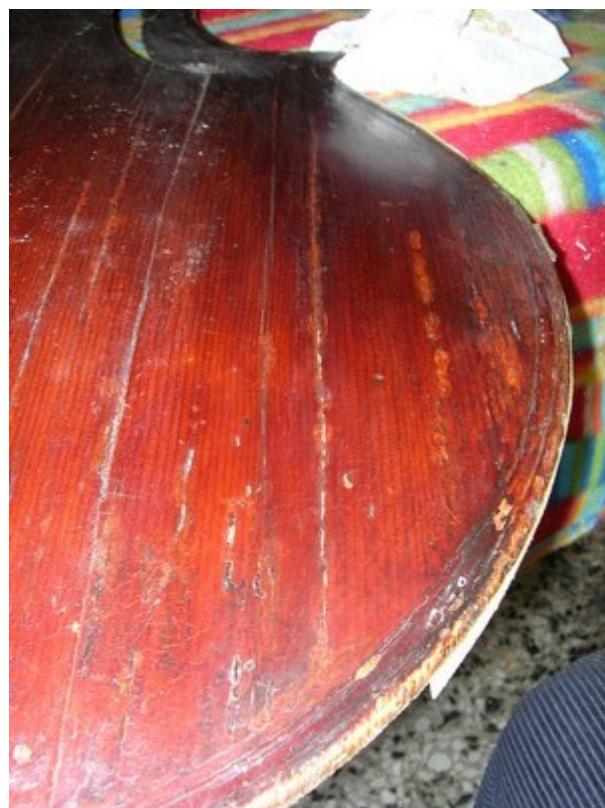
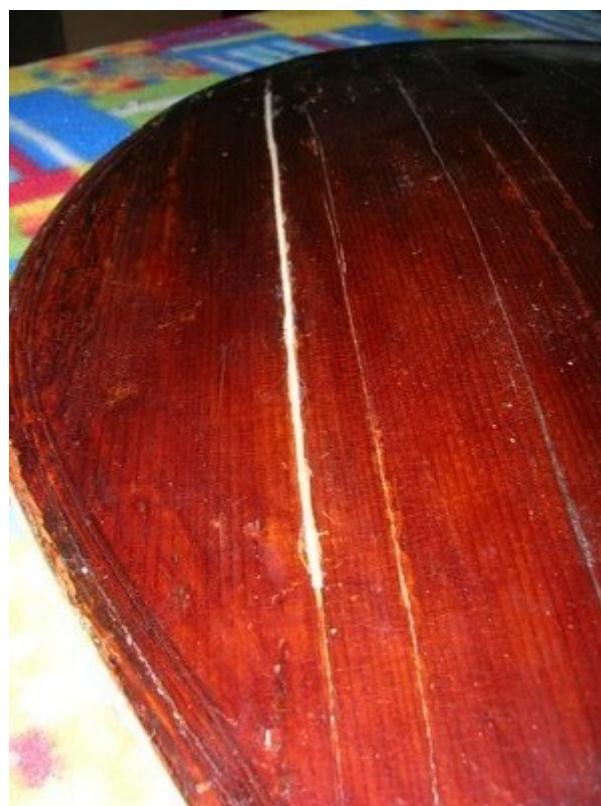
The following crack was glued with non aligned sides.

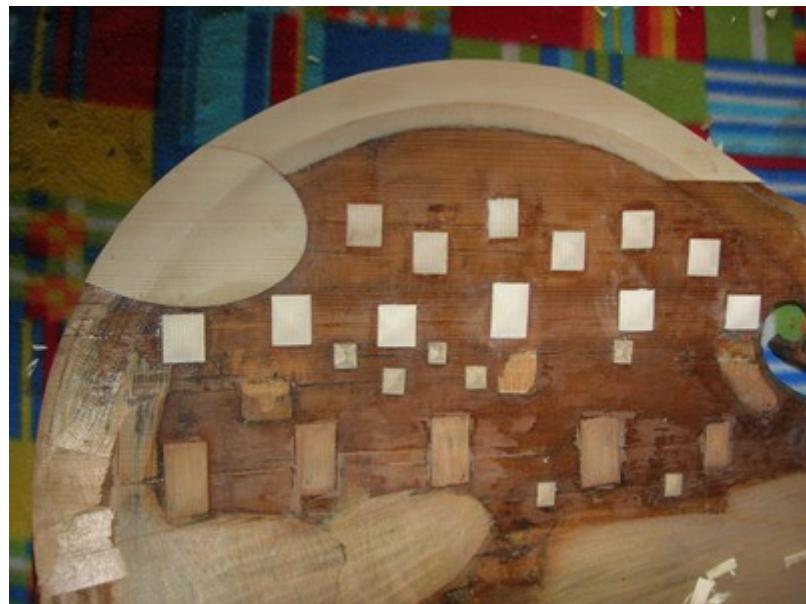
I proceed in the same manner with the following two cracks
The inner one has been repaired with stiches, of which holes still remain.
The outer one has two well made shims.

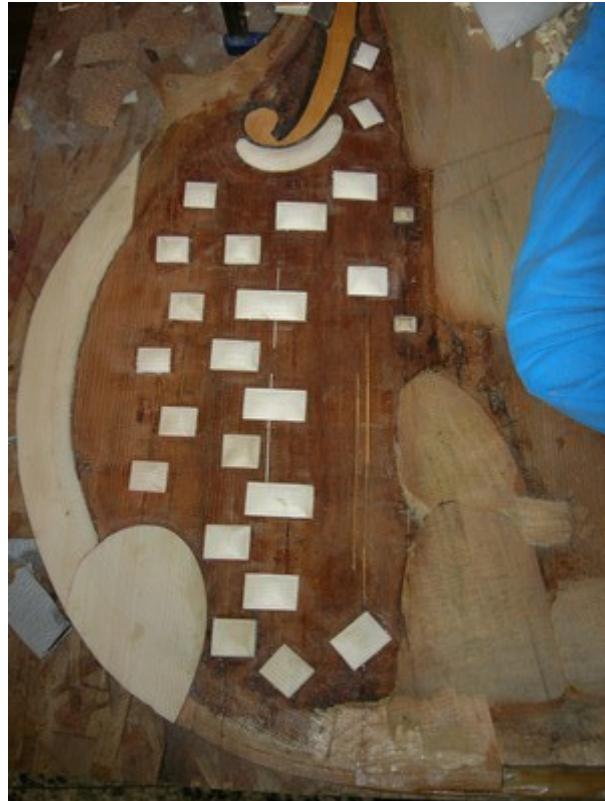
The lower part presents a thickness decreasing, where the cracks have been poorly closed and the top leveled from the outside.

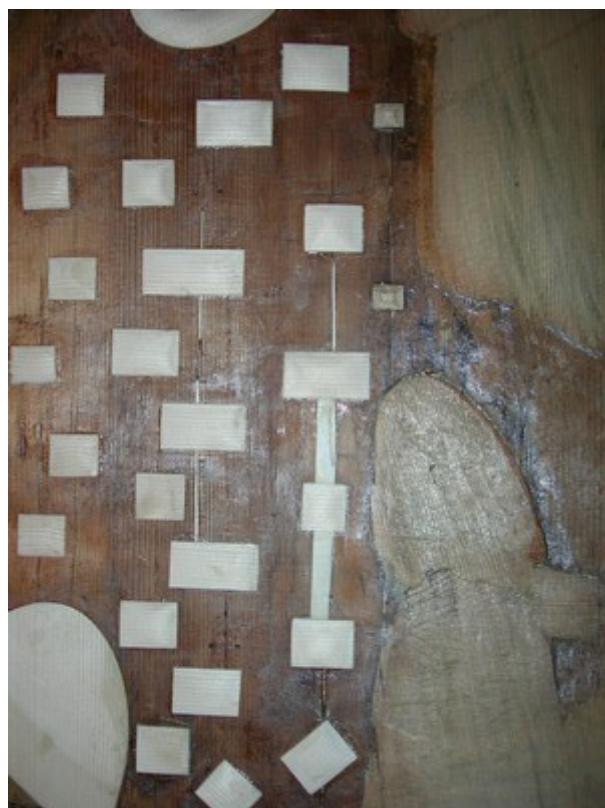
I remove the doubling from the lower block's glueing surface, and part of the surrounding reinforcements placed on a large reconstruction of the lower center part of the top, which is also cracked.

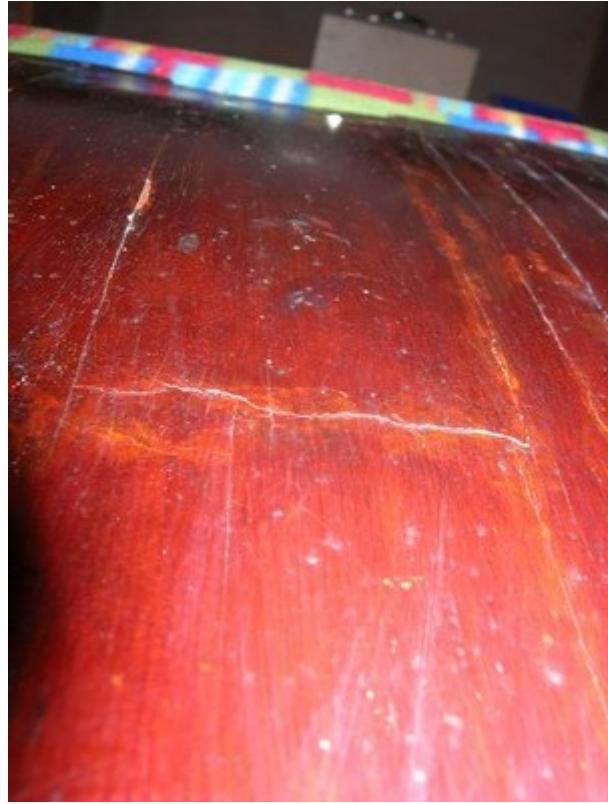
I notice that an old doubling covers the large reconstruction, made before the edge doubling and the lateral reinforcements.

Both doubling and reconstruction show a crack repaired with a walnut shim.

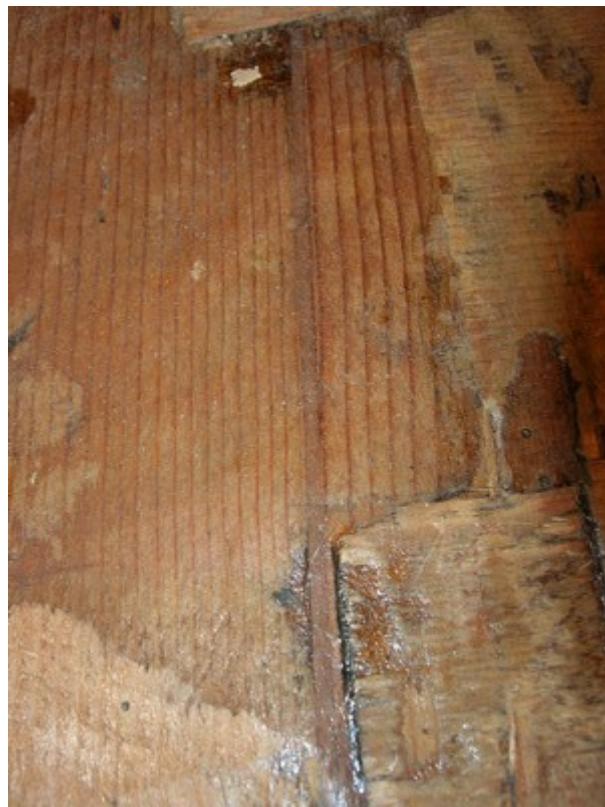
The thickness of the external reconstruction is of about 2 millimetres. The old doubling covering it brings this area to 4,2 millimetres.

The glueing area under the bass bar has been lowered to 4,5 millimetres, and then reinforced with doublings with perpendicular fiber.

The extension of the edge doubling between the bass bar and the lower bout was partially inserted in the top, where it drops to 3,2 millimetres.

This requires a large doubling at the lower part of the top.

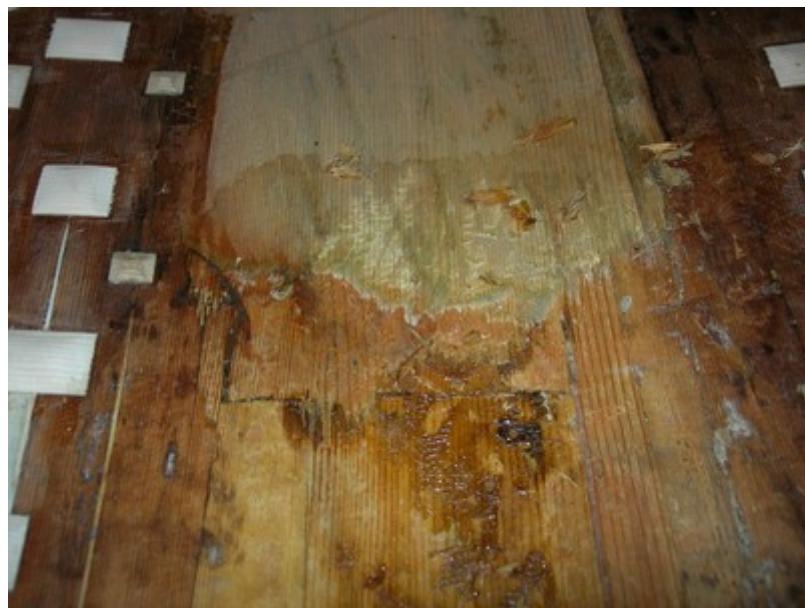
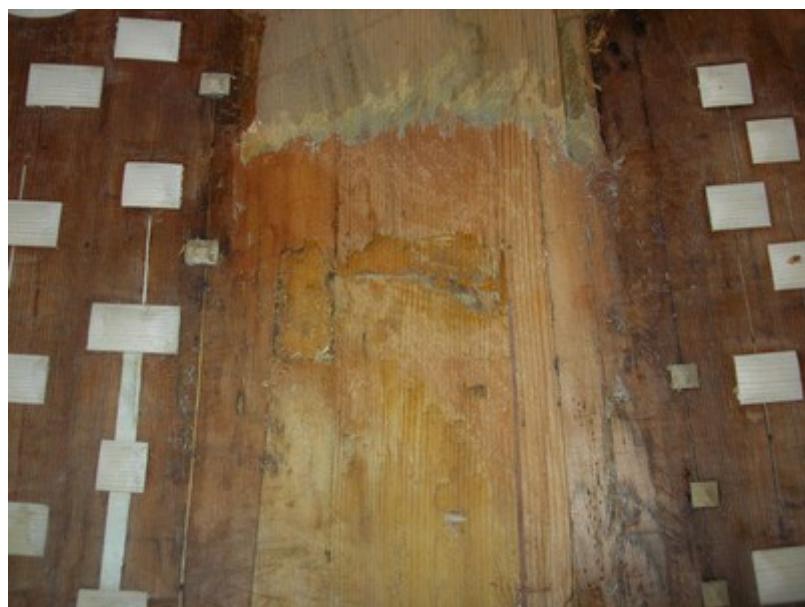
So I can see that the top is in three pieces.

the central reconstruction is connected to the central piece with a slanted joint, while on the sides there is a walnut shim and a larger spruce reconstruction.

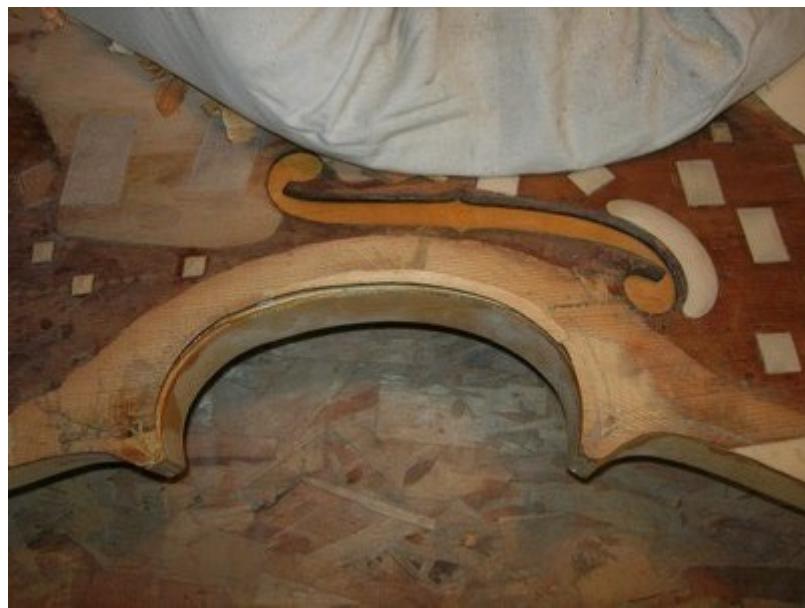
It is possible to see an edge replacement of the treble C bout, maybe made because of the bowing action. The corners have centering pins.

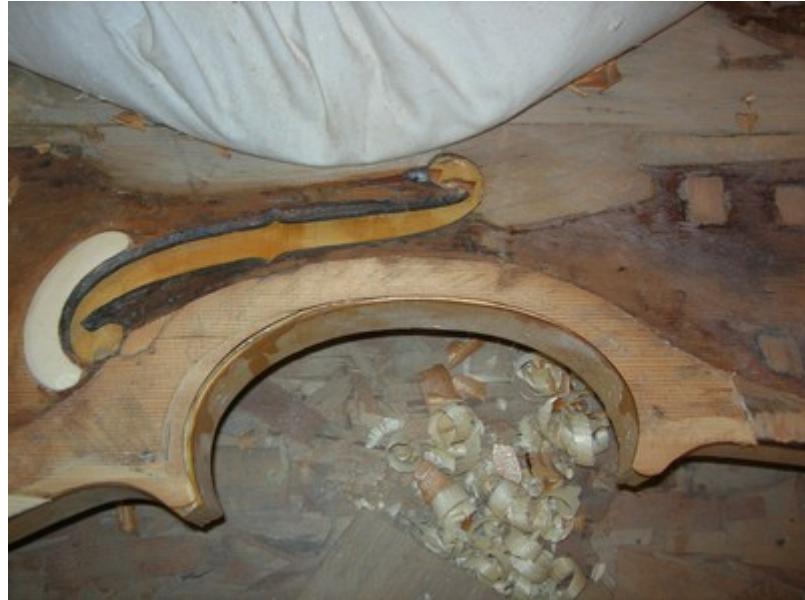
The bass C bout has both corners reconstructed.

Here as well are centering pins.

I remake part of the edge doubling, with slightly sloped fiber.

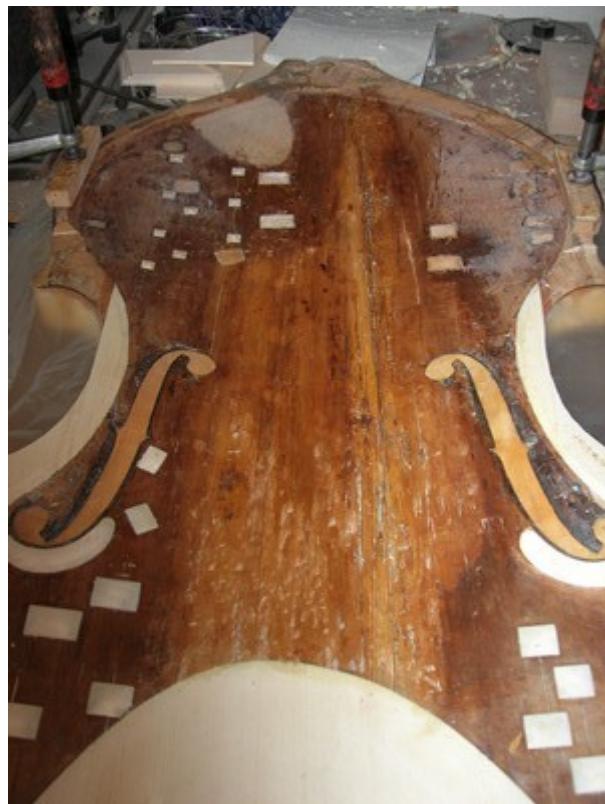
The remaining thickness of original wood varies between 3,4 and 1,7 millimetres, and is particularly thin on the bass side in proximity to the upper part of the bass bar and on the treble side on the upper part of the f hole.

In order to avoid thinning the plate too much, I make partial doublings to level irregularities.

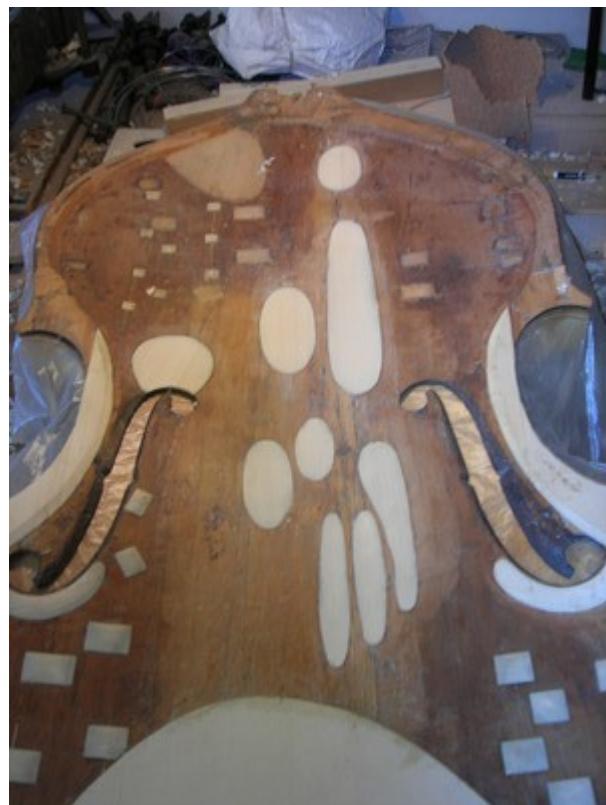
The joint on the bass side has been partially filled with a shim and filler.
I clean, and remake the shim.

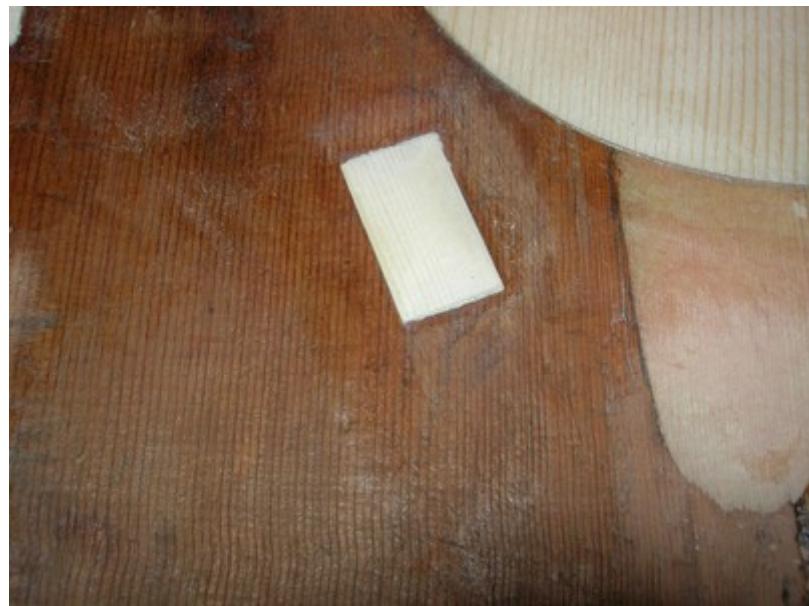
I place a temporary cleat to block the two cracks, properly closed, next to the center doubling, in an area that has been thinned to 2,5 millimetres, that will need a doubling.

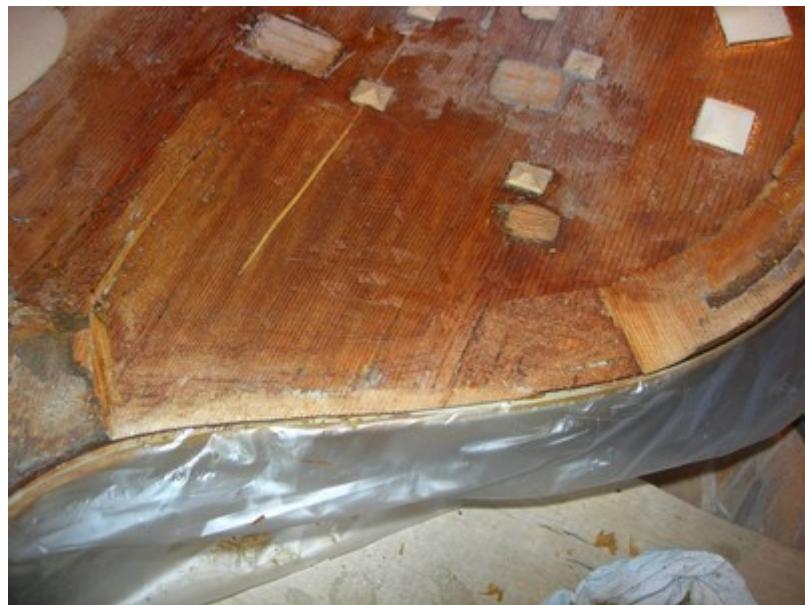
This way the replacement of the top edge made to widen it can be clearly seen.

The extension of the edge doubling towards the inner part of the top was inserted in the wood, and the top is here thinned to 2,7 millimetres.

There are two well done shims as well.

I remove the cleats, open, clean and repair the next crack, reinforcing it with new cleats.

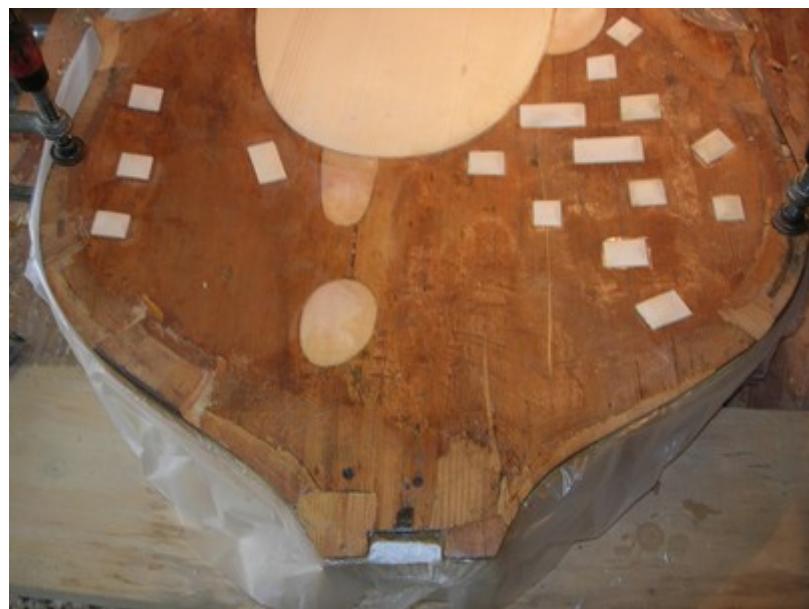
Now it is possible to see the edge reconstruction and four centering pins in the upper part of the top.

I make the upper doubling, that will repair:
the thinned area on the treble side, where the edge doubling would extend towards the inside;
the thinned area on the bass side, flanking the bass bar, where two cracks are temporarily hold together with a cleat;
the thinned area on which the tip of the bass bar was glued, reinforced with a transverse fiber doubling.

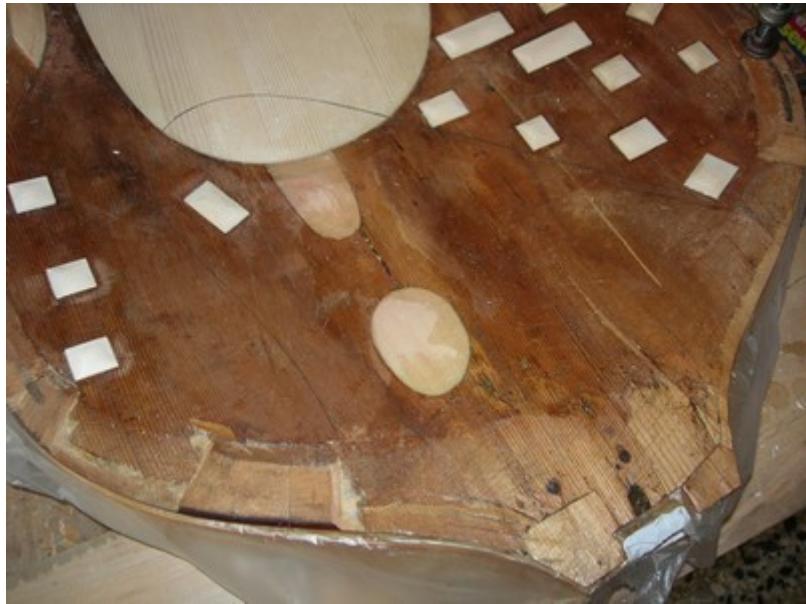
Between the tip of the bass bar and the edge doubling there is an area, 7 millimetres thick, that is maybe original. Unfortunately I will have to thin it to glue the upper new doubling. This area is cracked anyway.

The thickening of this area is interesting, maybe revealing the maker's intention to reinforce a part of the top subject to sollicitation.

Another thickening of the upper part of the top, up to 11,5 millimetres, can be found in proximity to the central "crest" carved on the outside.

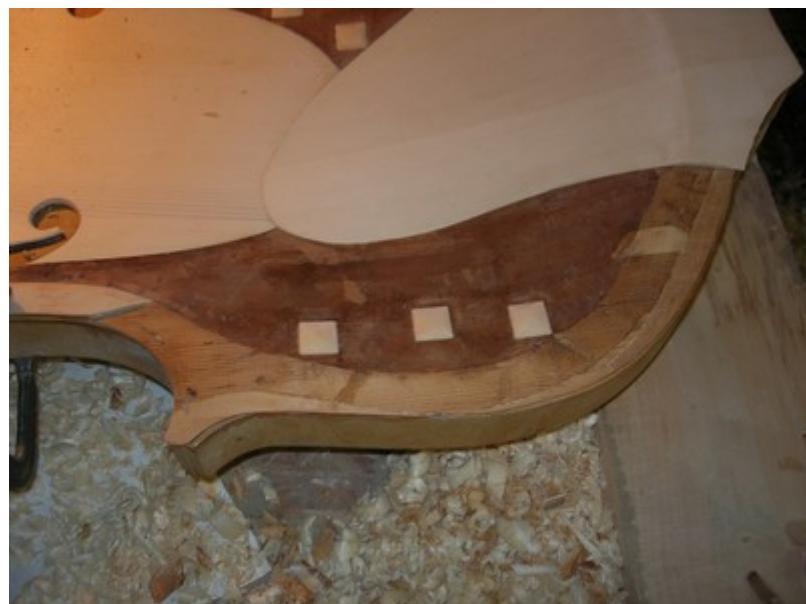
This way, the edge and upper corner reconstruction on the bass side come to light, together with a superficial addition.

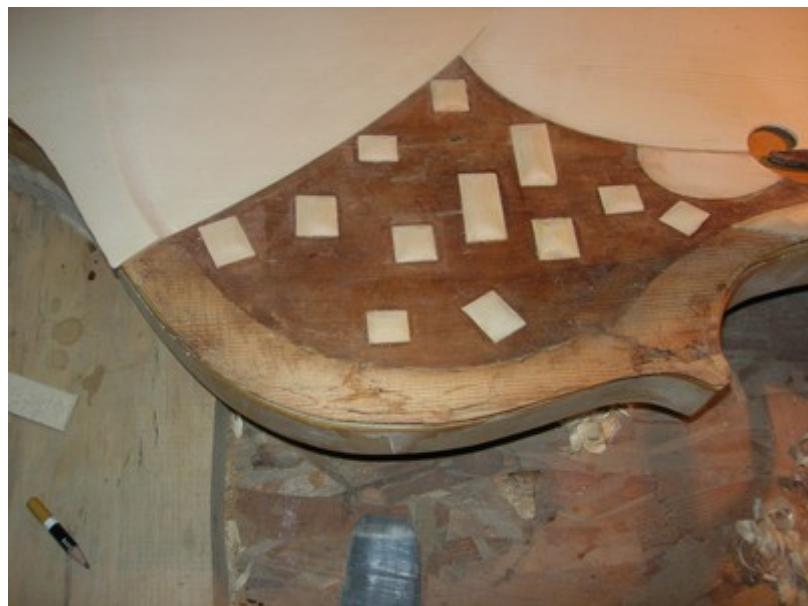
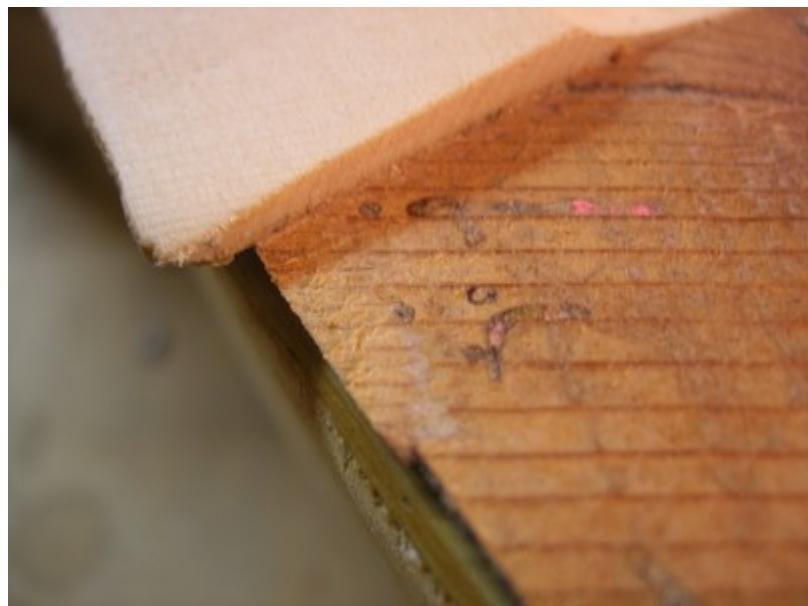
On the treble side, the shorter upper edge reconstruction is almost entirely covered by the doubling.

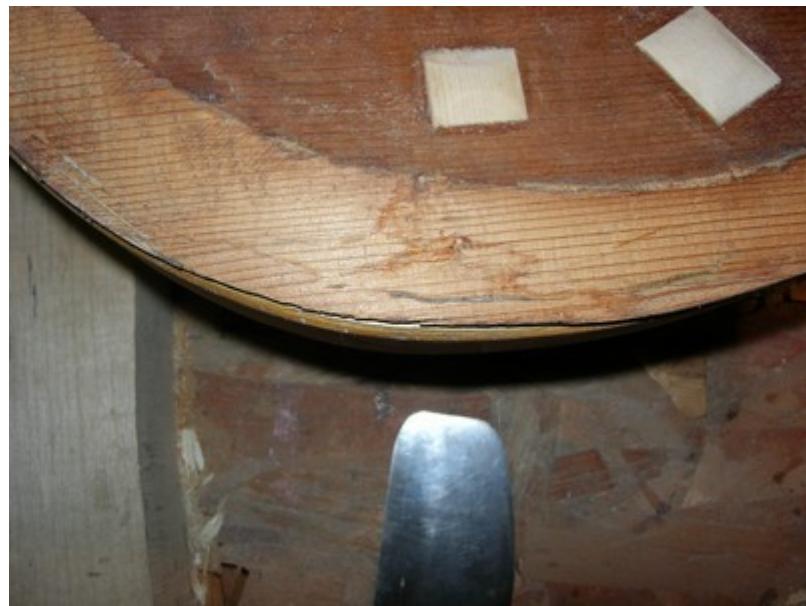
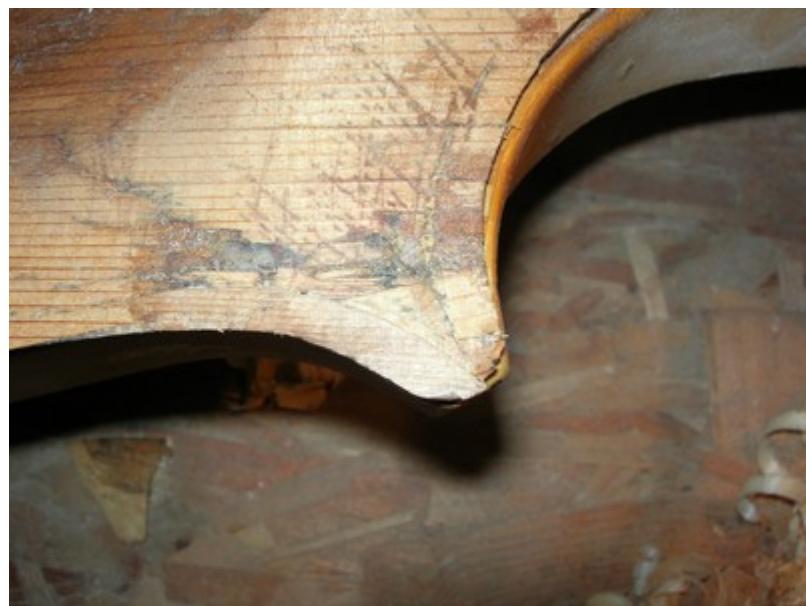
Then there is an edge reconstruction in the widest part of the bout, and the corner rebuilt in multiple pieces.

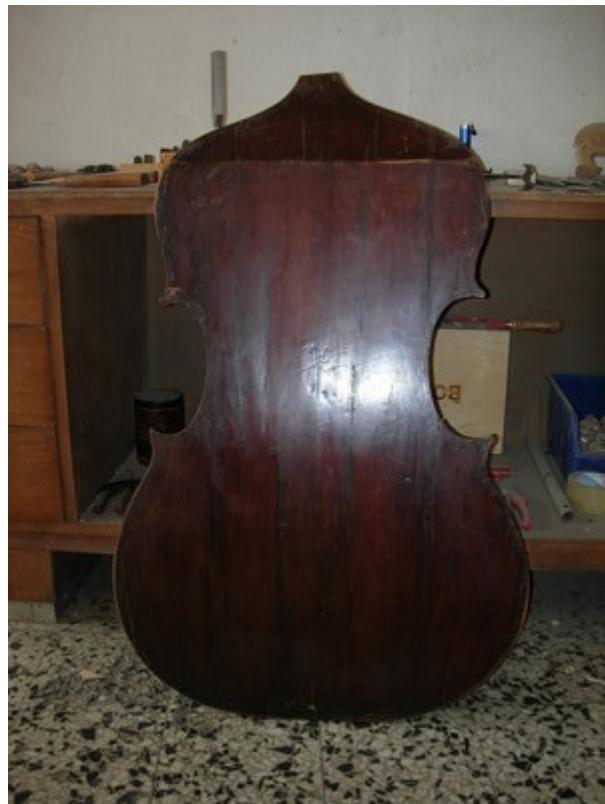
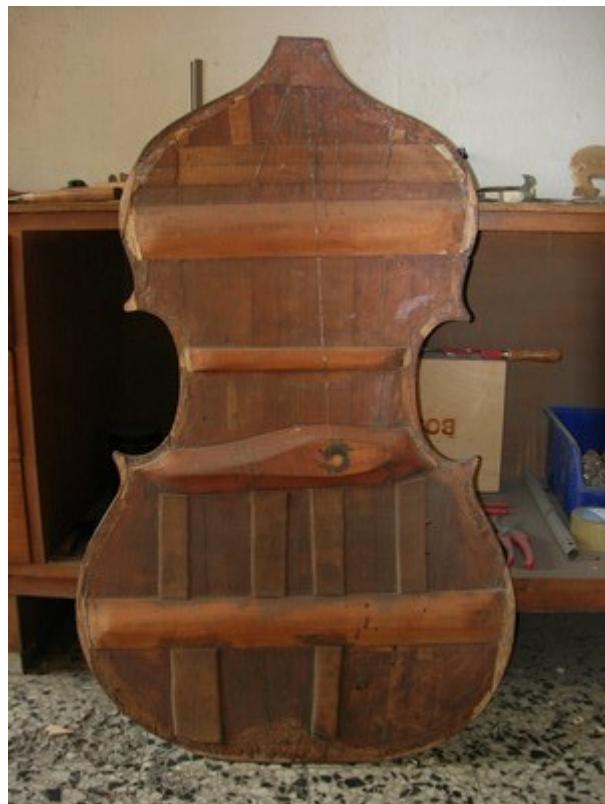
The back is made from cherry wood, in two pieces, cracks are present over the entire surface, the button is missing.

The thickness decrease from 4,5 - 5,2 millimetres in the lower bouts to 3,7 - 4,3 millimetres in the upper part.

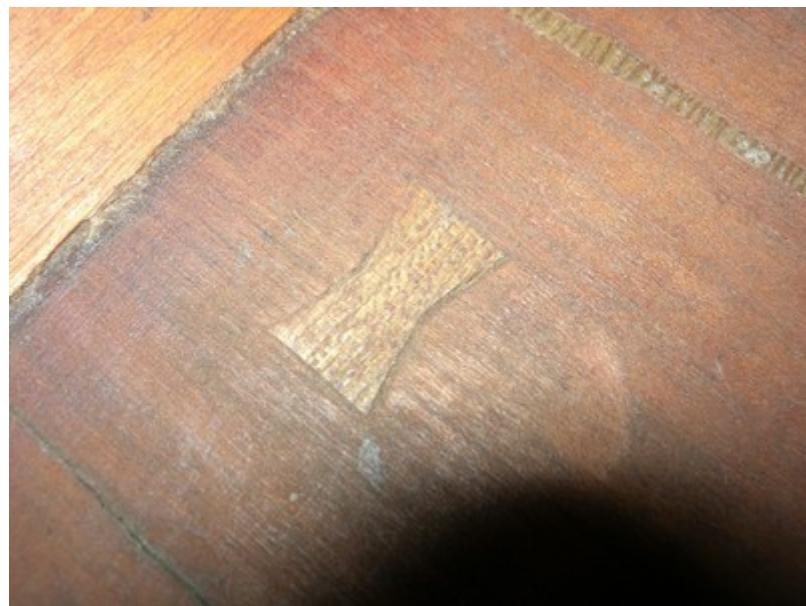
The joint was reinforced, I believe at the time of construction, with butterfly maple inserts.
