Giuseppe Cazzaniga, Liutaio

Bernareggio, July 2009 - June 2012

Restoration of a Brescian style double bass

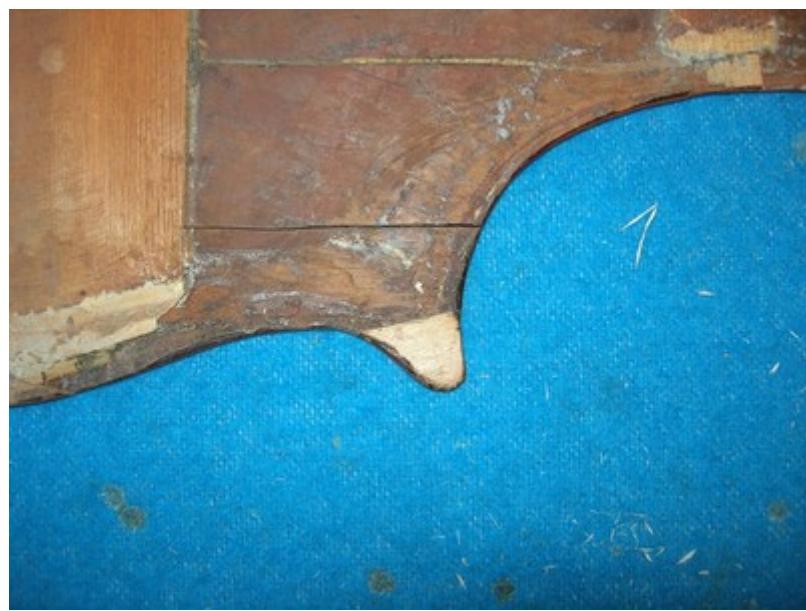
The corners on the bass side were remade, and there are large sections at the maximum upper and lower width which have been replaced.

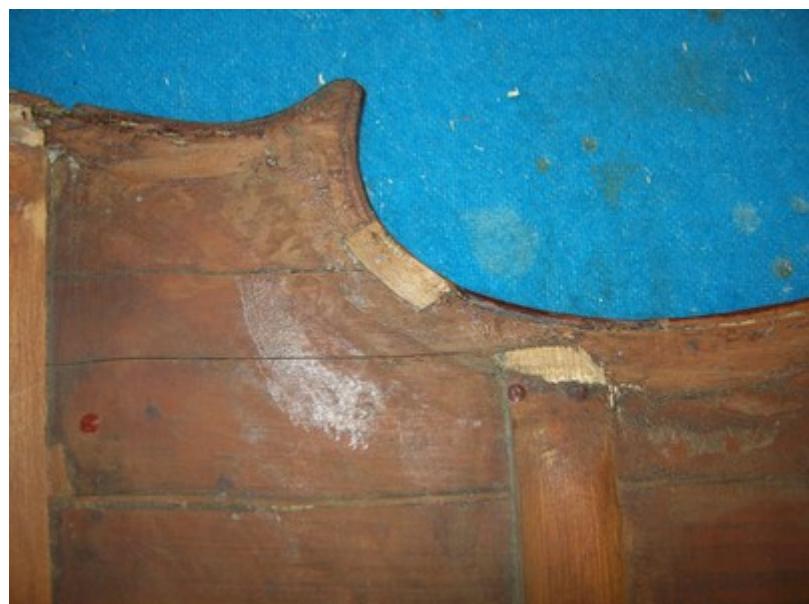
A remade section is also present at the treble C bout.

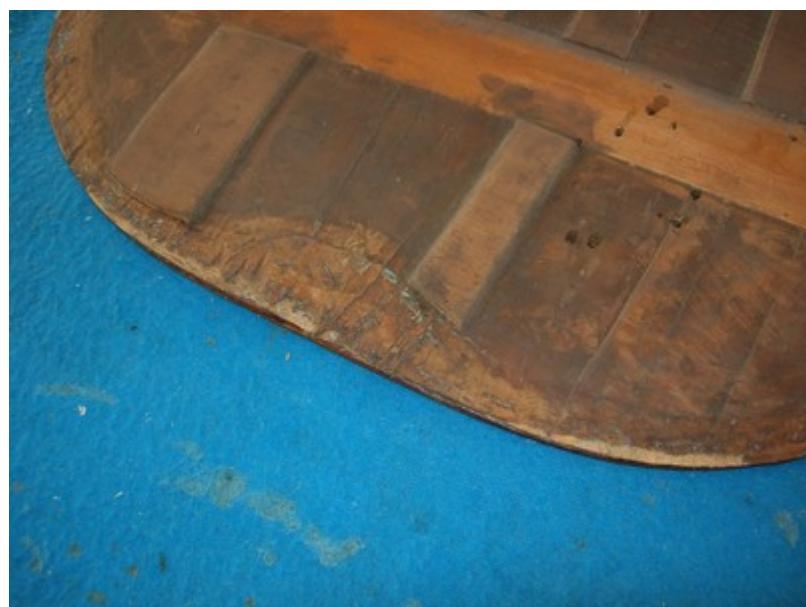
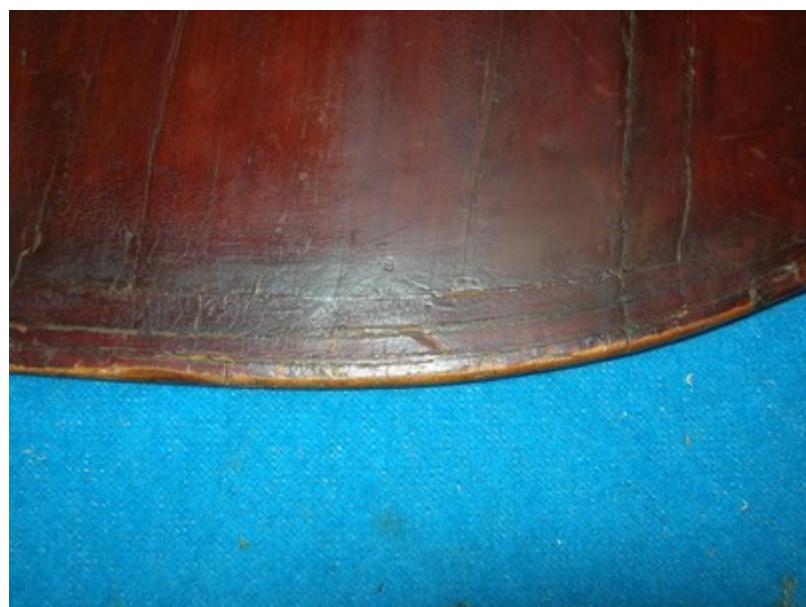
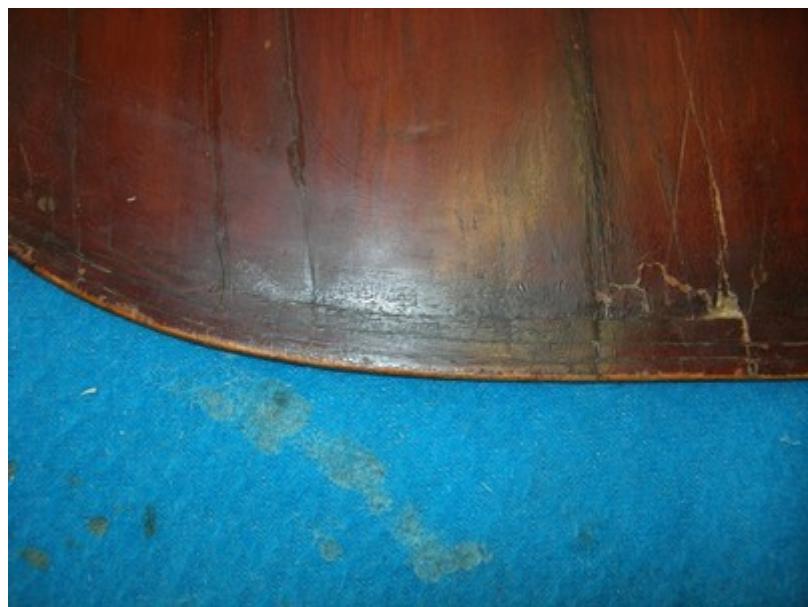
The lower edge, adjacent to and under the block has been remade, maybe to repair the damage caused by playing the instrument without an endpin.

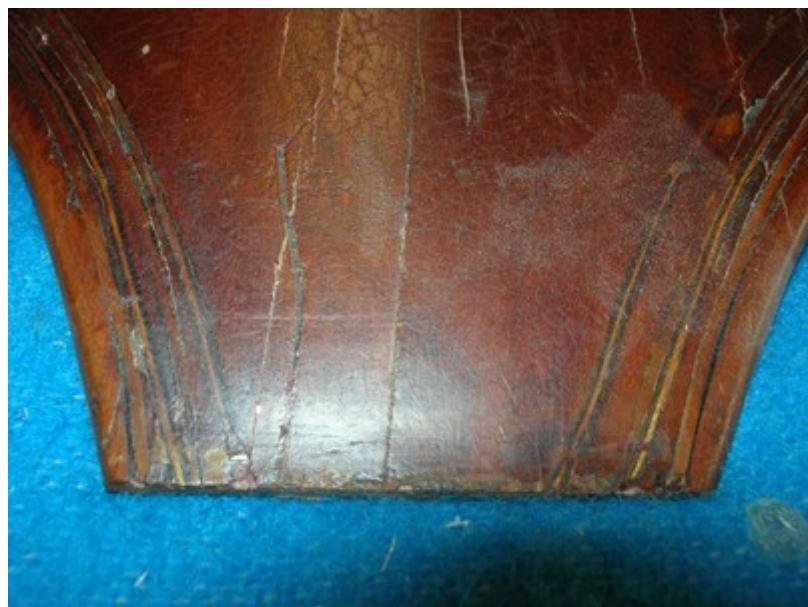
In the upper section, near the upper block, the presence of wider purfling may show that the profile has been reduced in width

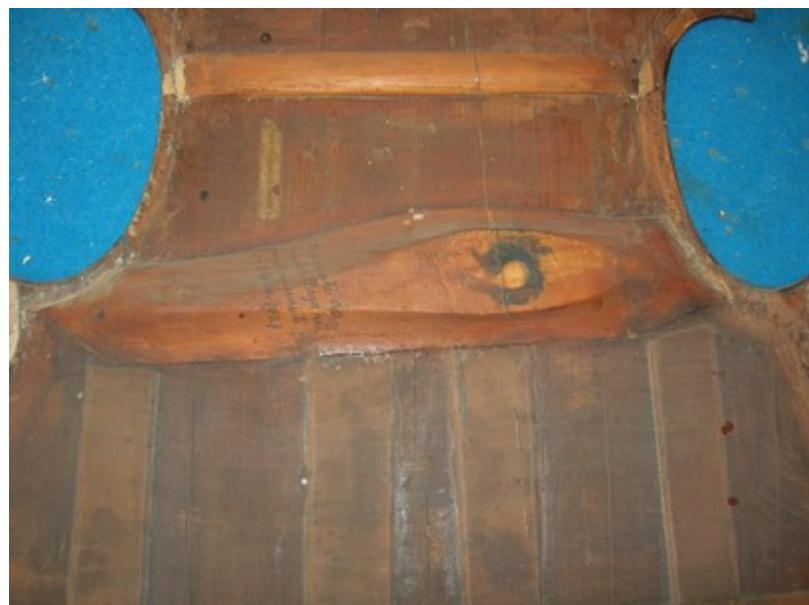
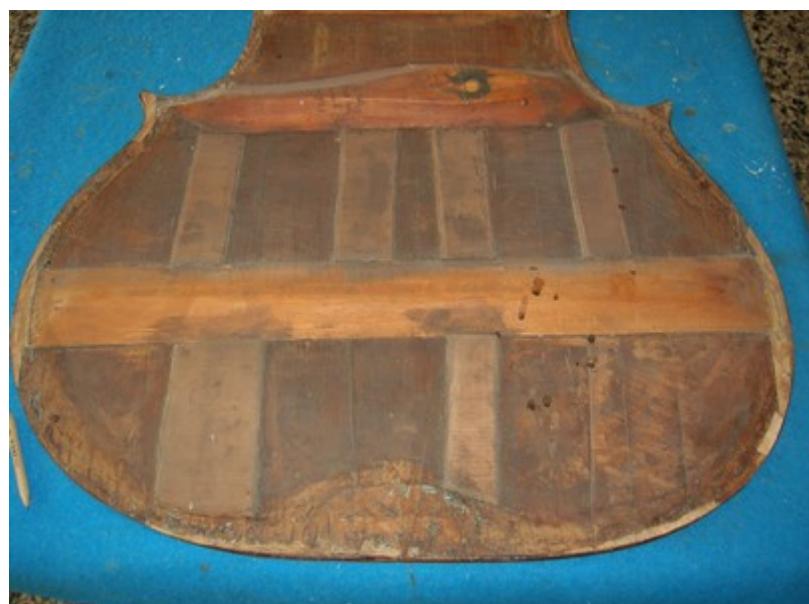
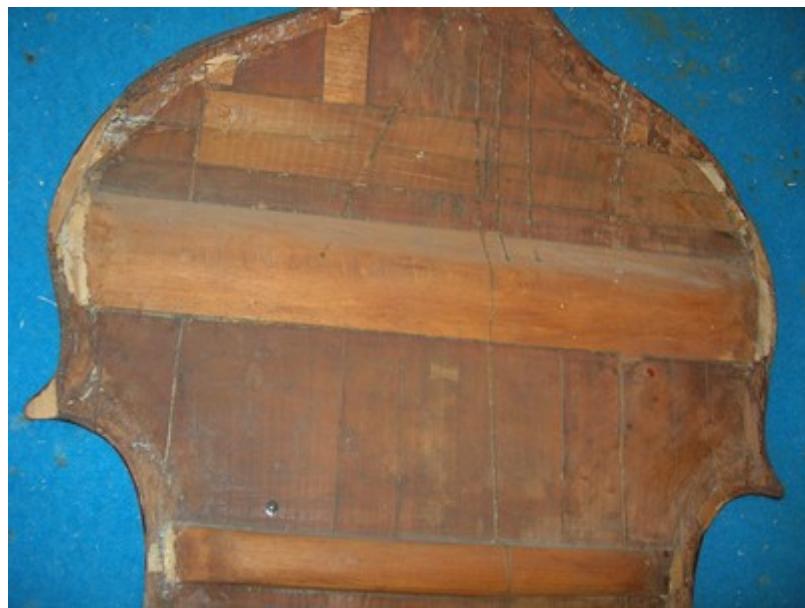
The soundpost crossbar, of strange form, as well as the upper and lower bars, are made of the same wood and seem to have been replaced by the same person, whose work resembles the shaping of the linings and of the reinforcements at the upper and lower blocks, which I found while repairing the ribs.

None of the bars is original, their excessive weight and rigidity could have caused some of the damage the back has suffered, the removal is necessary to repair the cracks under the bars.

I choose to remove the bars with a plane and gouge, and then cleaning the glueing surfaces with hot water; this way avoid the possibility of causing further damage to the back while unsticking the bars.

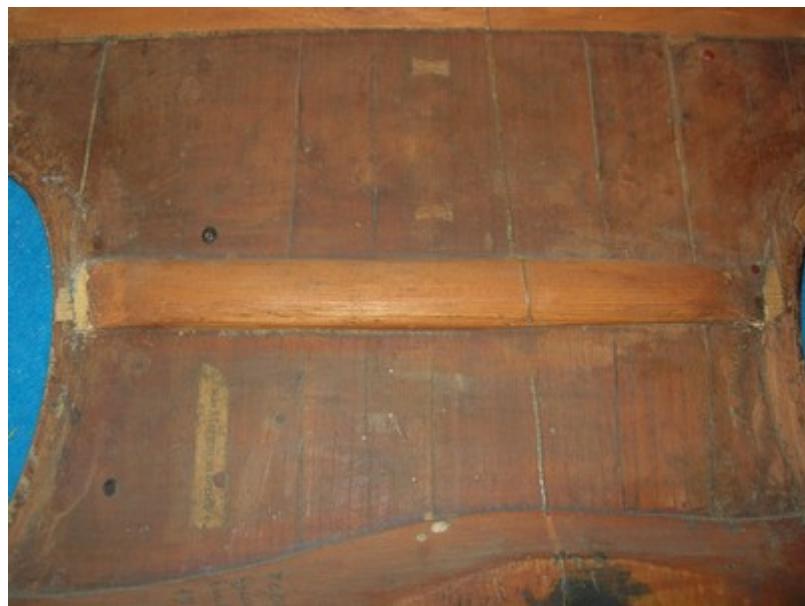
The small bar is from a different maker and seem to have been replaced more recently.

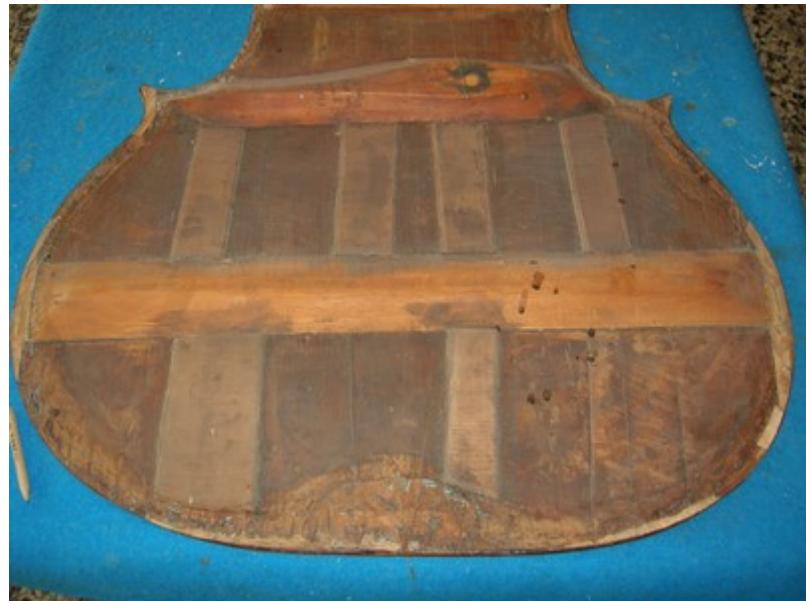
In the lower part there are several rectangular reinforcements, placed along repaired cracks. those above the lower bar are in walnut, and those below in spruce.

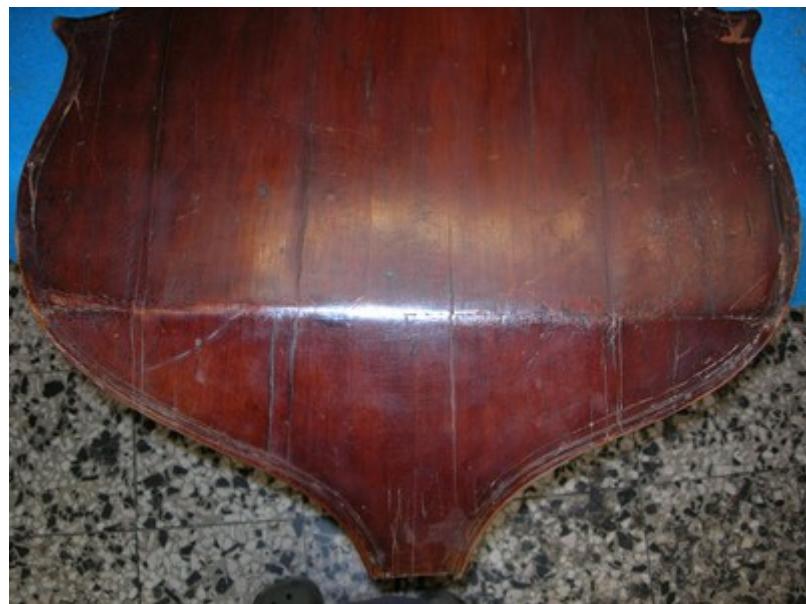
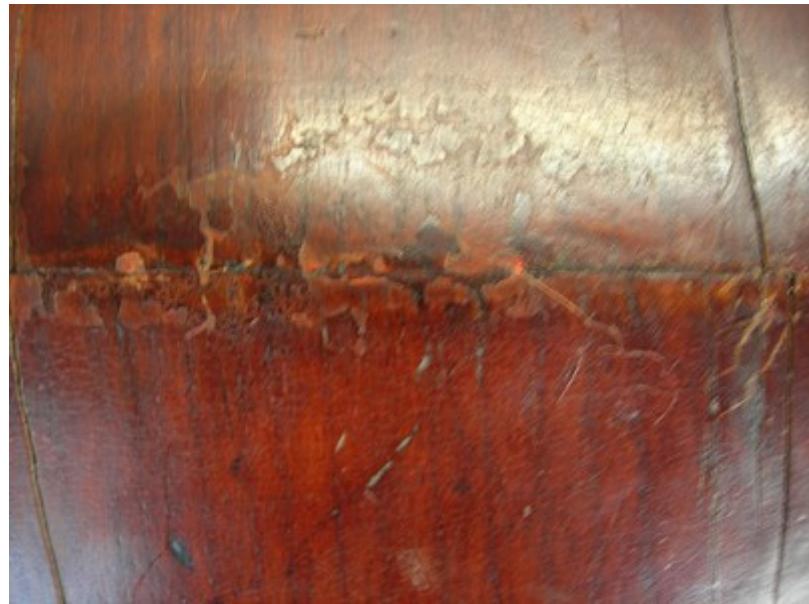
The bend, placed fairly high, has been broken, and there is some filler from the outside. Inside it has been reinforced with a strip of walnut, with grain parallel to that of the back.

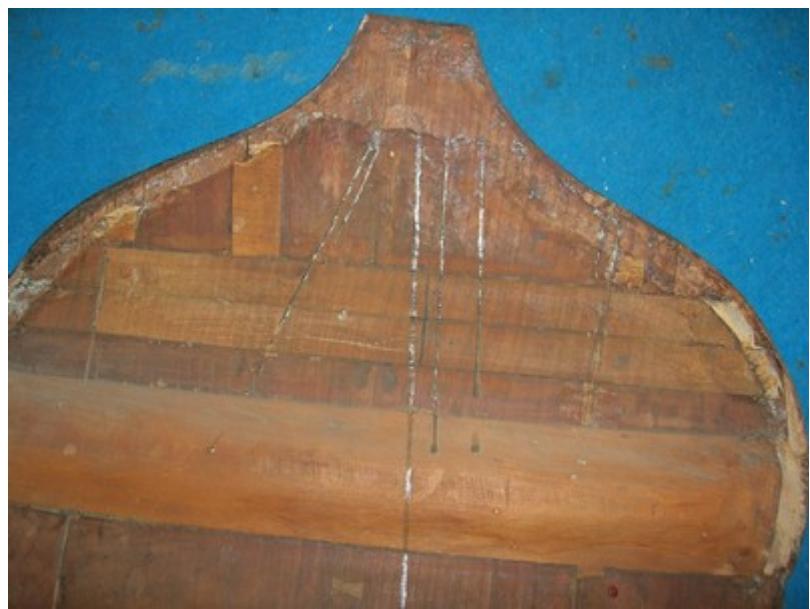
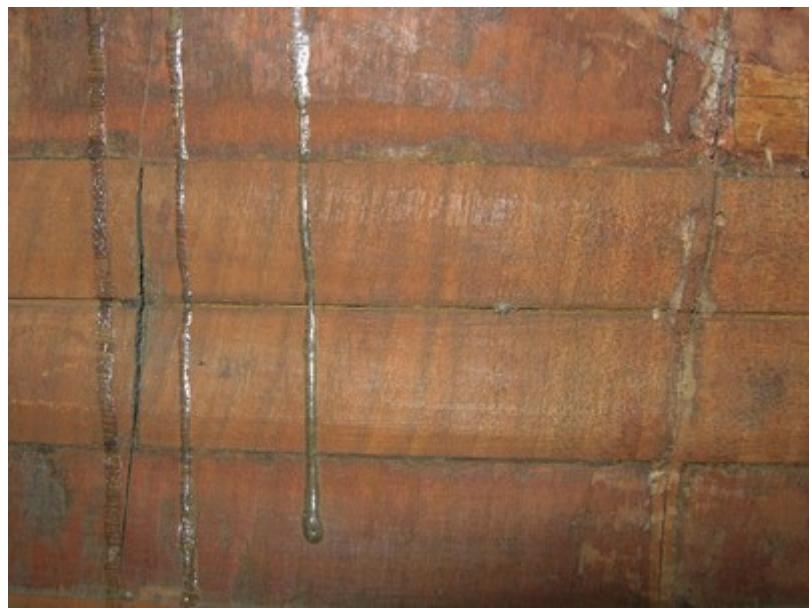
There are additional reinforcements, maybe in ash, along two cracks on the bass side, as well as two others smaller in size on the treble side.

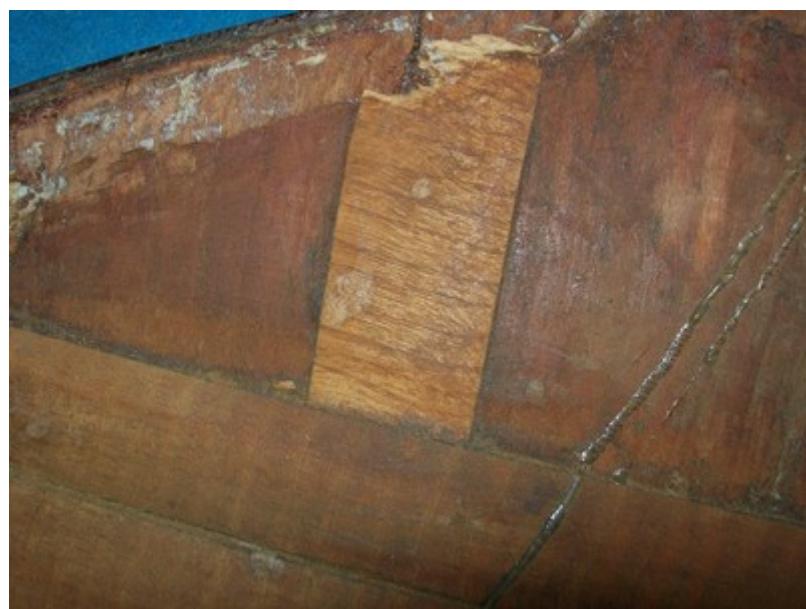
The reinforcement along the bend has also cracked.

I remove the reinforcements along the cracks in the lower section, and clean the area.

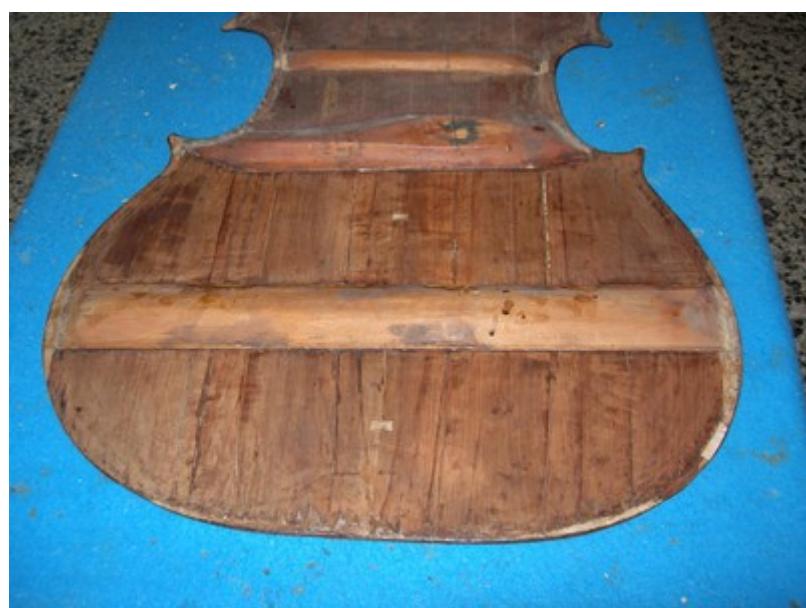
It is now possible to see the profile of the ribs, traced with a scribe roughly 4 millimetres from the border.

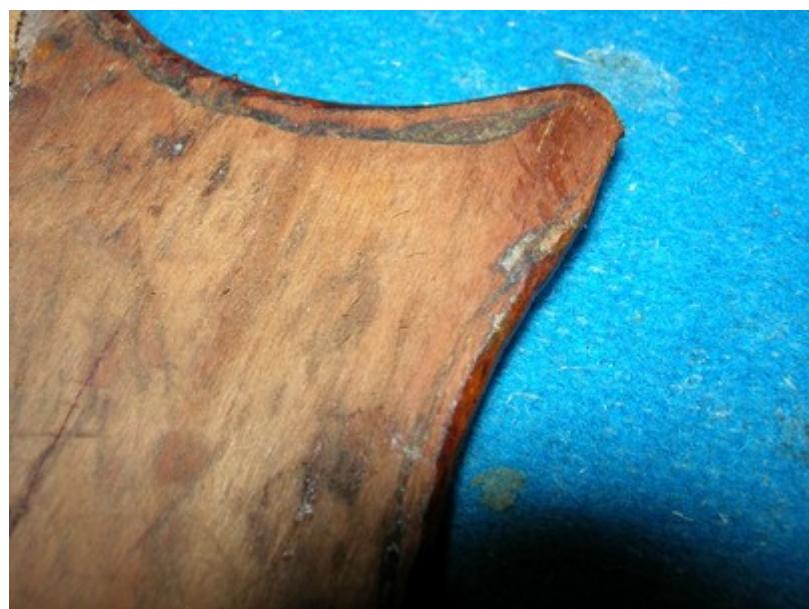
Some of the cracks have been filled with strips of walnut, and one was filled with white putty.

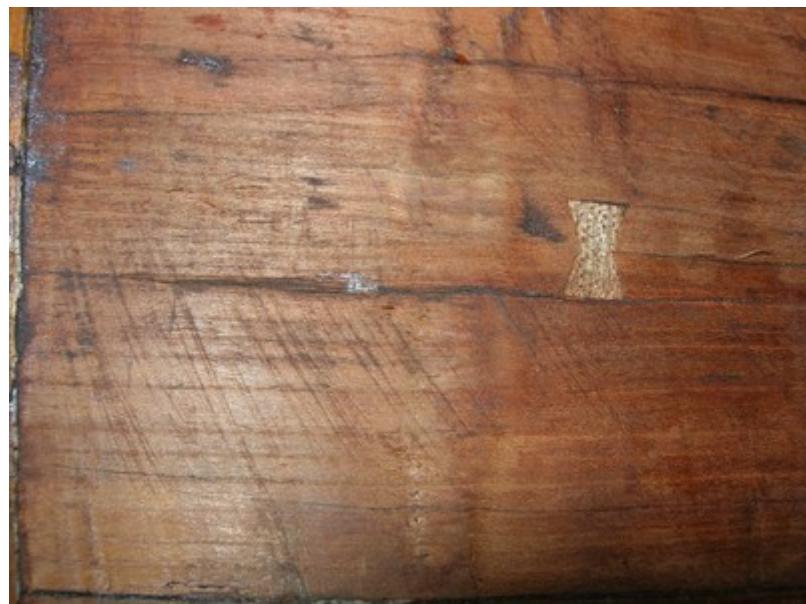
There are marks from a scraper or a small plane present on the entire surface.

Under the reinforcements there are scribe marks.

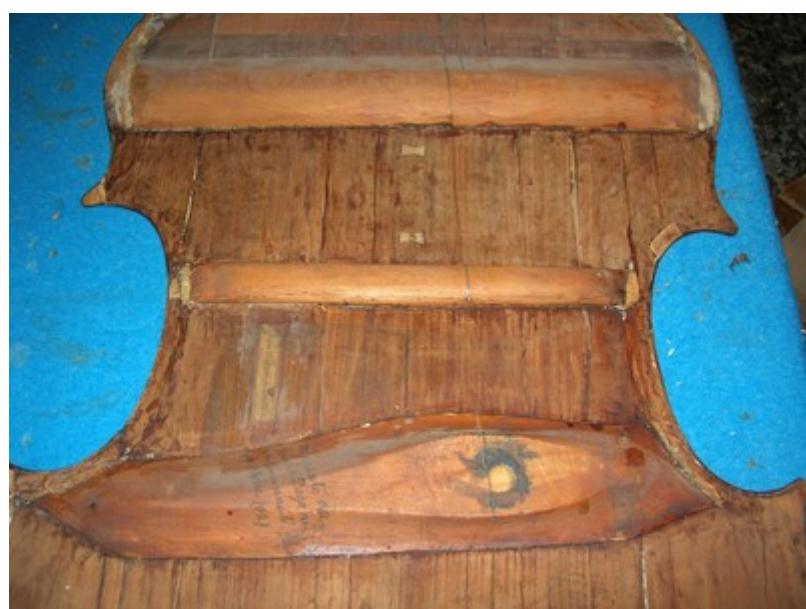
The area around the label has been varnished, maybe to protect the label.

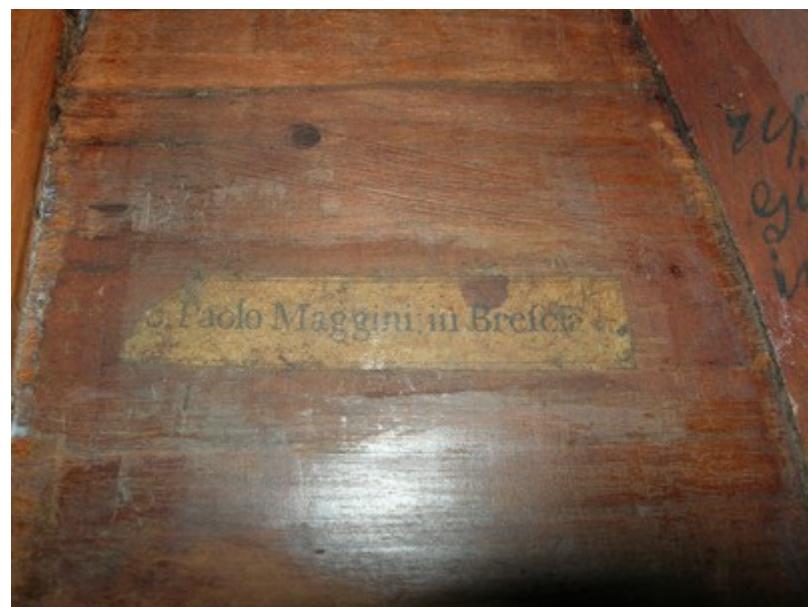
The profile of the ribs is present here as well.

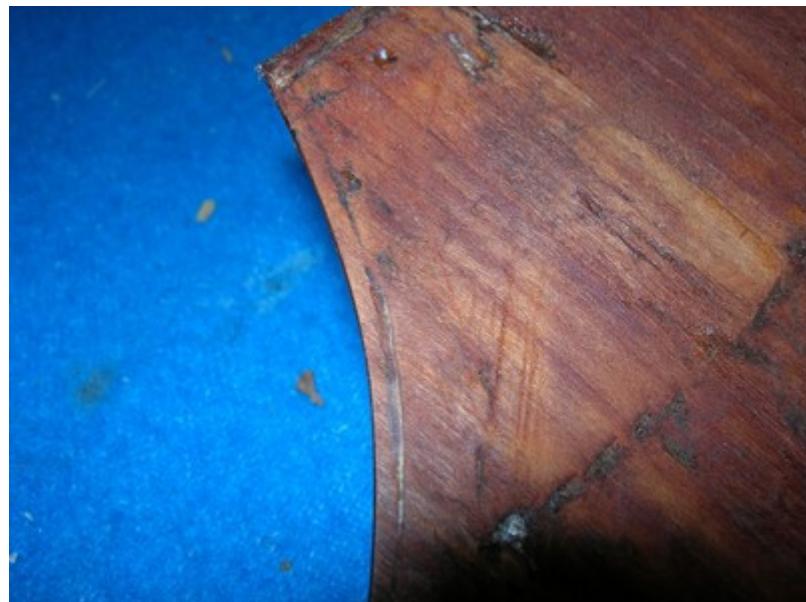
Given that the upper part of the back has been modified, it is probable that the profile of the ribs was rescribed during a previous repair.

I apply temporary cleats along all cracks.

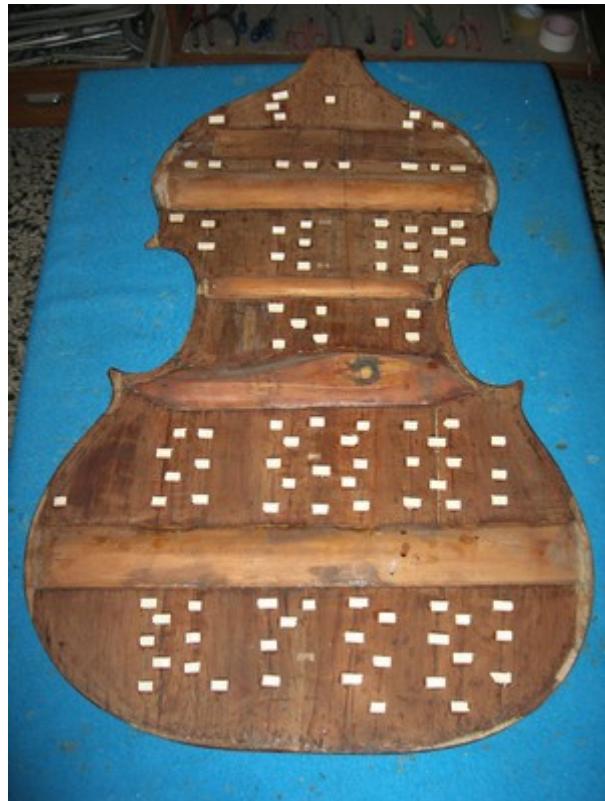
The spruce with which the lower bar was made is fairly hard and rigid.

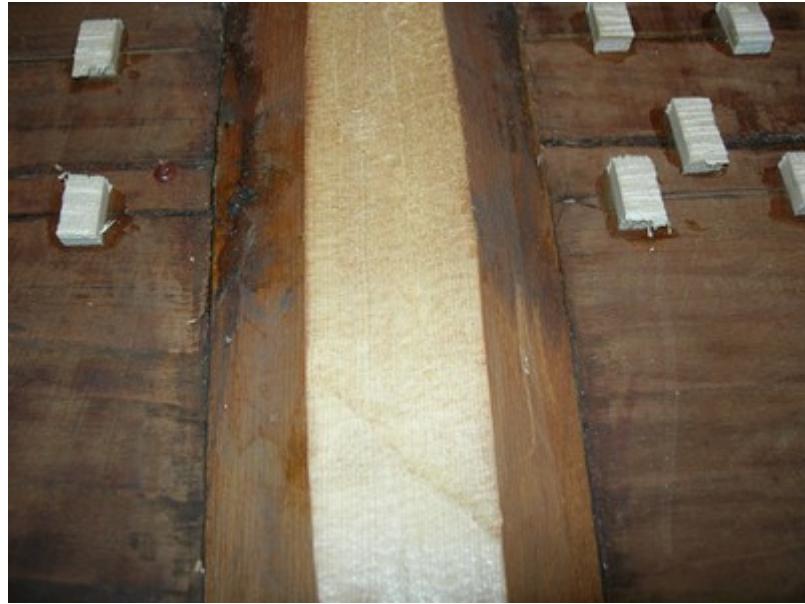
The glueing surface of the back to the lower bar was scratched with a scribe. Similar to the surface under the walnut and spruce reinforcements along the cracks.

One of the butterfly inserts was covered by the bar.

There are also several round pins, maybe placed from the outside during a bad repair to a previous smaller bar, whose position is still visible on the surface of the back

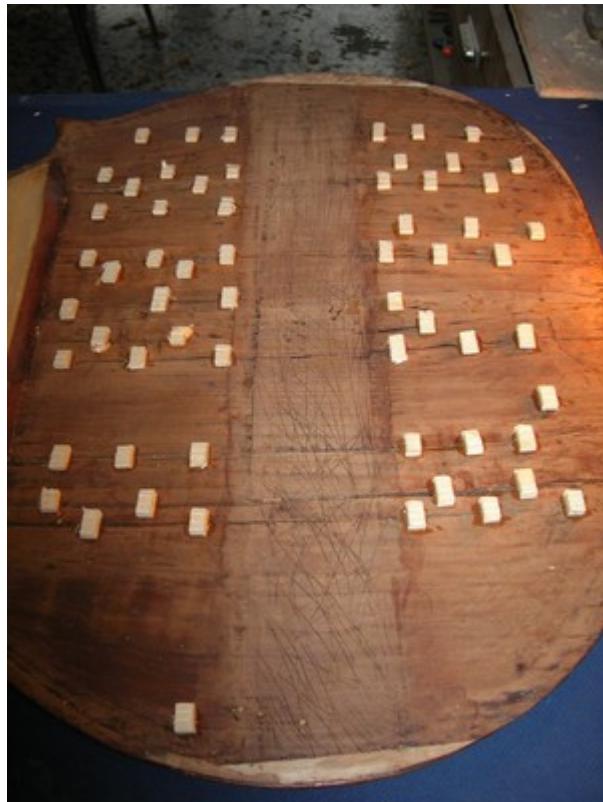
The previous bar would have had a width of 20 - 22 millimetres, and was placed along the upper edge of the bar I removed, corresponding with the widest point of the back.

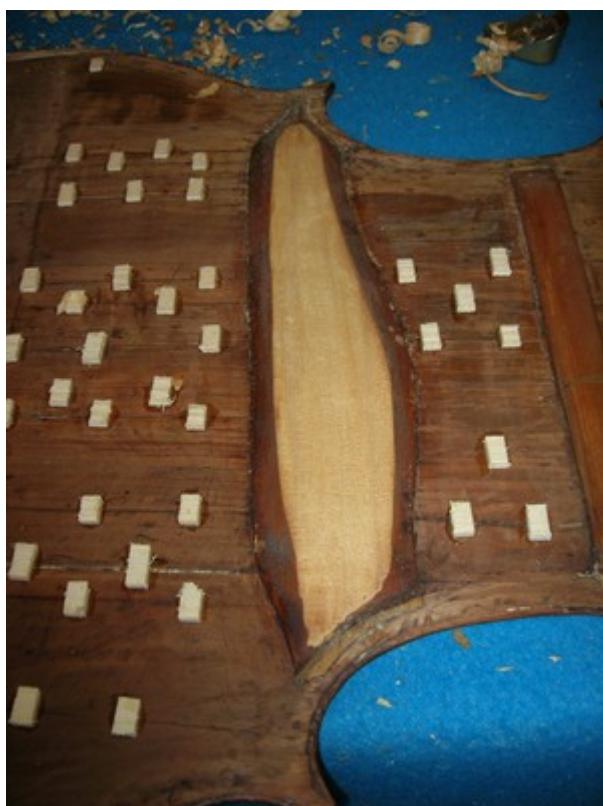
The scratch marks on the glueing surface are present here as well, and under the bar there is another butterfly insert.

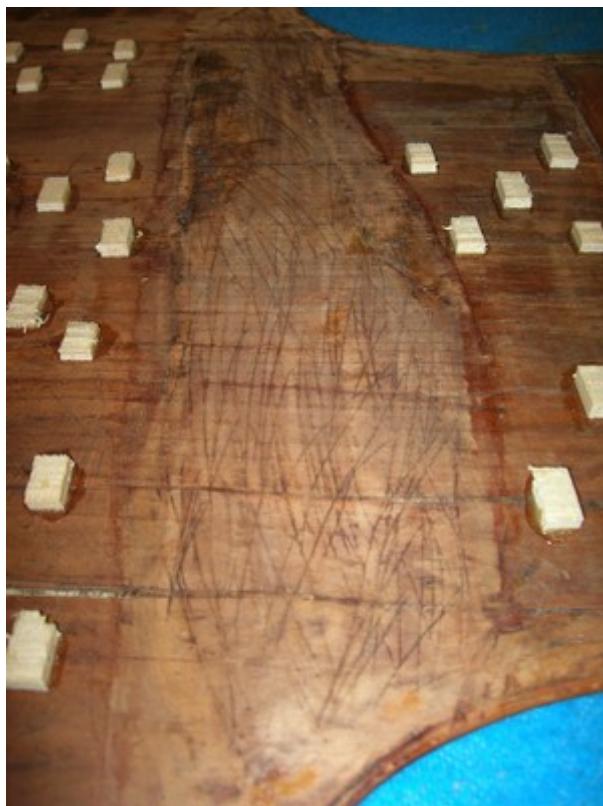
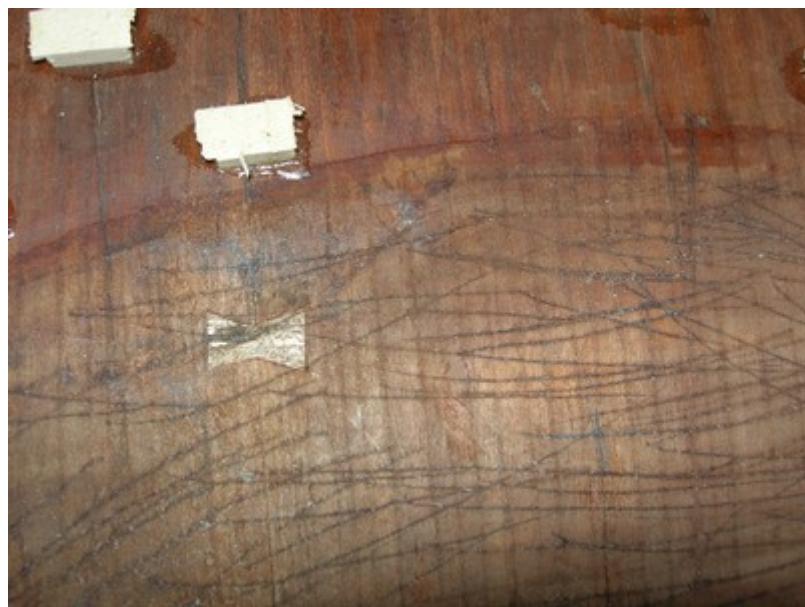
The butterfly and the surrounding area are rich with tool marks. Maybe a previous bar was narrower, but similar to the one I removed.

The small central bar was made from a softer spruce, with a wider grain than that used for the other bars. This material seems less oxidized as well.

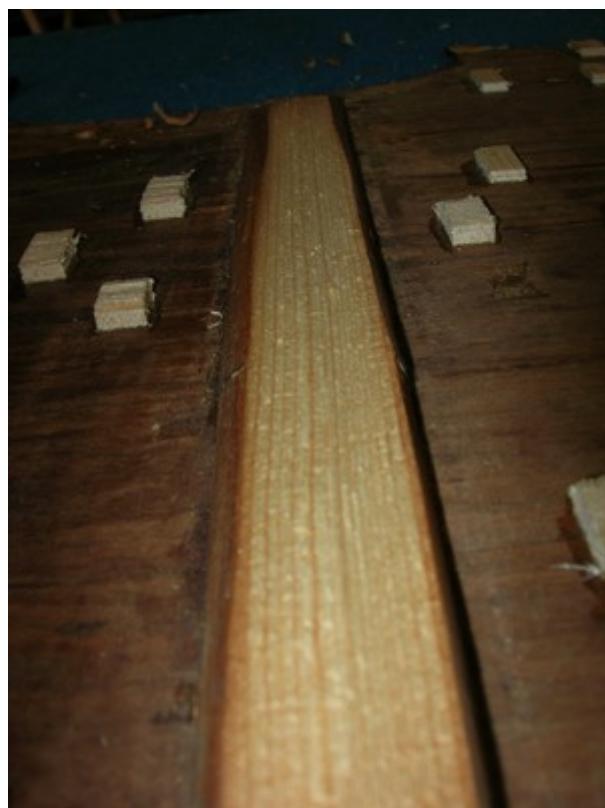
The glueing surface under the small bar has been scribed as well.

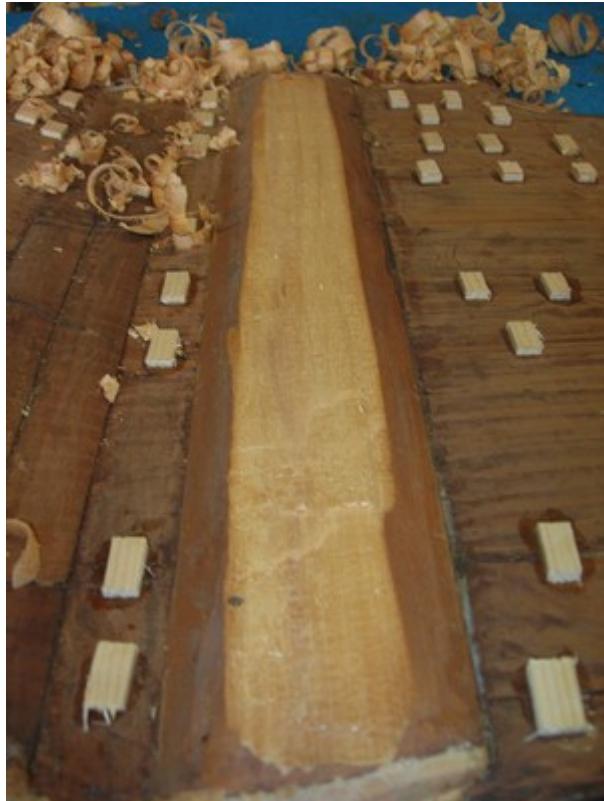
The glueing surface has been scribed here as well, and there are several pins similar to those under the lower bar.

The position of a previous bar is visible, at the widest point of the upper bouts, and 20 -22 millimetres wide.

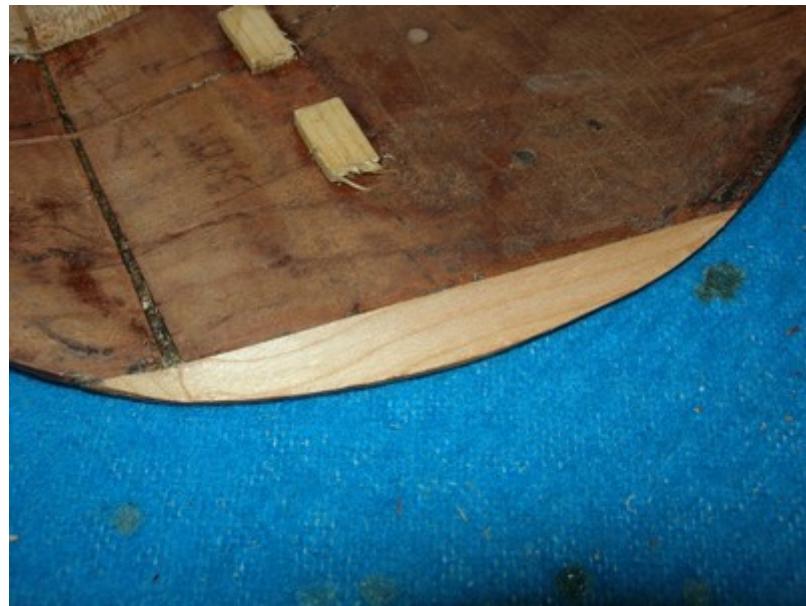
There are double lines of non original purfling inlaid into the remade edge, which are present along the entire profile of the back, placed over or near another wider purfling with very thin black sides, maybe the original.

The older purfling would outline a wider profile in this area of the instrument.

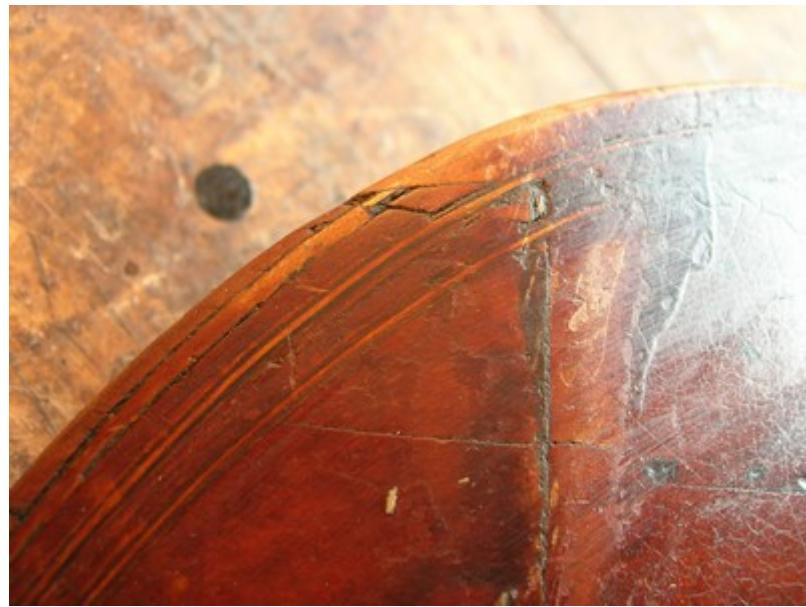
I remove a temporary cleat near the upper corner on the bass side where there is a crack as well as splintered wood, and clean the surface.

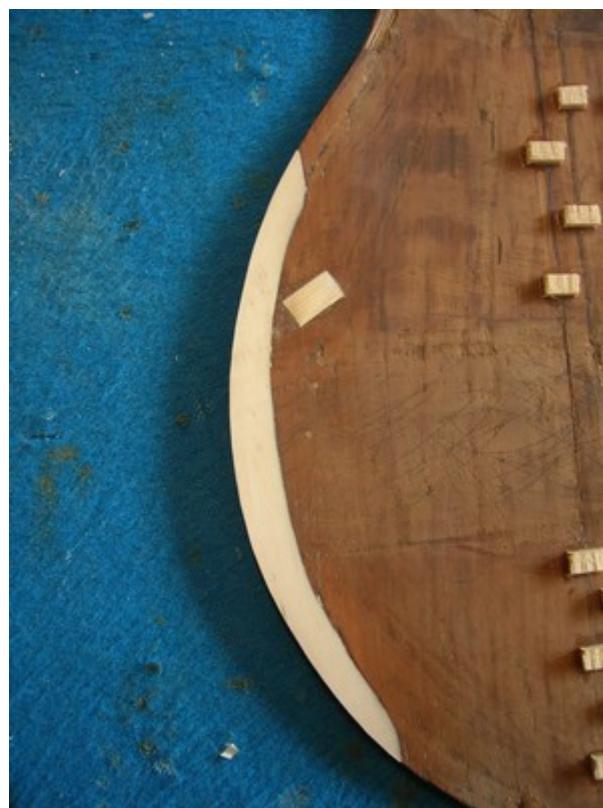
The next crack, in the lower section on the bass side, was repaired with several slivers of walnut and with putty. It reopened.

I remove the temporary cleats, open the crack, remove the slivers and repair the crack, rebuilding the missing part in white maple.

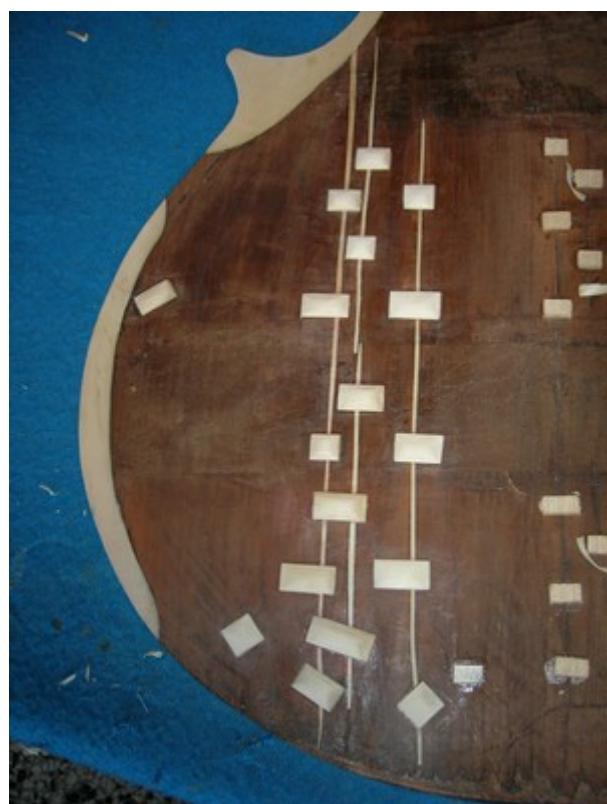
The next crack, on the lower bass side, has been repaired with a sliver of walnut.

From the outside the sliver is well glued and the crack is level, inside the sides of the crack are slightly offset, and the sliver shows gaps.

The offset sides of the crack inside do not merit a doubling, and the crack can be reinforced with the adjustment of the cleats.

I work from the inside, without touching the outer surface, inserting a new sliver into the back, which enters halfway into the thickness.

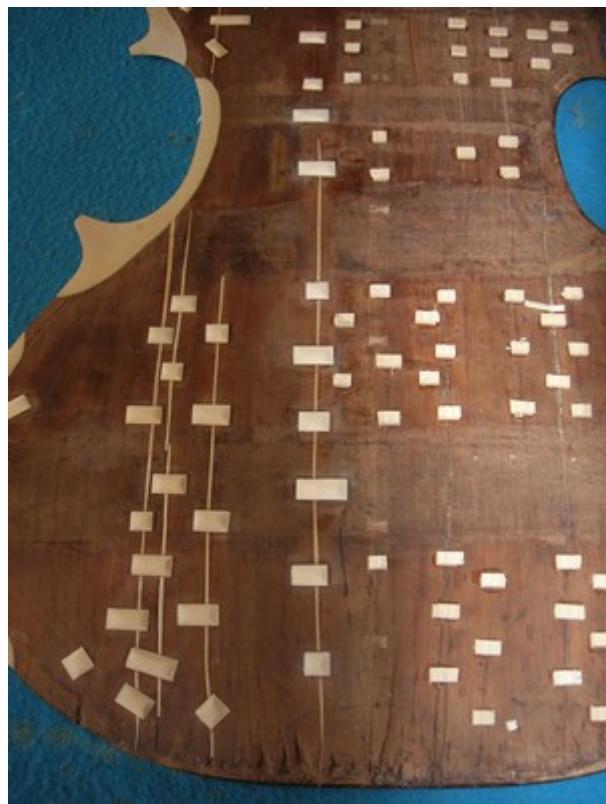
The next crack runs from the glueing surface of the lower block to the center of the instrument. The sides are partially offset, and it has been filled with strips of walnut and putty. I reopen the crack, remove the fillers and close the crack with a new sliver.

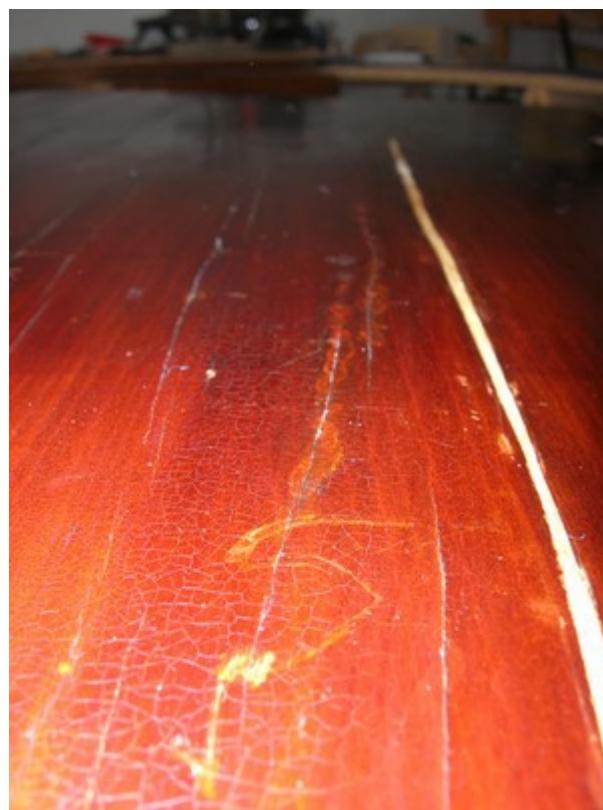
Continuing towards the central joint, in the lower section there are three small cracks, the first between the lower block and the lower bar, the second under the bar, and the third above it.

The first is well glued and level, but has a gap filled with glue on the inside; the second and third are partially open and offset, with brownish retouches to the varnish.

I remove the temporary cleats and repair the cracks, inserting maple into the gaps.

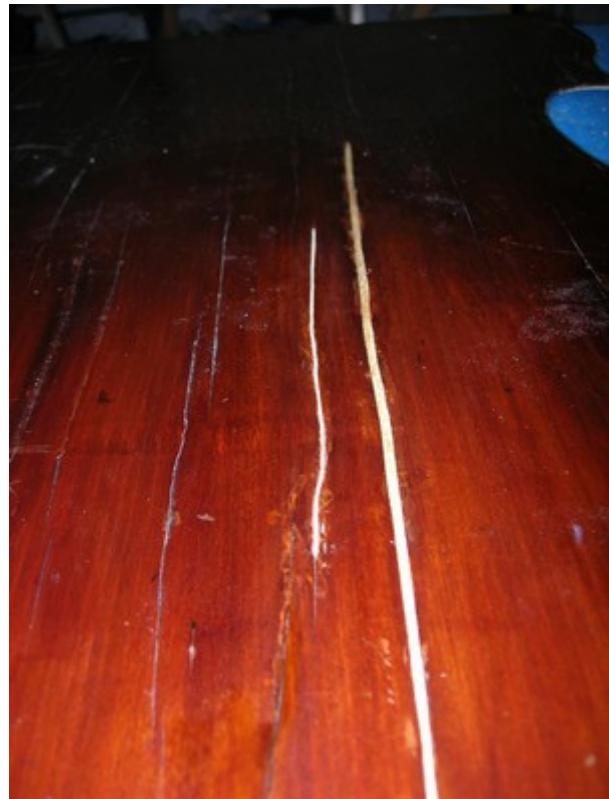
The central joint in this area is solid, maybe due to the butterfly inserts, and I can reinforce it with cleats without reopening.

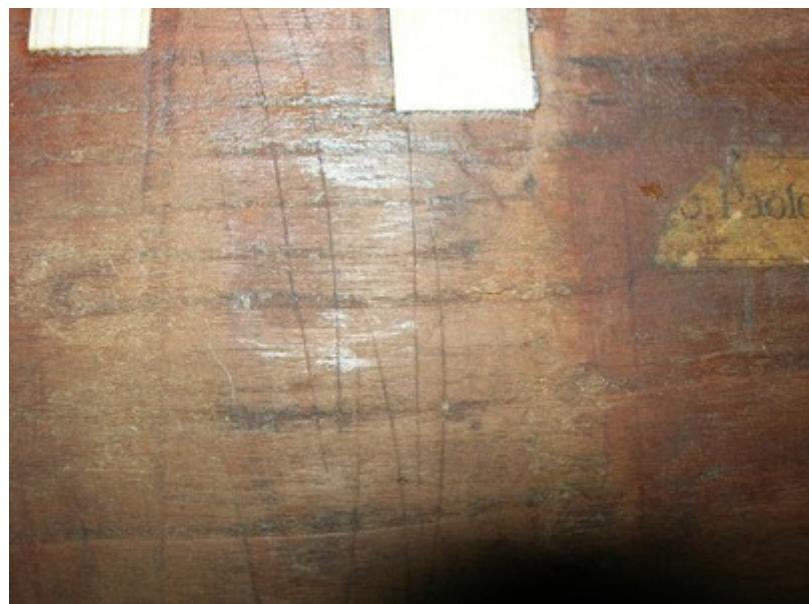
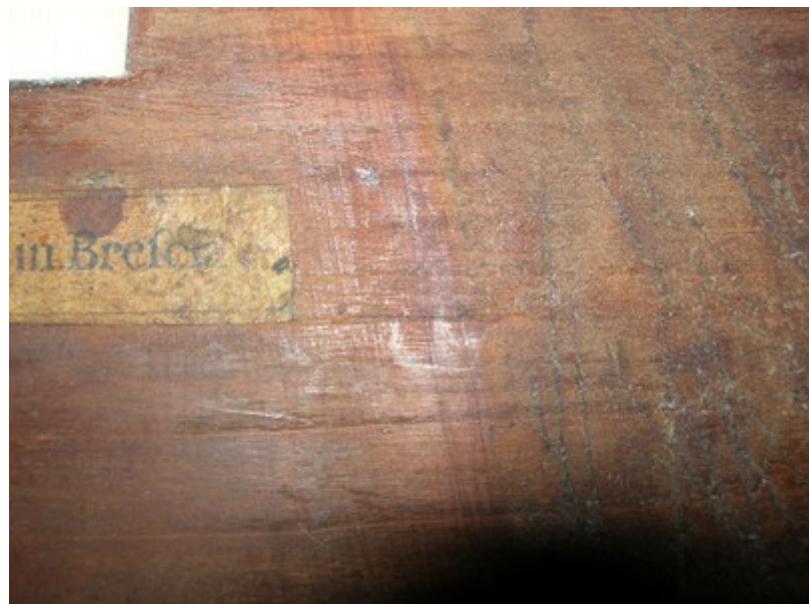
In the center there is a crack next to the label, which I repair inserting glue from the outside and placing cleats on the sides. This way I do not risk damaging the label, while a large part of the crack will be reinforced by the soundpost bar.

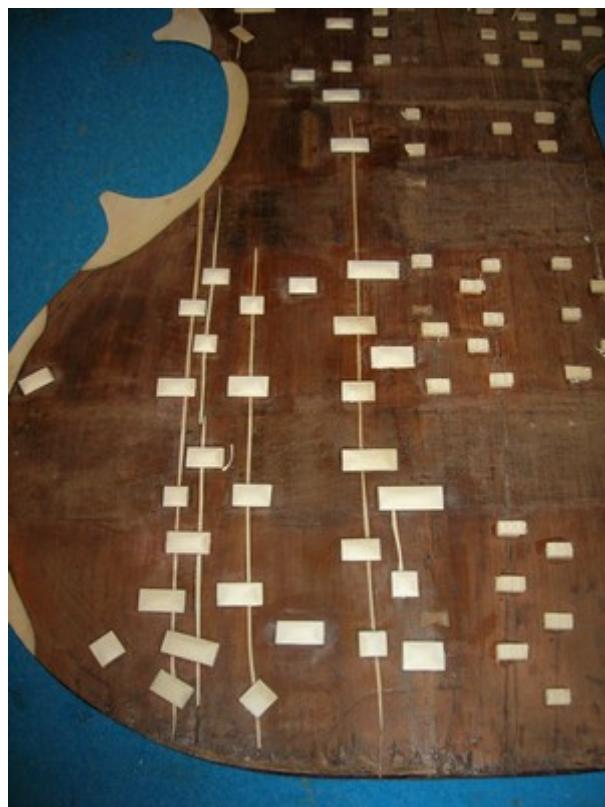
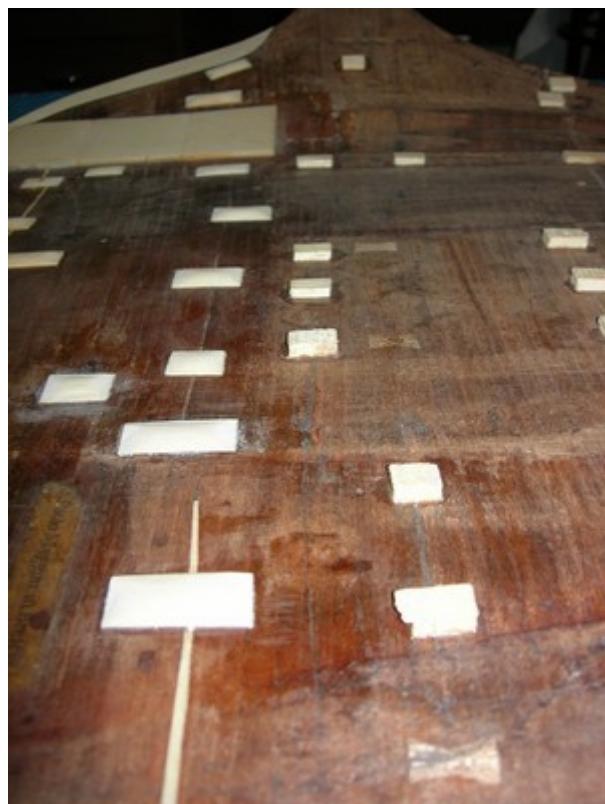
In the upper section, between the bend and the soundpost bar, along the side of the central joint on the bass side, there is a long crack, repaired without filler, partially open and dirty.

I remove the temporary cleats, reopen, clean and glue the crack, reinforcing with cleats.

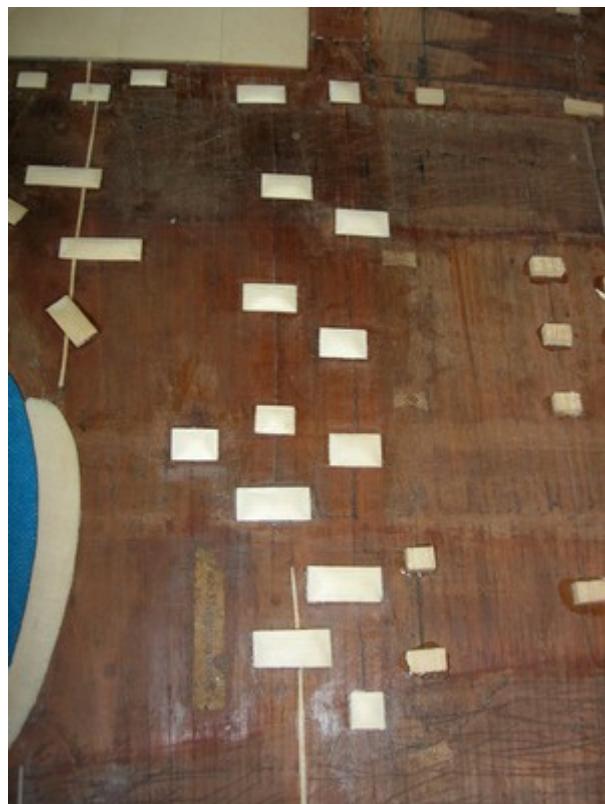
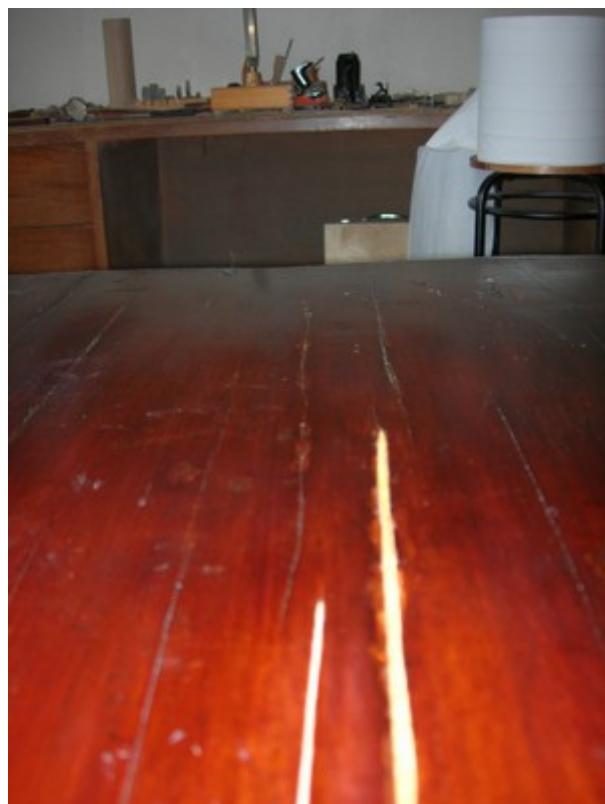
In spite of, or maybe thanks to the butterfly inserts, the central joint is for the most part closed.

The exception is a short area on top of the soundpost bar, which has been repaired with a walnut shim.
