Giuseppe Cazzaniga, Liutaio

Bernareggio, July 2009 - June 2012

Restoration of a Brescian style double bass

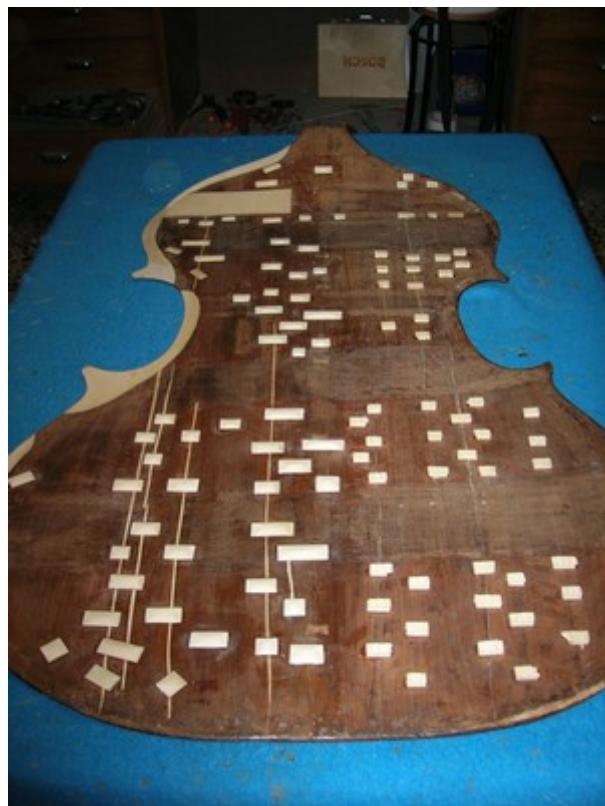
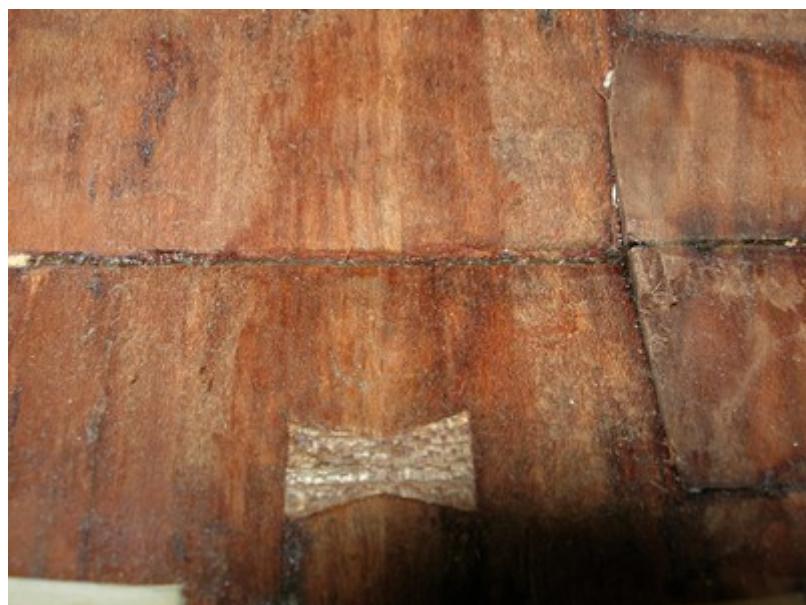
I remove part of the bend reinforcement, uncovering the joint and a butterfly insert.

In this way it can be noticed that the section of the back on the upper side of the bend was shifted of about 2 millimetres towards the treble side, probably during a previous bend repair.

I replace part of the reinforcement at the bend.

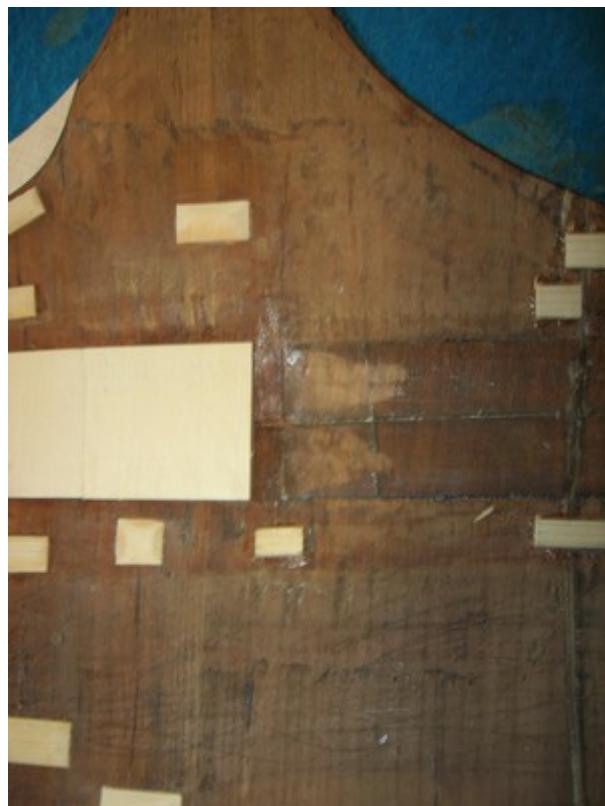
I remove the next section, uncovering a crack that starts at the upper block's glueing surface and continues down to the upper bar, through the bend, where it is open.

I repair the crack and replace another part of the reinforcement.

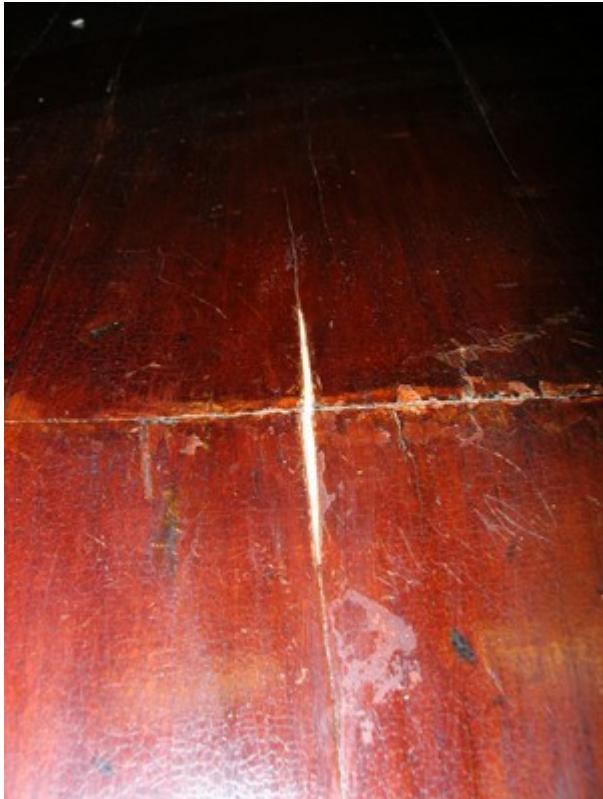
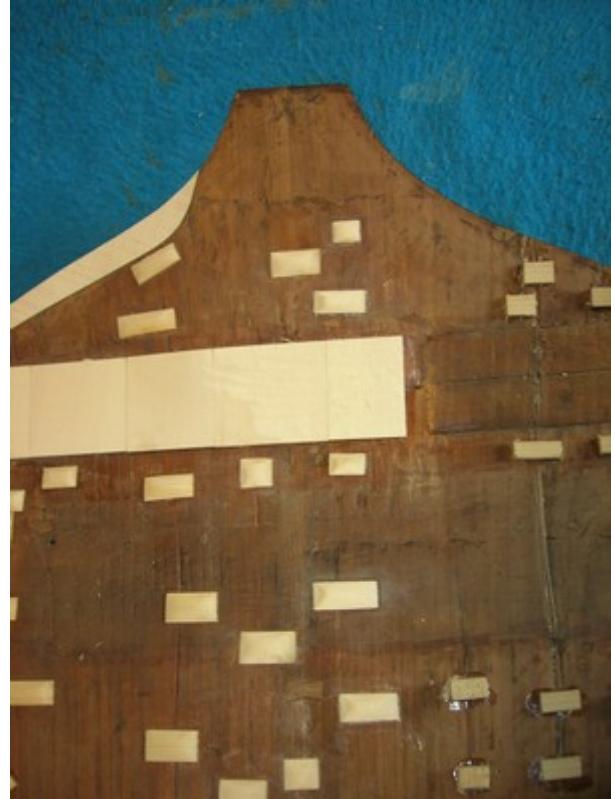
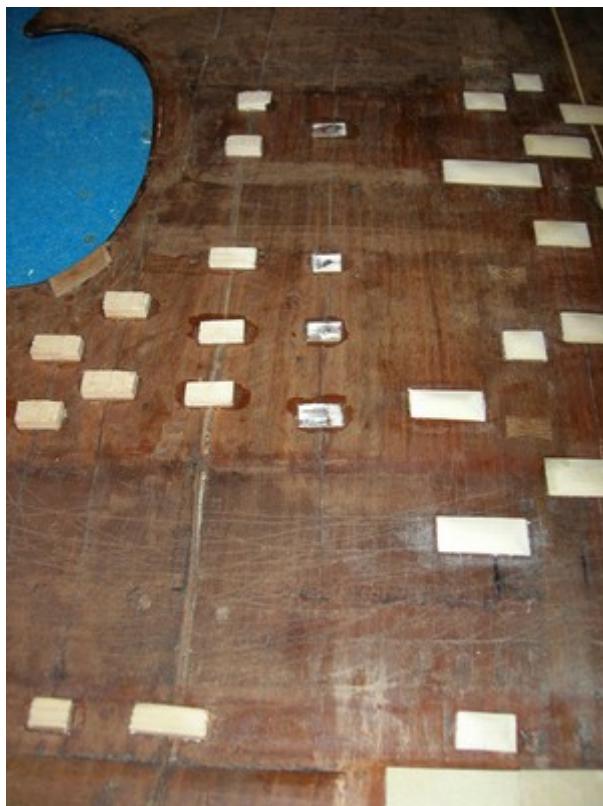
In the area between the upper bar and the soundpost bar, there is a crack repaired with a walnut shim, well glued from the inside, but open and putty filled on the outside.

I remove the temporary cleats, clean and repair.

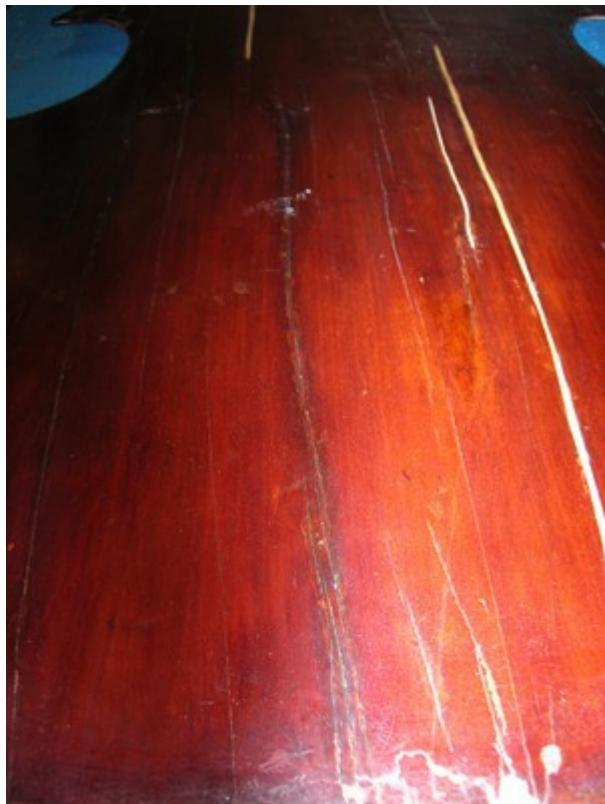
There is another open crack between the soundpost area and the lower edge, repaired with a walnut shim and putty, and two shorter cracks alongside, one right under the soundpost bar, the other at the lower edge.

I remove the temporary cleats, clean and repair.

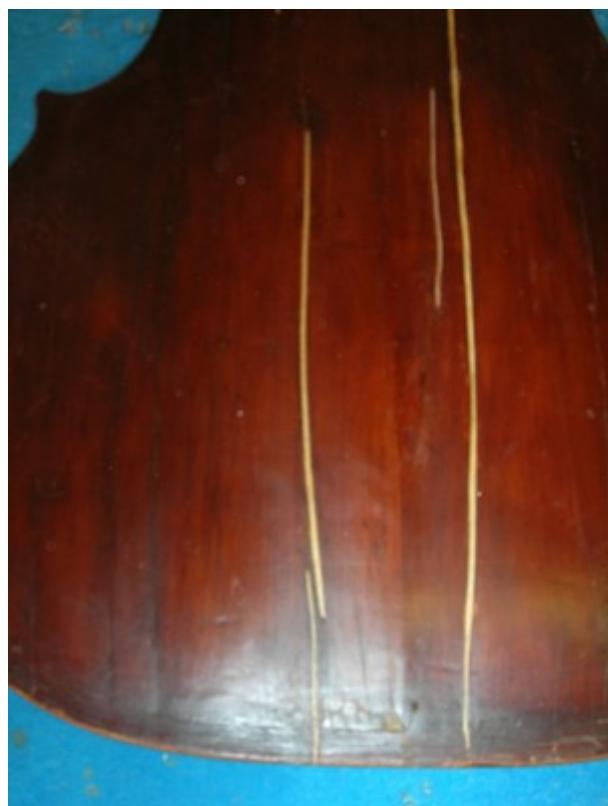
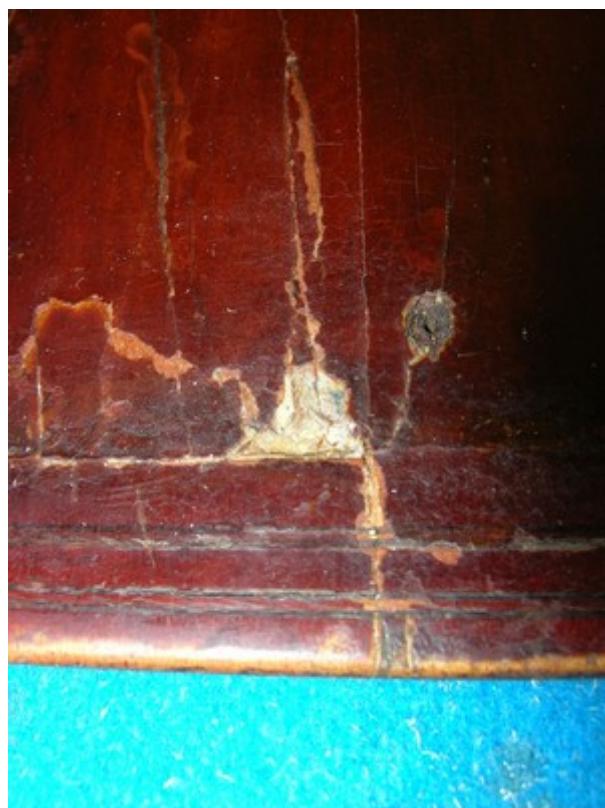
At the glueing surface of the lower block, a broken part has been reglued and a missing part filled. There is an hole flared on the outside as well.

I remake the missing parts.

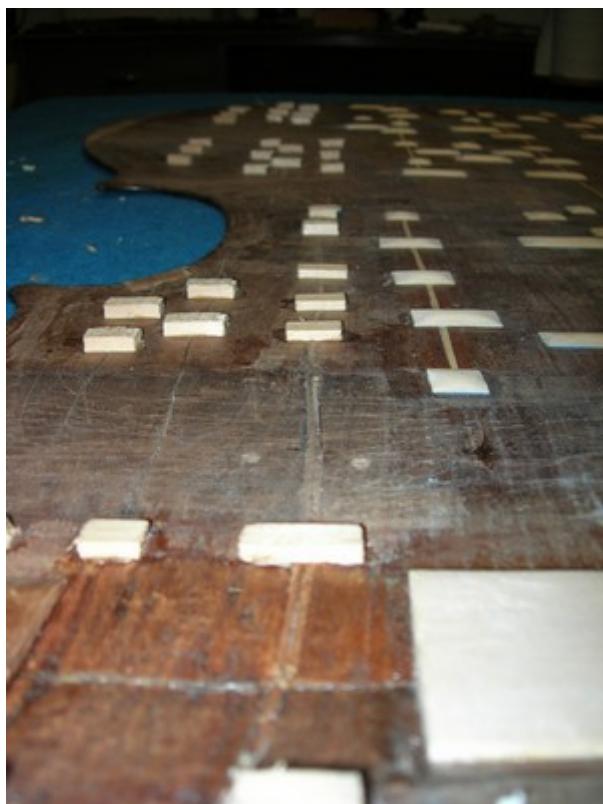
Then I uncover a crack by removing another section of the reinforcement.

This runs from the upper edge to the lower bar.

The section between the lower bar and the soundpost bar is open but has no filling shims.

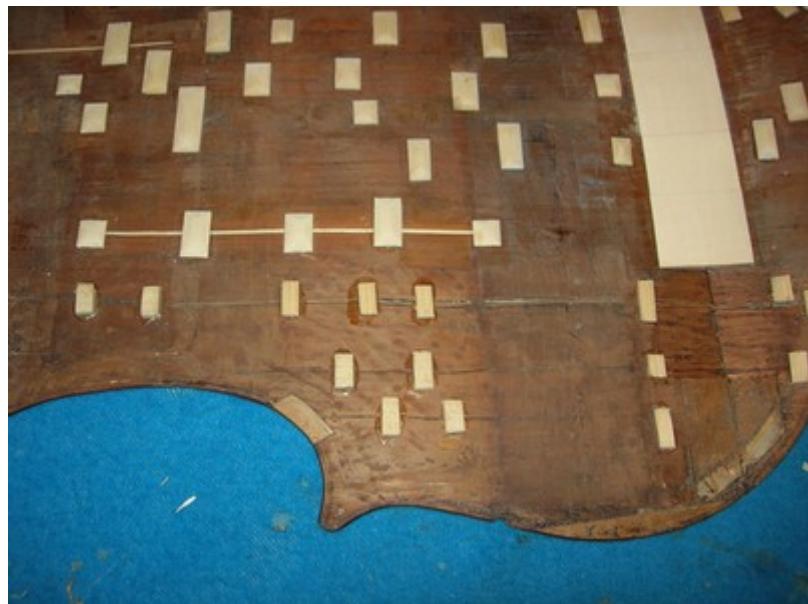
From the soundpost bar to the upper edge there are many shims, some side by side, and putty.

Also, the sides of the crack are offset on the inside, while they were smoothed and retouched from the outside, making the joint sunken.

I remove the temporary cleats and clean the crack.

Then repair the lower part with no filling shims, replace the two upper shims and put new cleats.

I pushed both sides of the crack on a flat surface on the outside to eliminate the sinking, while the unlevelling on the inside will remain as it is, with the cleats shaped to follow it.

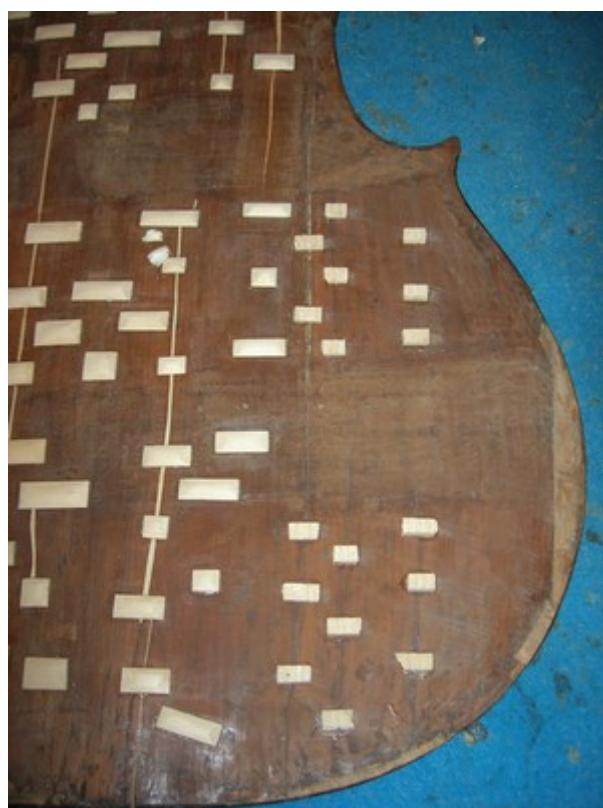
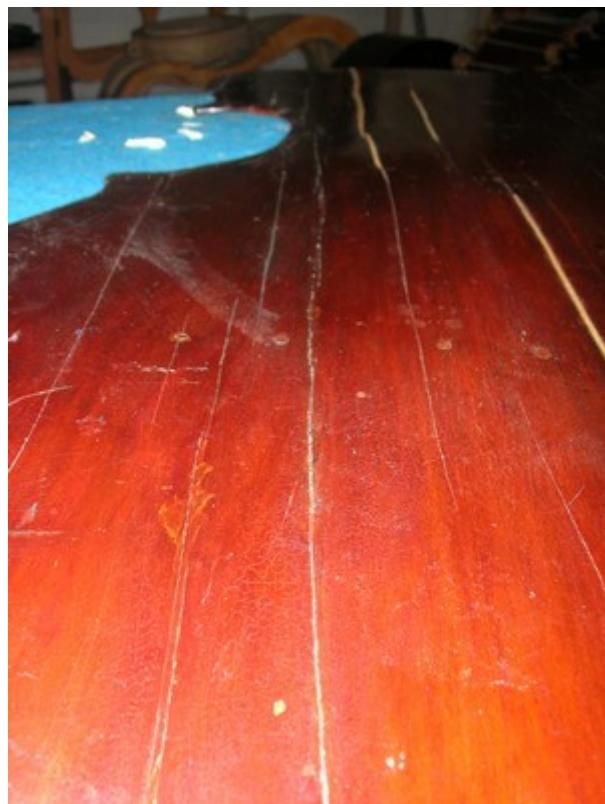
There is a crack in the lower part between the lower edge and the treble C bout, repaired with shims and filler.

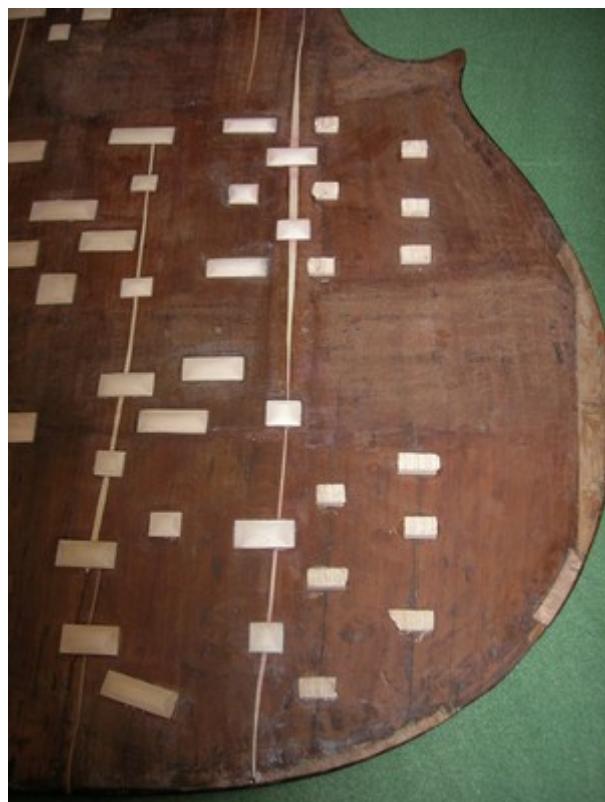
Two more cracks run parallel to the last, one between the lower edge and the glueing surface of the lower bar, the second one between the bar and the treble C bout.

In the lower crack a walnut shim was inserted from the outside, properly glued but missing a part on the inside

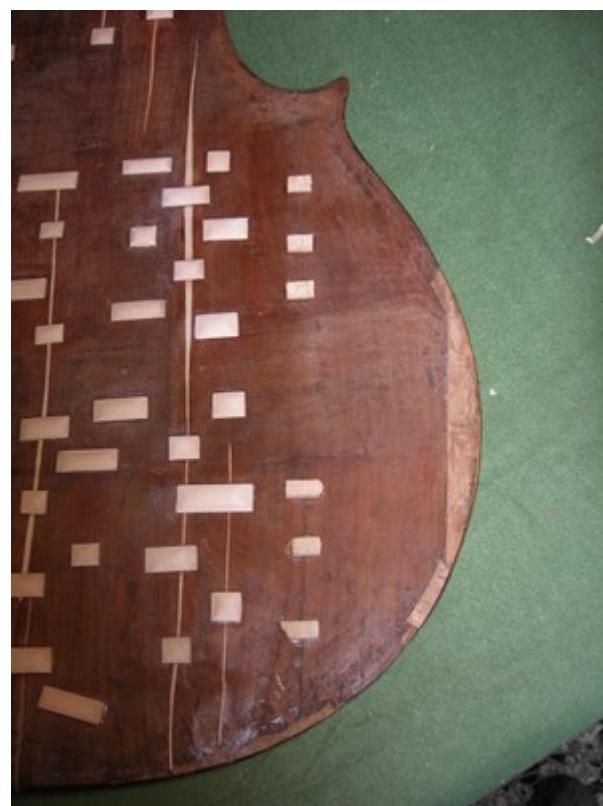
In the lower treble part there is a last crack, between the lower edge and lower corner, properly repaired with a shim, well glued.

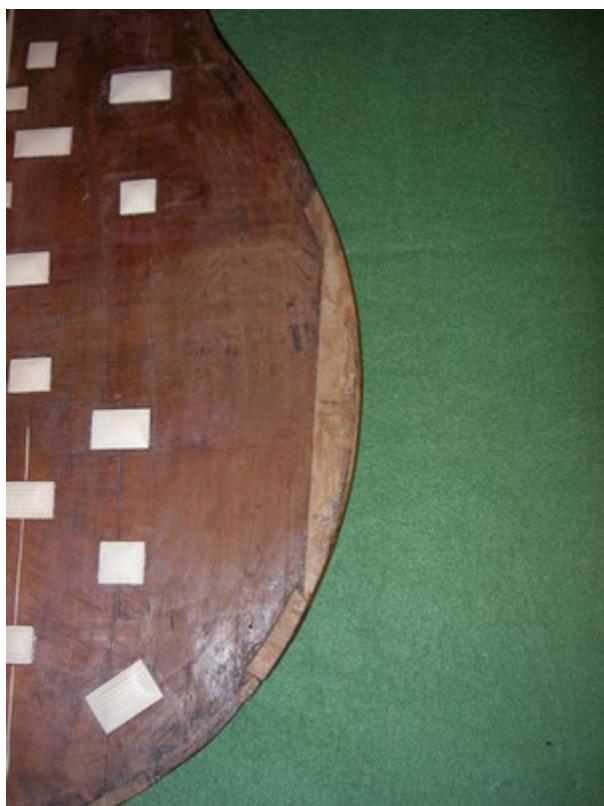
The widest part of the treble lower bout was reconstructed in various parts.

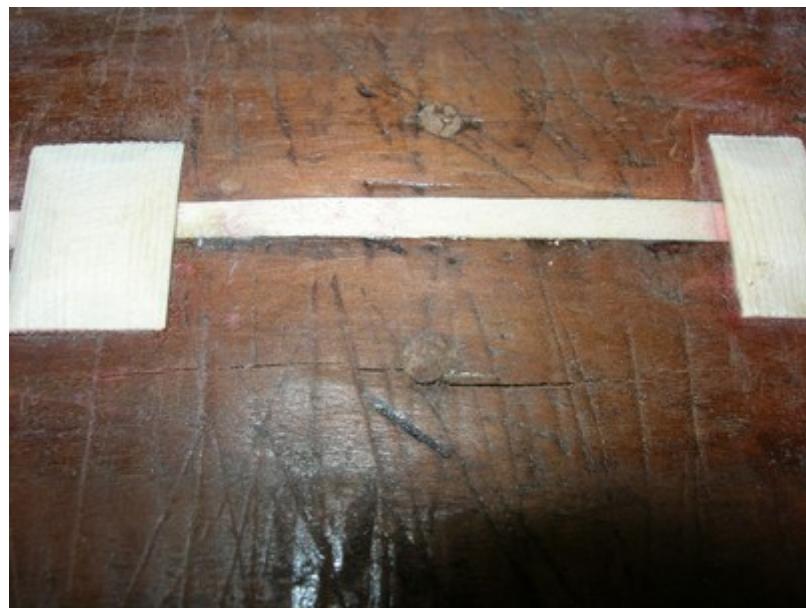
In the upper part I remove a pin in the upper bar glueing surface, which caused a small crack.

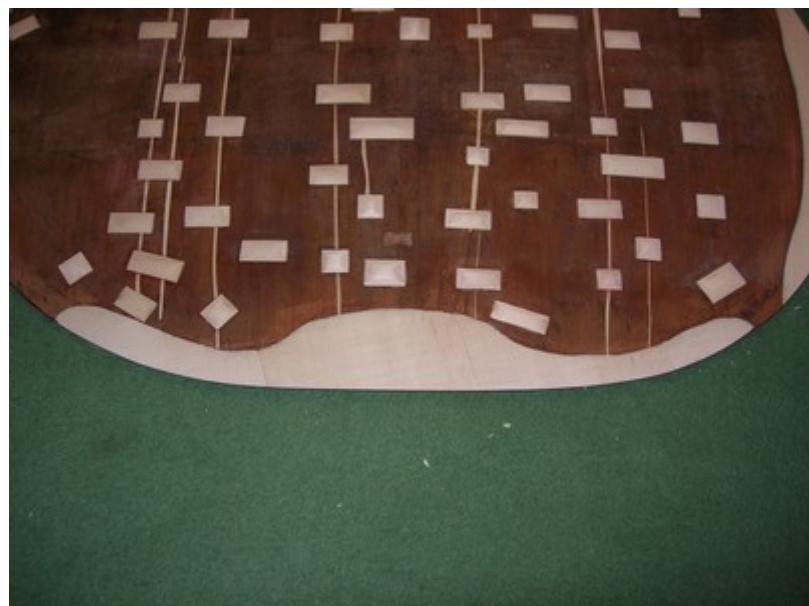
In the upper part, a crack is open from the bend to a reconstruction at the treble C bout. The reconstruction has the grain parallel to the C bout's edge.

I then make an edge doubling from the bend to the lower corner, to have a better glueing surface, to secure the upper reconstruction, to thin out and make less dangerous the reconstruction at the C bout, and to fill some missing spots.

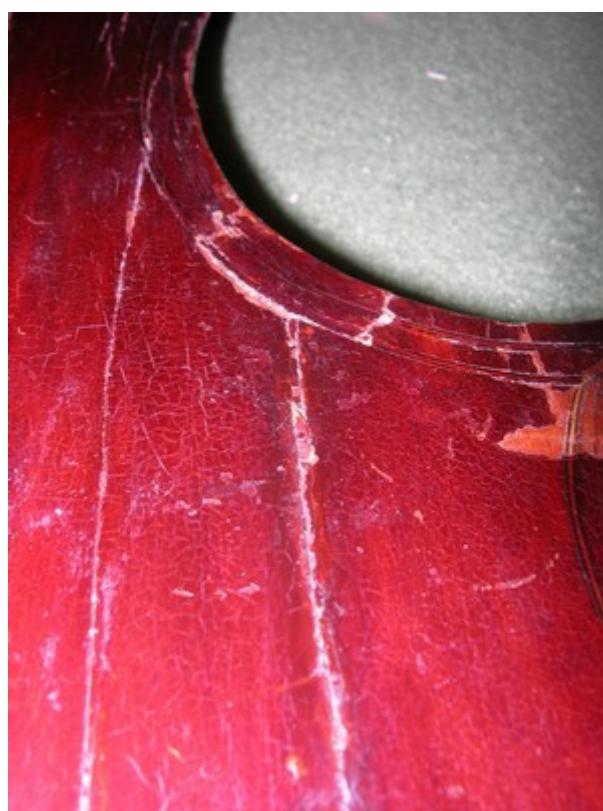
It has been repaired from the outside with a walnut shim and filler.

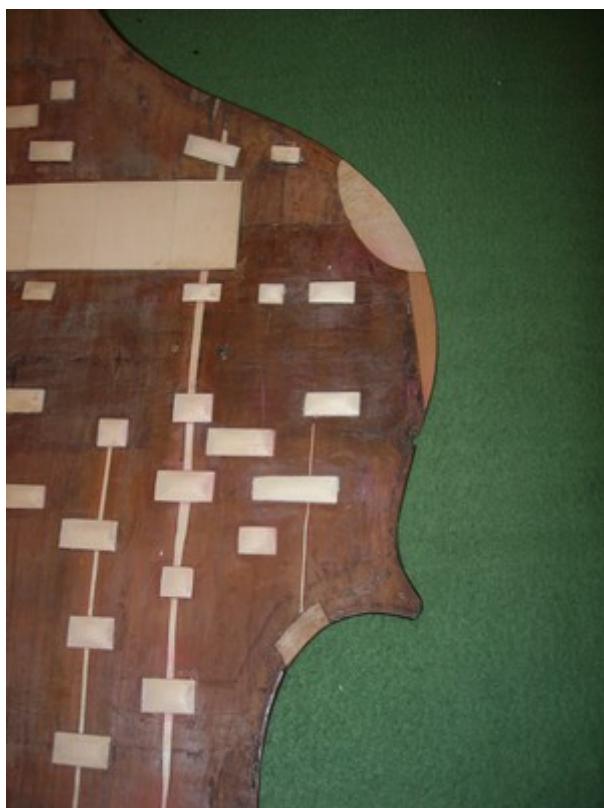
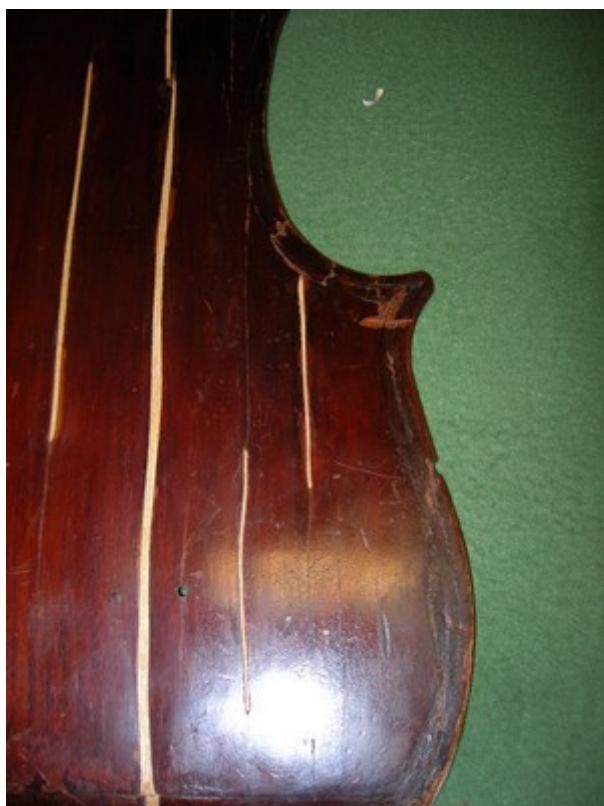
Next to this one, between the bend and the upper bar, a second small crack is open.
I clean and repair the two cracks, replacing the shim with a longer one.

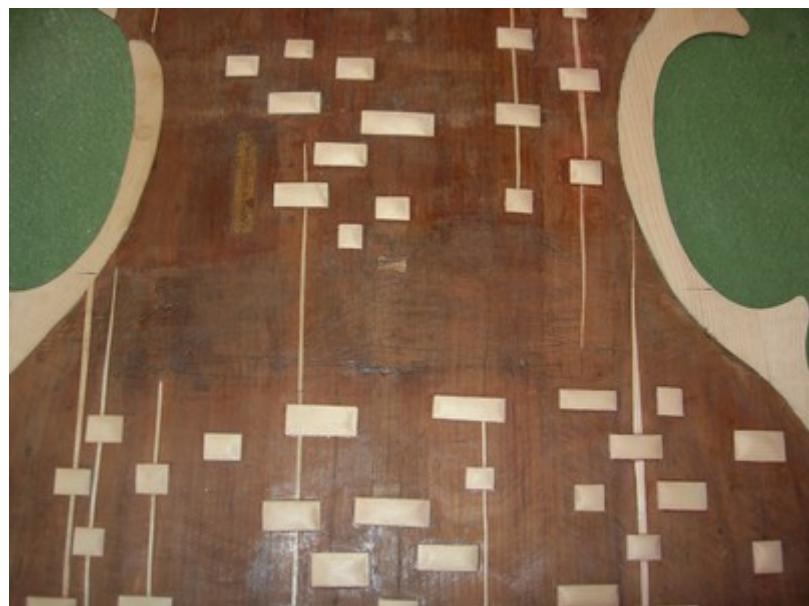
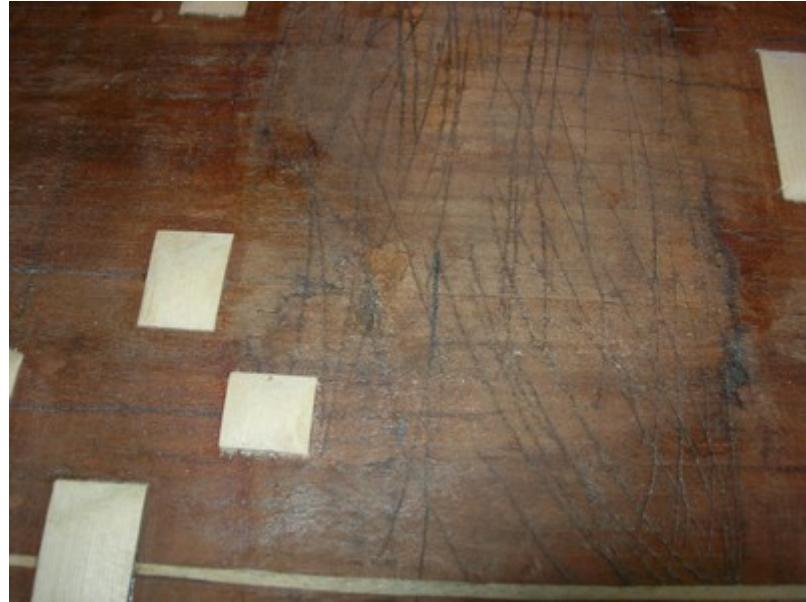
A previous one, narrower, had similar shape but sharper curves.

Both covered a butterfly insert at the center joint.

I decide to make a bar parallel to the upper one and to the bend, of constant width, narrow enough to not cover the butterfly insert.

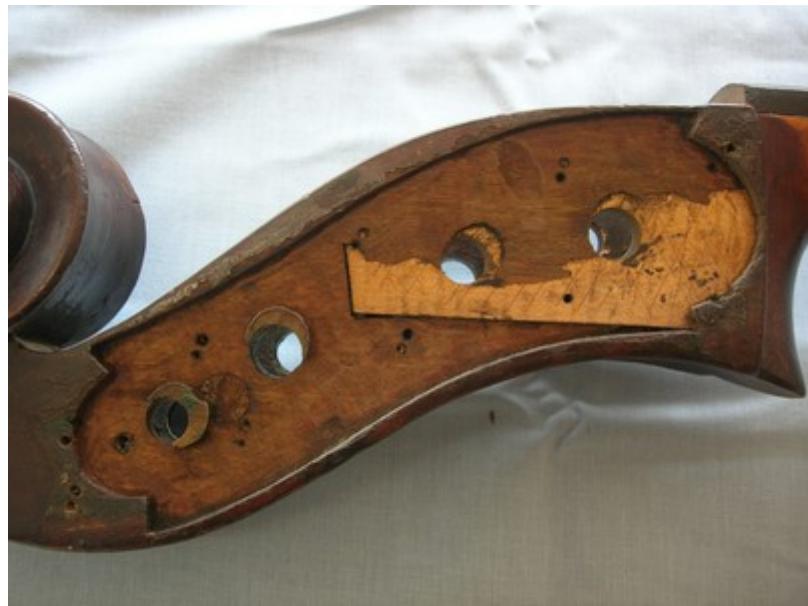
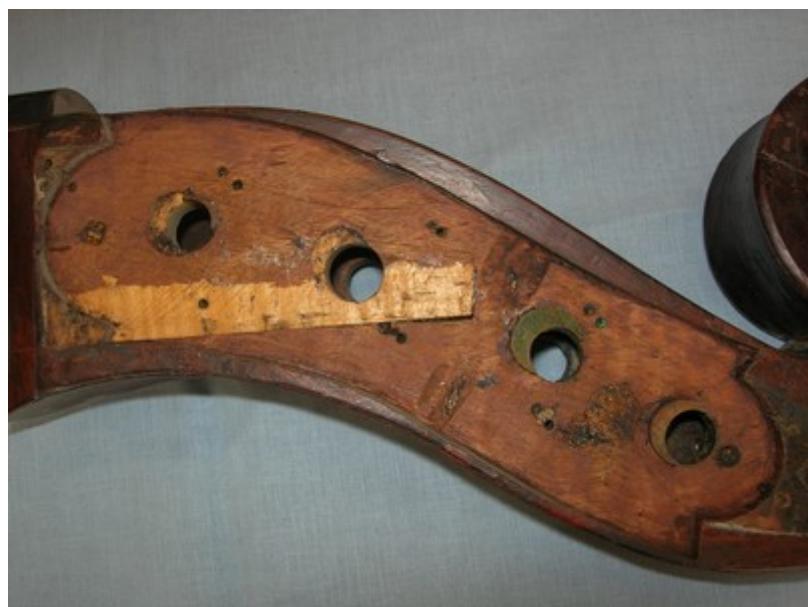
It is possible to see that at least two different stringings were used before the current.

One used three strings.

The hole closer to the scroll used for this stringing had been closed, of the central one a trace remains on the part of the cheek left from the carvings made to fit the external reconstructions and the graft, while the hole closer to the nut has been reused.

I remove the reconstructions in ebony and filler from the pegbox cheeks.

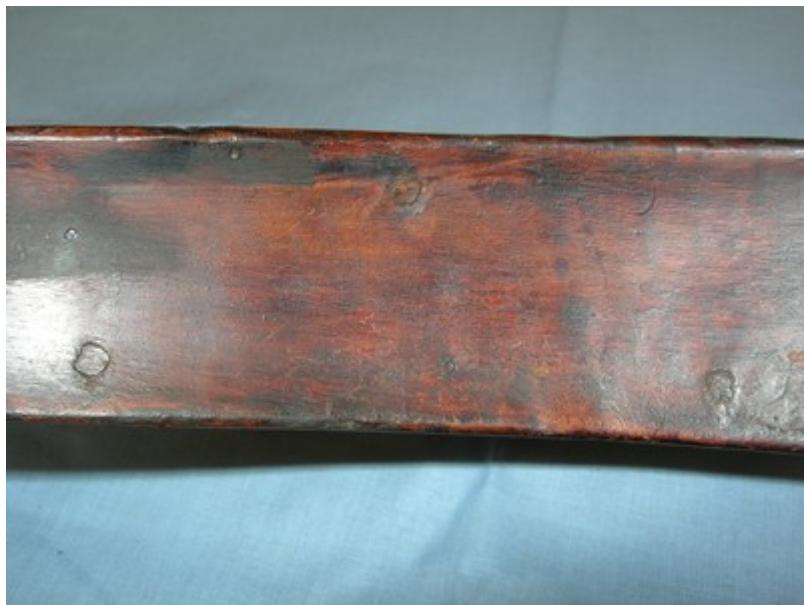
The three holes are aligned with pins on the back of the pegbox, which probably replace metal ones meant to keep in place an old kind of tuning gears.

The fact that the three holes on the cheeks are more or less perpendicular to the pegbox's centerline suggests that maybe pegs were used before.

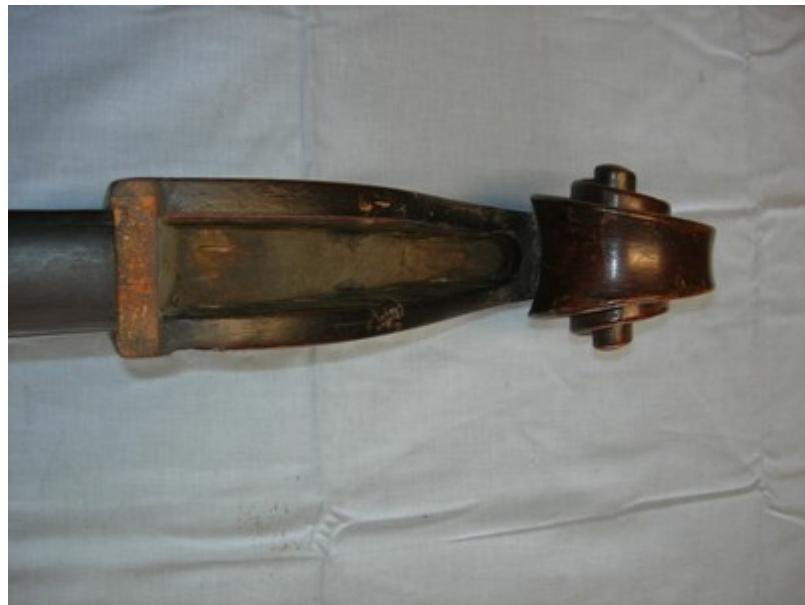
The position of the plugged hole, the last one of the three string set up, suggests that the peg box excavation has been extended to leave space for the four strings set up.

The nut's glueing surface, clearly finished together with the graft and cheeks, and the fact that the upper edge of the cheeks is lower than the nut, are clues that the cheeks were modified during the finishing of the neck graft.

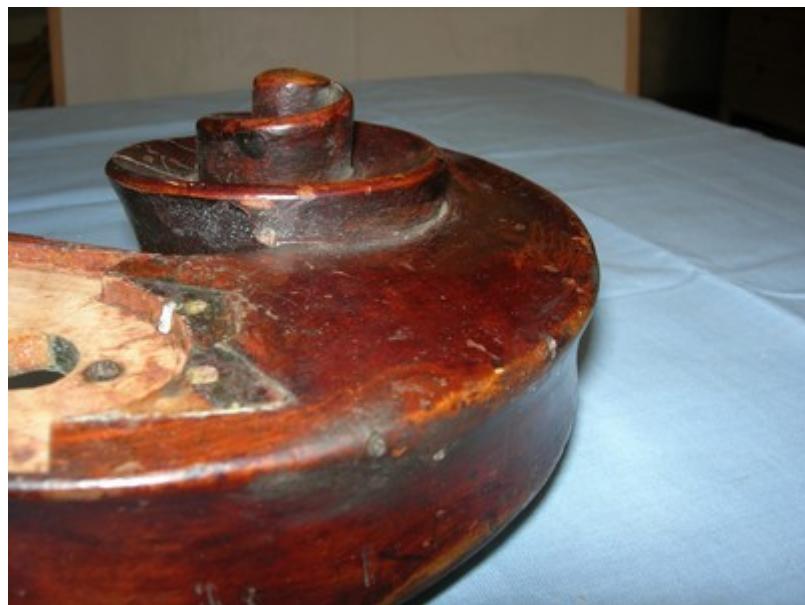
The cheeks are tilted towards the back of the peg box, which is 8 millimetres narrower than the upper part.

This contour continues in the first turn of the scroll, which is convex in the first part.

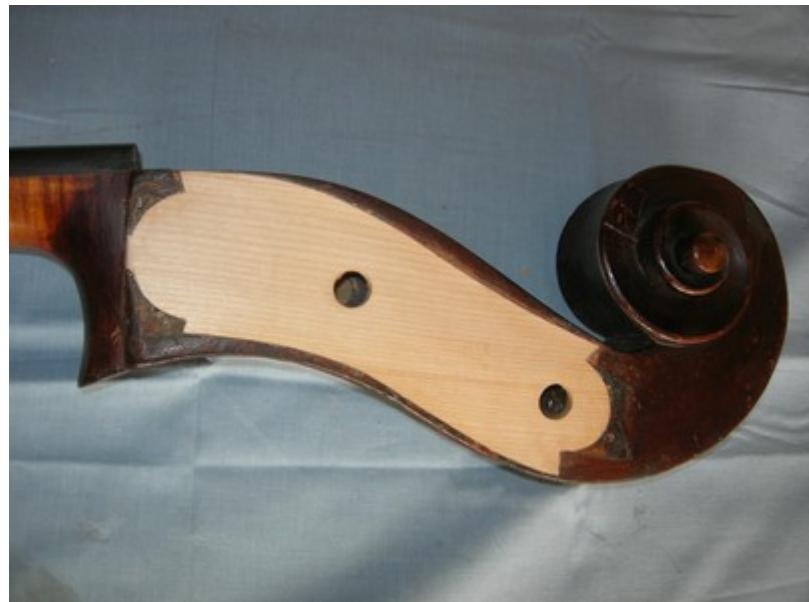
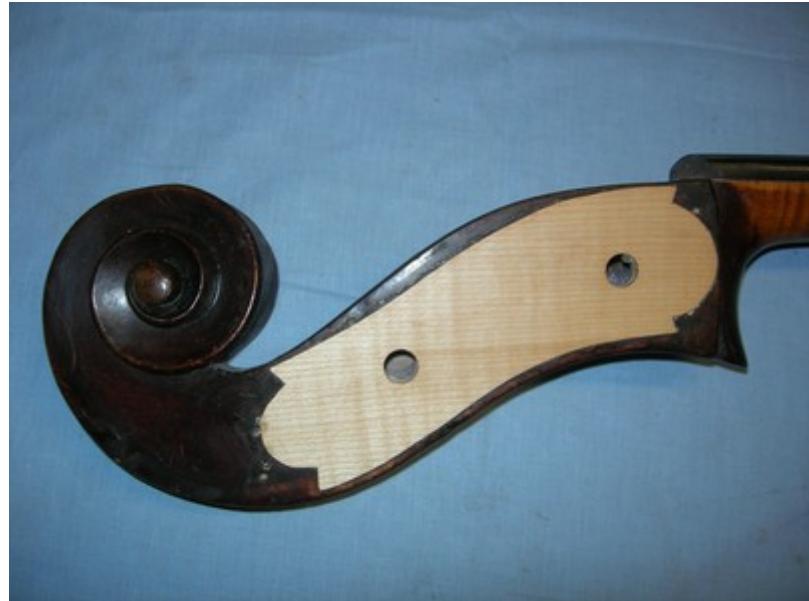
The exiting holes were not centered, so I had to close and redrill them, under the cheeks reconstructions.

I smooth the glueing surfaces and make the cheeks reconstructions; I drill holes corresponding the existing ones for the entering of the tuning gears, in order to not compromise the solidity with new holes.

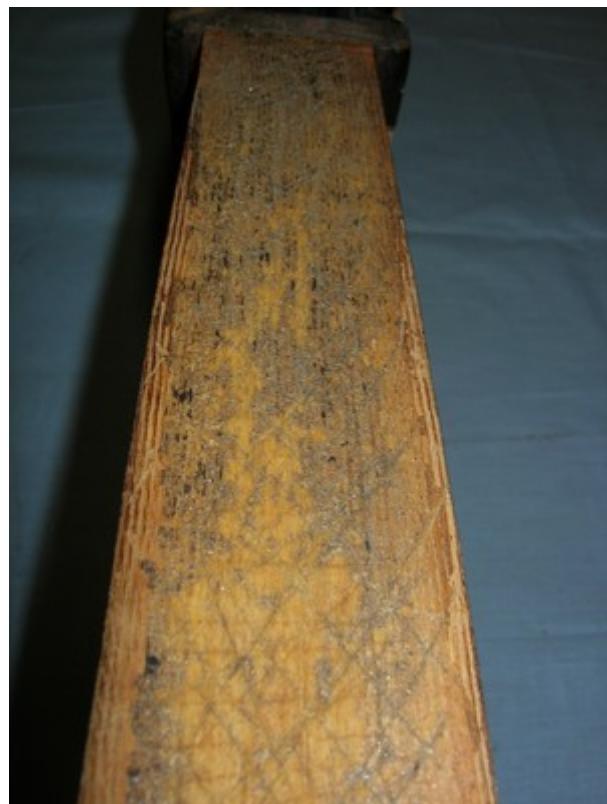
As I remove the fingerboard, it is possible to see marks made with a pointed tool on the glueing surfaces, very similar to the ones found on the back.

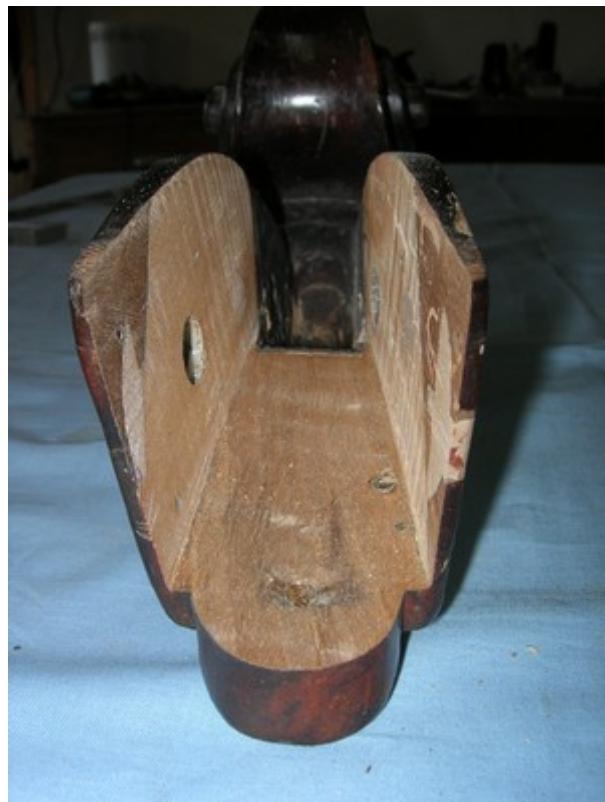
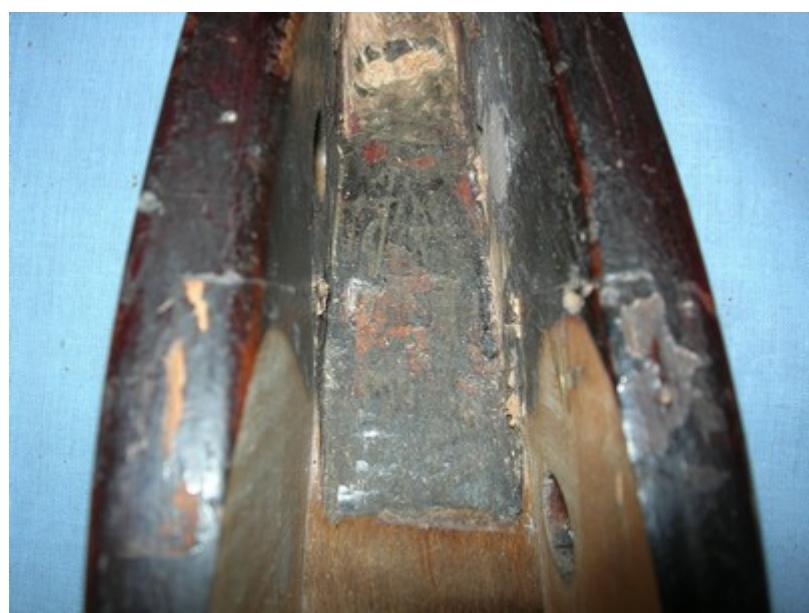
The previous graft had squared upper edges.

I make the cuts to graft the neck.

I do not remove the upper parts of the cheeks of the old graft, which are solid, to avoid weakening, and on these I make the new graft.

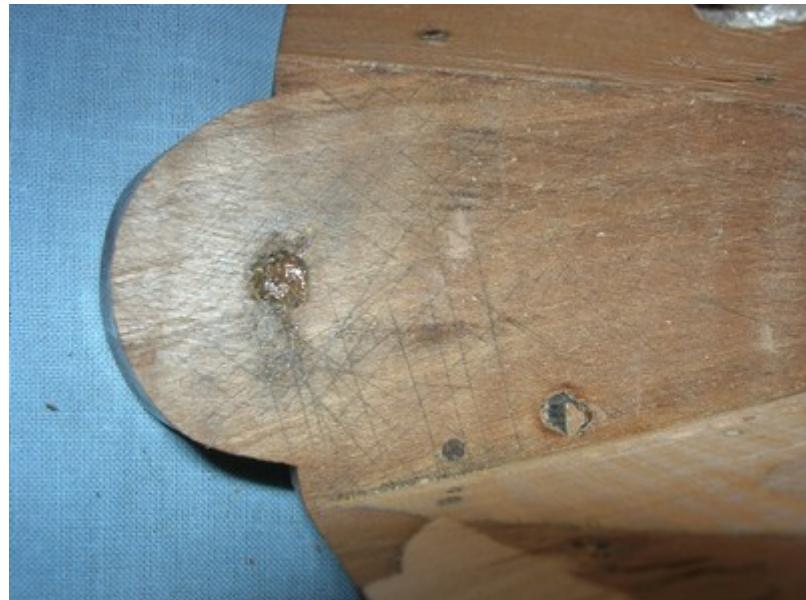
I though completely remove the remainings of the old graft from the back of the peg box.
The spine in the center of the button is flared towards the inside.

It is possible that before the last graft a screw was used for a bad repair of the base of the peg box.

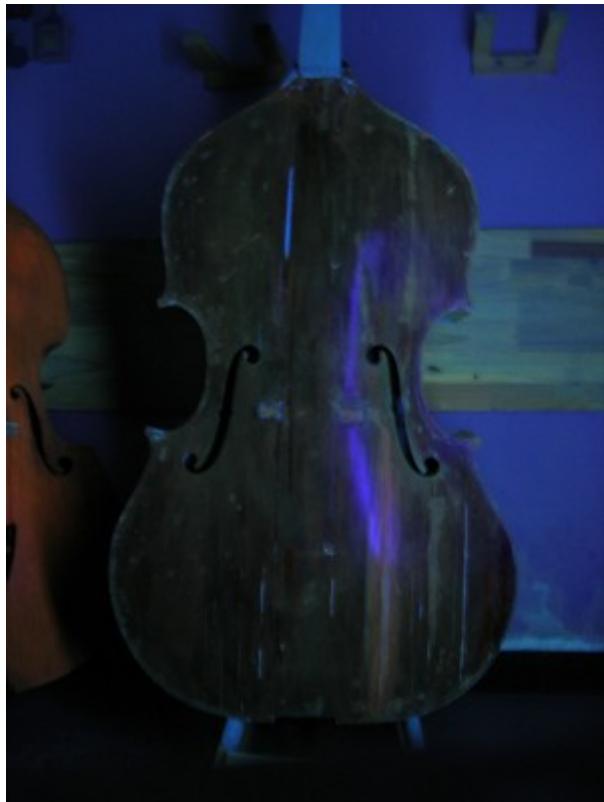
Superficial fillings are more extended on the top, covering many cracks, reconstruction joints, and woodworm holes in the bass bar area.

A very evident touch with orange fluorescence covers the long crack under the treble f hole, where the varnish was in the past scraped away down to the wood to eliminate a gap, and then replaced. This was definitely done after the application of the homogeneous layer.

For this reason I decide not to remove any of the layers, but only to clean the existing, retouching scratches, missing spots and reconstructions.

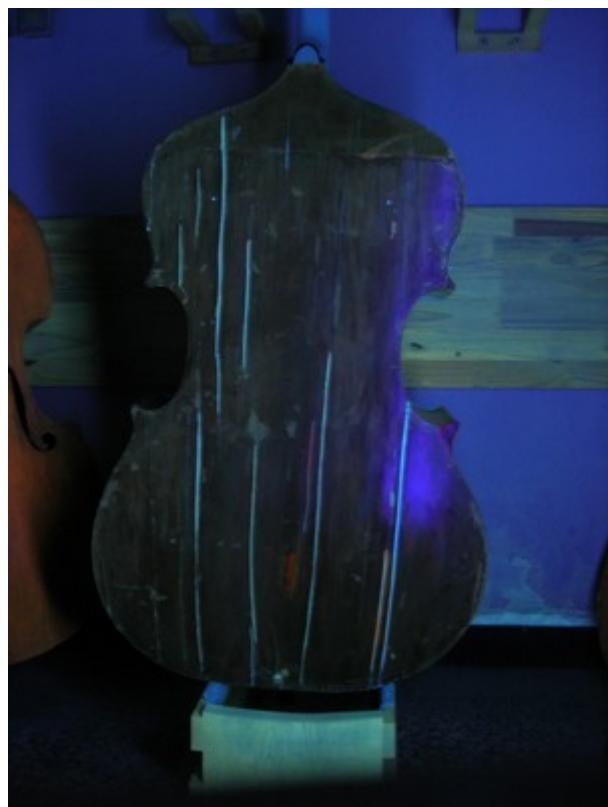
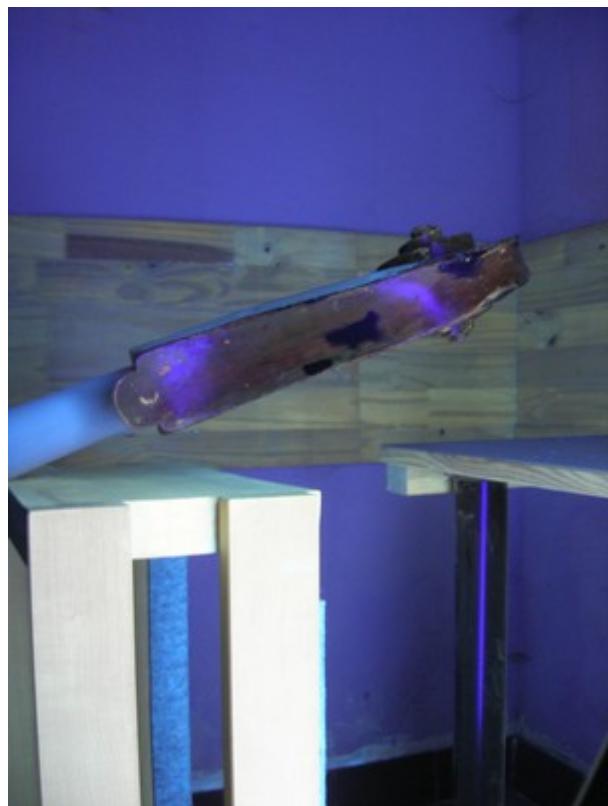
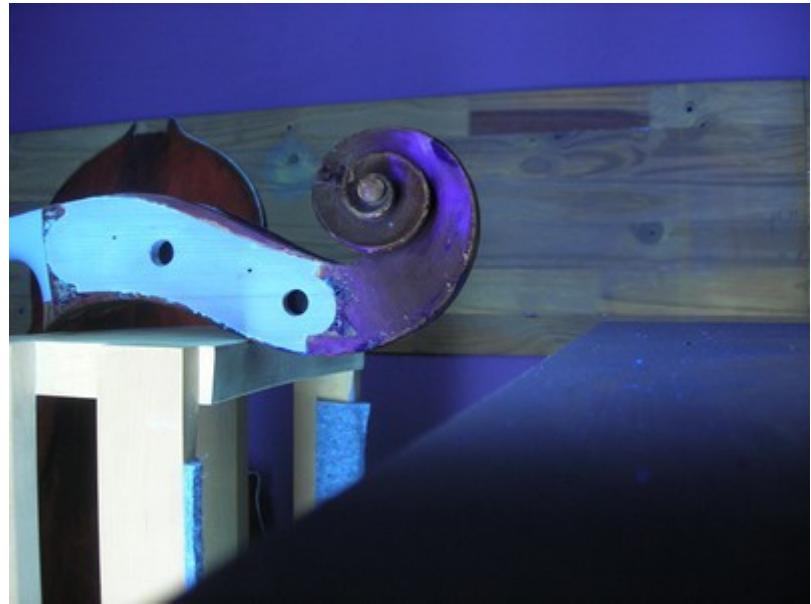
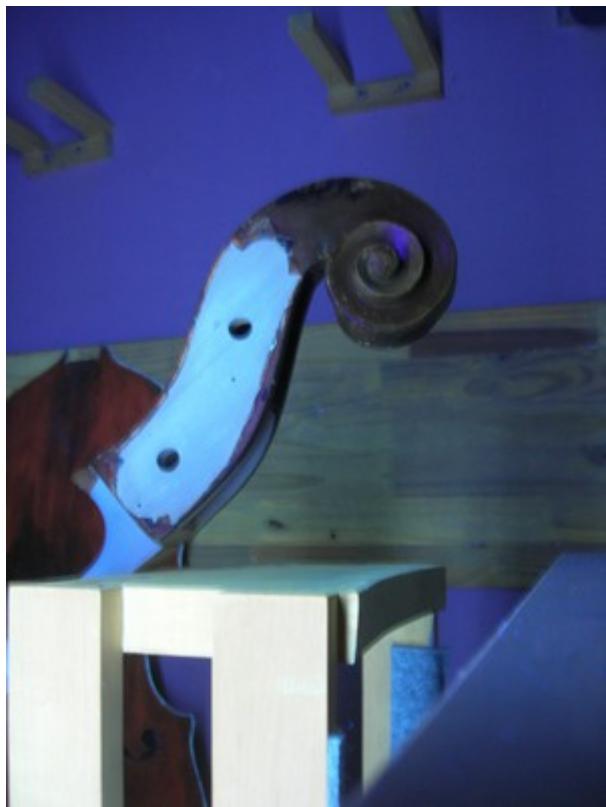
By doing so, many touches of various materials can be seen, over an homogeneous layer of varnish with gray-brownish tones.

The most frequent touches consist of a light gray, semitransparent varnish, rising over scratches and superficial fillings.
