# TAN003 - B402 RF Circuit Component

*B402 modules manufactured during week 28 of 2020 have incorrect components in their RF circuit, impacting connectivity.*

Published: Jan 5, 2021

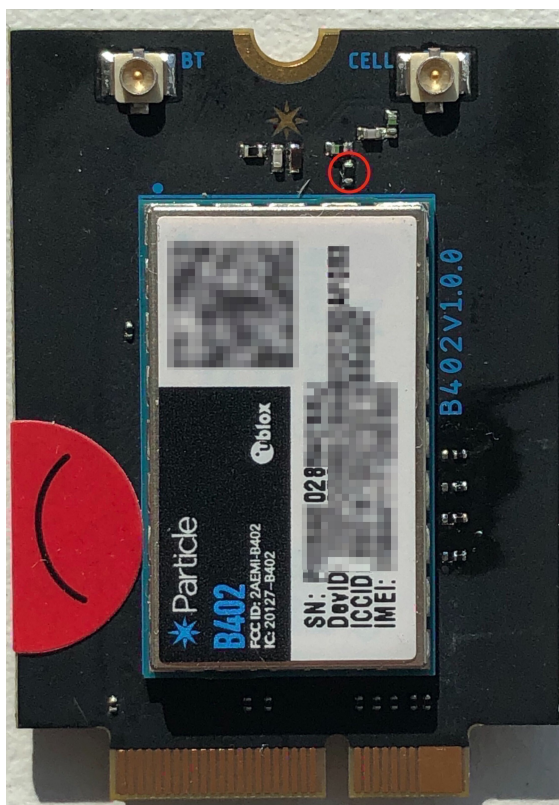
A manufacturing run of B402 SOMs in week 28 of 2020 mis-populated 10K resistors in place of 15pF capacitors in the RF matching circuit. This can lead to weakened connectivity and component heating.

If your device was manufactured during week 28, please perform a visual inspection to confirm if the incorrect component was placed. The photos below represent an incorrect and correct component usage respectively. The resistor (Black) highlighted in red is the incorrect component and the SoM should be replaced. The capacitor (Brown) highlighted in green is the correct component and the SoM should function normally.

*(Above: incorrect component)*

Particle will send a replacement for all affected units.

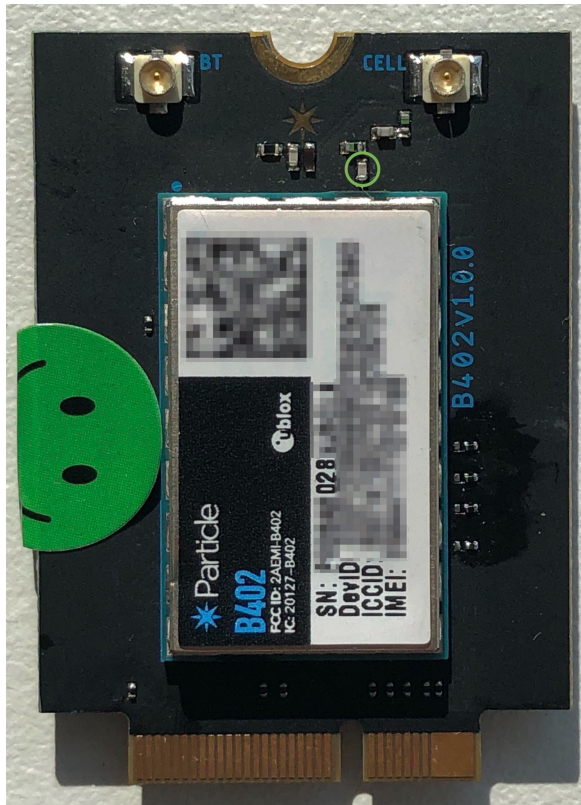
(Above: correct component)
