# TAN002 - Tracker One v1.0 Shipping Mode

*Shipping mode issue impacting Tracker One v1.0 devices manufactured before August 31, 2020.*

Published: May 4, 2021

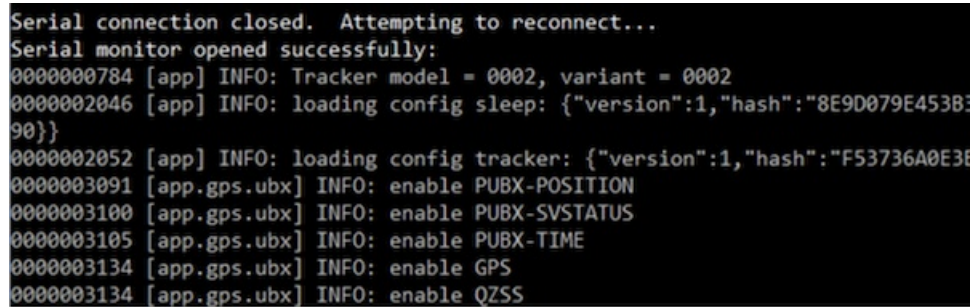
- Plug in a USB cable while monitoring the print on the CLI while the device is initializing Tracker Edge.
- A v1.0 device will be model = 0002 and variant = 0002, while a V1.1 device will be model = 0002 and variant = 0003, see picture below for a V1.0 device.
