# The Hydraulic Aspects of High Head Barrages

Ashish Doshi<sup>1</sup>, Manoj Kumar Gupta<sup>2</sup>, Amruta S. Kale<sup>3</sup>, Shital S. Nadagire<sup>4</sup> & P. B. Deolalikar<sup>5</sup>

<sup>1</sup>Director, Infraplan Hydraulic Laboratory, Pune, India

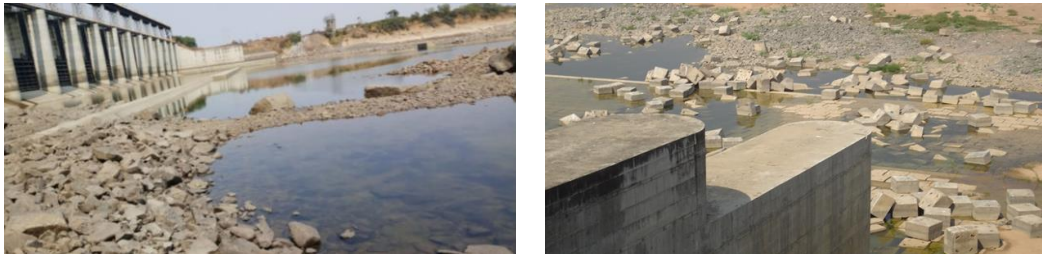
Balegaon barrage is constructed across river Godavari near Nanded in Maharashtra, India. Considerable damage to the river portion, just downstream of the Energy Dissipation Arrangement of the barrage, post construction was observed as seen in Photo 3.

**Photo 3 & 4:** Damages downstream of energy dissipation arrangement of barrages

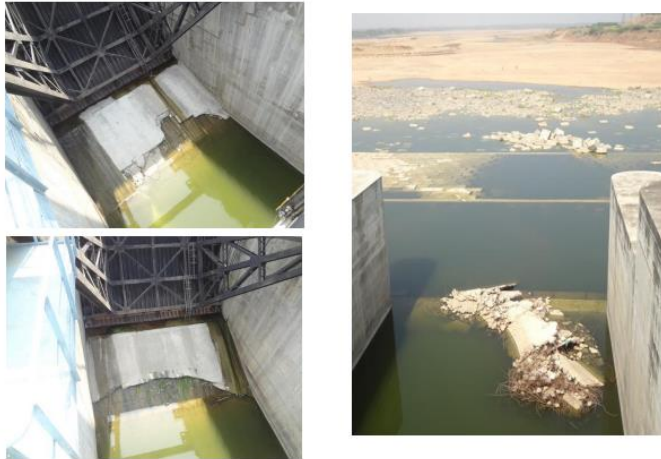
**Photo, 5, 6 & 7:** Damages to wearing coat and c.c. blocks

During the initial operations of barrage, tailwater levels were almost nil and gates were operated at crack opening which led to high flow velocities and instantaneous damages to the downstream. Due to non-availability of tailwater level, hydraulic jump could not be developed, and energy could not get dissipated. The high energy flow passed downstream and high turbulence was created making damages to the downstream C.C. Blocks and boulders were also dislodged and washed away. The probable causes for the damage of the wearing coat further include high velocity flows, associated turbulence and fluctuating velocities and various joints across the wearing coat. Due to hydraulic forces and consequent turbulence, the

fluctuating velocities were around 2 to 2.5 times the mean values depending on the turbulence intensity at that location. The drag and lift due to these phenomena resulted into the tearing and damages to the wearing coat. The project and design authorities recognized that recent damage to the barrage was primarily caused by inefficient energy dissipation and persistent high downstream velocities, due to low tailwater levels during smaller floods (10,000-15,000 m<sup>3</sup>/s). This also indicated a time lag in the development of tailwater levels.

Infraplan Hydraulic Laboratory (IHL) was involved in various aspects of the barrage's performance and the hydraulic analysis of damage to the wearing coat and downstream protection works for the project. After site visit and subsequent to numerous discussions with project authorities and after considering several alternatives, IHL recommended the provision of an extended stilling basin downstream of the existing structure. Consequently, the physical hydraulic model studies were referred to IHL for studying energy dissipation arrangement. A geometrically similar 1:45 scale sectional model covering four spans, conforming to Froude's similitude, was constructed at Infraplan Hydraulic Laboratory (IHL) in Pune to assess the efficacy of the existing stilling basin and to study alternative proposals for improving energy dissipation. The studies also included assessments of water surface profiles, flow conditions, the discharging capacity of the barrage, including the partial operation of the radial gates, and evolving the schedule of gate operations.

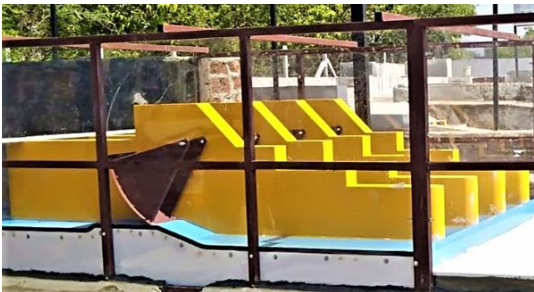
**Photo 8:** Model for existing situation

The hydraulic performance of the stilling basin was tested by measuring velocities, water surface profiles, pressures, and flow conditions. The studies indicated satisfactory performance of both the existing and extended stilling basins across a range of discharges. During initial overflows, velocities were low, but as the head increased, tailwater levels also rose, ensuring effective energy dissipation in the extended stilling basin. For smaller gate openings and low tailwater levels, ski-jump flow occurred due to the existing end sill, but this flow was dissipated effectively without high-velocity impacts reaching the bottom. However, some turbulent flows with velocities of 3 to 5 m/s were observed just downstream of the end sill. When tailwater levels exceeded 110 m, performance improved significantly. For gate openings of 3.5 m and above, it was recommended to open 60 spans equally, leaving three spans on either side closed. Some turbulence and fluctuating flows were observed in the existing stilling basin due to insufficient tailwater levels. Further the studies were carried out to assess the sediment deposition and movement in the stilling basin.

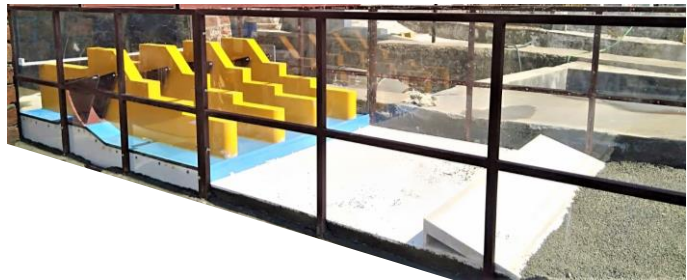
**Photo 9:** Model showing extended stilling basin with raised end sill

The hydraulic performance of the extended stilling basin was acceptable in terms of protecting the existing structure and diverting the high velocity flows of the order of 8 to 15 m/s downstream of the existing stilling basin by length of 50 m, thereby reducing the velocities in the range of 3 to 5 m/s. It was suggested to provide submerged divide walls in the stilling basin along the centerline of double piers. The studies indicated that the provision of the extended stilling basin would provide sufficient factor of safety to the existing structure as far as hydraulic performance as observed in the model for entire range of discharges and gate openings.

considered was raising the existing end sill from EL 104.5 m to EL 106.0 m. It was observed that, in the absence of tailwater levels, ski-jump like flow conditions were observed in the stilling basin as the downstream tailwater levels upto EL 107 to 108 m were not effective in formation of proper hydraulic jump in the existing stilling basin. Here it may be mentioned that, the length and the depth of the existing stilling basin is inadequate for dissipation of energy as per the design standards and criteria given in BIS in view of the actual tailwater levels realised at the project site.

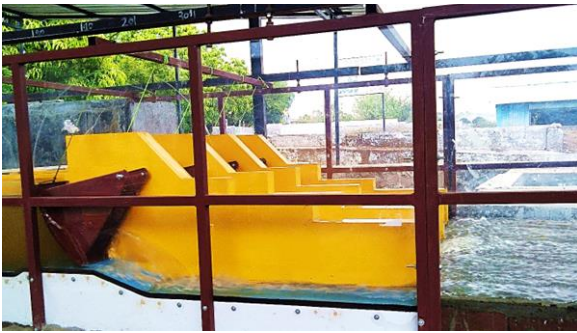
**Photo 10 :** Flow conditions for lower gate openings

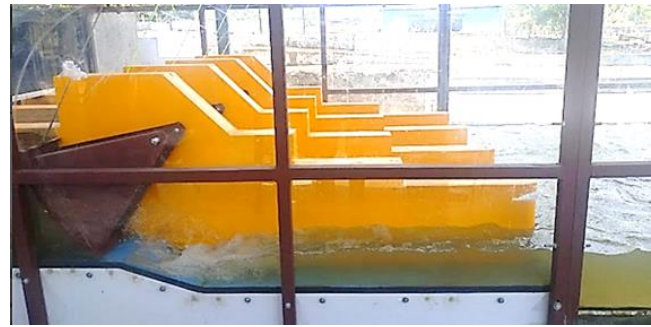
**Photo 11:–** Flow conditions after addition of extended stilling basin (hydraulic jump formed due to raised end sill of extended basin)
