# EdgeVision - Aerospace Inspection Report

**\*\*Inspection Report for Screenshot\_27-6-2026\_02229\*\***

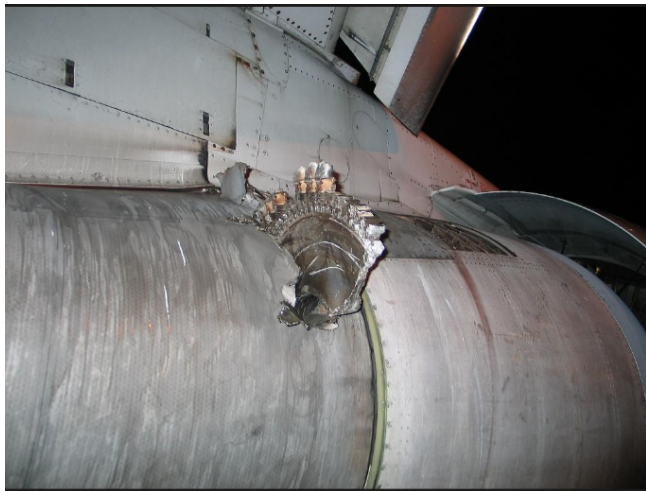
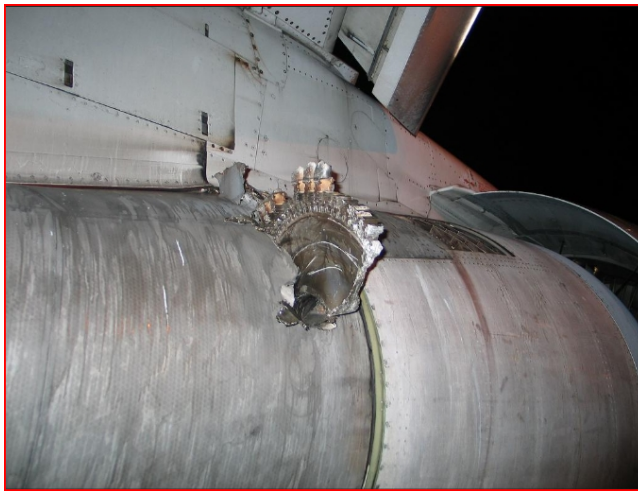
- Crack | conf 0.86 | risk: Critical | size: 99.3%

- A significant crack has been detected in the inspected component, covering approximately 99.3% of the image area. The detection confidence is high at 86%.

- Immediate inspection by a qualified aircraft maintenance engineer is required to assess the severity and implications of the crack. Given the critical risk tag, this defect poses a serious concern for structural integrity.

- Implement regular inspections of the affected area to monitor for any further deterioration or new defects.  
- Review maintenance protocols to ensure that similar issues are identified earlier in future inspections.
