## Detailed Diagnostic Report (DDR)

The property, Flat No. 103, exhibits widespread dampness issues in multiple internal areas including the hall, common bedroom, master bedroom, and kitchen, primarily at skirting levels and on walls. Bathrooms (Common and Master Bedroom) show signs of tile hollowness, open/gapped tile joints, and plumbing issues, leading to constant leakage. The external wall of the building near the Master Bedroom has visible cracks, duct issues, and moderately leaked external plumbing pipes, along with biological growth. Seepage is also noted in the parking area ceiling below Flat No. 103. Furthermore, Flat No. 203 has issues with open tile joints and outlet leakage in its bathrooms, which may be related.

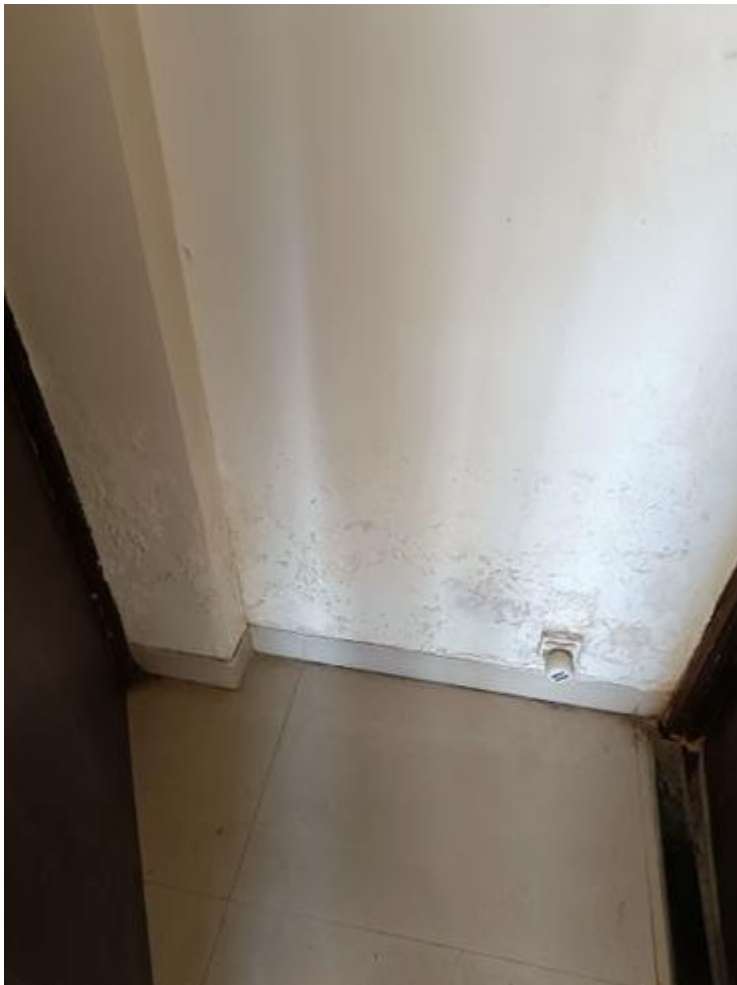
**Area: Hall (Flat No. 103)**

**Finding:** Skirting level dampness observed.

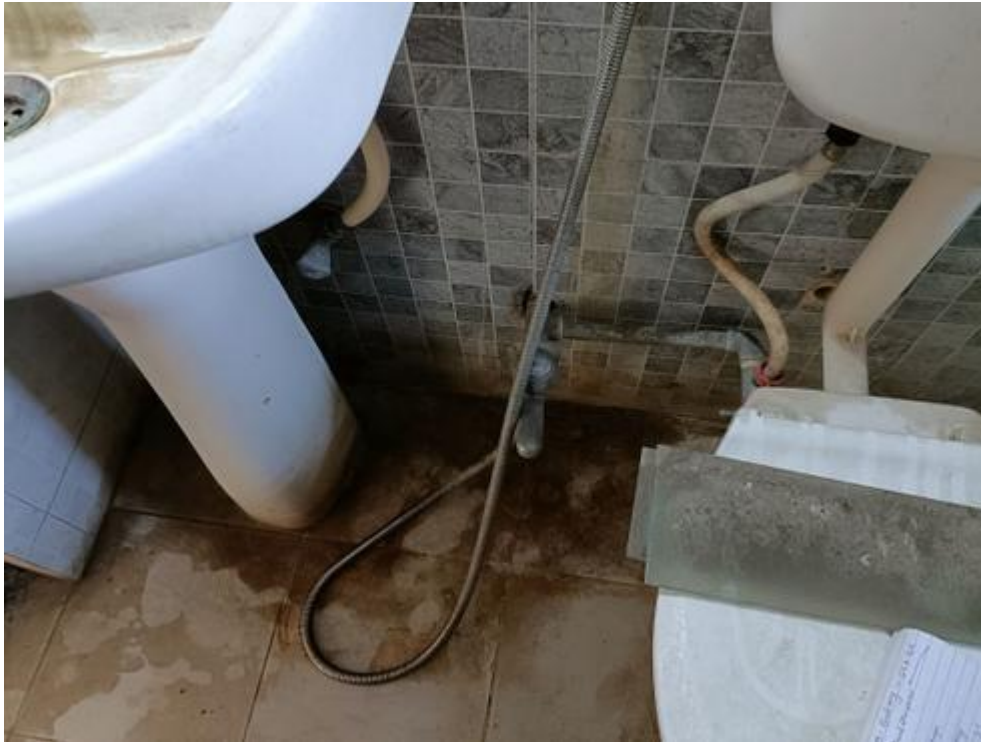
**Area: Common Bathroom (Flat No. 103)**

**Finding:** Tile hollowness, gaps between tile joints, and plumbing issues including gaps around Nahani Trap Joints and loose/rusted plumbing joints, leading to constant leakage.

1. Conduct a thorough inspection and repair of all identified plumbing issues in the Common and Master Bedroom bathrooms of Flat No. 103, including concealed plumbing lines, Nahani trap/brickbat coba, and loose plumbing joints. 2. Rework bathroom tile joints and address tile hollowness in both Common and Master Bedroom bathrooms of Flat No. 103. 3. Repair cracks on the external wall, RCC columns and beams, and the duct issue near the Master Bedroom. 4. Repair or replace all cracked and leaking external plumbing pipes. 5. Apply appropriate waterproofing solutions to affected external walls and internal wet areas to prevent future water ingress. 6. Treat dampness and efflorescence on interior walls and ceilings, followed by replastering and repainting of affected areas in the hall, bedrooms, and kitchen. 7. Investigate and repair the source of seepage in the parking area ceiling. 8. Coordinate with Flat No. 203 to address open tile joints and outlet leakage in their bathrooms, as this may be contributing to the overall problem.

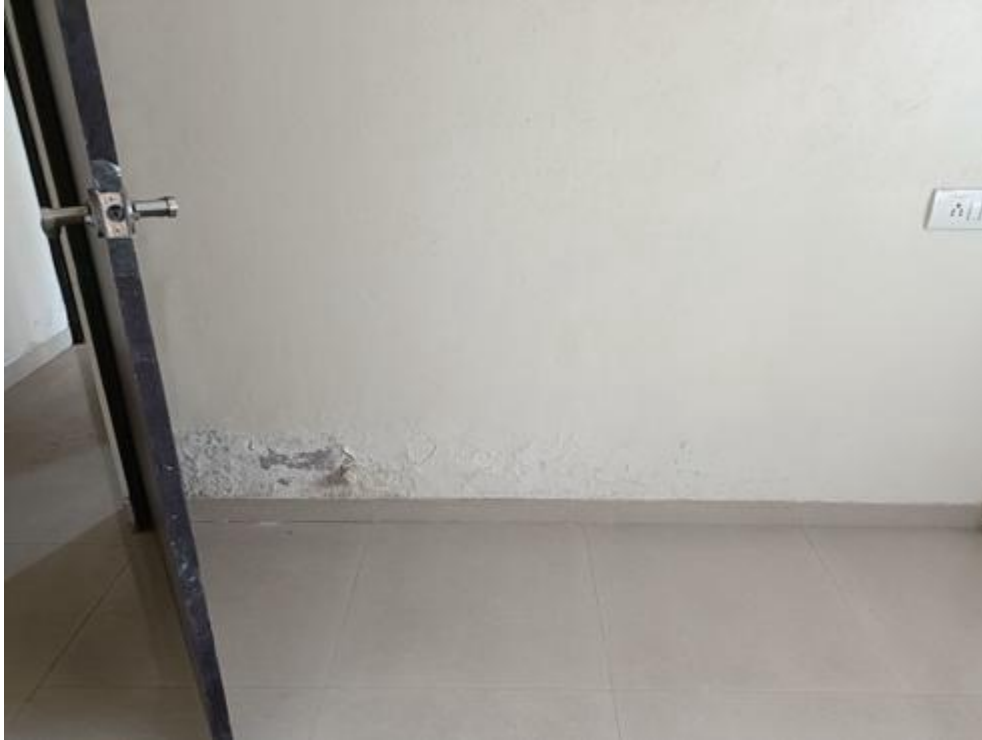
**Area: Common Bedroom (Flat No. 103)**

**Finding:** Skirting level dampness observed.

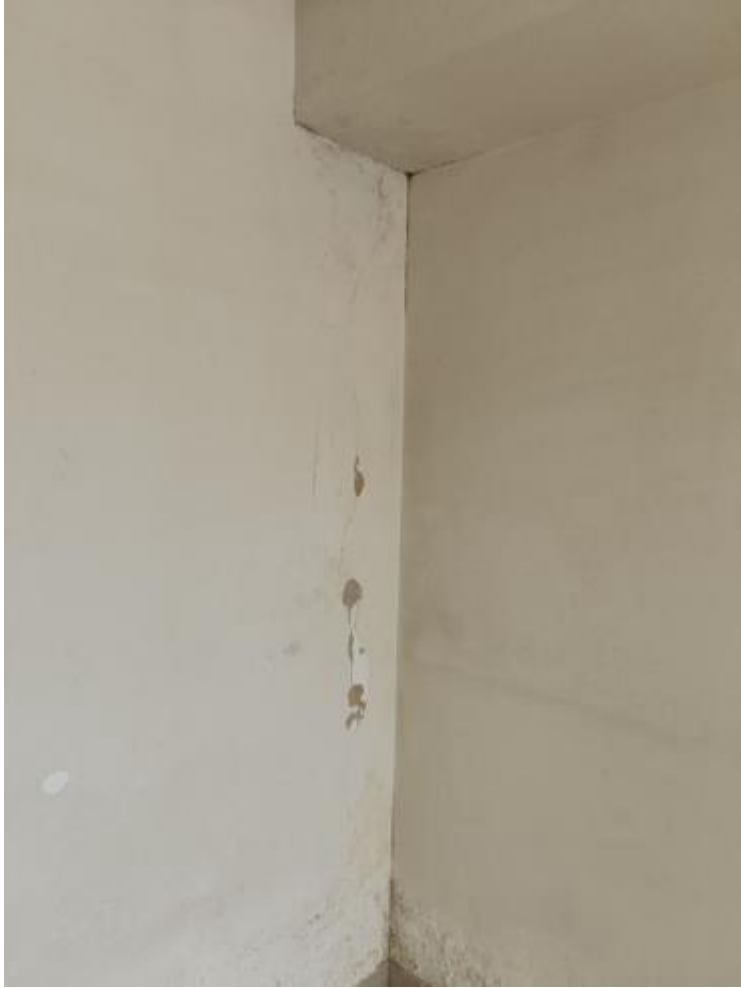
**Area:** Master Bedroom (Flat No. 103)

**Finding:** Skirting level dampness and efflorescence observed on the wall surface.

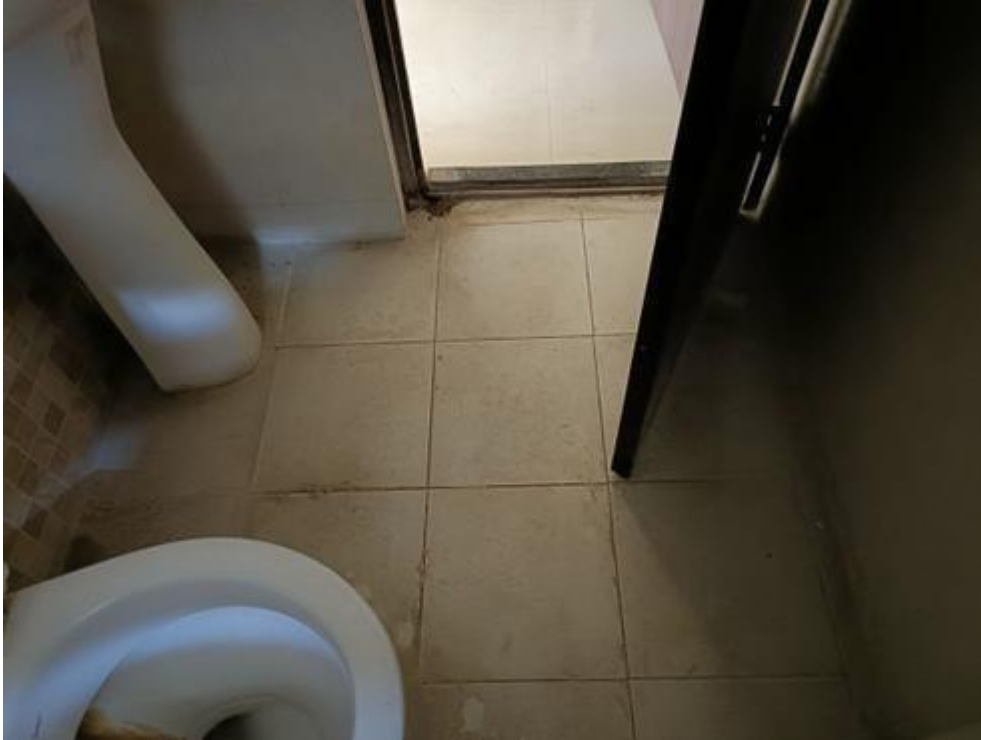
**Area: Master Bedroom Bathroom (Flat No. 103)**

**Finding:** Tile hollowness and gaps between tile joints observed.

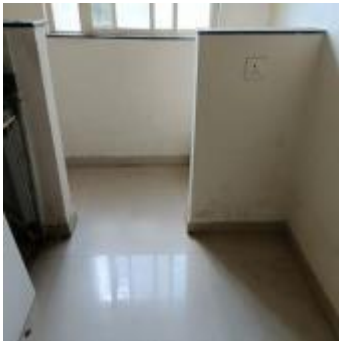
**Area: Kitchen (Flat No. 103)**

**Finding:** Skirting level dampness observed.

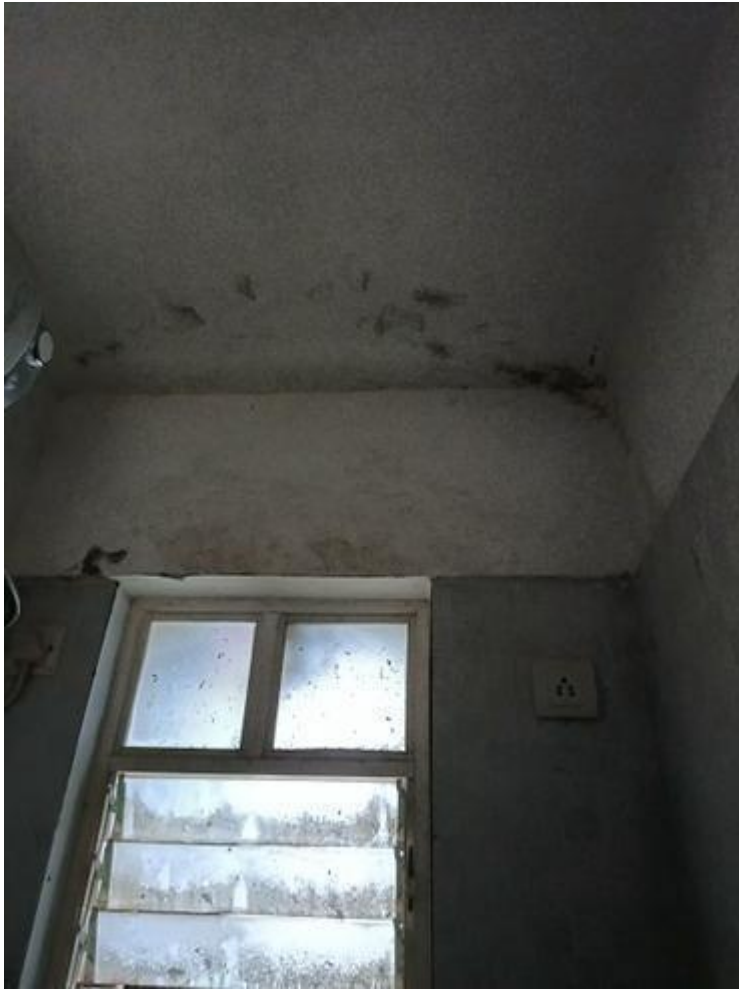
**Area:** Common Bathroom Ceiling (Flat No. 103)

**Finding:** Mild dampness observed.

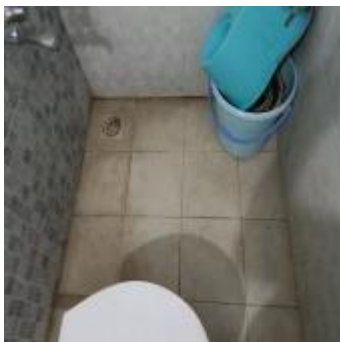
**Area: Common & Master Bedroom Bathrooms (Flat No. 203)**

**Finding:** Open tile joints and outlet leakage observed.
