AN-24 Accident at Nizhneangarsk, Russia

On Thursday 27 June 2019 an AN-24 of Angara Airlines, flight number 2G-200, flying from Ulan-Ude Airport was destroyed whilst landing at Nizhneangarsk Airport. Reportedly, the left engine had failed in flight. A video of the landing was posted online apparently taken by a passenger sitting on the right hand side under the wing (this video is called here video 'A').

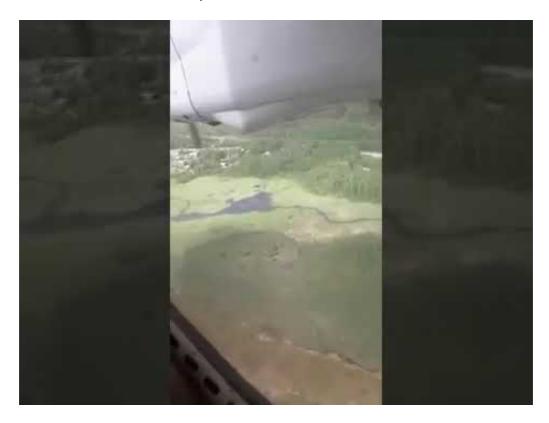
The aircraft approaches at high speed and after touchdown it veers off the runway to the right eventually colliding with a series of obstructions. This is some analysis of that video to give a picture of the speed, position and acceleration forces experienced by the aircraft.

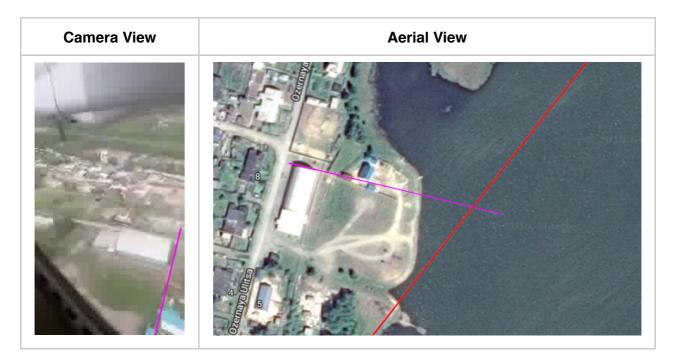
The second example is frame 483 (t=16.0s) where a two distinctive buildings are lined up:

This puts the aircraft at 1041 ±49m from the start of runway 23.

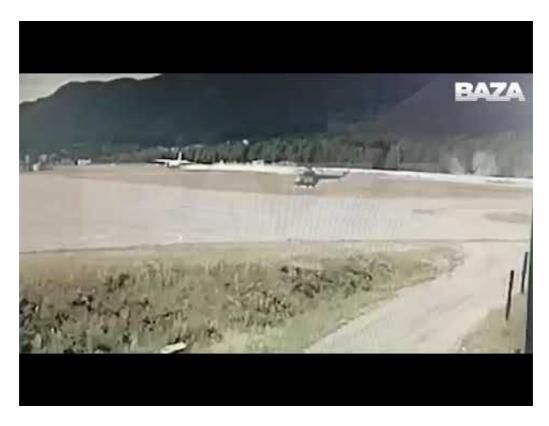
A second video was posted on YouTube that showed images from a security camera overlooking the airport, here referred to as video 'B'. The camera is facing roughly west south west and was recorded at 25 frames per second:

The distinctive foreground means the camera position is fairly easily identified on aerial imagery from Google Earth at a position x=491m down runway 23 and y=-161m to the left off the runway centreline.
