AN-24 Accident at Nizhneangarsk, Russia

On Thursday 27 June 2019 an AN-24 of Angara Airlines, flight number 2G-200, flying from Ulan-Ude Airport was destroyed whilst landing at Nizhneangarsk Airport. Reportedly, the left engine had failed in flight. A video of the landing was posted online apparently taken by a passenger sitting on the right hand side under the wing (called here video 'A').

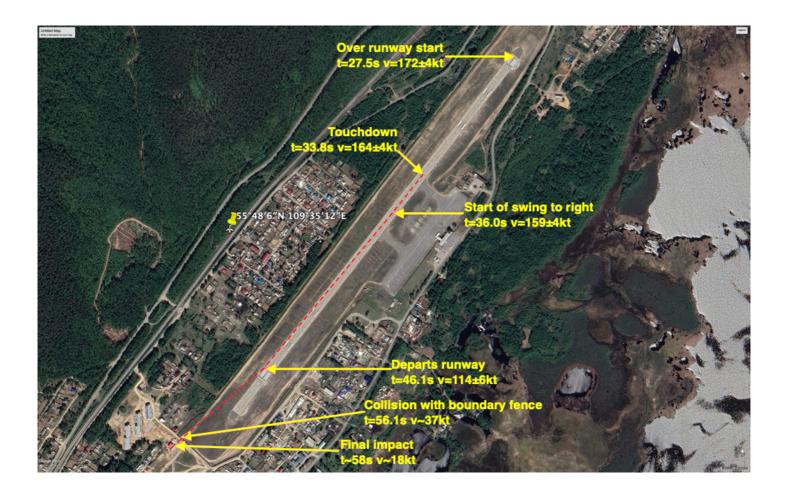
- The aircraft departs the runway at t=46.1 s, 1463±41 m down the runway at 58.7±3.0 m/s (114±6 knots). Acceleration is -3.9 m/s².
- At t= 56.1 there is an impact with the boundary fence 1853m from the start of the runway. This
 collapses the starboard undercarriage (and probably the port one as well). Impact speed is around 19
 m/s (37 knots).

- The aircraft would have slid to a stop roughly 45m later unfortunately there was a building 36m from the boundary fence which is the site of the final impact. Time is about t=58.0 and speed is somewhere around 9 m/s (18 knots).

The annotated image below shows the estimated ground path of the aircraft in dotted red with significant events in magenta:

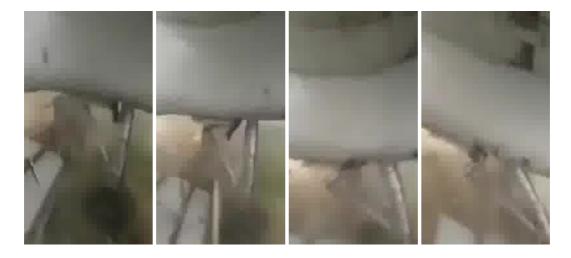
At t=56.1s the aircraft collides with the boundary fence and this fence is readily identifiable on the aerial imagery as being 1853m from the start of runway 22. The sequence below shows four consecutive frames from the video of the starboard undercarriage collapse as the aircraft goes through the airfield boundary.

The first frame [1684] shows the moment before impact, the obstruction is on the left which looks like as substantial concrete block, the dark disc at the bottom is the tyre and the silver vertical is the undercarriage leg. The second frame (t=56.1s) shows the moment of impact and the last two frames show progressive collapse of the starboard landing leg. The last frame is rotated somewhat to right, most likely due to the forces on the person filming which would naturally rotate a hand held camera to the left.
