## AN-24 Accident at Nizhneangarsk, Russia

On Thursday 27 June 2019 an AN-24 of Angara Airlines, flight number 2G-200, flying from Ulan-Ude Airport was destroyed whilst landing at Nizhneangarsk Airport. Reportedly, the left engine had failed in flight.

This is an analysis of these videos that gives a picture of the speed, position and acceleration forces experienced by the aircraft.

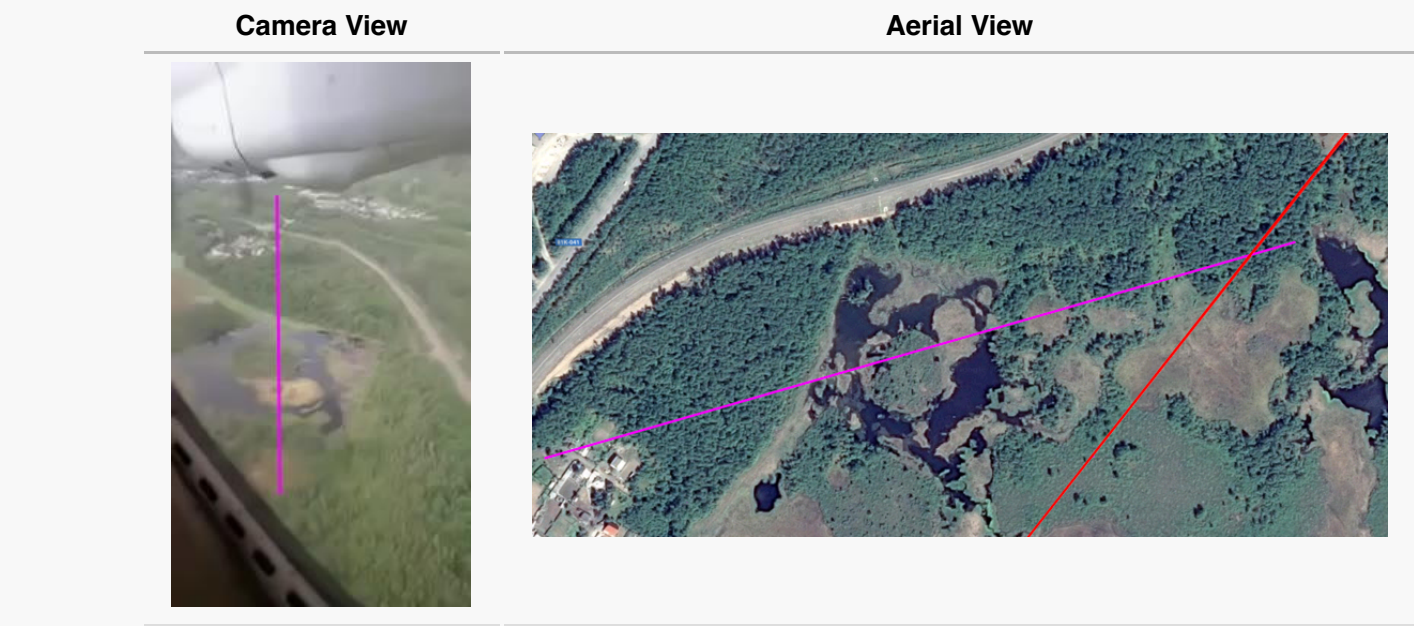
Here are two examples. Frame 1 ( $t=0s$ ) shows the line up of the edge of a settlement with a dark smudge on a sandy part of an island. The magenta line shows the estimated ground line the aircraft is flying across, the red line is the extended centreline of runway 23:

This puts the aircraft  $2490\pm98m$  from the start of runway 23.

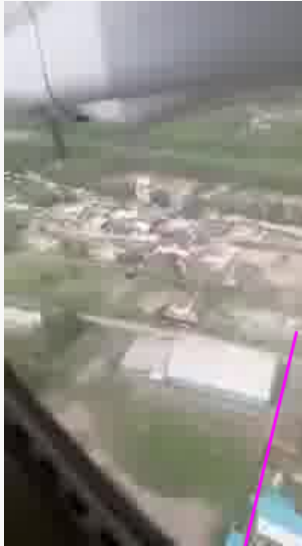
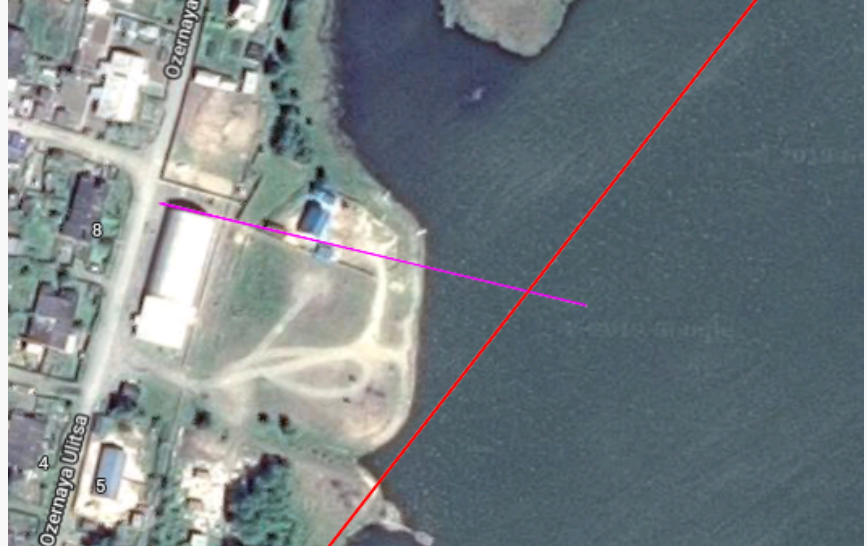
The second example is frame 483 ( $t=16.0s$ ) where a two distinctive buildings are lined up:

This puts the aircraft at  $1041 \pm 49\text{m}$  from the start of runway 23.

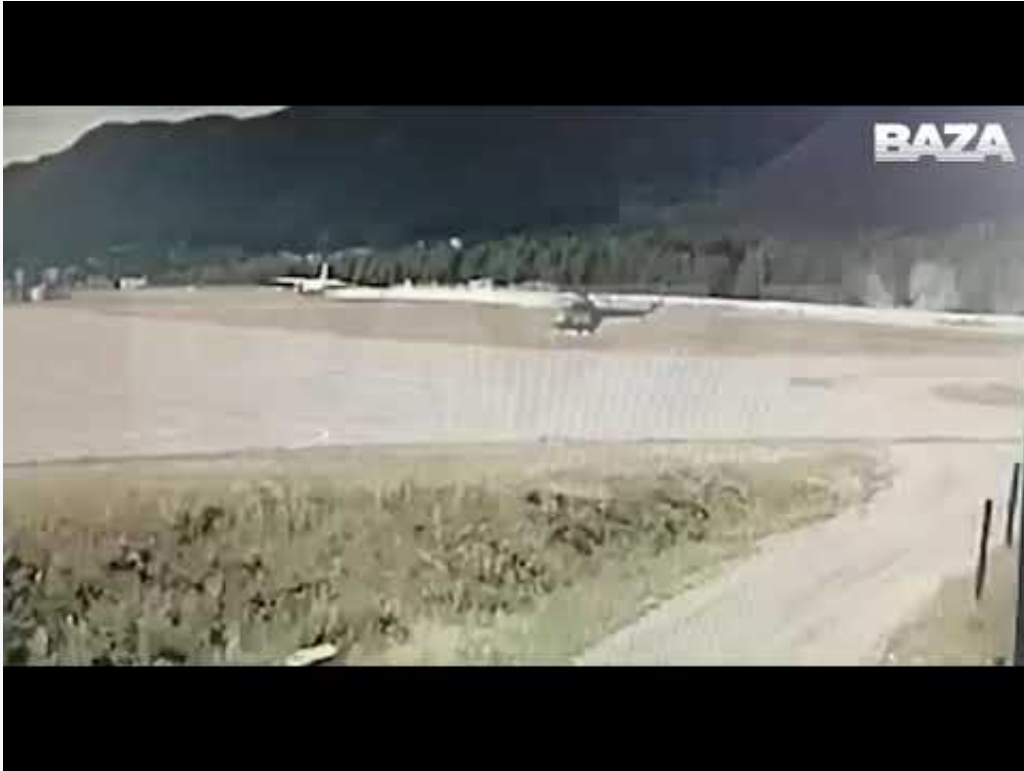
A second video <https://youtu.be/BQ8ujmRhLH0> was posted on YouTube that showed images from a security camera overlooking the airport, here referred to as video 'B'. The camera is facing roughly south west and was recorded at 25 frames per second.

The distinctive foreground means the camera position is fairly easily identified on aerial imagery from Google Earth at a position  $x=491\text{m}$  down runway 23 and  $y=-161\text{m}$  to the left of the runway centreline.
