## AN-24 Accident at Nizhneangarsk, Russia

On Thursday 27 June 2019 an AN-24 of Angara Airlines, flight number 2G-200, flying from Ulan-Ude Airport was destroyed whilst landing at Nizhneangarsk Airport. Reportedly, the left engine had failed in flight.

This is an analysis of these videos that gives a picture of the speed, position and acceleration forces experienced by the aircraft.

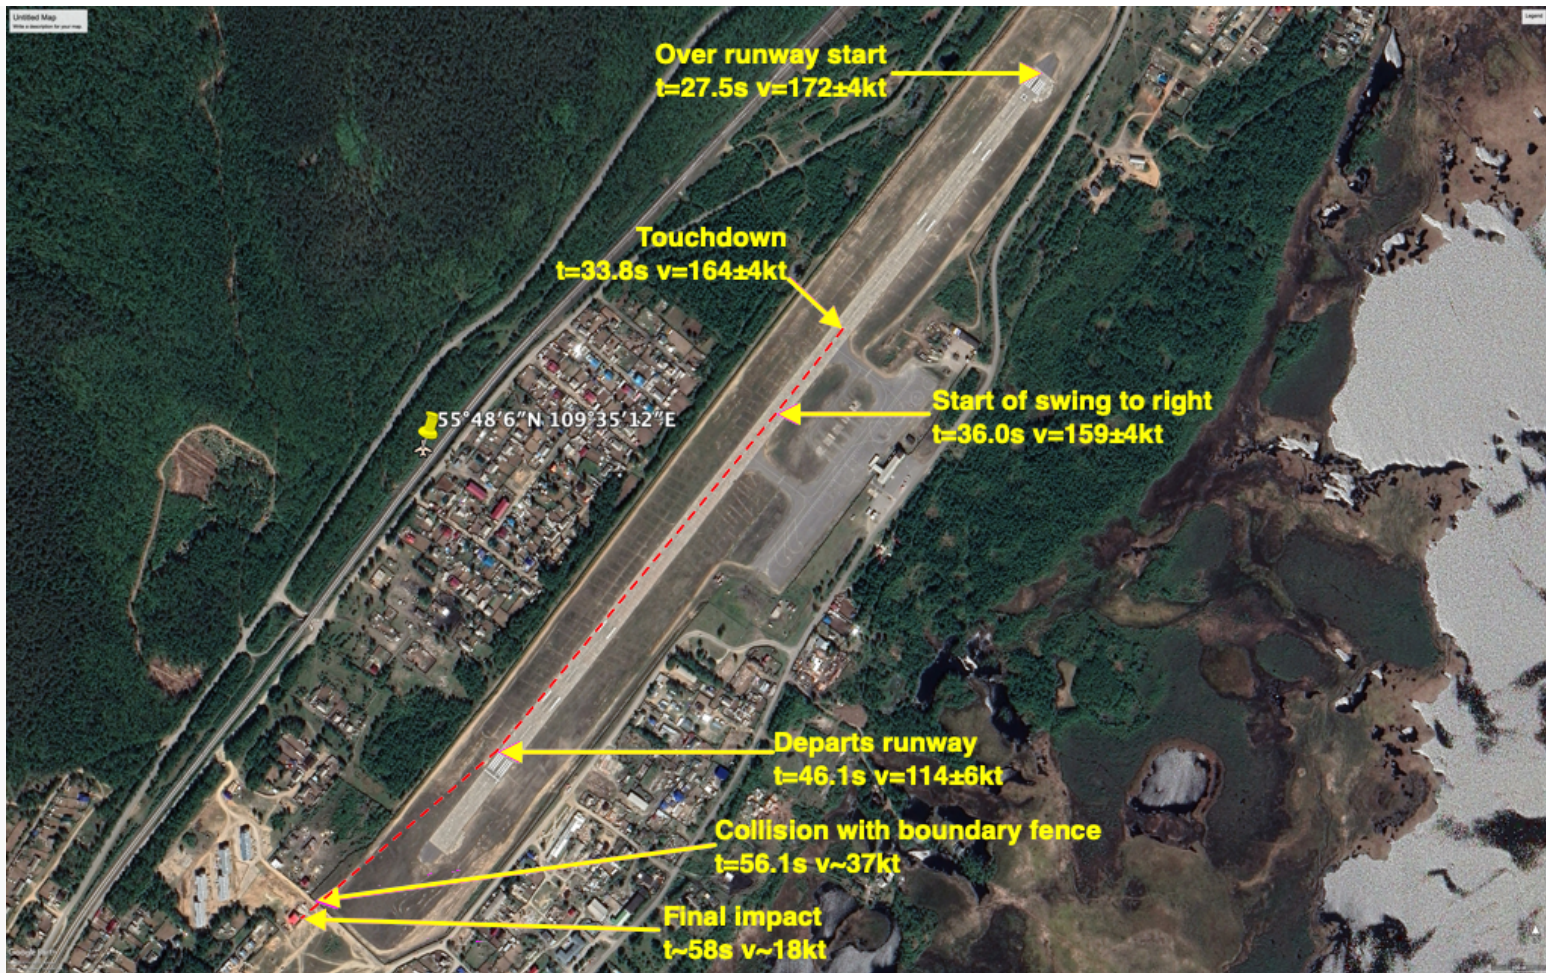
- At the start of the video A the aircraft is on the extended centreline of Nizhneangarsk runway 23 (length 1653 m) at a distance of  $2482 \pm 98$  m from the start of the runway. Ground speed is  $82.8 \pm 2.0$  m/s, ( $161 \pm 4$  knots).

- The ground speed slowly increases to a maximum of  $92.7 \pm 3.5$  m/s ( $180 \pm 7$  knots) at around  $t=17.0$  seconds when the aircraft is  $964 \pm 44$  m from runway 23.

- The aircraft crosses the start of runway 23 at  $t=27.6$  travelling at  $88.6 \pm 2$  m/s ( $172 \pm 4$  knots).
- Touchdown is at  $t=33.8$  s,  $549 \pm 14$  m from the runway start (about 1/3rd of the way down) at  $84.3 \pm 2$  m/s ( $164 \pm 4$  knots). Acceleration is  $-1.1 \text{ m/s}^2$ .

- At  $t=36.0$  the aircraft starts drifting to the right, possibly due to a burst tyre. The aircraft is  $731 \pm 16$  m down the runway travelling at  $81.8 \pm 2$  m/s ( $159 \pm 4$  knots).

- The aircraft departs the runway at  $t=46.1$  s,  $1463 \pm 41$  m down the runway at  $58.7 \pm 3.0$  m/s ( $114 \pm 6$  knots). Acceleration is  $-3.9 \text{ m/s}^2$ .

- At  $t=56.1$  there is an impact with the boundary fence 1853m from the start of the runway. This collapses the starboard undercarriage (and probably the port one as well). Impact speed is around 19 m/s (37 knots).

- The aircraft would have slid to a stop roughly 45m later unfortunately there was a building 36m from the boundary fence which is the site of the final impact. Time is about  $t=58.0$  and speed is somewhat less than 9 m/s (18 knots).

The annotated image below shows the estimated ground path of the aircraft in dotted red with significant events in yellow:

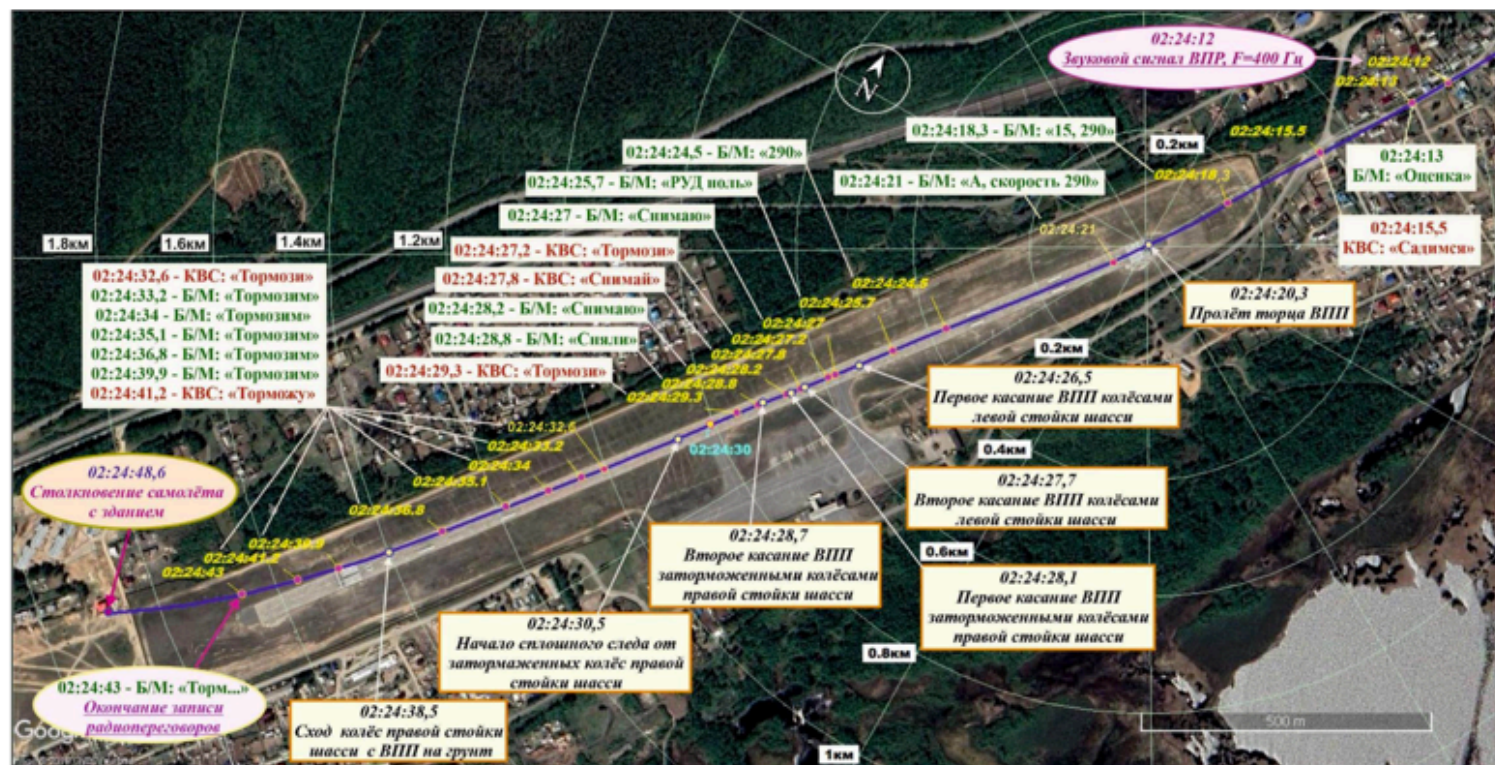
Рис. 48. Траектория движения самолёта с наложением радиообмена при приземлении, торможении, пробеге и выкатывании

This can be compared with figure 48 of the final report:

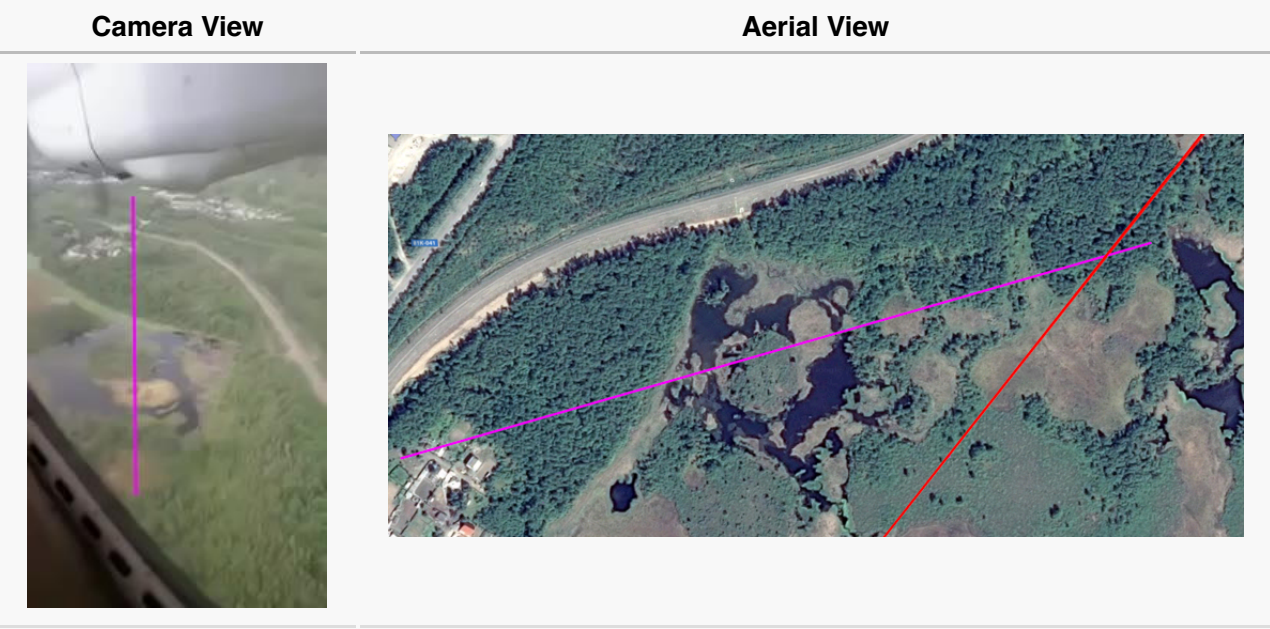
Here are two examples. Frame 1 ( $t=0s$ ) shows the line up of the edge of a settlement with a dark smudge on a sandy part of an island. The magenta line shows the estimated ground line the aircraft is flying across, the red line is the extended centreline of runway 23:

This puts the aircraft  $2490 \pm 98m$  from the start of runway 23.

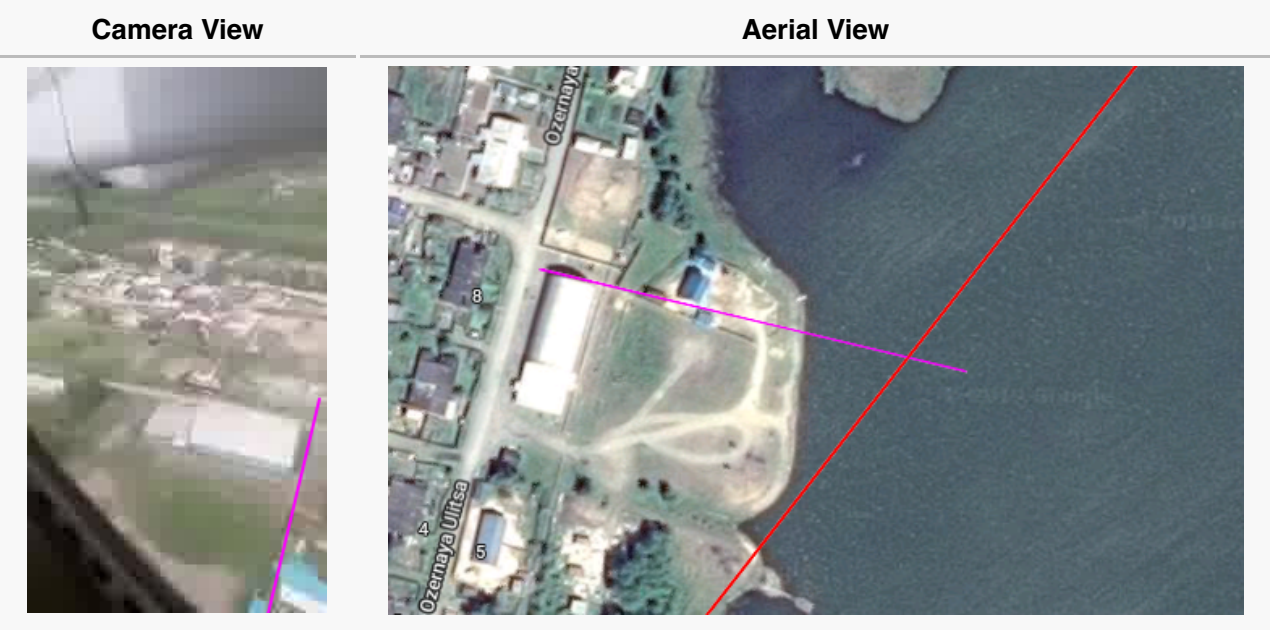
The second example is frame 483 ( $t=16.0s$ ) where a two distinctive buildings are lined up:

This puts the aircraft at  $1041 \pm 49m$  from the start of runway 23.

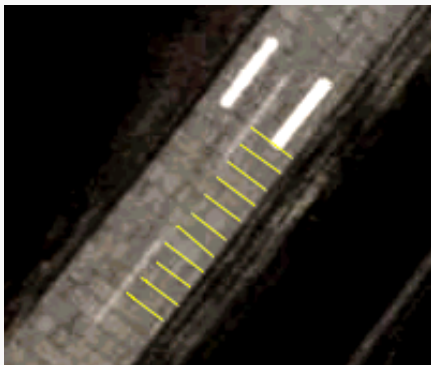
Standardised slabs used for roads and runways in Siberia measure 6m x 1.8m (data from the author's engineering file). For confirmation here is an enhanced aerial image of the runway at Nizhneangarsk where the south side of the runway has been annotated, rather crudely, with yellow lines at the edge of each slab (the slabs are laid with their long side in the runway direction).

Measurement of this imagery shows that these 10 slabs are 98 pixels long which, at 0.617 m/pixel for this image, gives a slab length of 6.05m. The value of 6m for slab length is used hereon.

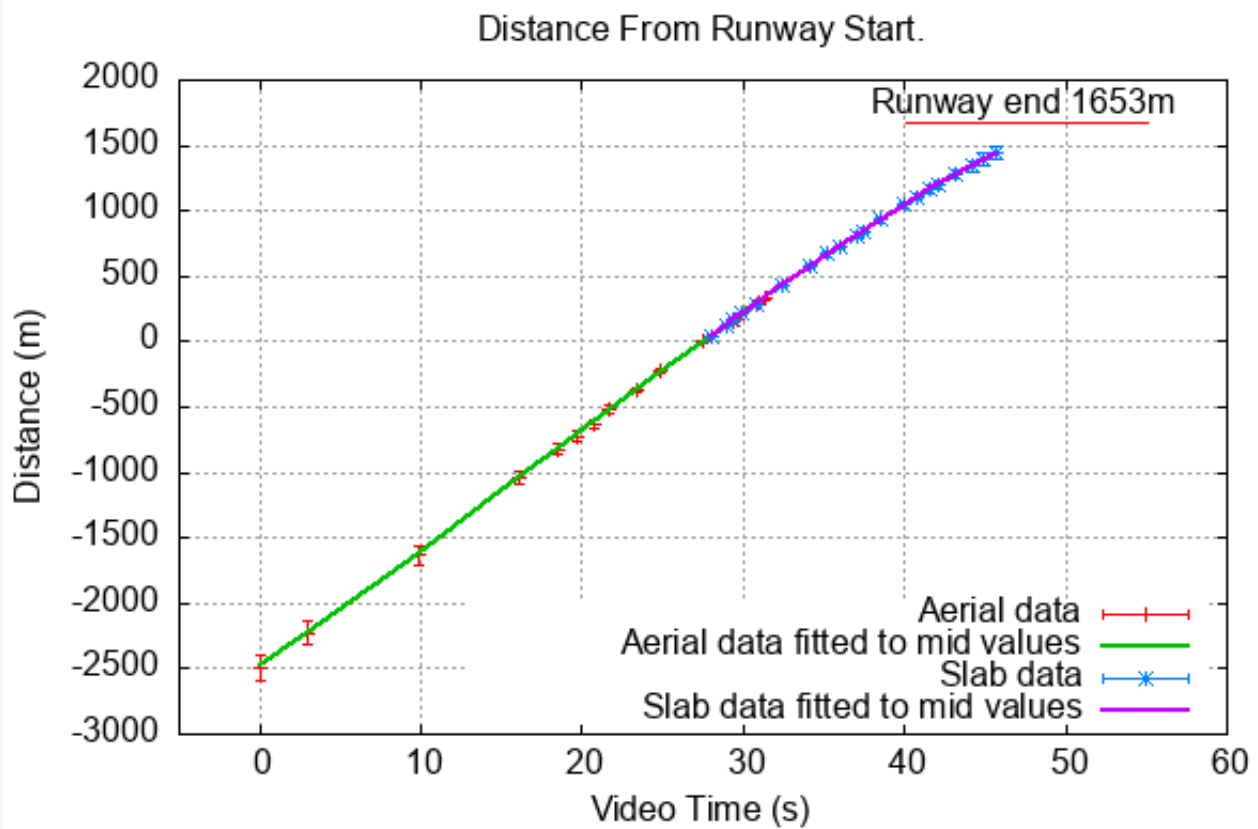
Here is a plot of distance from the start of runway 23 over time from video A, the mid points are fitted to a third order polynomial.

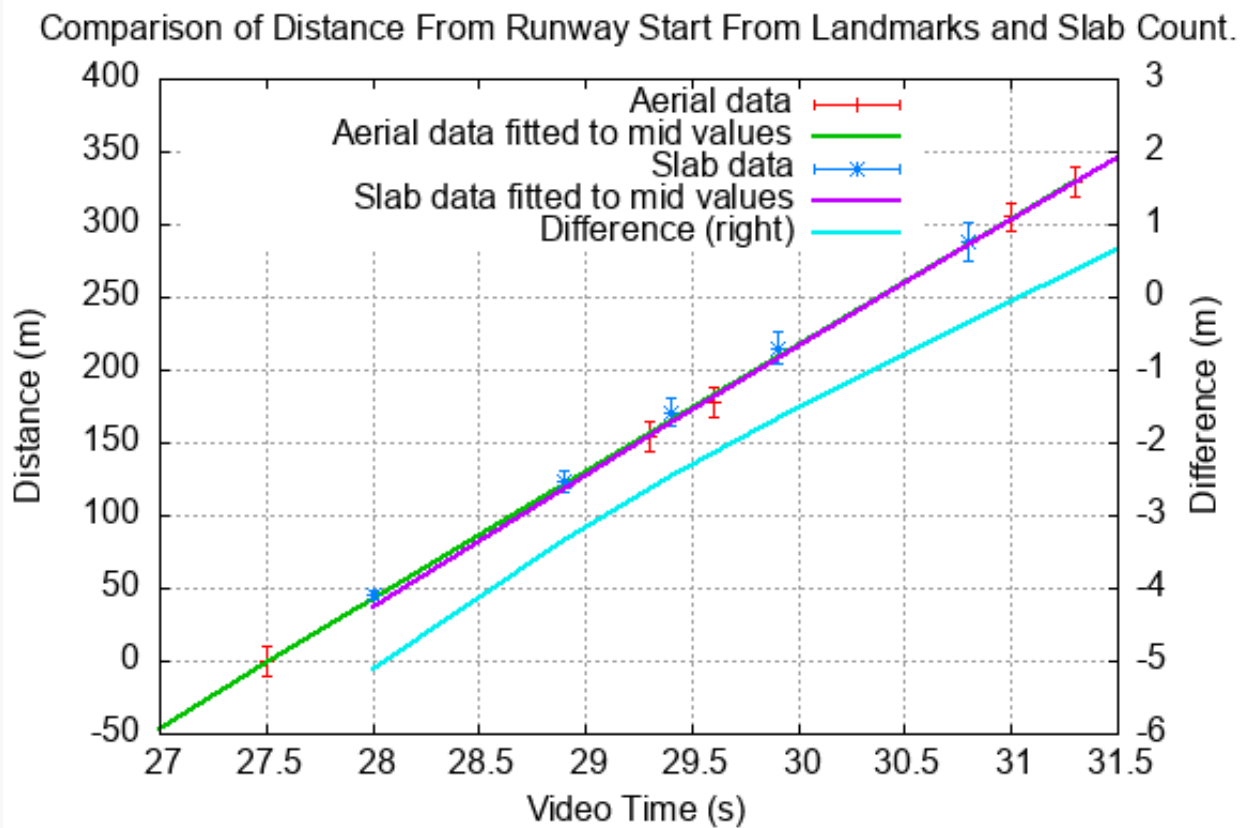
This graph shows the comparison where the two measurements overlap, the difference is positive when the 'slab' data is greater than the 'tile' data:

The difference between the two techniques is 5m or less.

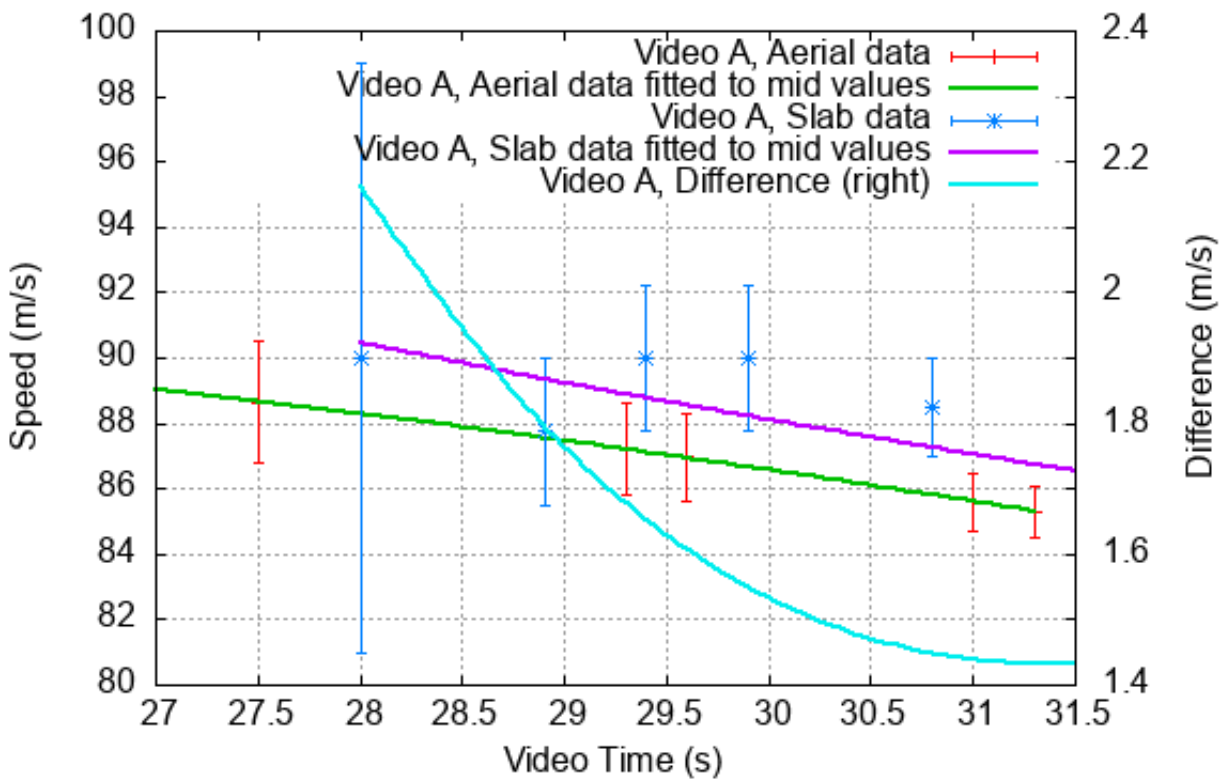
Comparison of Ground Speed From Landmarks and Slab Count.

The errors are here. Difference is positive when the 'slab' computed value is greater than the 'tile' computed value:

The difference is 1.4 to 2.2 m/s over this interval with the fitted data which is just about within the error terms of each if centred on the respective fitted data.

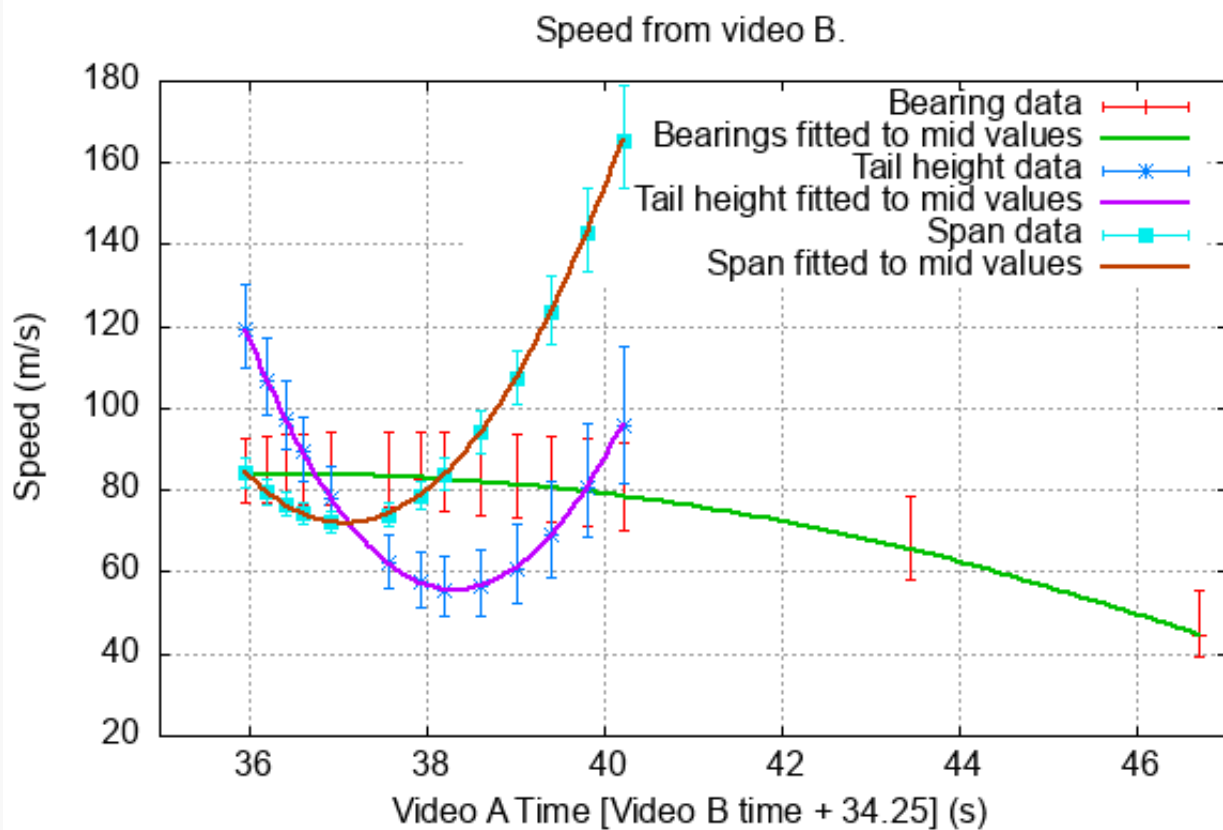
The errors are:

The poor results from this analysis could be for many reasons; the low resolution of the video, measurement error, non-linear camera field and so on. Even the bearing data does not make sense giving a de-acceleration of around -5m/s, if this were true

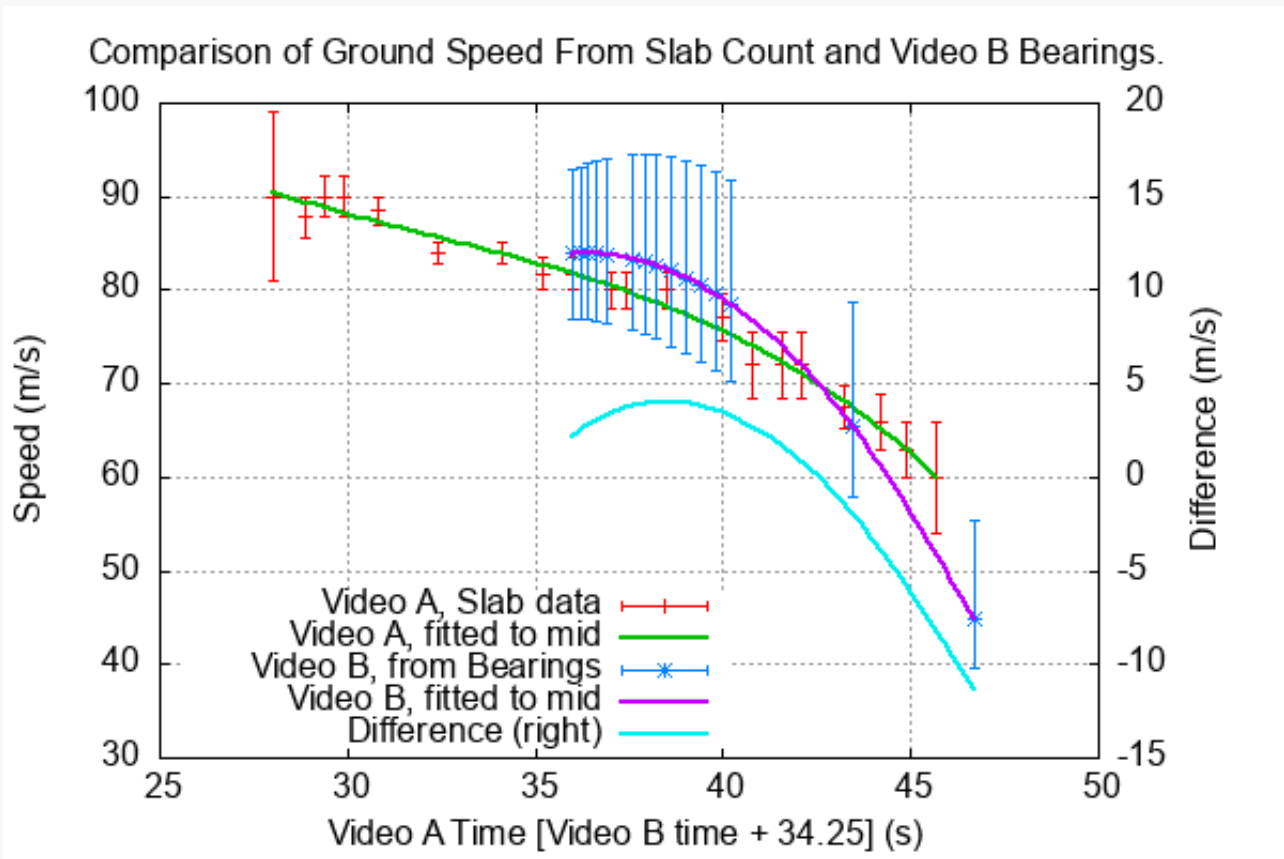
the aircraft would have stopped well before the boundary fence which was not the case. The following graph compares the ground speed from the slab speed data of video A to the bearing data of video B:

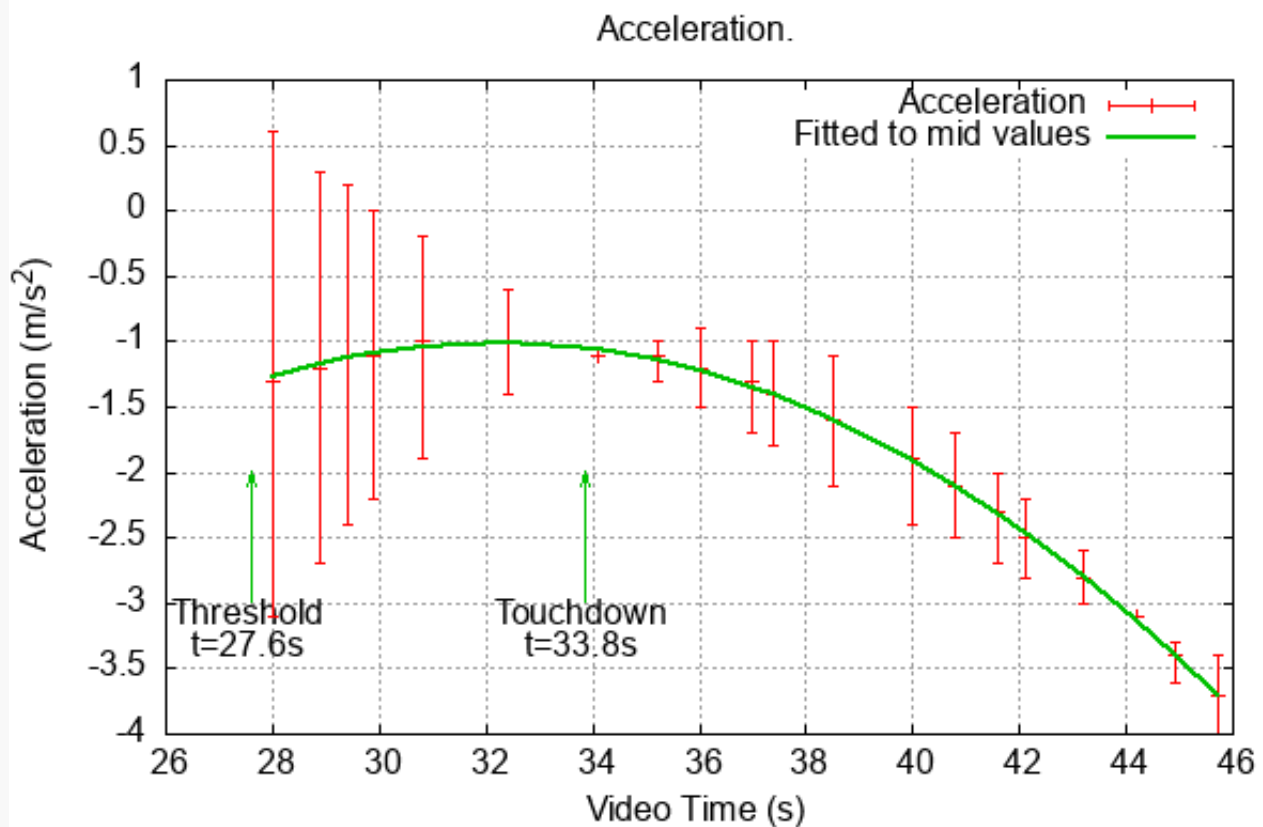
The ground speed if the aircraft computed from video A can be differentiated to give the longitudinal acceleration:

There are no visible discontinuities of sudden changes of acceleration such as might be caused by a tyre burst or running of the runway. Possibly this is because of the smoothing caused by the curve fitting process.

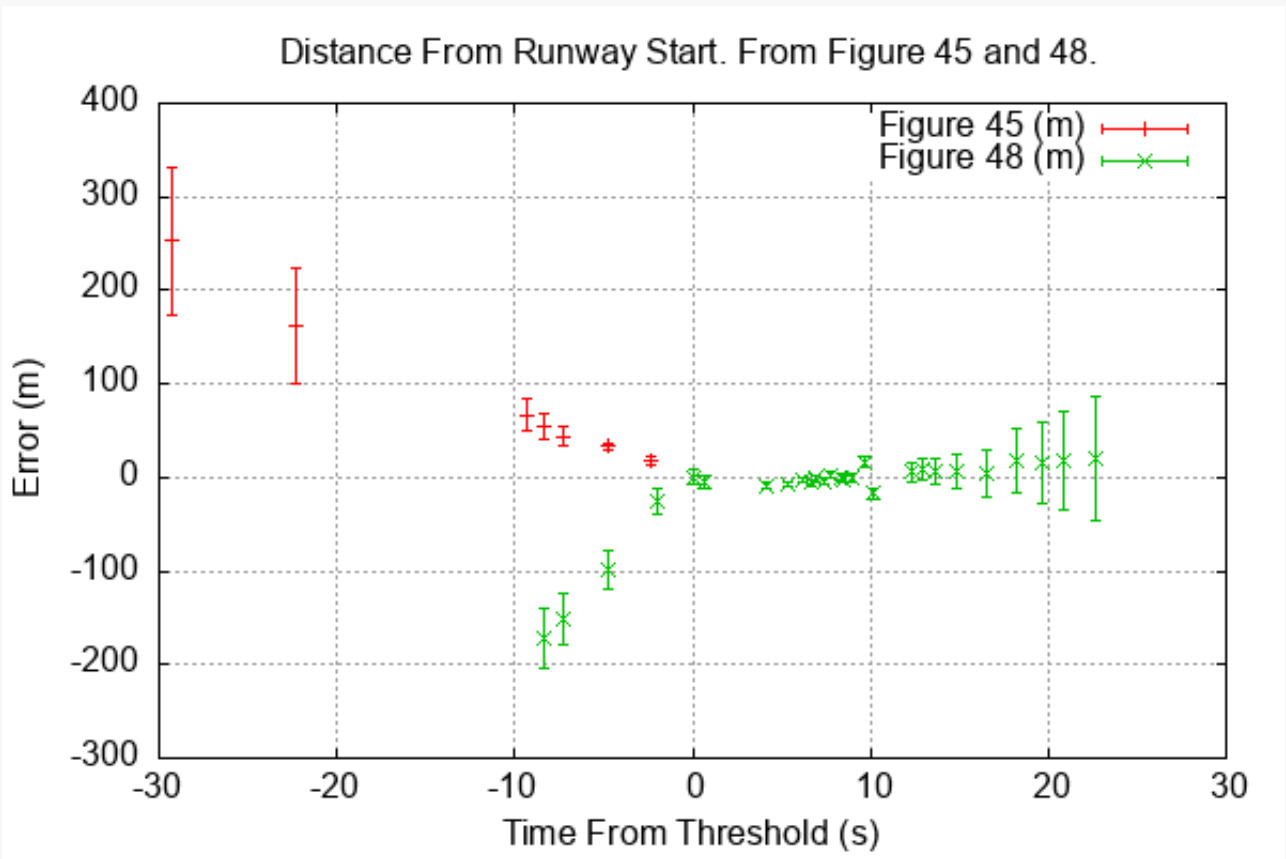
Here is the comparison, on the x-axis is time relative to the threshold crossing time. The y-axis shows the difference between my calculations and the positions shown in the two figures.

My model is only valid from -27.6 to 18.1 (s) but can be extrapolated with some confidence. The error is calculated as (myvalue - finalreport\_value) in meters.

- Prior to touchdown there is significant divergence from my model and the final report.
- After touchdown my model agrees very closely with the final report. The increased error range over time is a natural consequence of integrating velocity data to determine position.
- There is an unexplained anomaly in the final report; the two figures 45 and 48 do not agree with their plots of the aircraft positions in five places in the 10 seconds before touchdown. I checked these carefully with two different methods and obtained substantially the same results so I suspect that this is a plotting error in the final report. This is why there is a divergence between the green and red graphs in the range -10 to 0 (s) as we are comparing two different values against a single one (mine).
