## AN-24 Accident at Nizhneangarsk, Russia

On Thursday 27 June 2019 an AN-24 of Angara Airlines, flight number 2G-200, flying from Ulan-Ude Airport was destroyed whilst landing at Nizhneangarsk Airport. Reportedly, the left engine had failed in flight.

This is an analysis of these videos that gives a picture of the speed, position and acceleration forces experienced by the aircraft.

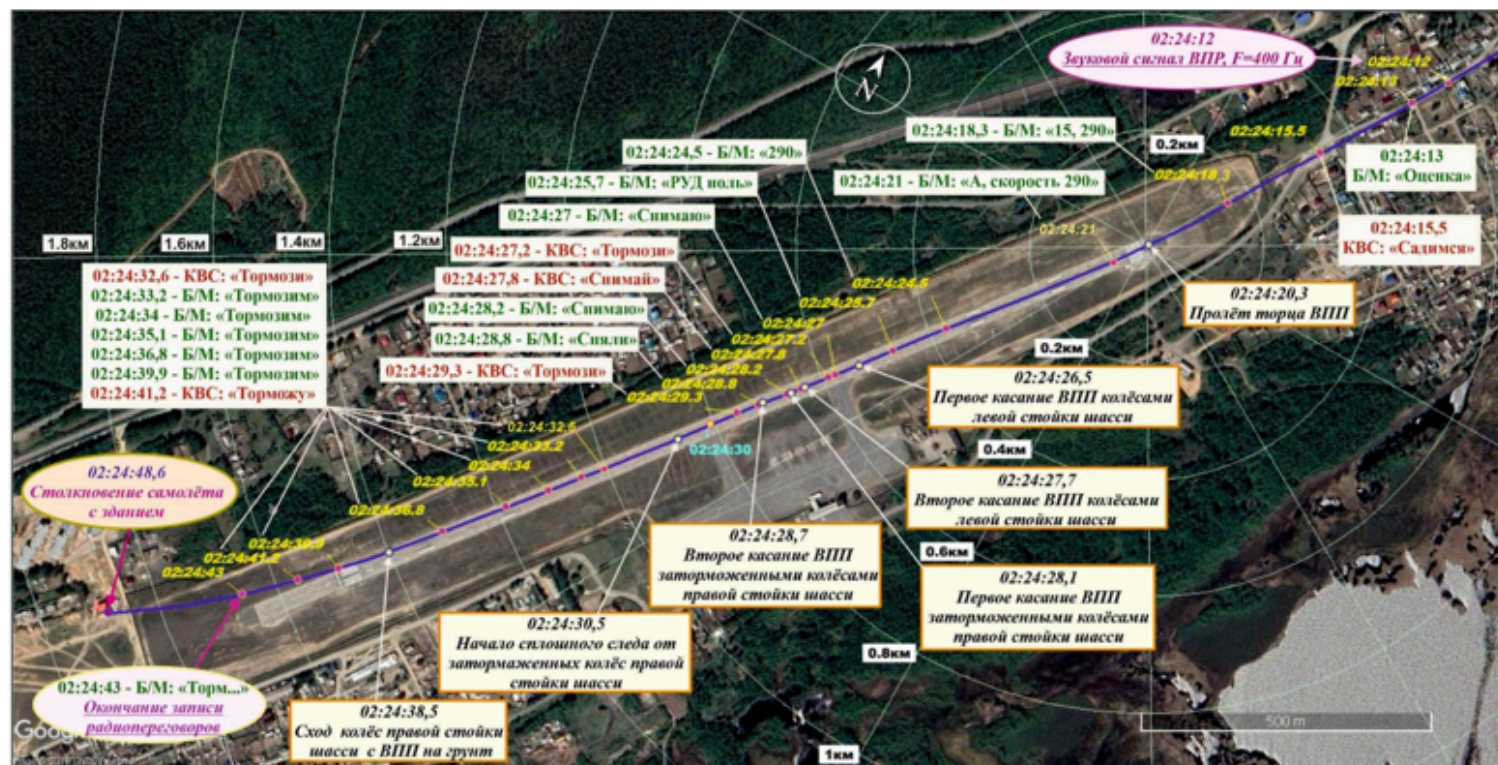
This can be compared with figure 48 of the final report:

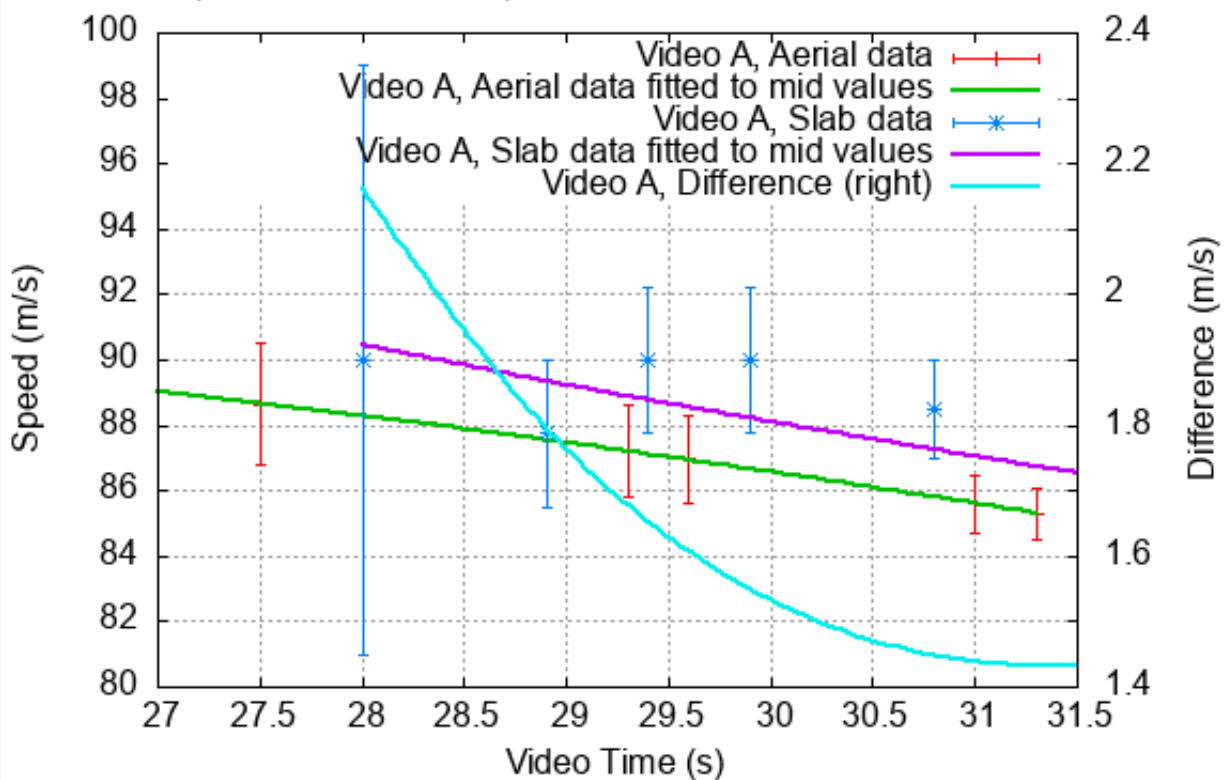
Comparison of Ground Speed From Landmarks and Slab Count.

The errors are here. Difference is positive when the 'slab' computed value is greater than the 'tile' computed value:

The difference is 1.4 to 2.2 m/s over this interval with the fitted data which is just about within the error terms of each if centred on the respective fitted data.

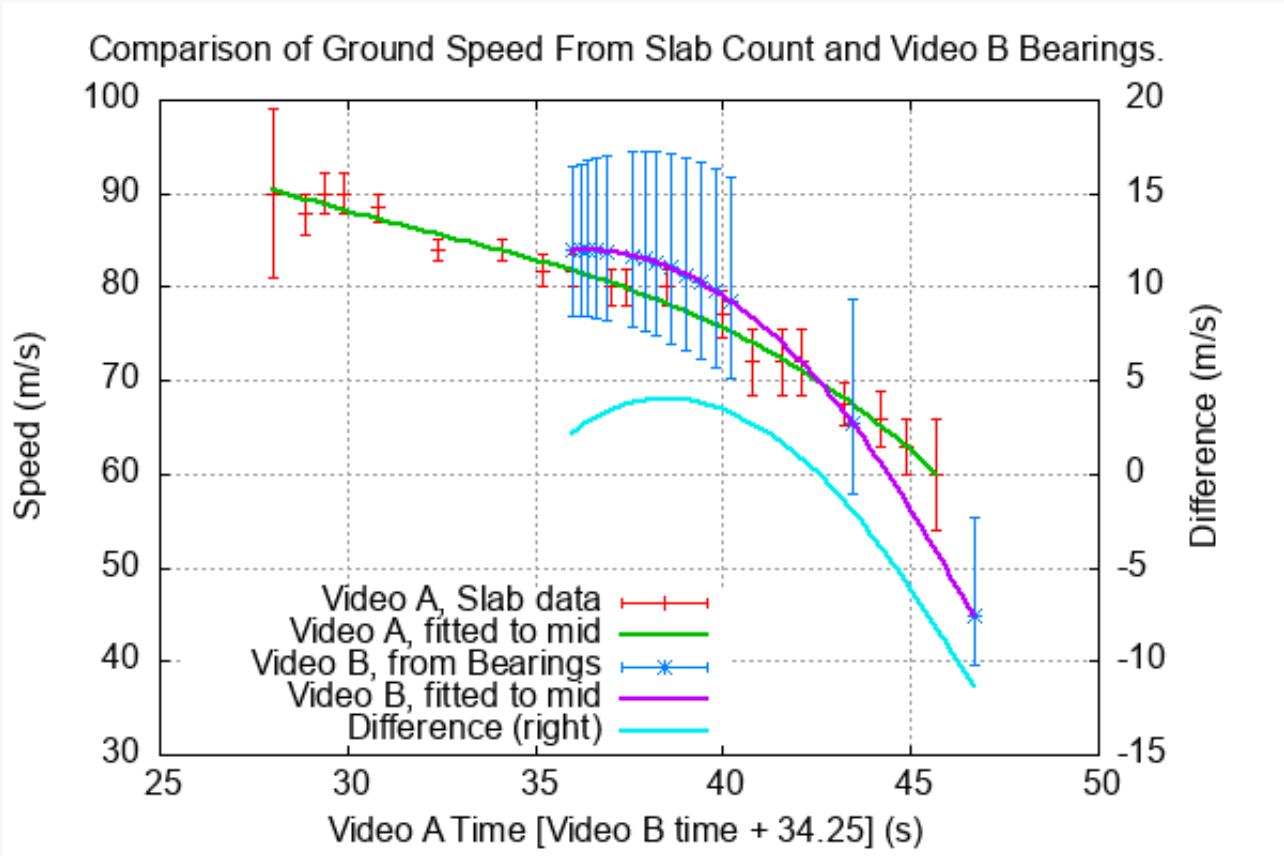
the aircraft would have stopped well before the boundary fence which was not the case. The following graph compares the ground speed from the slab speed data of video A to the bearing data of video B:

The data obtained from video B is not useful for calculating the position or speed of the aircraft. The data from video B is useful in that it can tie visible events to the motion of the aircraft seen in video A, for example the smoke and dust appearing from the tyres and the start of the aircraft swinging to the right.

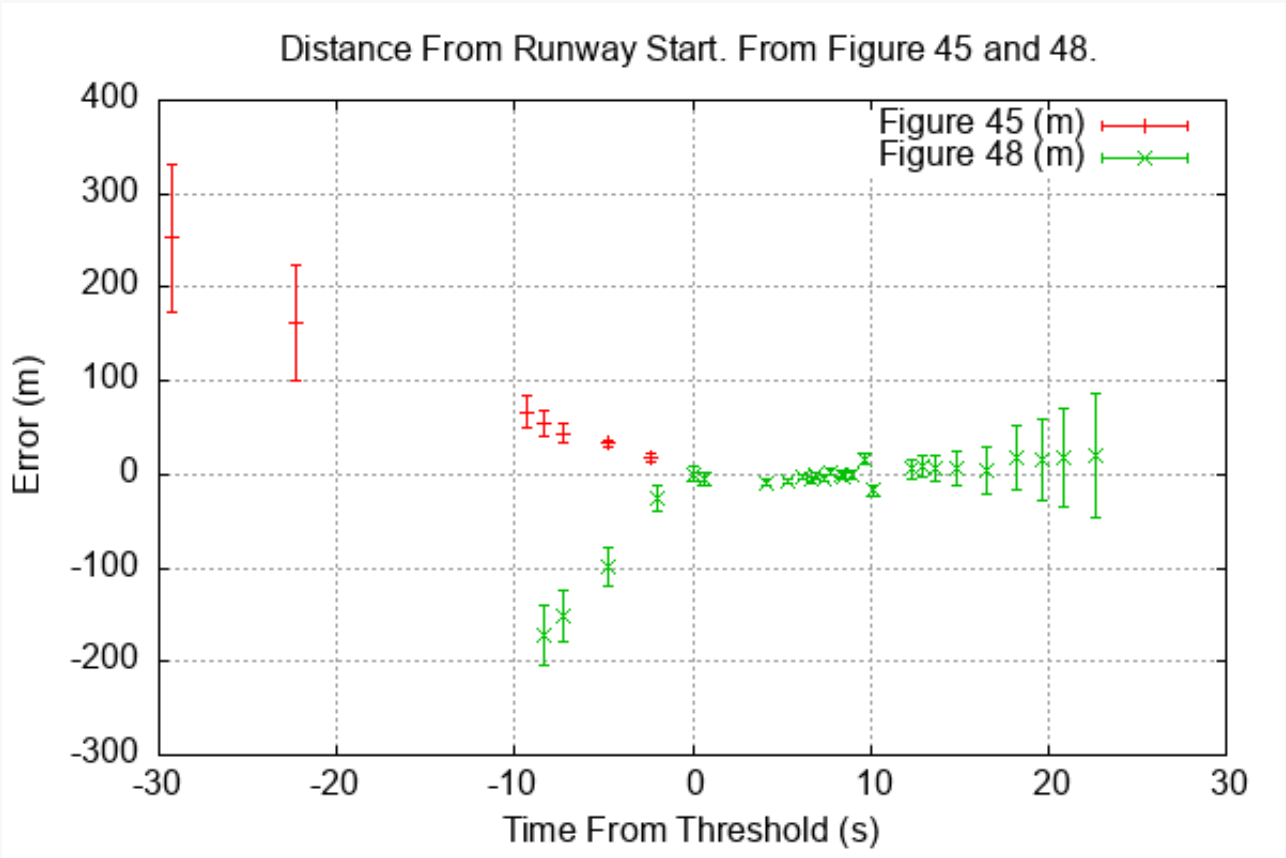
Here is the comparison, on the x-axis is time relative to the threshold crossing time. The y-axis shows the difference between my calculations and the positions shown in the two figures.

My model is only valid from -27.6 to 18.1 (s) but can be extrapolated with some confidence. The error is calculated as (myvalue - finalreport\_value) in meters.

- Prior to touchdown there is significant divergence from my model and the final report.
- After touchdown my model agrees very closely with the final report. The increased error range over time is a natural consequence of integrating velocity data to determine position.
- There is an unexplained anomaly in the final report; the two figures 45 and 48 do not agree with their plots of the aircraft positions in five places in the 10 seconds before touchdown. I checked these carefully with two different methods and obtained substantially the same results so I suspect that this is a plotting error in the final report. This is why there is a divergence between the green and red graphs in the range -10 to 0 (s) as we are comparing two different values against a single one (mine).
