# AN-24 Accident at Nizhneangarsk, Russia

On Thursday 27 June 2019 an AN-24 of Angara Airlines, flight number 2G-200, flying from Ulan-Ude Airport was destroyed whilst landing at Nizhneangarsk Airport. Reportedly, the left engine had failed in flight.

This is an analysis of these videos that gives a picture of the speed, position and acceleration forces experienced by the aircraft.

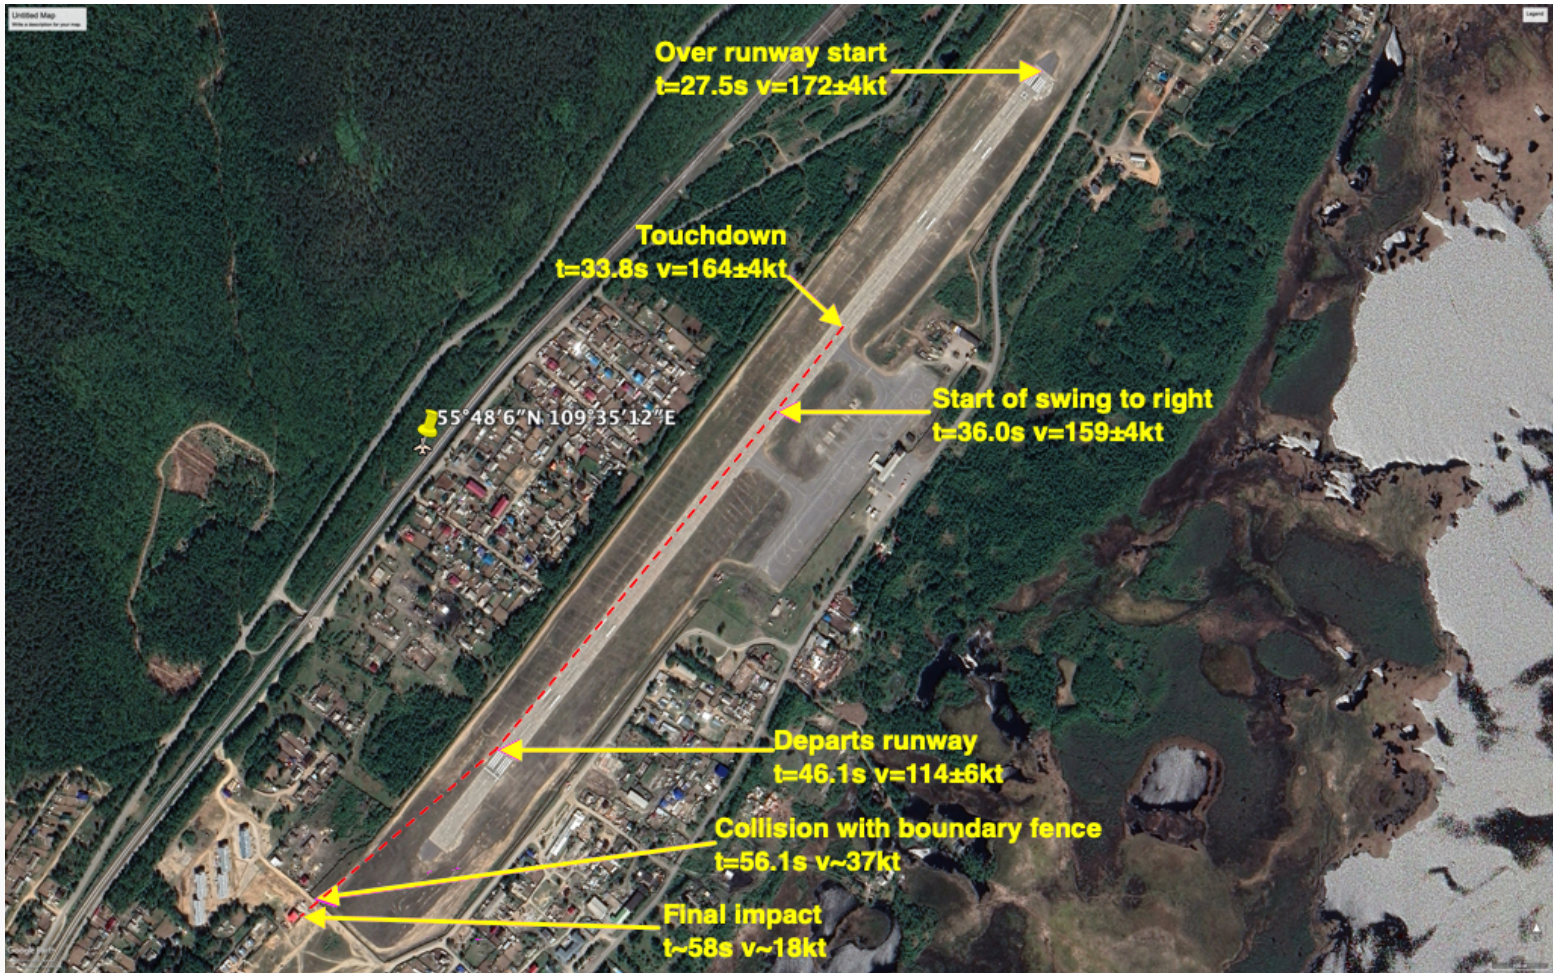
- At  $t=36.0$  the aircraft starts drifting to the right, possibly due to a burst tyre. The aircraft is  $731 \pm 16$  m down the runway travelling at  $81.8 \pm 2$  m/s ( $159 \pm 4$  knots).

- The aircraft departs the runway at  $t=46.1$  s,  $1463 \pm 41$  m down the runway at  $58.7 \pm 3.0$  m/s ( $114 \pm 6$  knots). Acceleration is  $-3.9$  m/s<sup>2</sup>.

- At  $t=56.1$  there is an impact with the boundary fence 1853m from the start of the runway. This collapses the starboard undercarriage (and probably the port one as well). Impact speed is around 19 m/s (37 knots).

- The aircraft would have slid to a stop roughly 45m later unfortunately there was a building 36m from the boundary fence which is the site of the final impact. Time is about  $t=58.0$  and speed is somewhat less than 9 m/s (18 knots).

The annotated image below shows the estimated ground path of the aircraft in dotted red with significant events in yellow:

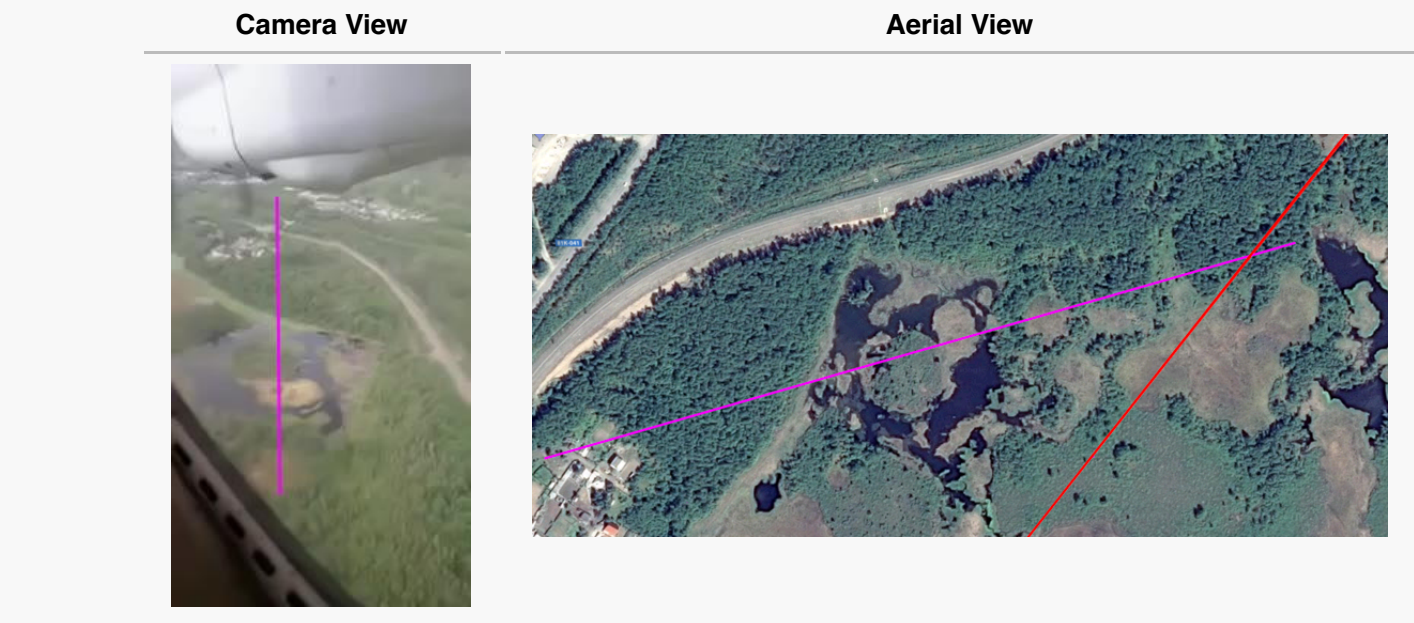
Here are two examples. Frame 1 ( $t=0s$ ) shows the line up of the edge of a settlement with a dark smudge on a sandy part of an island. The magenta line shows the estimated ground line the aircraft is flying across, the red line is the extended centreline of runway 23:

This puts the aircraft  $2490\pm98m$  from the start of runway 23.

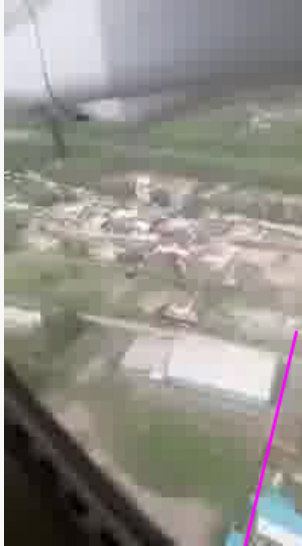
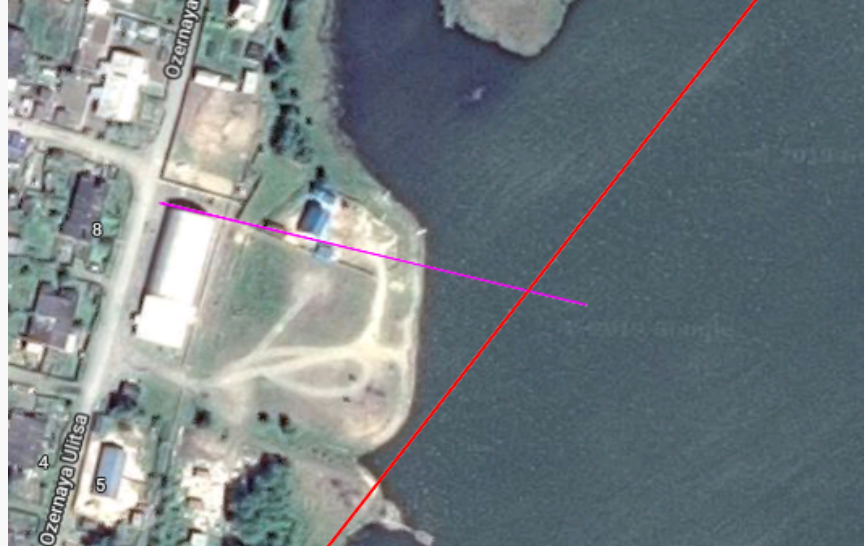
The second example is frame 483 ( $t=16.0s$ ) where a two distinctive buildings are lined up:

This puts the aircraft at  $1041 \pm 49\text{m}$  from the start of runway 23.

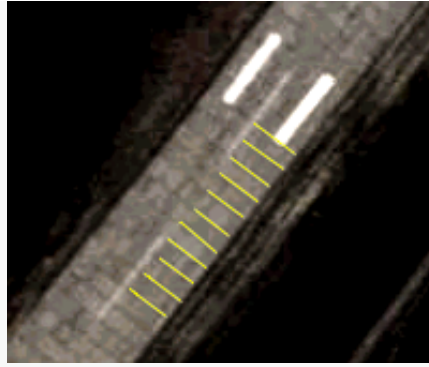
Standardised slabs used for roads and runways in Siberia measure  $6\text{m} \times 1.8\text{m}$  (data from the author's engineering file). For confirmation here is an enhanced aerial image of the runway at Nizhneangarsk where the south side of the runway has been annotated, rather crudely, with yellow lines at the edge of each slab (the slabs are laid with their long side in the runway direction).

Measurement of this imagery shows that these 10 slabs are 98 pixels long which, at 0.617 m/pixel for this image, gives a slab length of 6.05m. The value of 6m for slab length is used hereon.

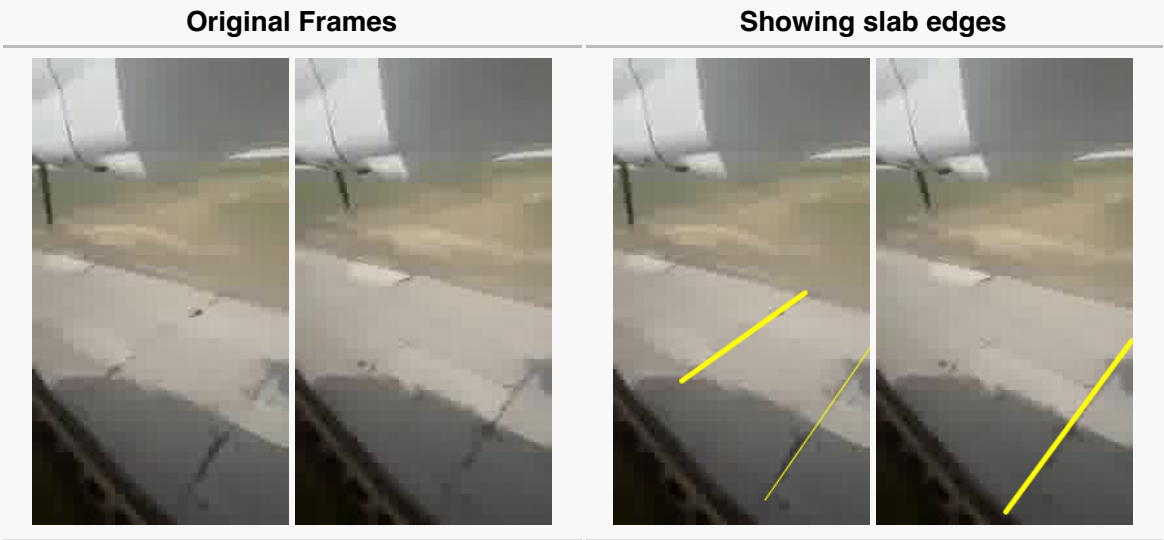
These slab edges can be seen quite clearly on video 'A', as an example here are two frames [841 and 843] which are 1/15 second apart (at 30 fps). On the left are the original frames, on the right the edges of the slabs are identified with yellow lines.

The broad yellow line on the first image is the same part of the runway as the broad line on the second image. The near match of the right hand line in the first frame with the line in the second frame indicates that the aircraft has traveled almost exactly 6m in that 1/15th second. The light patch on the right of the concrete, and the lightish patch in the grass confirms this sequence.

This gives a ground speed of 90 m/s (175 knots). The error term is how confident the slab match is, in general this assumed to be 10% of a slab, so 0.6m in this example thus  $\pm 9$  m/s ( $\pm 18$  knots). If a succession of slabs can be counted the error is proportionally reduced. This is a speed measurement and can be integrated for distance or differentiated for acceleration.

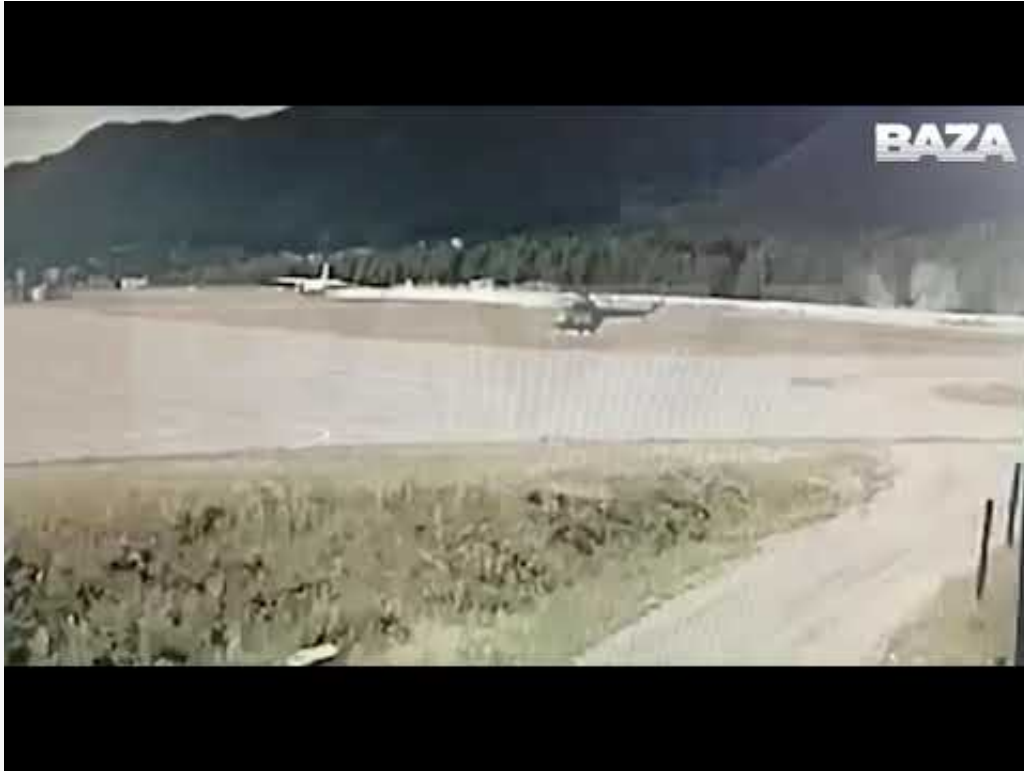
A second video <https://youtu.be/BQ8ujmRhLH0> was posted on YouTube that showed images from a security camera overlooking the airport, here referred to as video 'B'. The camera is facing roughly south west and was recorded at 25 frames per second.

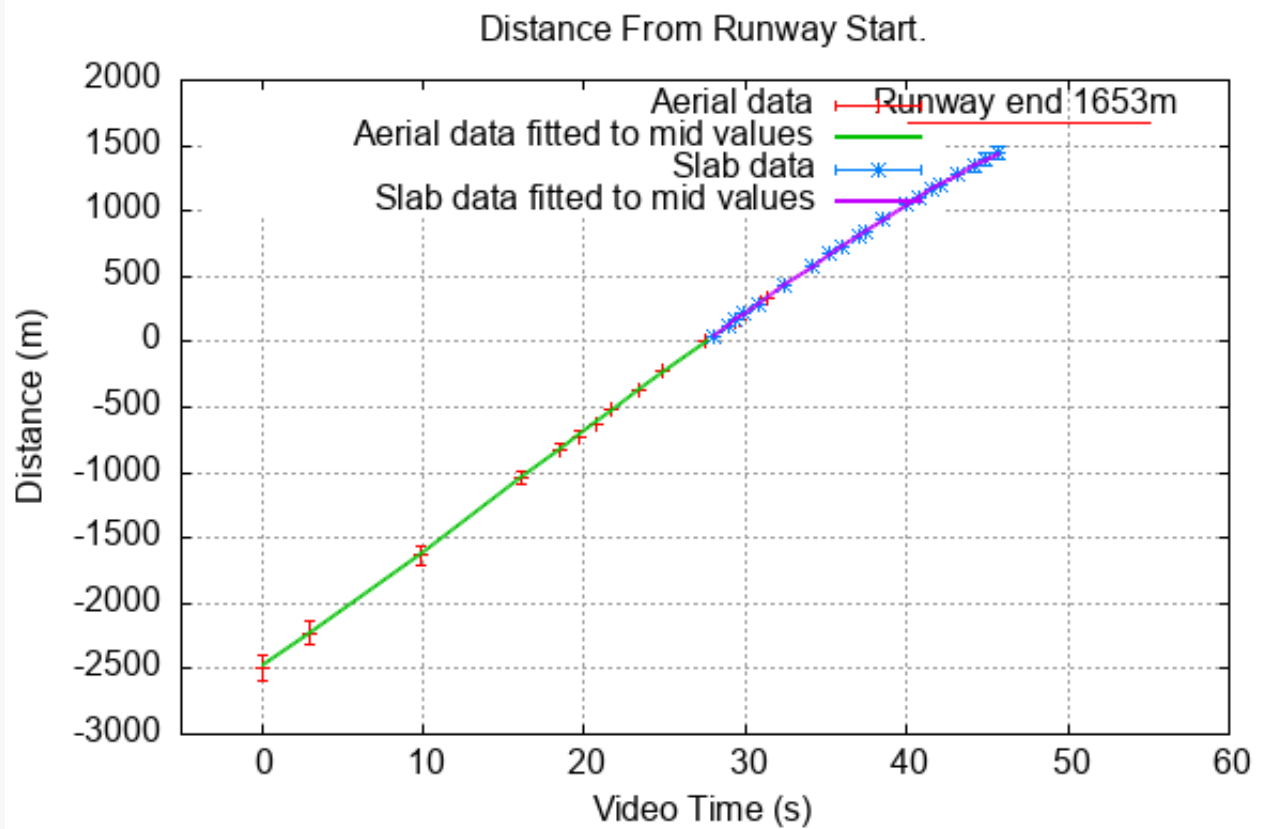
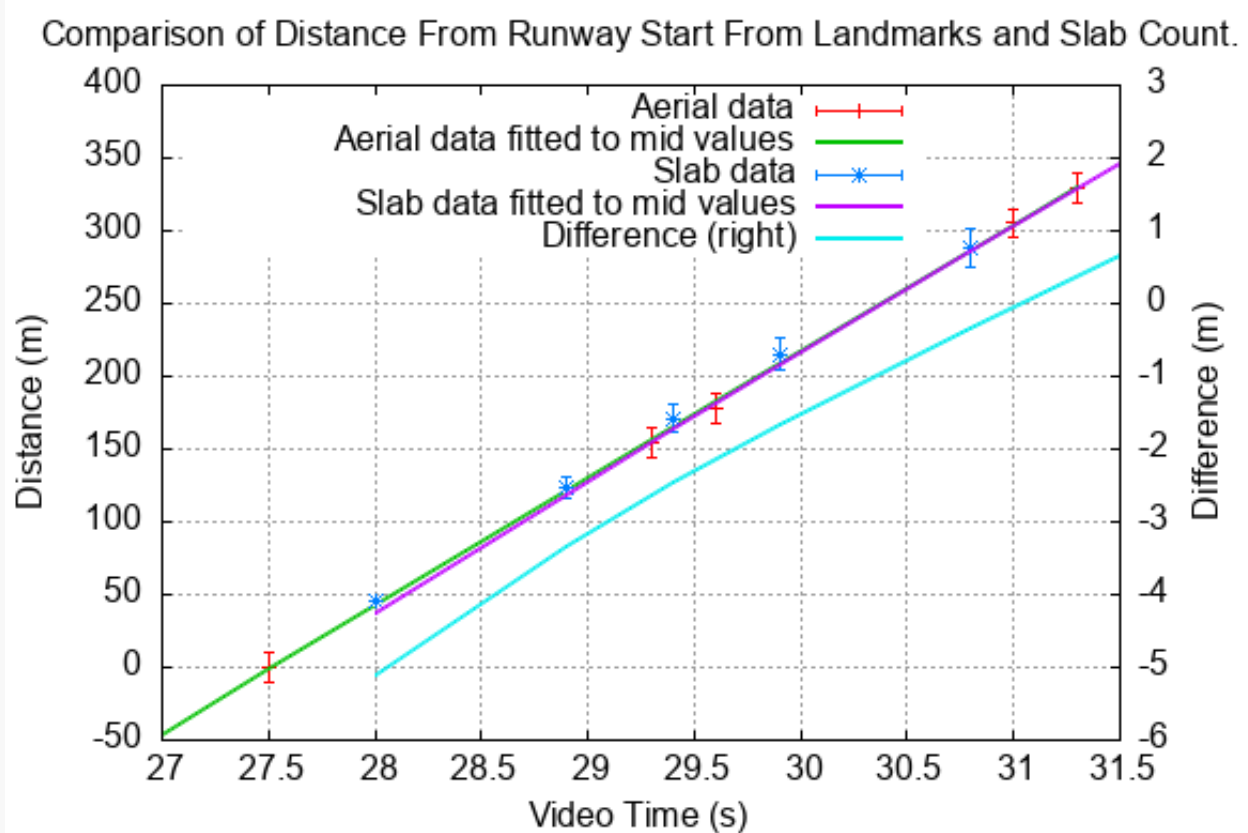
Here is a plot of distance from the start of runway 23 over time from video A, the mid points are fitted to a third order polynomial. The right hand graph shows the comparison where the two measurements overlap:

The difference between the two techniques is 5m or less.

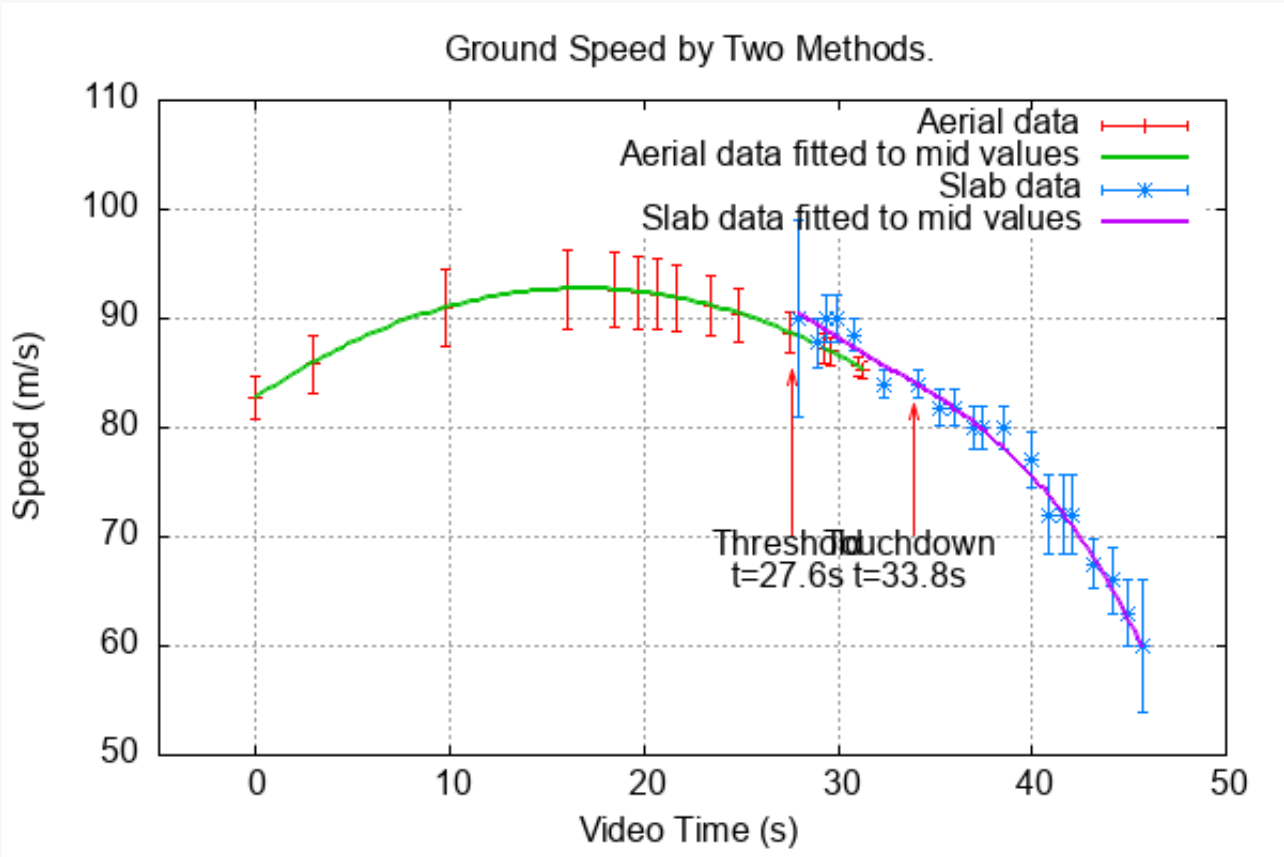
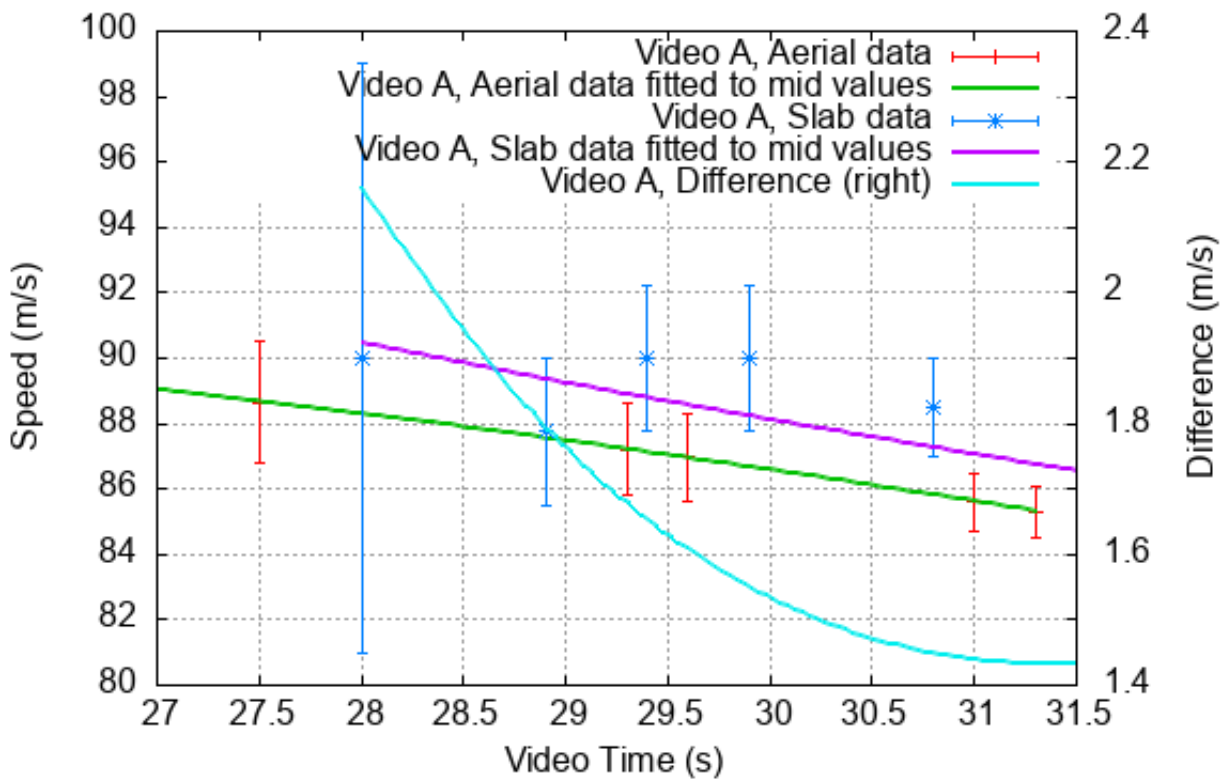
Comparison of Ground Speed From Landmarks and Slab Count.

Here is the ground speed by the two techniques. The right hand graph shows the comparison where the two measurements overlap:

The difference is 1.4 to 2.2 m/s over this interval with the fitted data which is just about within the error terms of each if centred on the respective fitted data.

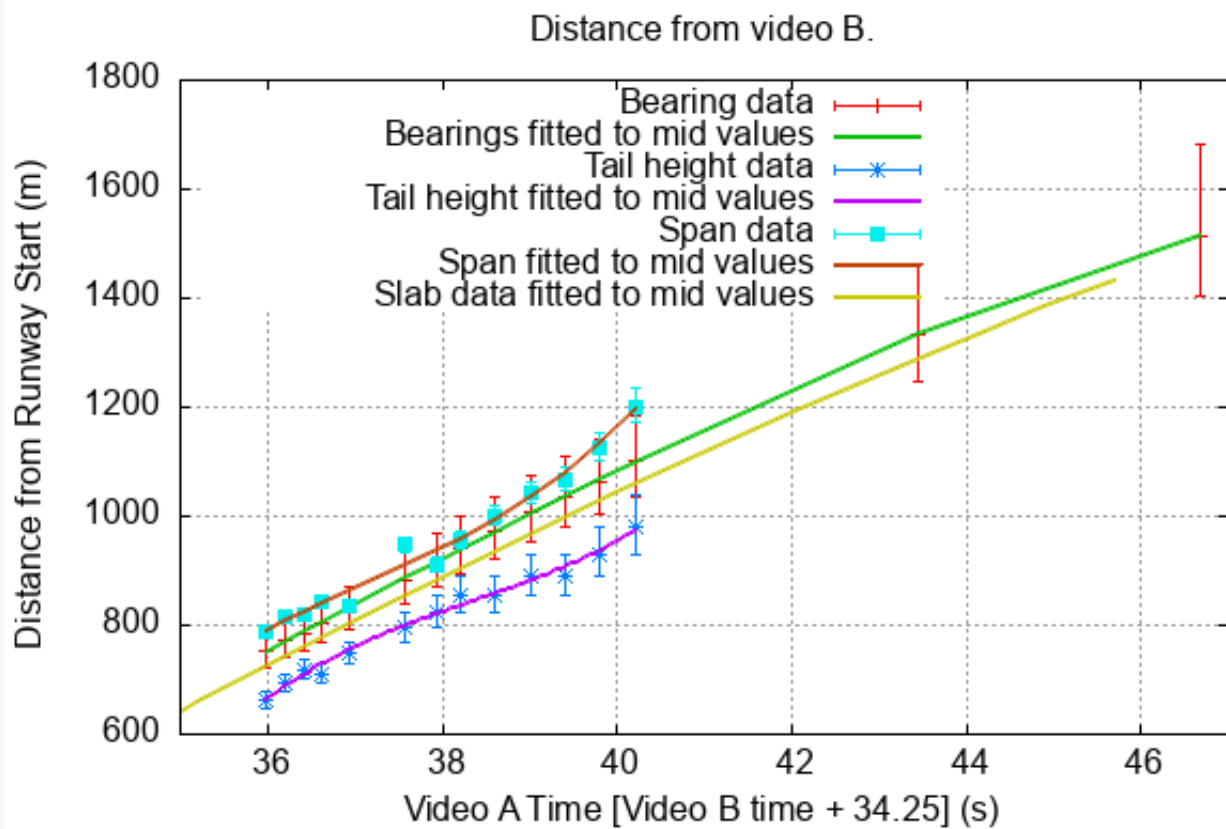
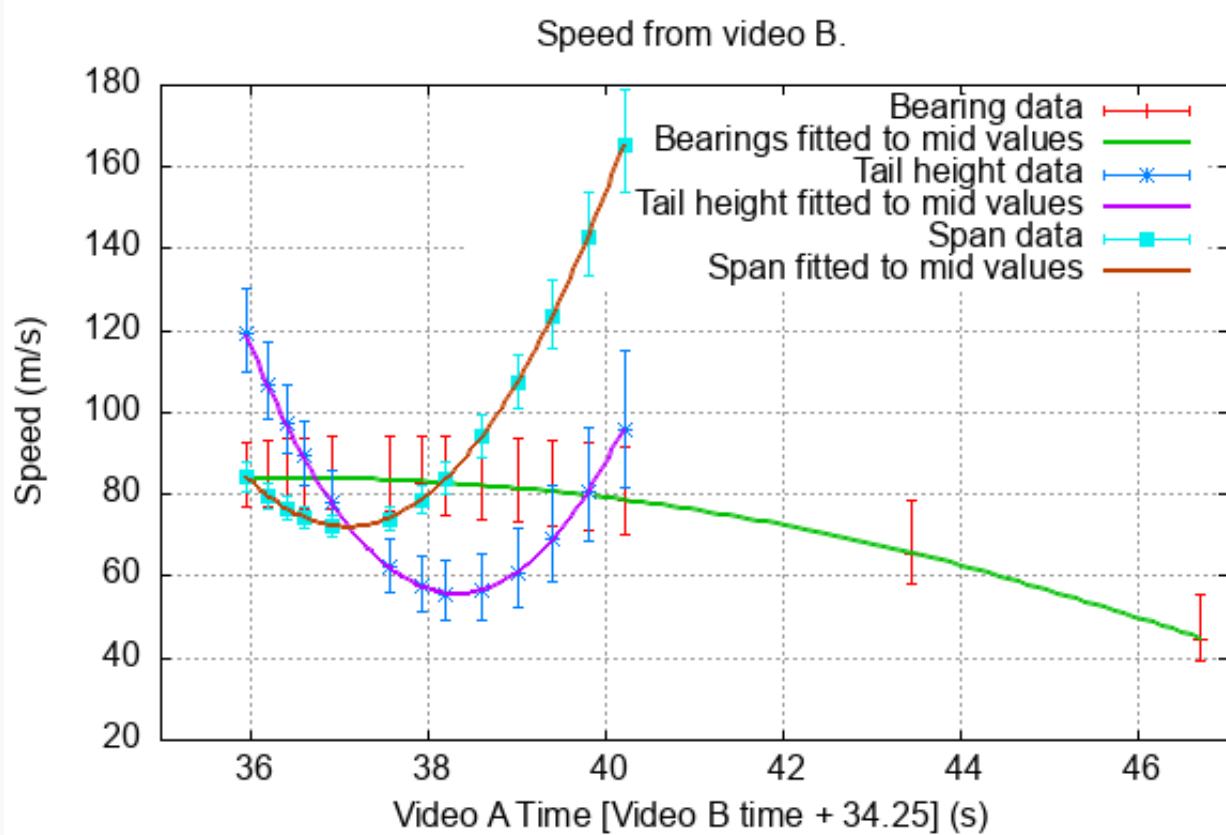
The calculated distance down the runway by these three methods agree rather roughly in magnitude as shown below on the left (the distance data from the slab measurements is also shown for comparison). However when differentiated to obtain ground speed the results are implausible except for the bearing data, as seen on the right.

The poor results from this analysis could be for many reasons; the low resolution of the video, measurement error, non-linear camera field and so on. Even the bearing data does not make sense giving a de-acceleration of around -5m/s, if this were true

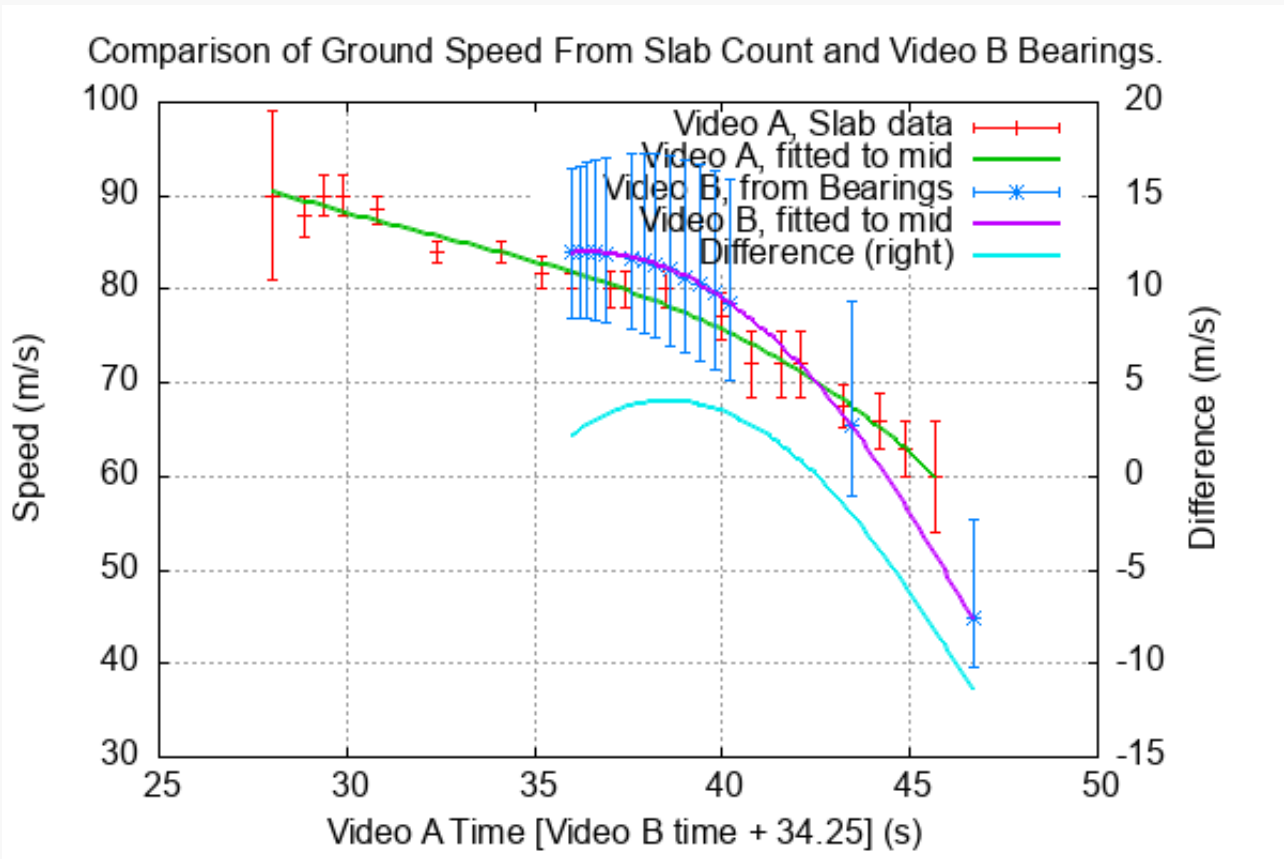
the aircraft would have stopped well before the boundary fence which was not the case. The following graph compares the ground speed from the slab speed data of video A to the bearing data of video B:

The data obtained from video B is not useful for calculating the position or speed of the aircraft. The data from video B is useful in that it can tie visible events to the motion of the aircraft seen in video A, for example the smoke and dust appearing from the tyres and the start of the aircraft swinging to the right.

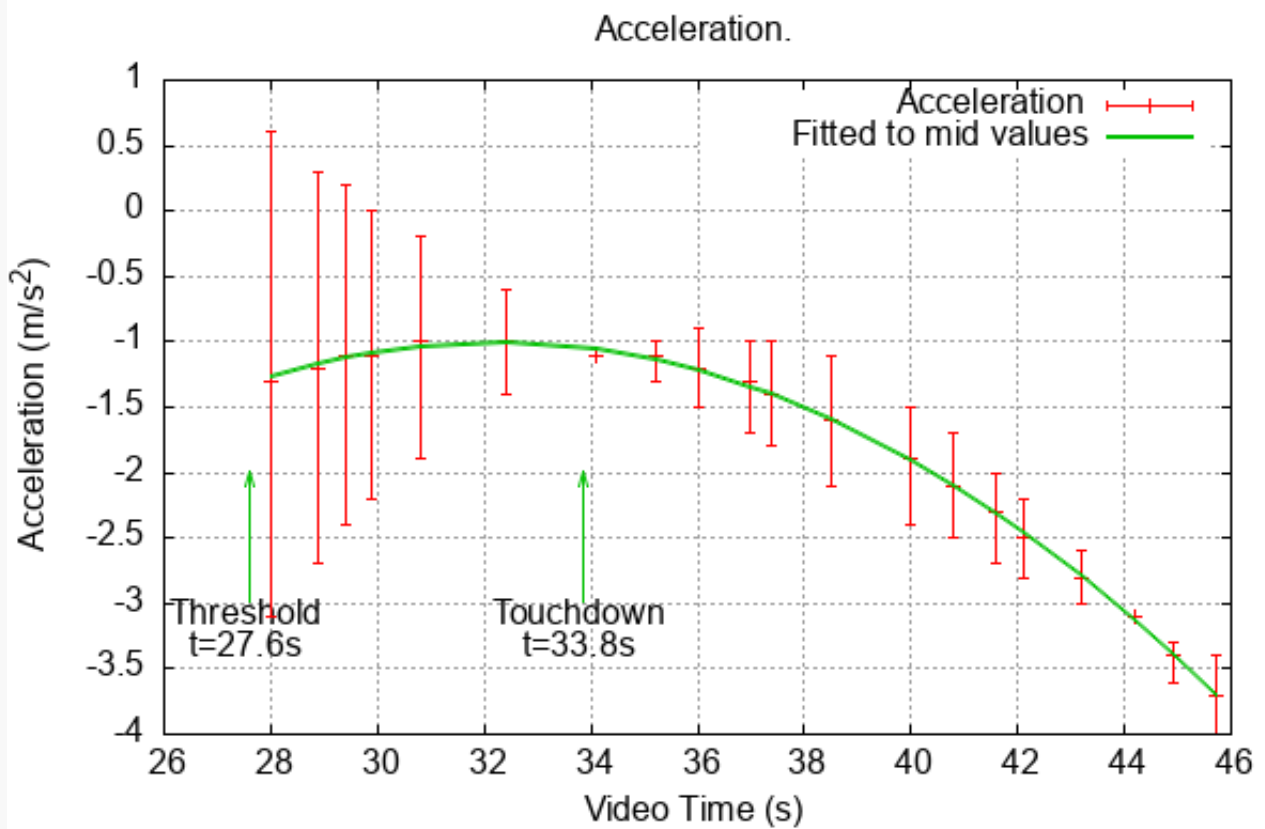
The ground speed if the aircraft computed from video A can be differentiated to give the longitudinal acceleration:

There are no visible discontinuities of sudden changes of acceleration such as might be caused by a tyre burst or running of the runway. Possibly this is because of the smoothing caused by the curve fitting process.
