**INTERSTATE AVIATION COMMITTEE**  
**AVIATION ACCIDENT INVESTIGATION COMMISSION**

**FINAL REPORT**  
**BASED ON THE RESULTS OF THE INVESTIGATION OF THE AVIATION ACCIDENT**

| Aircraft type | An-24RV aircraft |
| State and registration | RA-47366 |

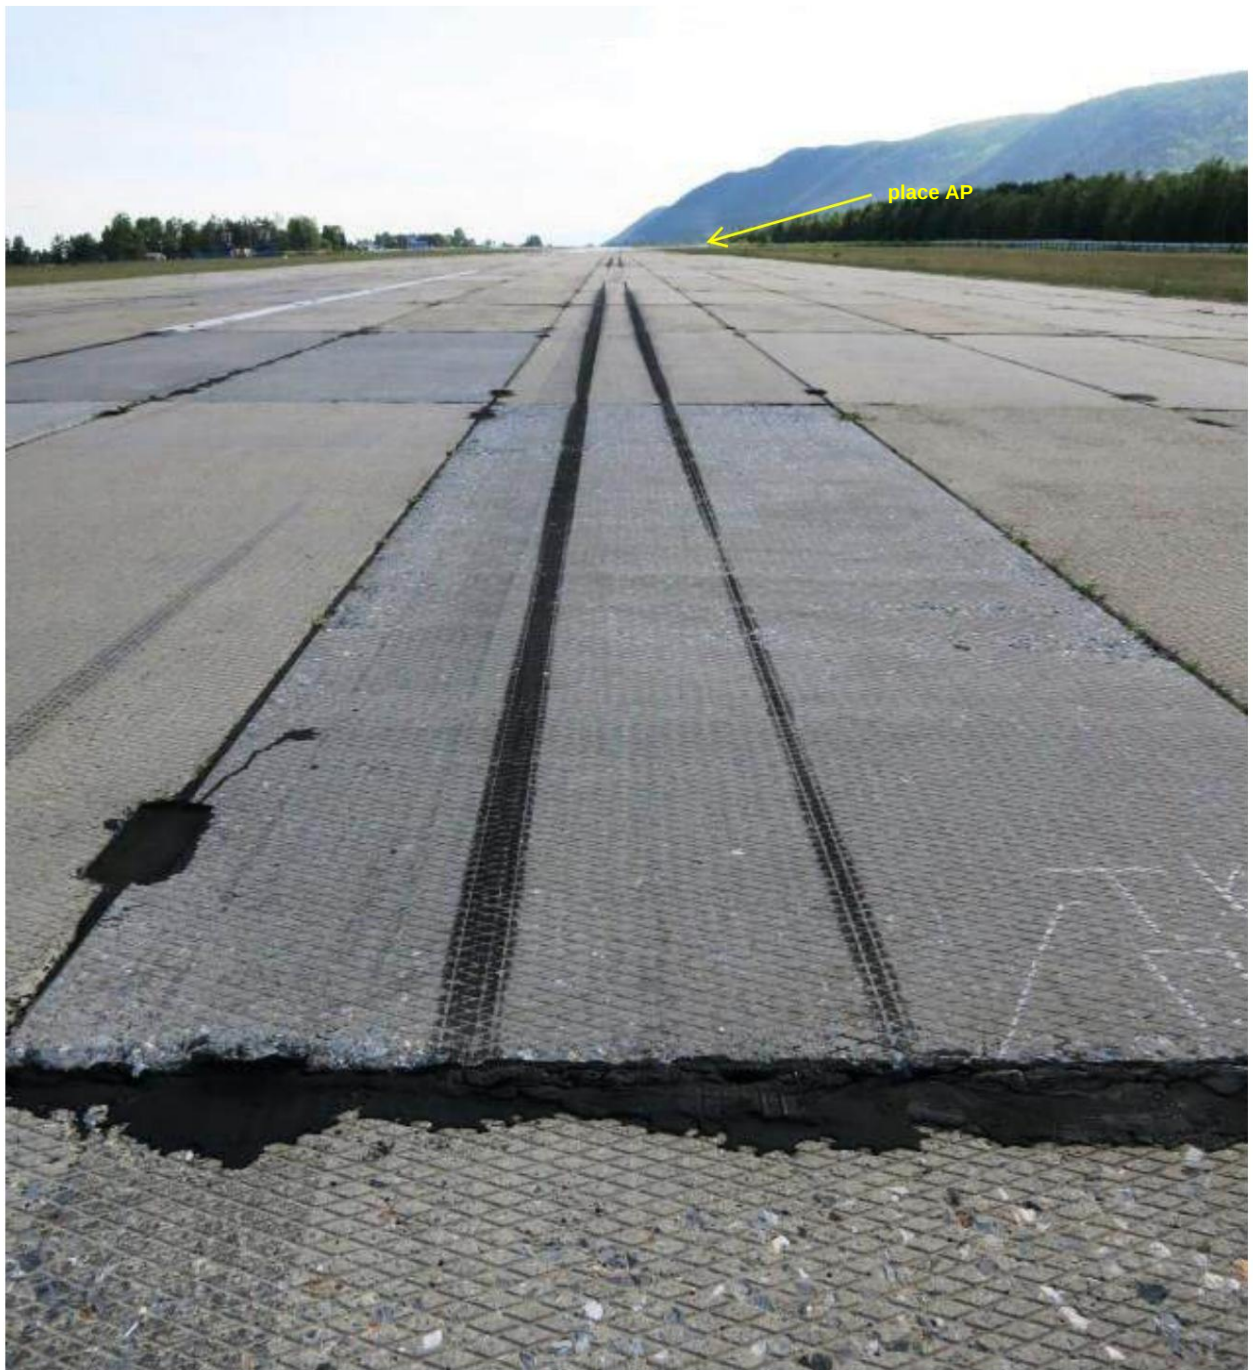
**Fig. 11. Traces of the beginning of destruction of the tires of the right main landing gear**

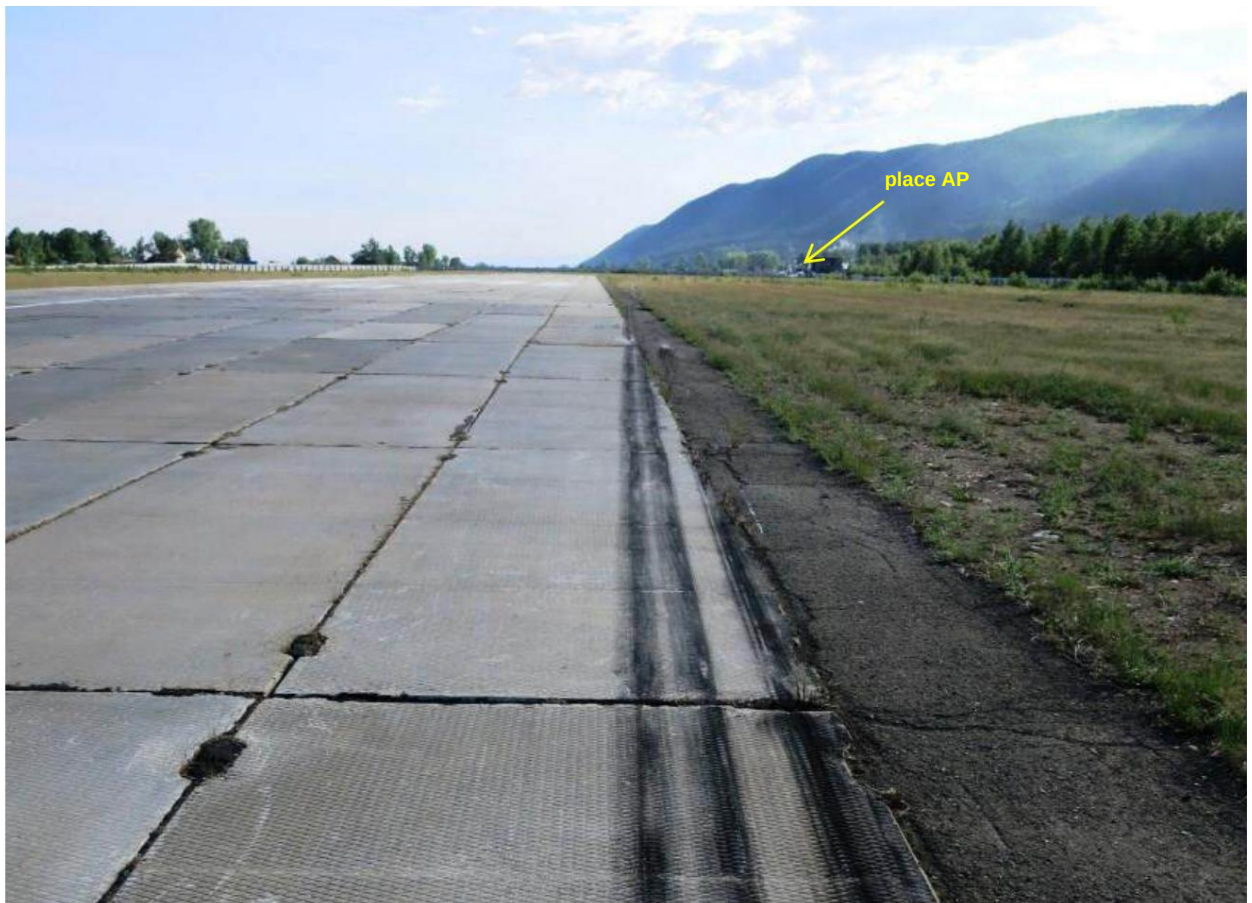
Fig. 12. Tire marks on the right main landing gear when leaving the runway and landing on the ground

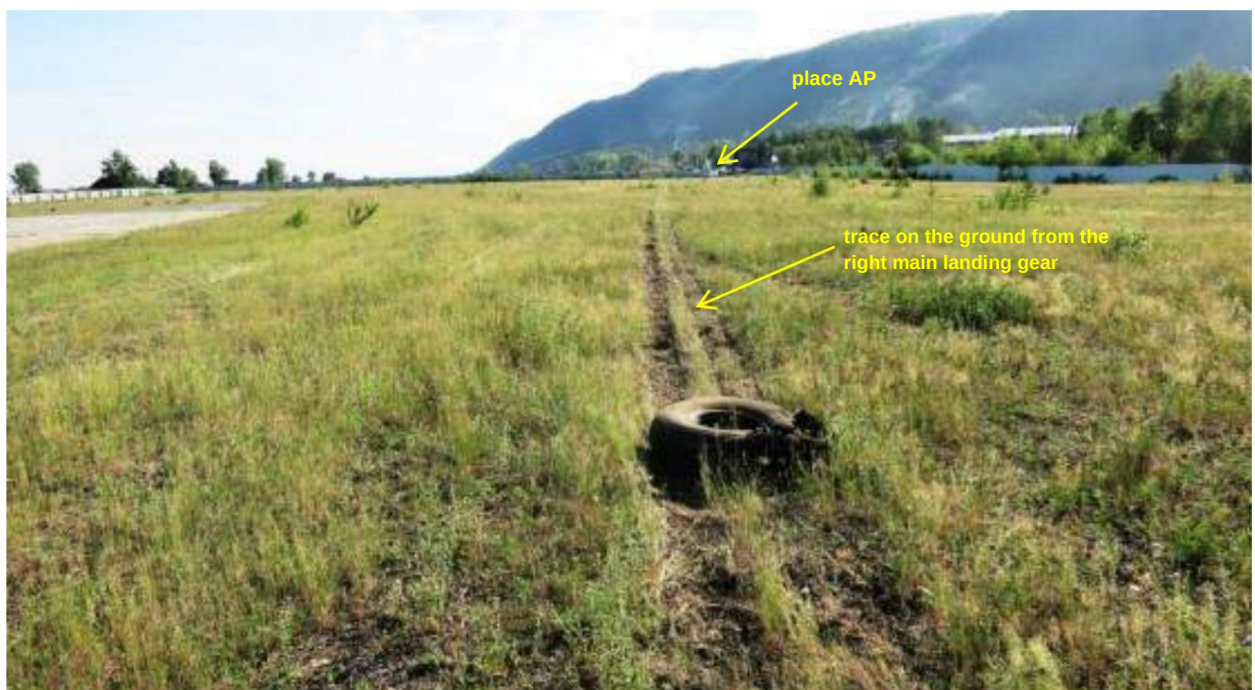
Fig. 13. Outer tire of the right main landing gear

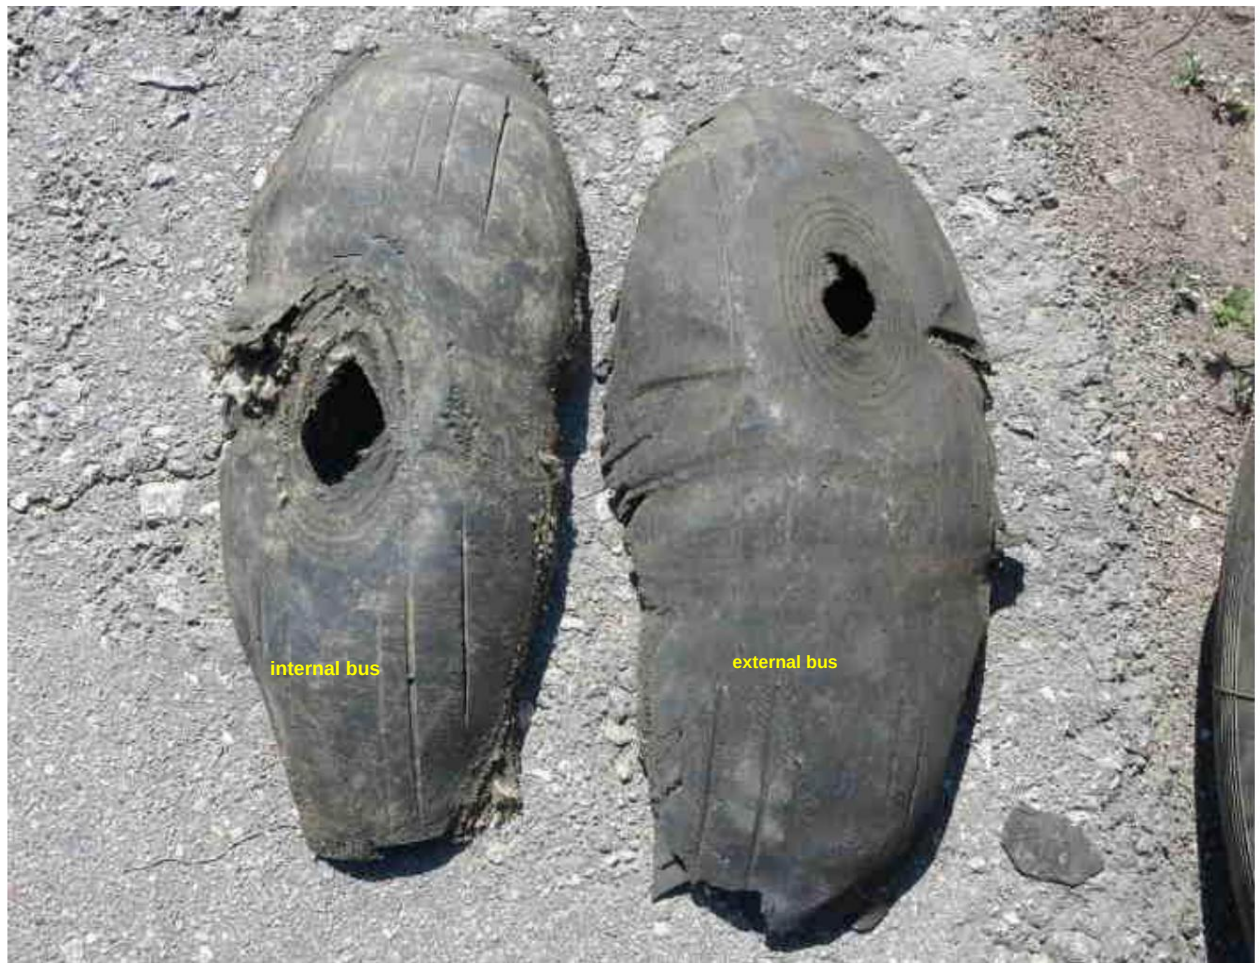
Fig. 14. Fragments of the inner and outer tires of the right main landing gear

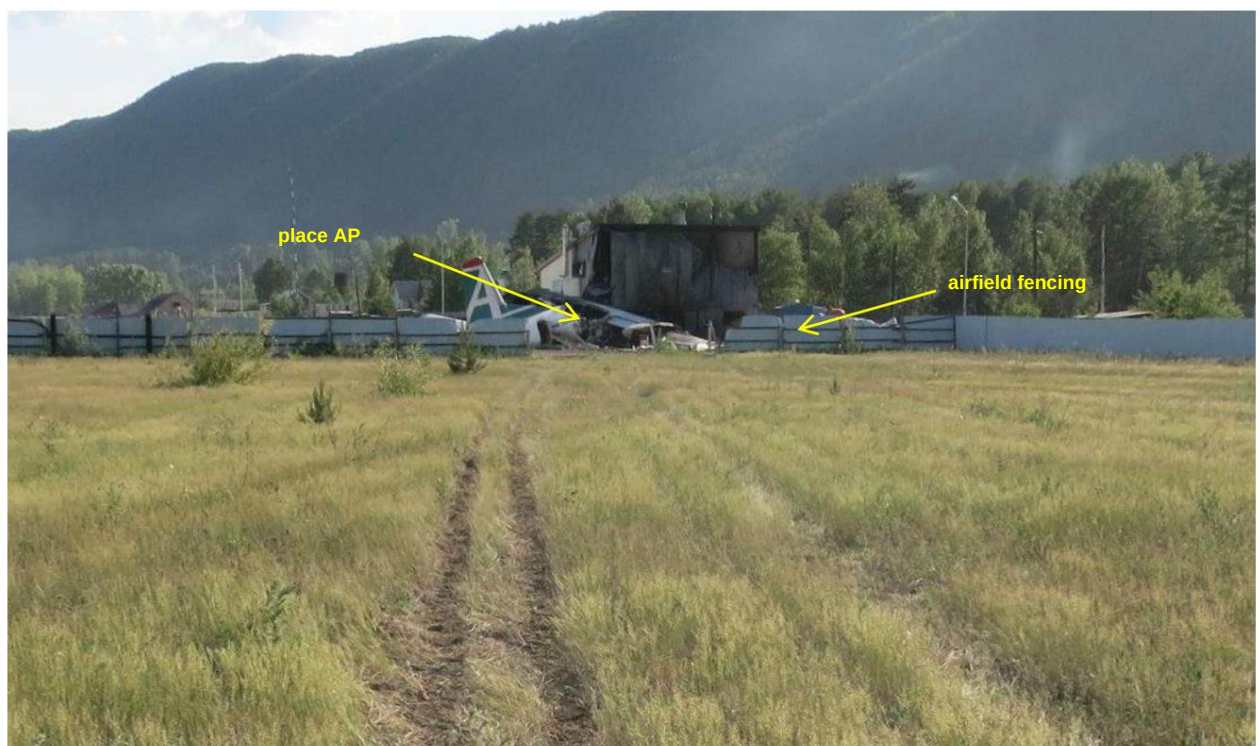
Fig. 15. Destroyed airfield fence

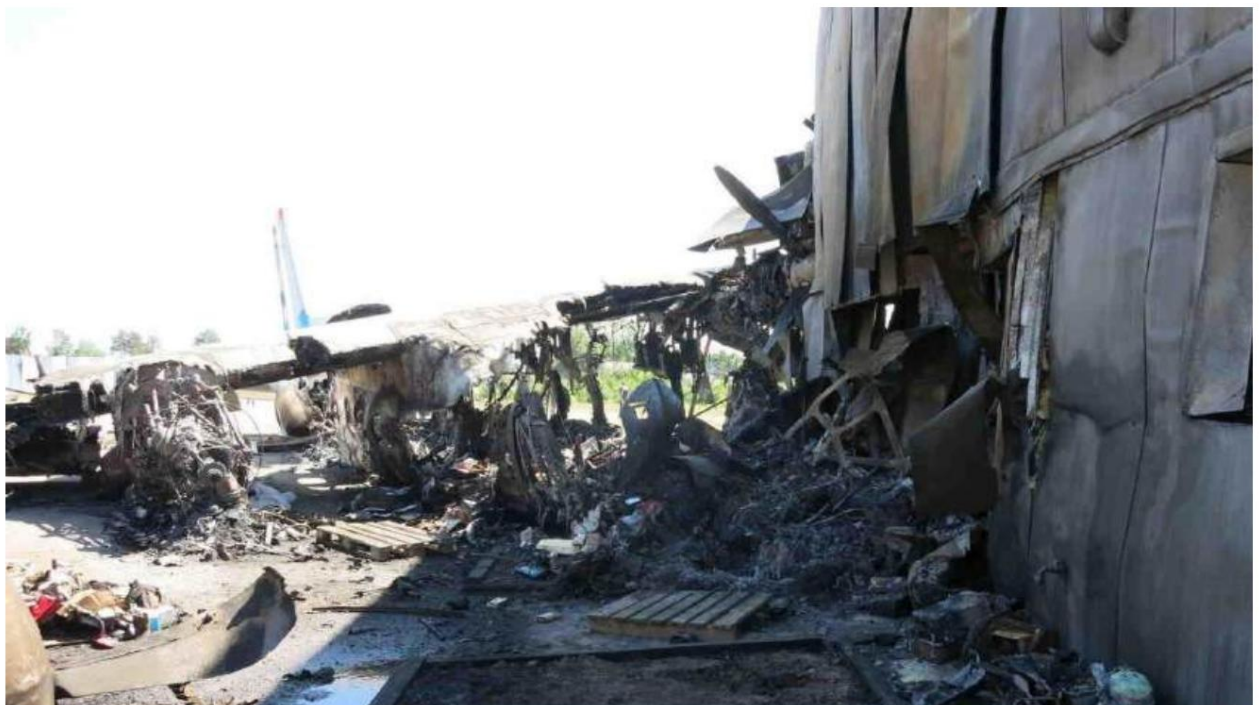
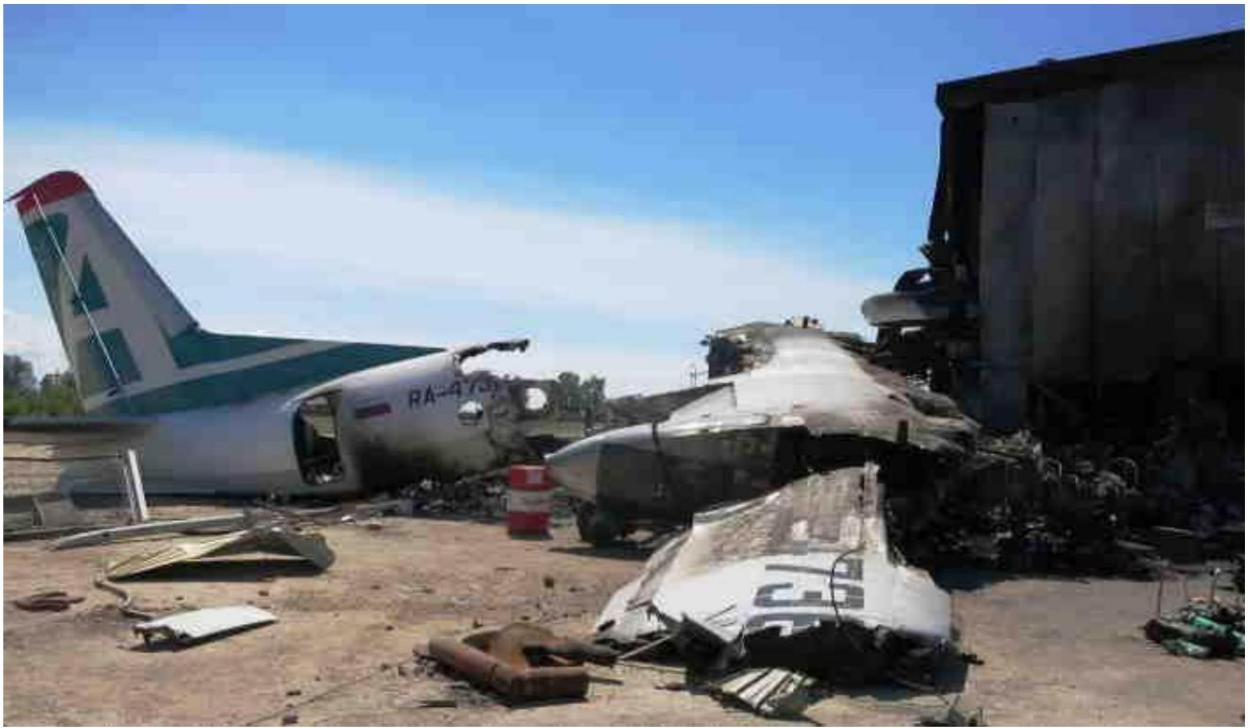
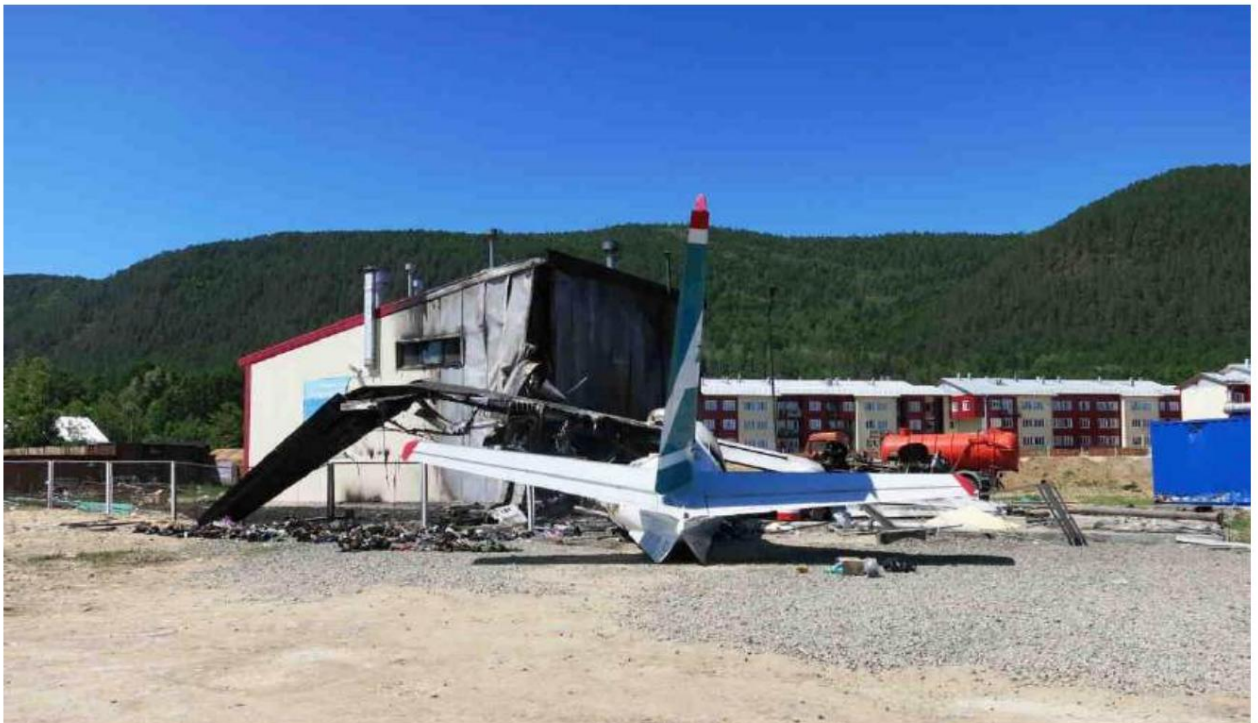
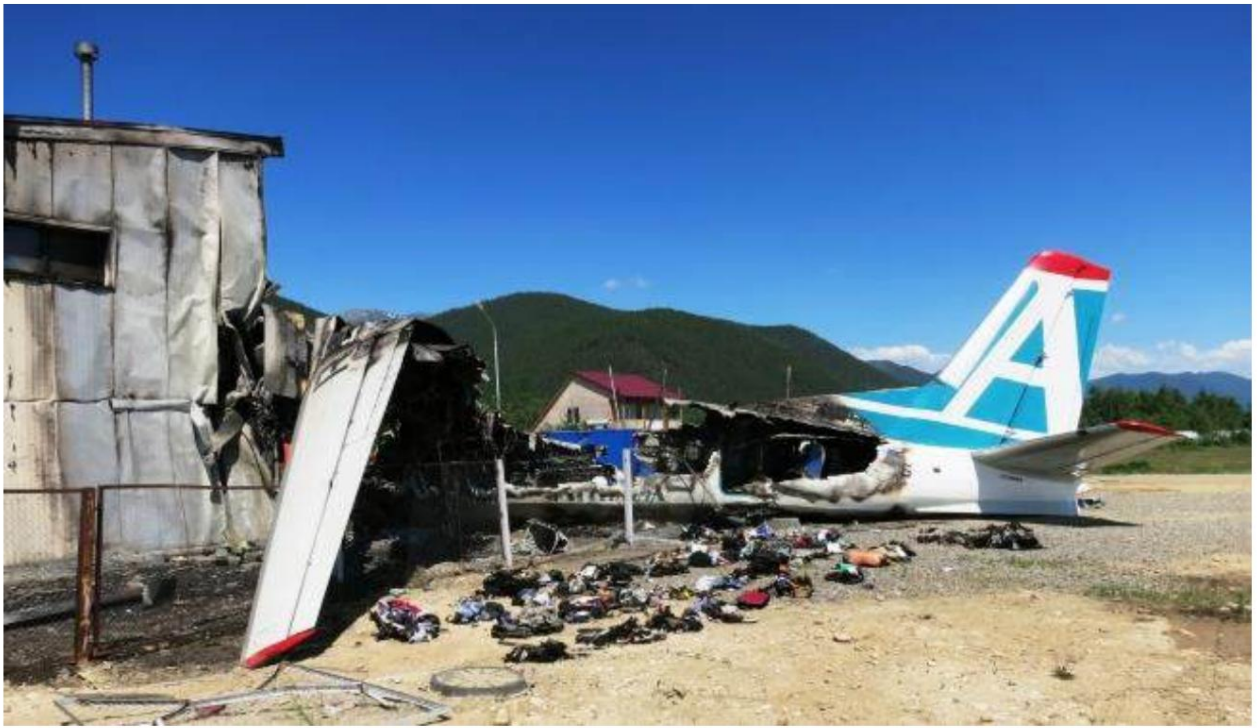
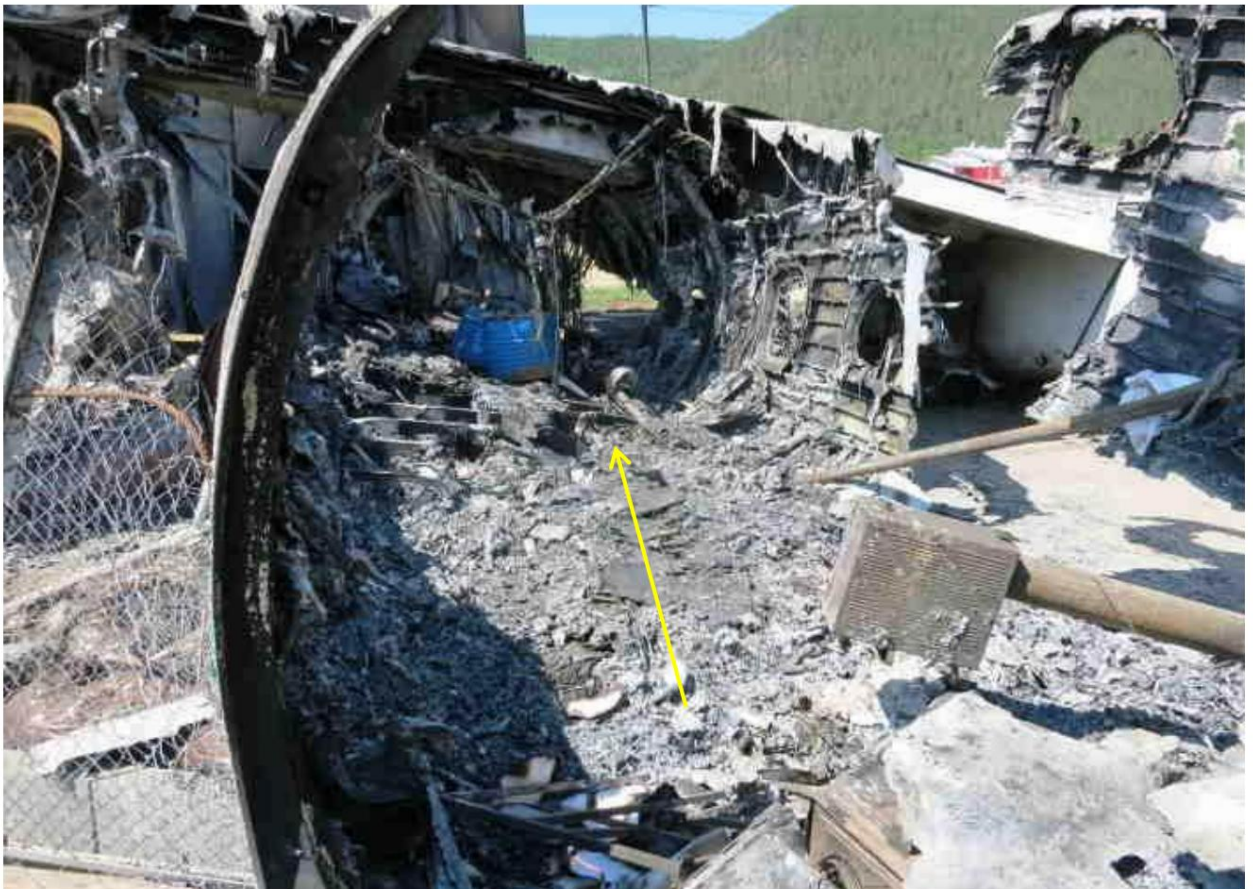
At the site of the AP, the aircraft is located with MK = 276° (Fig. 16). General view of the aircraft and its parts after AP is shown in Fig. 16 – Fig. 23.

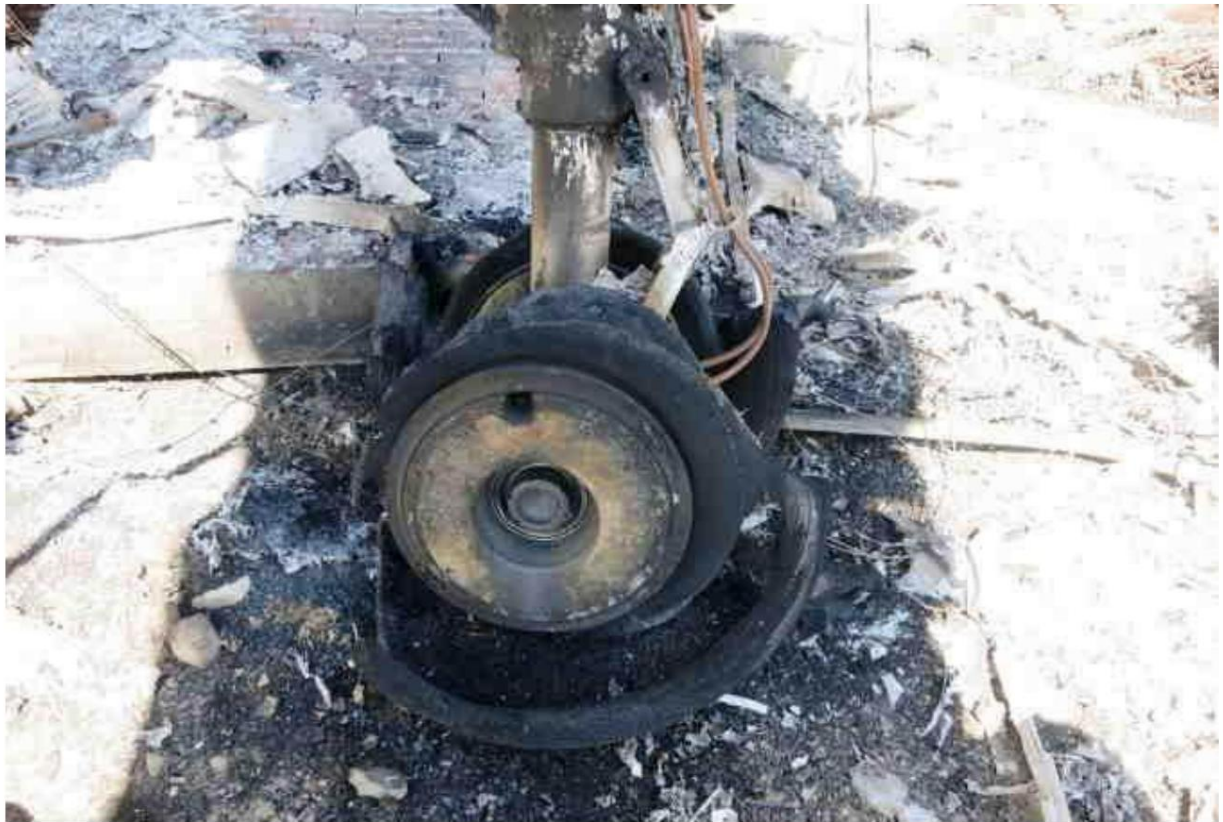
**Fig. 22. Aircraft at the accident site. Left main landing gear**

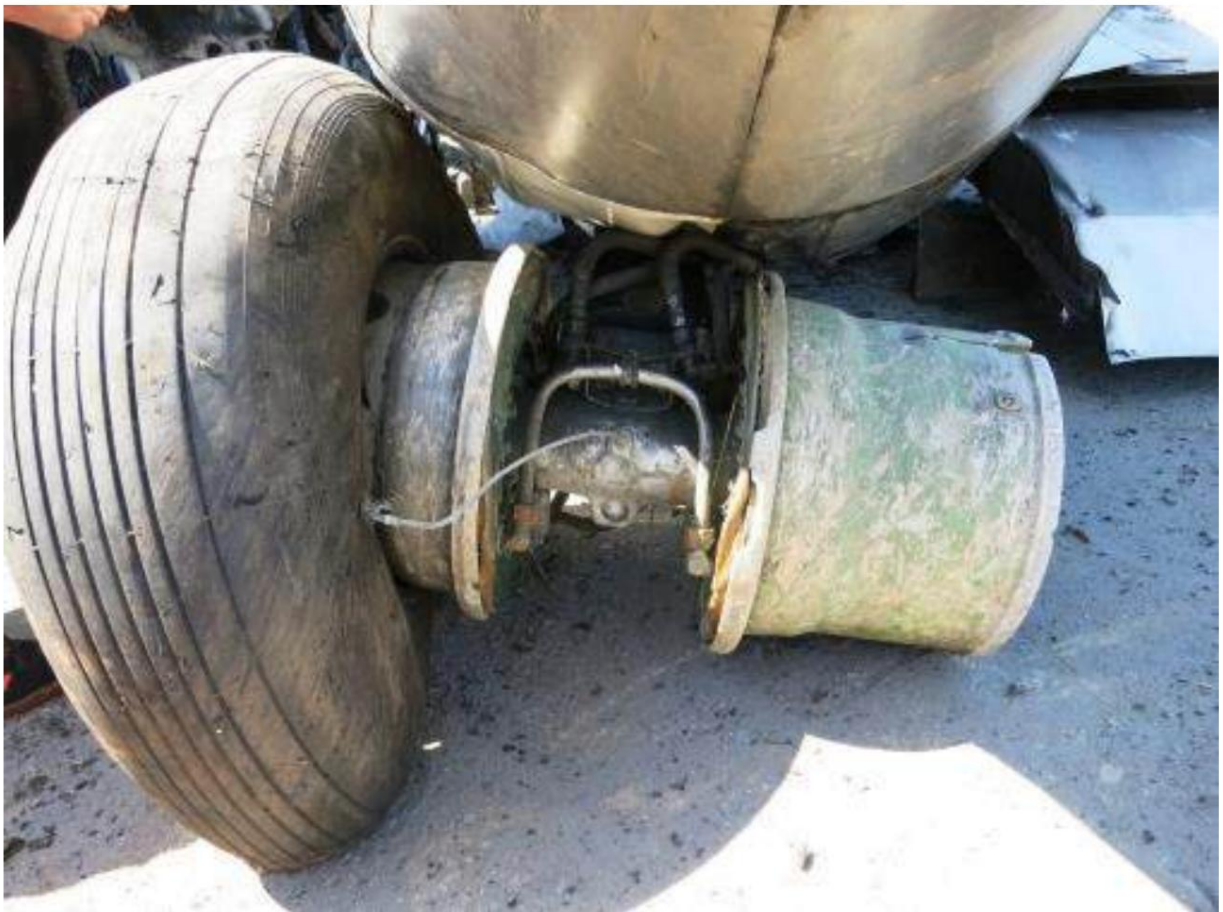
**Fig. 23. Aircraft at the accident site. Right main landing gear**
