**URGENT Medical Device Correction***Risk Management Department*

Philips Azurion and Allura with 1 Phase UPS  
Potential Loss of System Functionality

Philips Reference # C&R 2024-IGT-BST-009

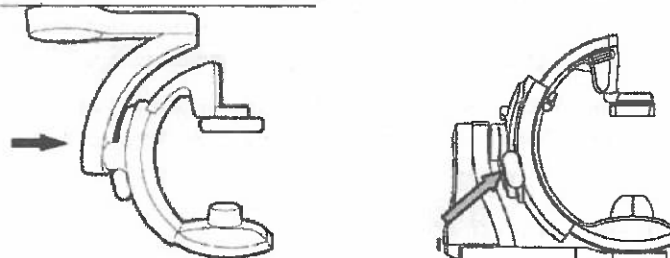
Figure 1: Location of the System identification label

The Product Number and Product Name can be found on the System Identification Label (Figure 1).
