**Service:** Full Home Inspection

Site Address: 11409 107th Pl NE, Kirkland, WA 98033  
Service Date And Time: September 01, 2025 At 12:30 PM  
Work Order Number: 14895780

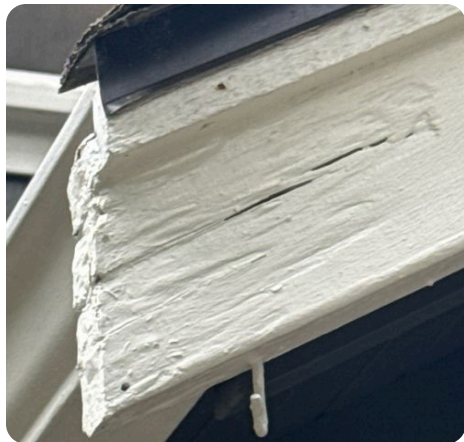
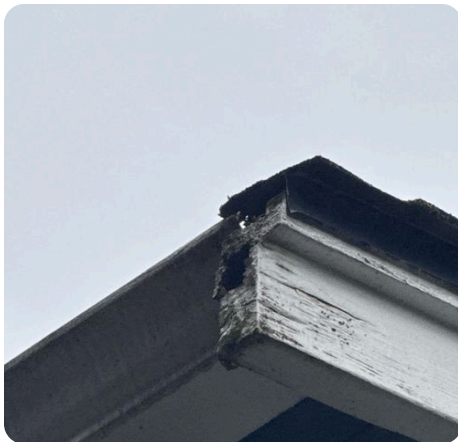
### 1 Fascia Paint 🚧 Repairs Recommended

The fascia boards around the structure are showing wear and require painting to avoid damage to the wood fascia. Recommend a qualified person paint and repair or replace any fascia boards as needed.

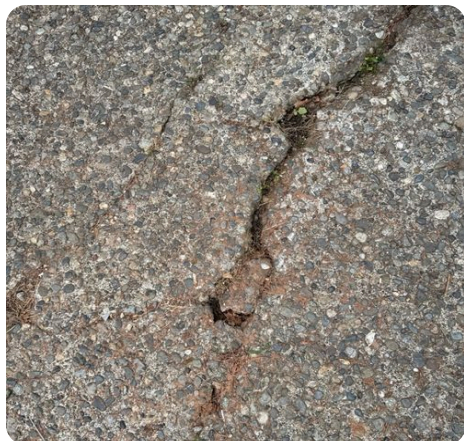
### 2 Concrete Cracking 🚧 Repairs Recommended

Cracking was observed in the concrete walkways and driveways. Cracking in concrete can occur due to various reasons such as shrinkage, settling of the ground, or temperature changes. While some minor cracks may not be a cause for major concern, evaluating the extent and severity of the cracking is recommended to prevent further damage. Contacting a qualified concrete contractor to assess the cracks and determine the best course of action is advised. This may include repairing the cracks to prevent water penetration and potential tripping hazards. Regular maintenance, like sealing the cracks and keeping the surface clean, can help prolong the life of the concrete and minimize further deterioration.

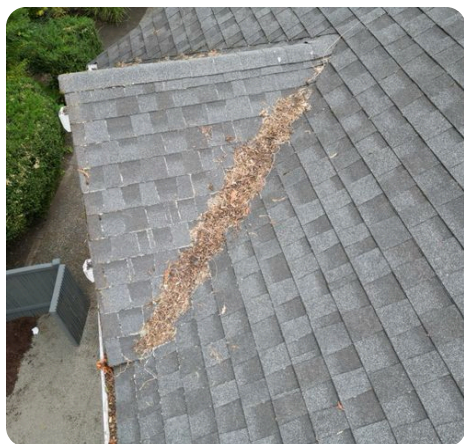
### 3 Debris On Roof

There is a small amount of debris on the roof. Leaves, branches, and/or other material that should be removed at some time in the near future. The debris can clog gutters, down spouts and/or drains. Debris can hold moisture that can cause damage to the roof system if large accumulations develop. Debris should be cleaned off the roof surface on an annual basis as a proper care and maintenance recommendation.

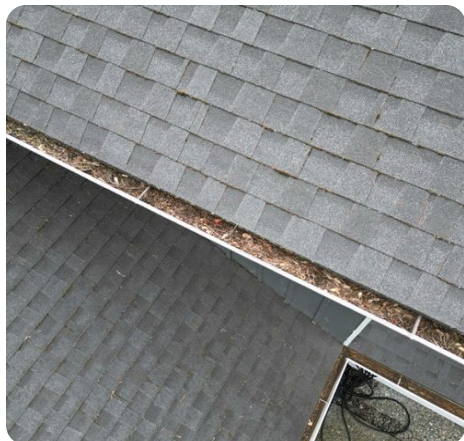
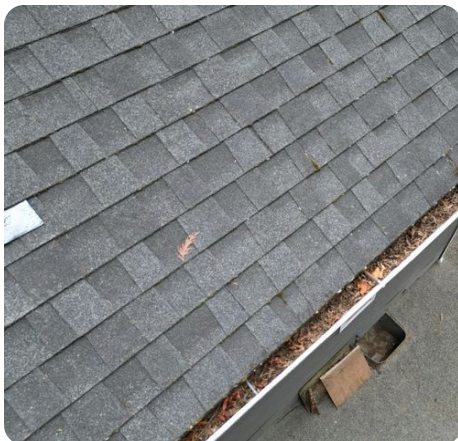
### 4 Maintenance Advised

The gutters need cleaning at this time. There is gutter screen material available on the market that can help keep leaves and other debris out of the gutter system to prevent clogging of the gutters, downspouts, and drain system. The roof also has some buildup of pine needles that needs to be removed. Buildup of debris on the roof can cause premature deterioration of the roofing material. It is recommended to inspect and clean the gutter system and roof surface on an annual basis.

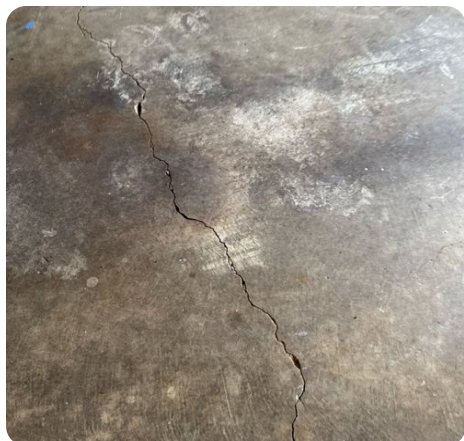
### 5 Cracks In Garage Floor

There are cracks noted in the garage floor. The size of the cracks do not indicate a significant issue at this time. It is recommended to evaluate and repair as needed to prevent further deterioration.

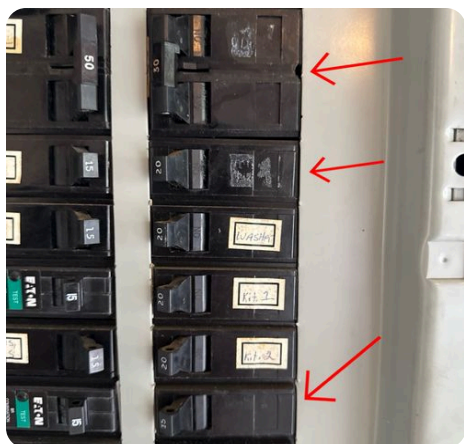
### 6 Electrical Panel Labeling

The electrical panel lacks full and proper labeling. It is recommended to label all circuits clearly for easier identification and safety purposes.

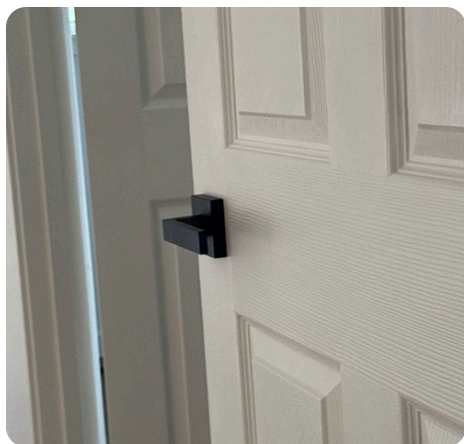
### 7 Install Deadbolt Lock

The door to the garage does not have a deadbolt lock. Adding a deadbolt lock can enhance security and deter unauthorized entry. Installing a deadbolt lock on this door is recommended to safeguard the property. This task can be completed by a qualified locksmith or a professional door installation service.

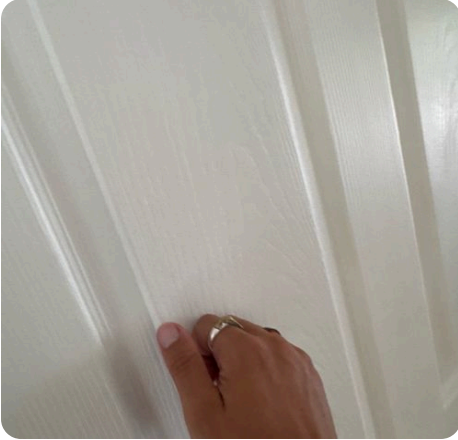
### 8 Hollow Core Door

The door to the garage is a hollow core door. The door should be a solid core for security and durability. Replacement of the door by a qualified trades person is advised.

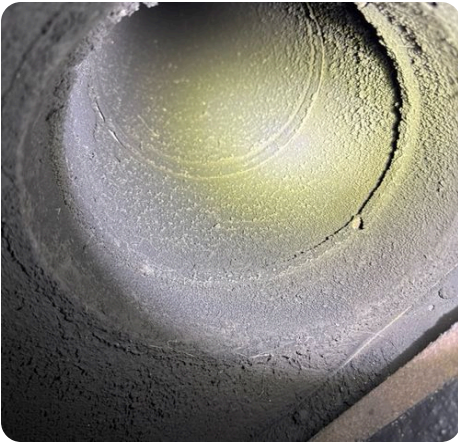
### 9 Flue Cleaning

The amount of soot and creosote buildup identified in the chimney flue would substantiate cleaning at this time. Contacting a qualified chimney sweeping company to clean and inspect the flue is recommended prior to the first use.

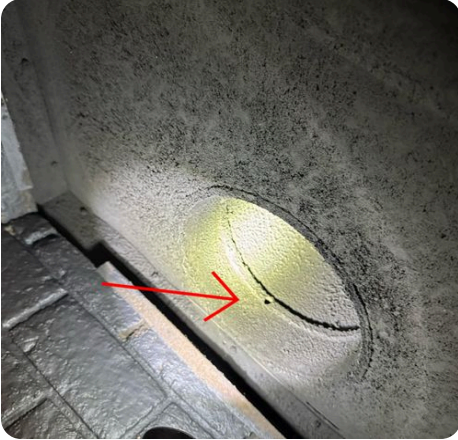
### 10 Damper Missing

The fireplace damper was found to be missing at the time of inspection. Recommend contacting a qualified fireplace contractor for repairs and replacement.

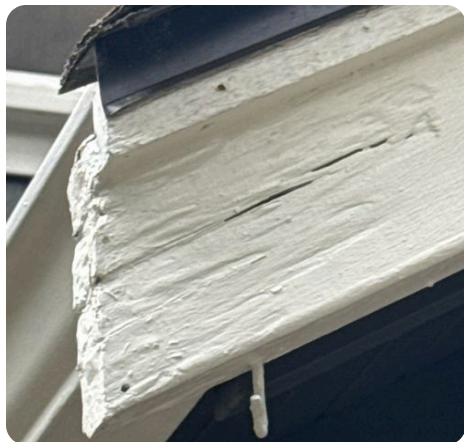
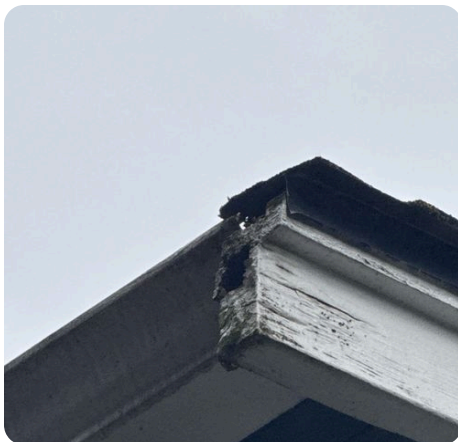
The fascia boards around the structure are showing wear and require painting to avoid damage to the wood fascia. Recommend a qualified person paint and repair or replace any fascia boards as needed.

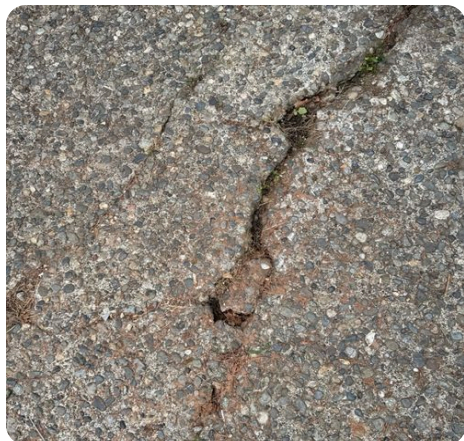
### Concrete Cracking

Cracking was observed in the concrete walkways and driveways. Cracking in concrete can occur due to various reasons such as shrinkage, settling of the ground, or temperature changes. While some minor cracks may not be a cause for major concern, evaluating the extent and severity of the cracking is recommended to prevent further damage. Contacting a qualified concrete contractor to assess the cracks and determine the best course of action is advised. This may include repairing the cracks to prevent water penetration and potential tripping hazards. Regular maintenance, like sealing the cracks and keeping the surface clean, can help prolong the life of the concrete and minimize further deterioration.

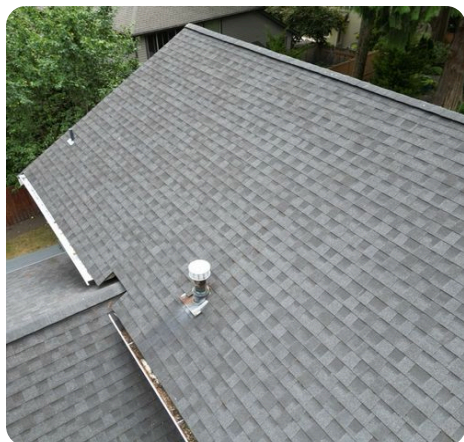
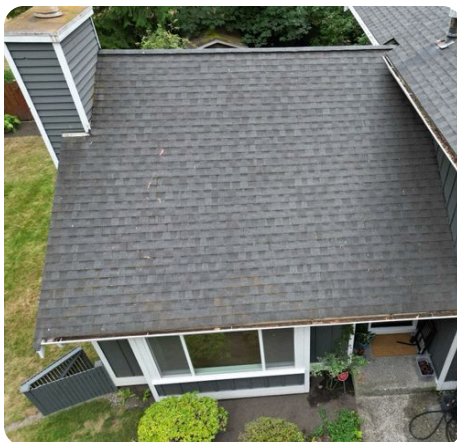
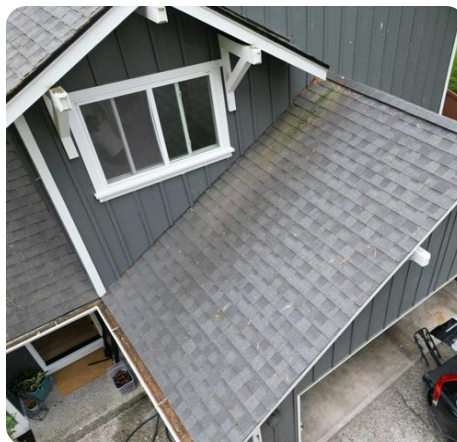
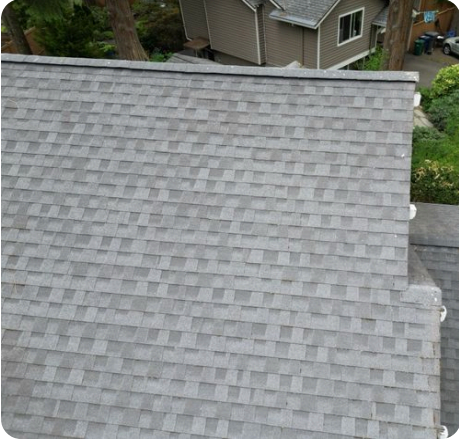
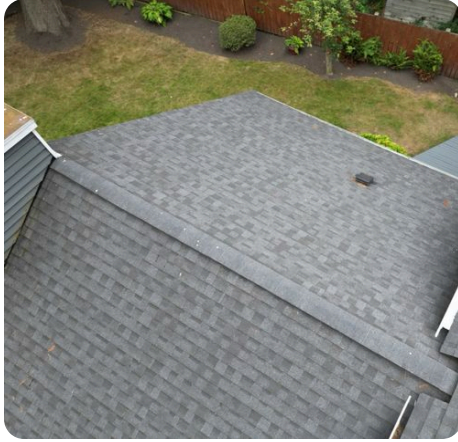
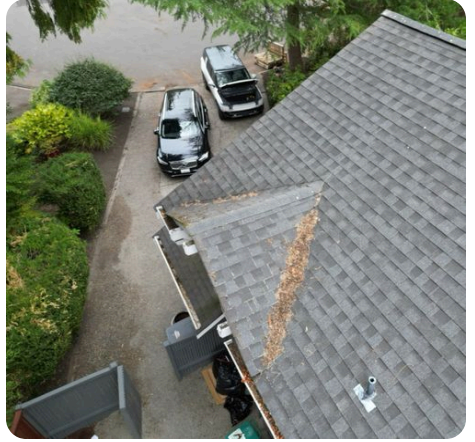
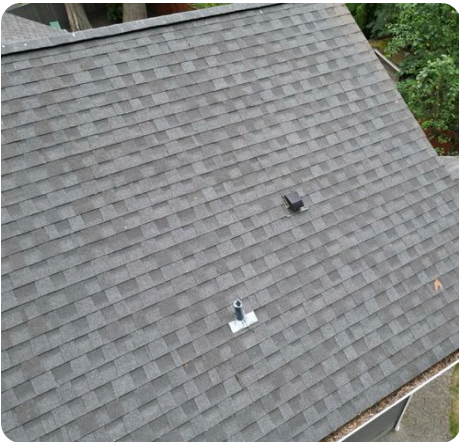
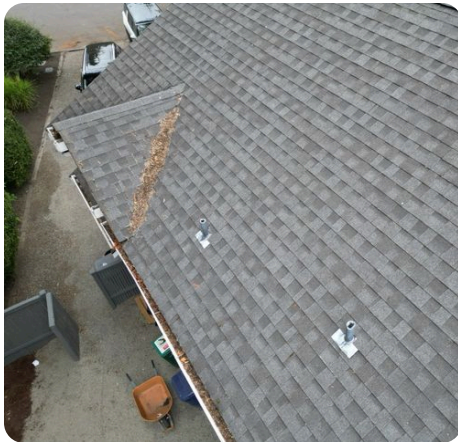
The inspector is NOT a licensed roofing contractor, and does not provide a leak-tight guarantee or a warranty for the roof system. The inspector only provides a general condition report on the visible surface areas based on his experience. For a more detailed inspection of the installation and remaining service life of the roof cover, contact a qualified roofing contractor for further review.

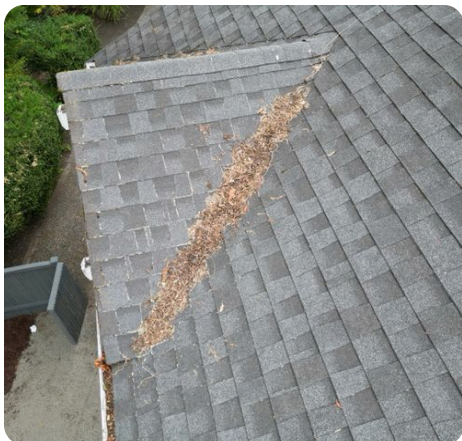
#### Debris On Roof

There is a small amount of debris on the roof. Leaves, branches, and/or other material that should be removed at some time in the near future. The debris can clog gutters, down spouts and/or drains. Debris can hold moisture that can cause damage to the roof system if large accumulations develop. Debris should be cleaned off the roof surface on an annual basis as a proper care and maintenance recommendation.

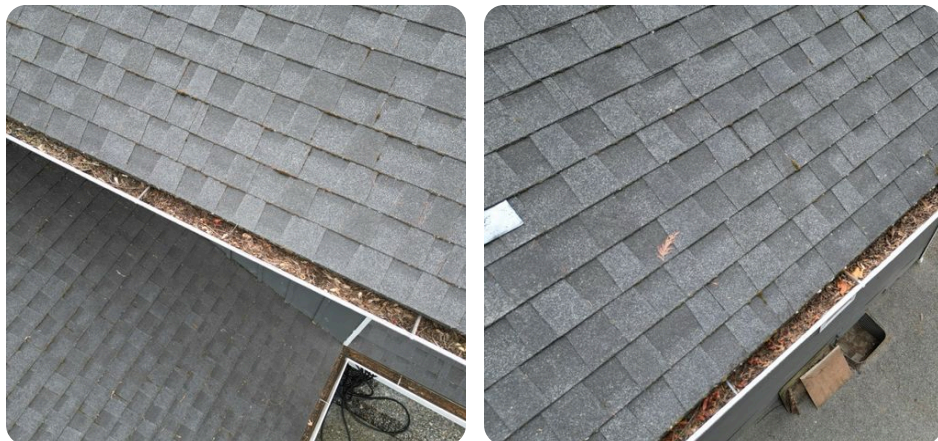
The gutters need cleaning at this time. There is gutter screen material available on the market that can help keep leaves and other debris out of the gutter system to prevent clogging of the gutters, downspouts, and drain system. The roof also has some buildup of pine needles that needs to be removed. Buildup of debris on the roof can cause premature deterioration of the roofing material. It is recommended to inspect and clean the gutter system and roof surface on an annual basis.

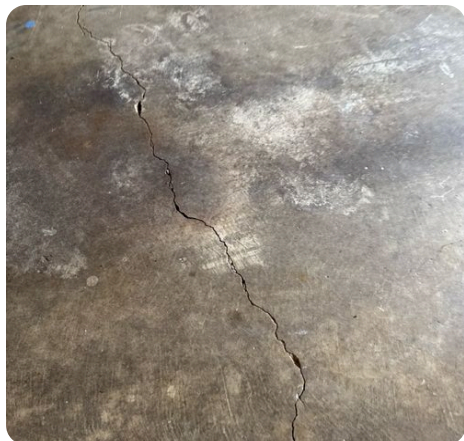
#### Cracks In Garage Floor

There are cracks noted in the garage floor. The size of the cracks do not indicate a significant issue at this time. It is recommended to evaluate and repair as needed to prevent further deterioration.

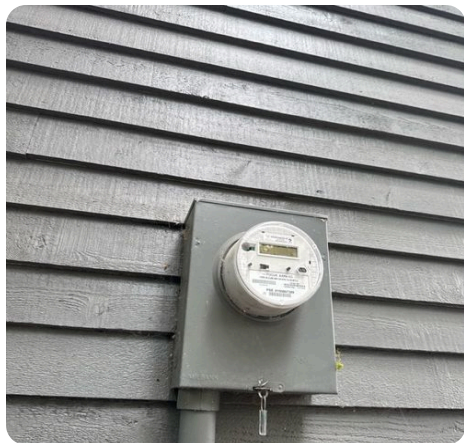
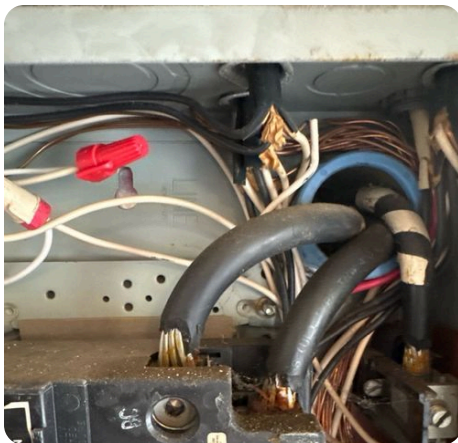
The service entrance components and grounding system were in serviceable condition at the time of the inspection.

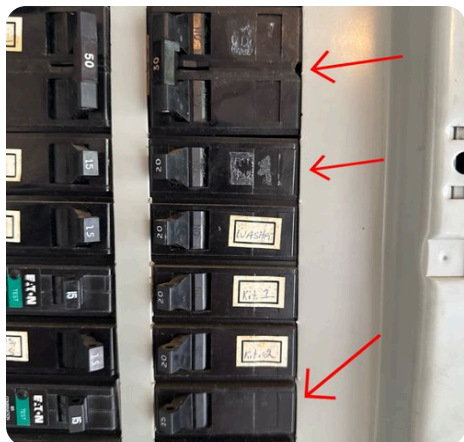
The electrical panel lacks full and proper labeling. It is recommended to label all circuits clearly for easier identification and safety purposes.

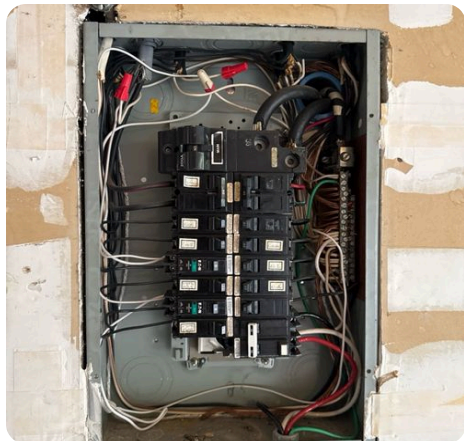
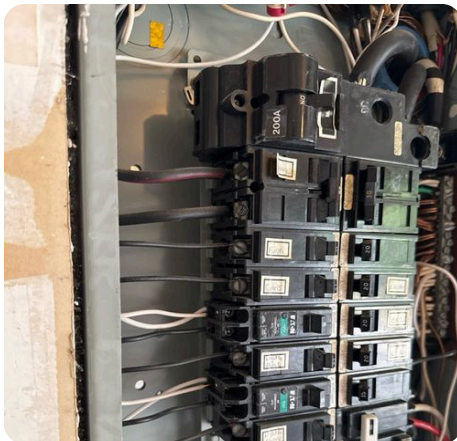
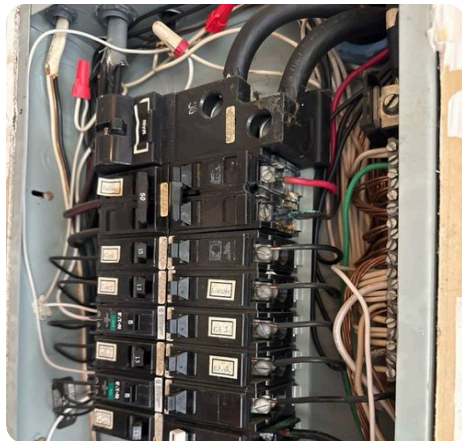
The interior components of the service panels were evaluated during the inspection, and they were found to be in working condition. It is always recommended to conduct regular maintenance and/or evaluation on the electrical panels to ensure continued performance.

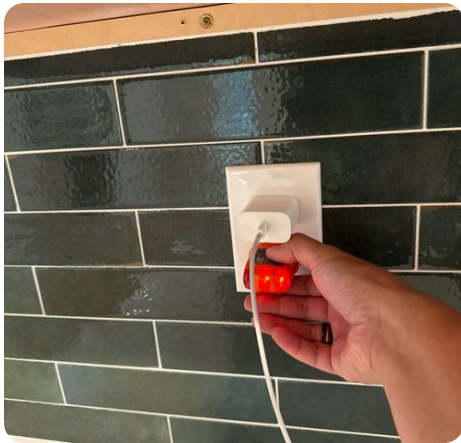
The current electrical code requires that ground fault circuit interrupters (GFCI) be located in areas with a potential danger of electrical shock (living spaces and internal rooms, garages, exterior outlets, etc.) The year the requirement was adopted for GFCI outlet installation varied for specific areas of the structure. As a safety upgrade, we recommend that GFCI outlets be installed in all areas susceptible to moisture.

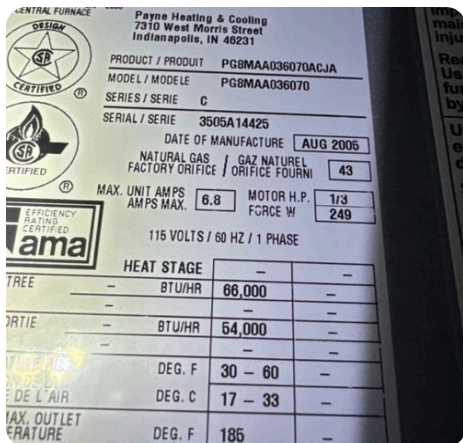
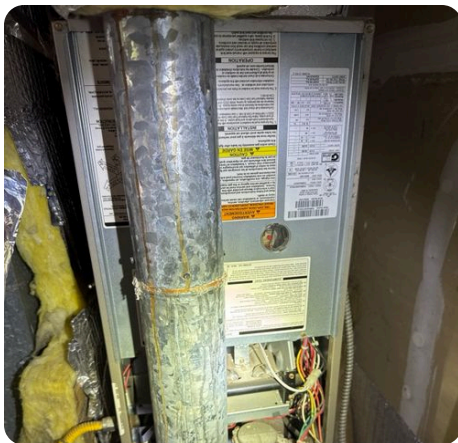
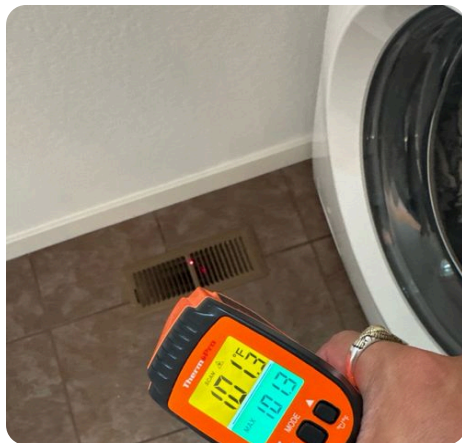
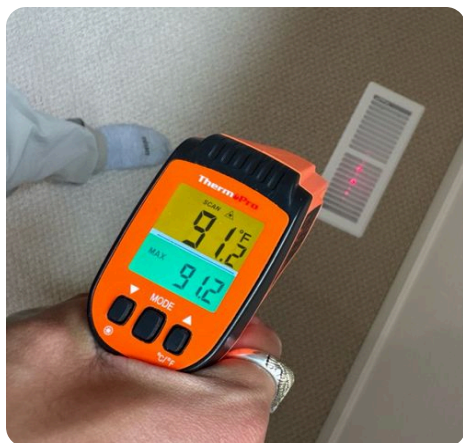
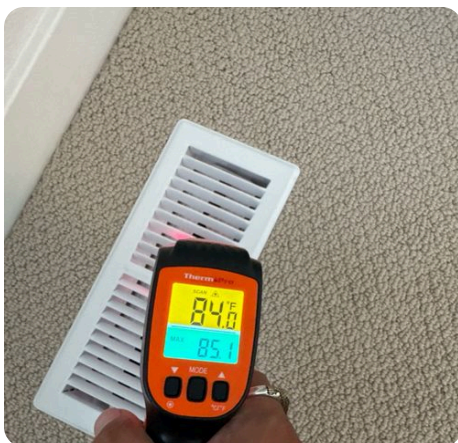
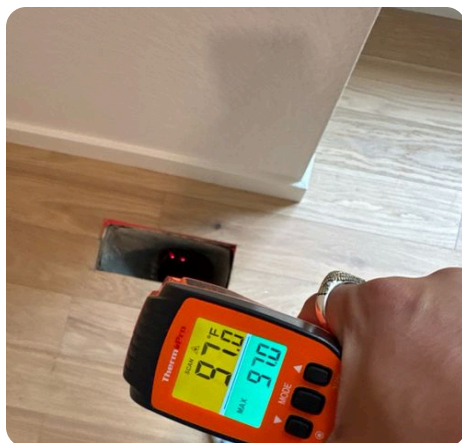
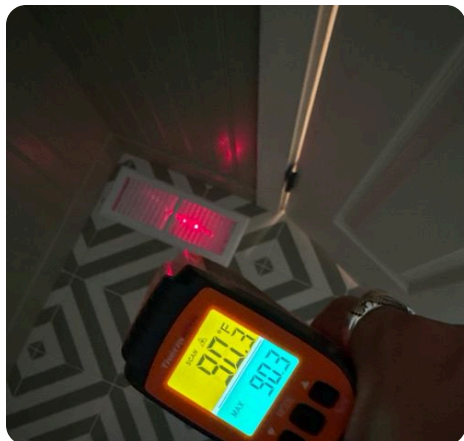
The average life expectancy of a heating system is approximately 15-25 years depending on the type and maintenance of the system. If the system is near or over this life span, consideration into saving for a replacement or a more efficient model, should be considered. The inspector is not required to remove flame guards or view/identify the condition of the heat exchanger. This inspection checks on the general function of the heating system and in no way guarantees any mechanical components for useful life, serviceability, or efficiency. It is also recommended you contact an HVAC company annually, or as needed, to perform servicing and maintenance on the unit.

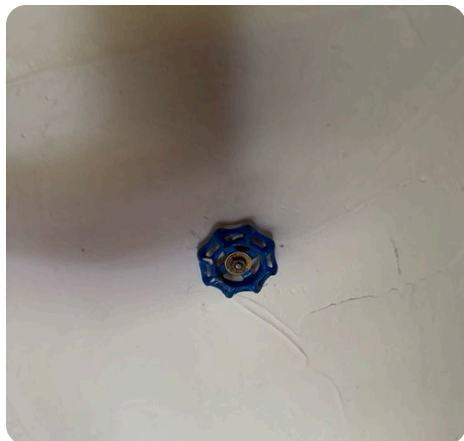
The main water shutoff appeared to be serviceable at the time of inspection.

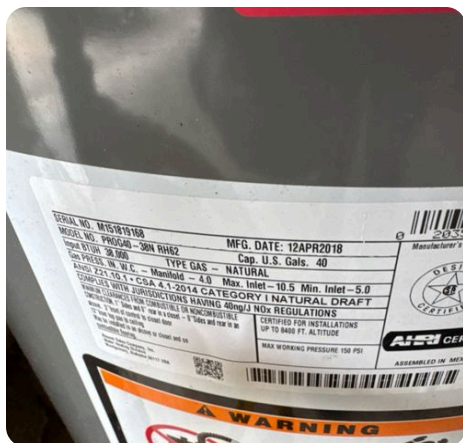
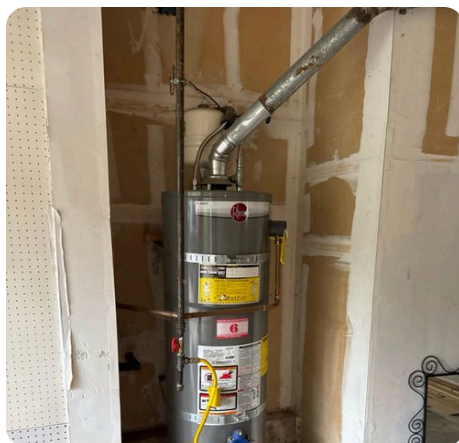
The water heater was visually inspected. The life expectancy of a water heater is typically 8-12 years from the date of installation, although there are exceptions on both sides. As a preventative maintenance recommendation, the water heater should be drained periodically to remove sediment buildup in the tank. The recommended setting for a residential water heater is under 120 degrees Fahrenheit. for safety.

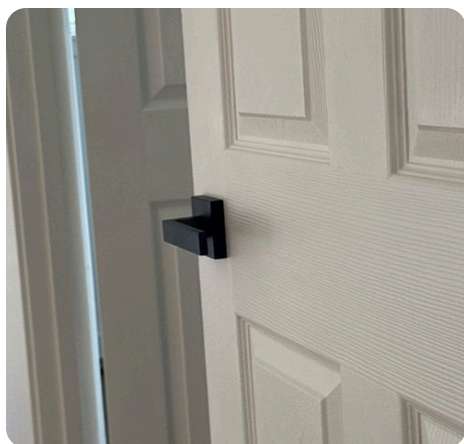
The door to the garage does not have a deadbolt lock. Adding a deadbolt lock can enhance security and deter unauthorized entry. Installing a deadbolt lock on this door is recommended to safeguard the property. This task can be completed by a qualified locksmith or a professional door installation service.

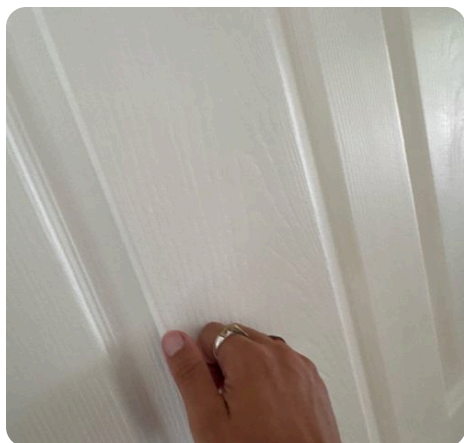
### Hollow Core Door

The door to the garage is a hollow core door. The door should be a solid core for security and durability. Replacement of the door by a qualified trades person is advised.

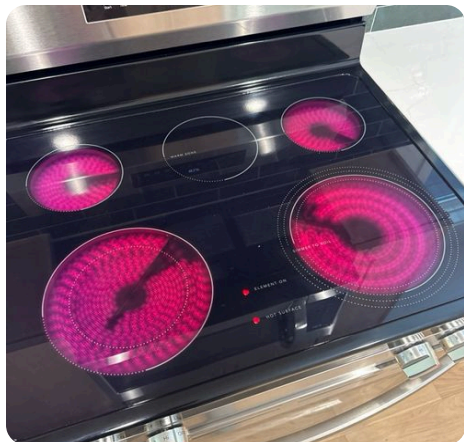
An on / off test was performed to determine if the cooktop was functioning. Periodic cleaning and maintenance is recommended for continued use.

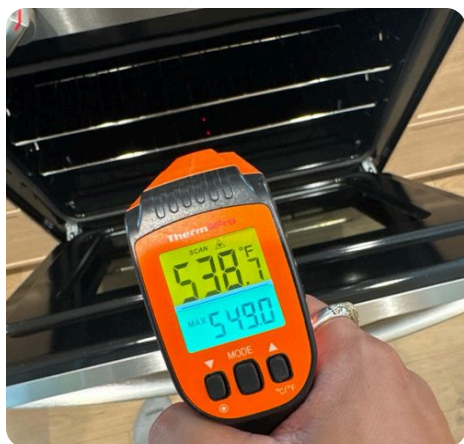
The bake and broil cycles were functional at the time of the inspection. This is an on/off test conducted on the oven.

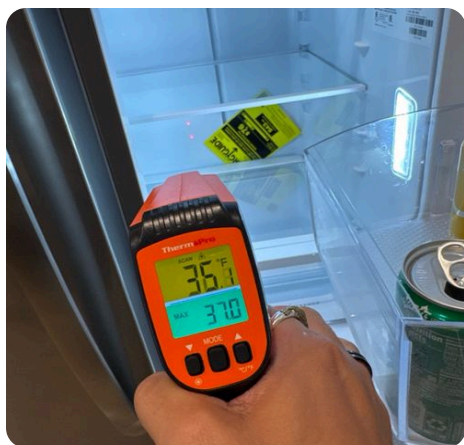
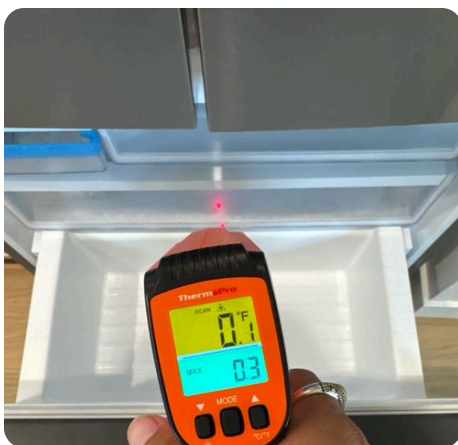
The interior of the refrigerator and freezer were cold when opened and functional at the time of inspection.

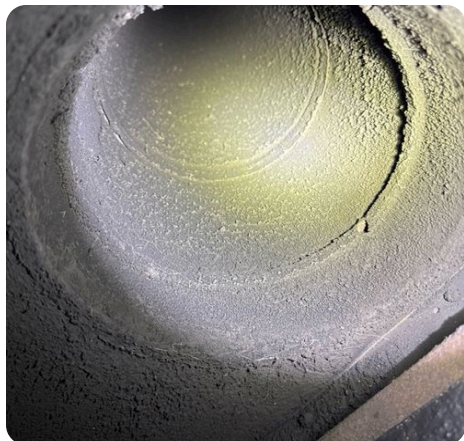
The amount of soot and creosote buildup identified in the chimney flue would substantiate cleaning at this time. Contacting a qualified chimney sweeping company to clean and inspect the flue is recommended prior to the first use.

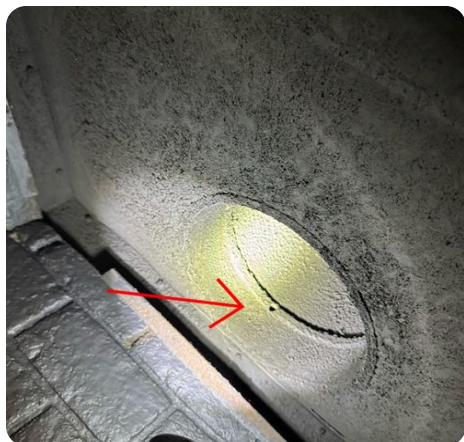
#### Damper Missing

The fireplace damper was found to be missing at the time of inspection. Recommend contacting a qualified fireplace contractor for repairs and replacement.

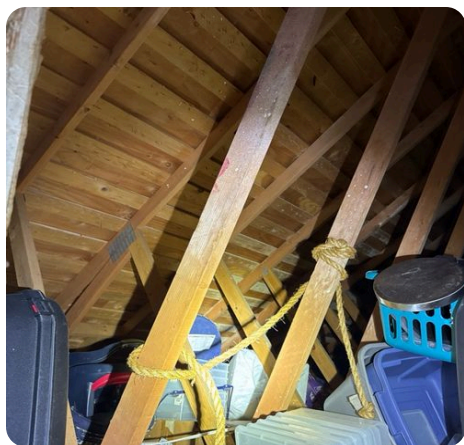
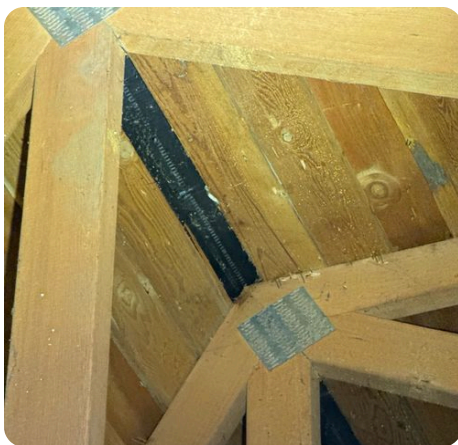
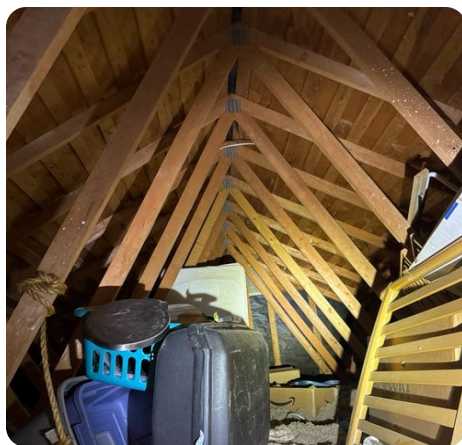
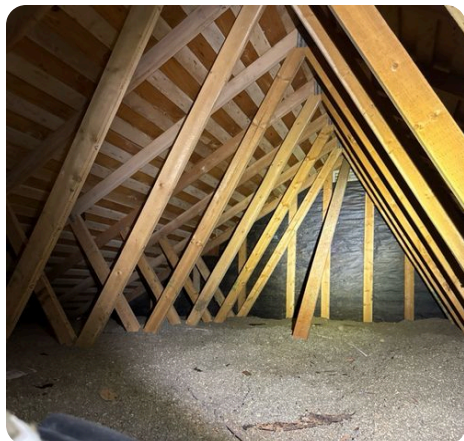
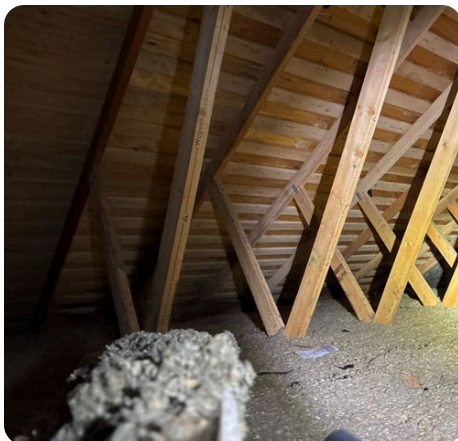
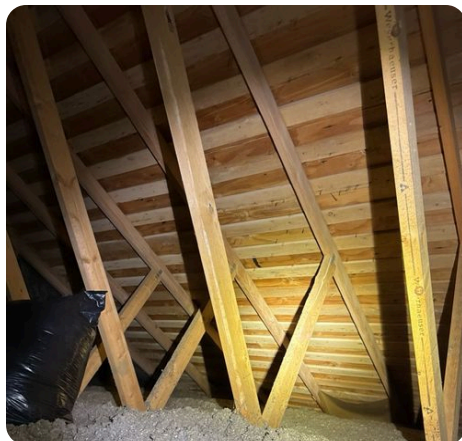
The insulation depth and material were inspected. Additionally, passive ventilation in the area appears satisfactory.

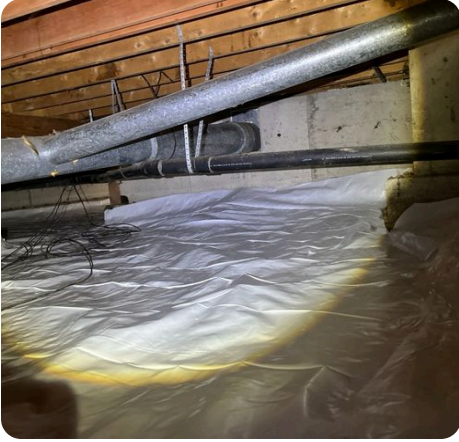
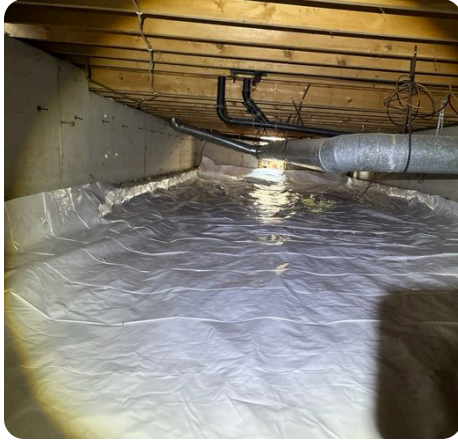
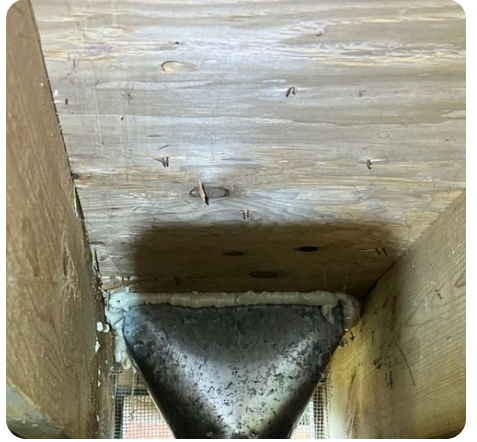
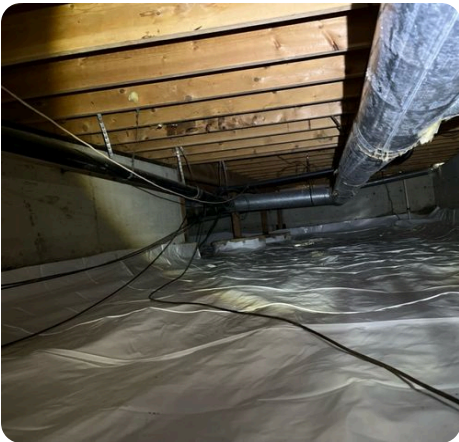
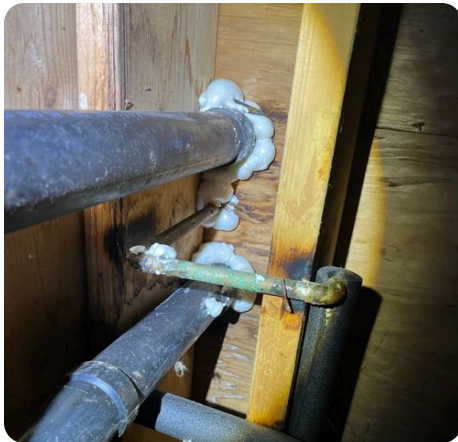
The crawlspace does not have any insulation present. Insulating the crawlspace is essential to improve energy efficiency, maintain consistent indoor temperatures, and prevent issues such as frozen pipes. It is recommended to evaluate and install proper insulation by a qualified insulation contractor.
