# Fouling in hollow fiber membrane microfilters used for household water treatment

Anna Murray<sup>1</sup>, Mario Goeb<sup>2</sup>, Barbara Stewart<sup>3</sup>, Catherine Hopper<sup>4</sup>, Jamin Peck<sup>2</sup>, Carolyn Meub<sup>2</sup>, Ayse Asatekin<sup>5</sup>, Daniele Lantagne<sup>1</sup>

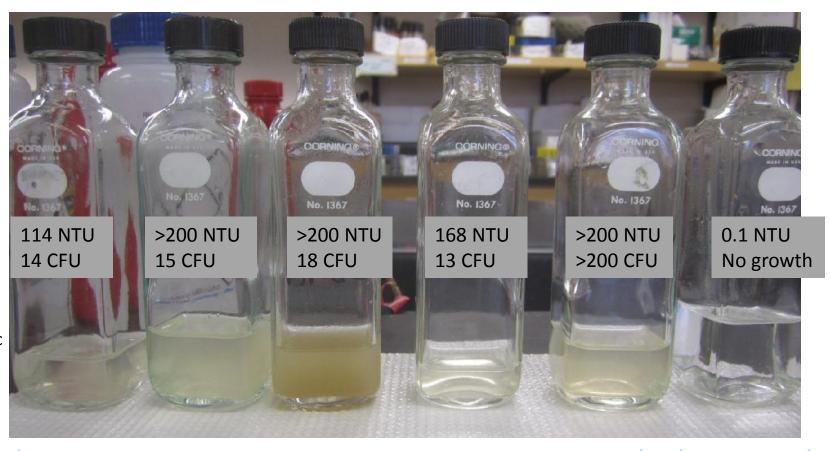
**Turbidity:** Bacteria:

Field-removed filters - Before Cleaning (one blocked - no effluent)

**New filter**

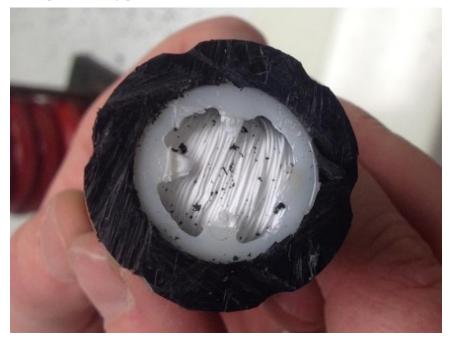
**New Filter**

#### Filter casings cut open (after cleaning) and photographed at the inlet end

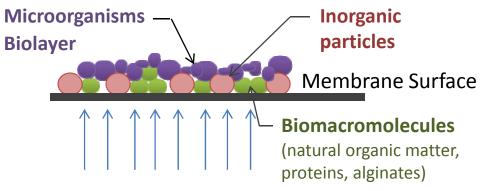
#### **Irreversible Fouling**

Solutes adsorb to pores

- Physical processes insufficient to remove
- Need chemical cleanings
  - Acidic, Alkaline, Biocide

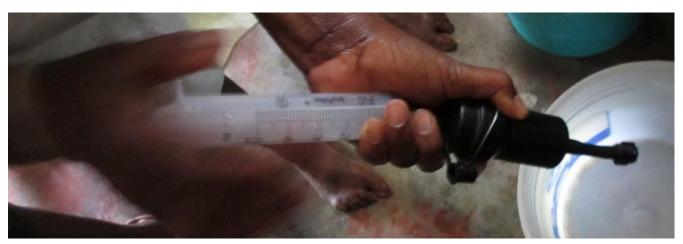
## PointOne Filter Membrane Fouling

#### **Burst Fibers?**

"Be forceful" when Backwashing

- ✓ Reversible Fouling
- X Irreversible Fouling
