# Pastoral Landscape with Ruins, 1664

Adriaen van de Velde (Dutch, 1636-1672)

## REPORT INFORMATION

| STOCK CODE / REFERENCE | CFA-2026-0147 |

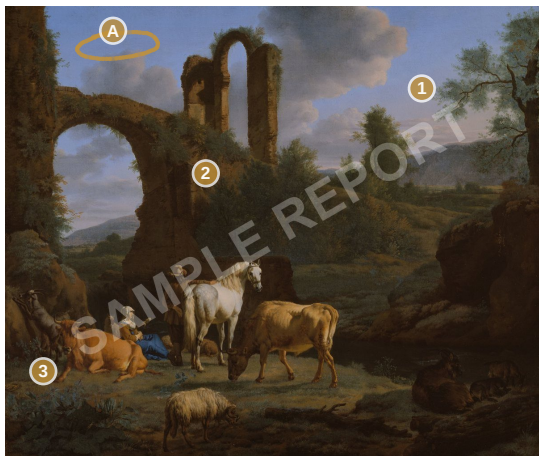
Recto, overall, normal illumination

Overall the painting is in stable condition consistent with its age. A fine network of age craquelure is present across the entire surface, most pronounced in the sky at upper right where the crack pattern is slightly raised but not actively flaking. Two small areas of old retouching are visible in the masonry of the ruins at centre left, discoloured and readily apparent under UV examination. Scattered pinpoint paint losses in the dark foreground passage at lower left, the largest approx. 3 mm, with associated abrasion to the impasto highlights on the cattle. The canvas has an old glue-paste lining, taut and in plane, with no evidence of recent movement. Varnish is moderately discoloured with a slightly uneven gloss but is not actively degrading. No mould, tears or deformation noted.

- 1 Raised craquelure across sky, stable, no active flaking
- 2 Discoloured retouching in masonry, fluoresces dark under UV
- 3 Scattered pinpoint losses, largest approx. 3 mm

The work is fit for display and transport in its current state. Condition issues are long-standing and stable; no treatment is required before exhibition, although the discoloured retouchings and varnish could be addressed by a conservator if the consignor wishes. Recommend re-examination on release. Photographed under normal illumination; UV examination carried out, raking light photographs on file.

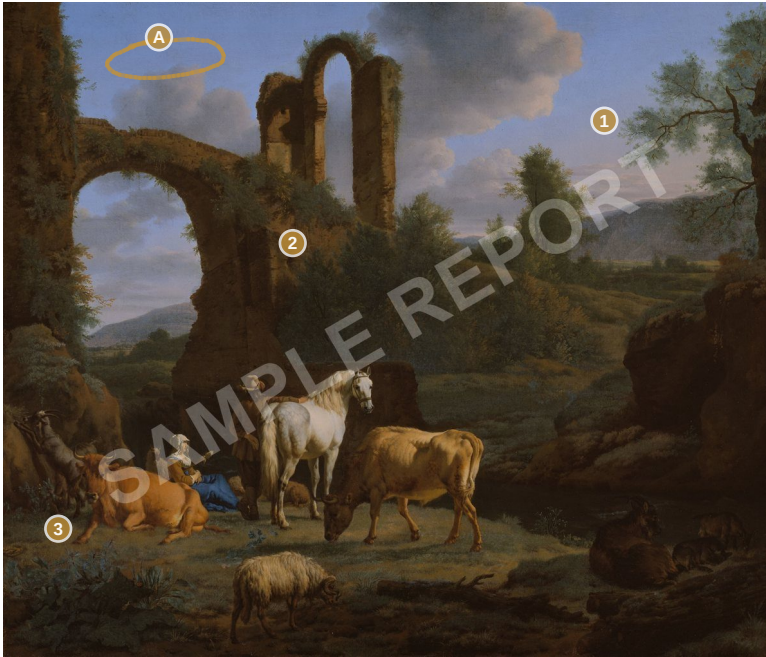
Recto, overall, normal illumination

- 1 Raised craquelure across sky, stable, no active flaking
- 2 Discoloured retouching in masonry, fluoresces dark under UV
- 3 Scattered pinpoint losses, largest approx. 3 mm

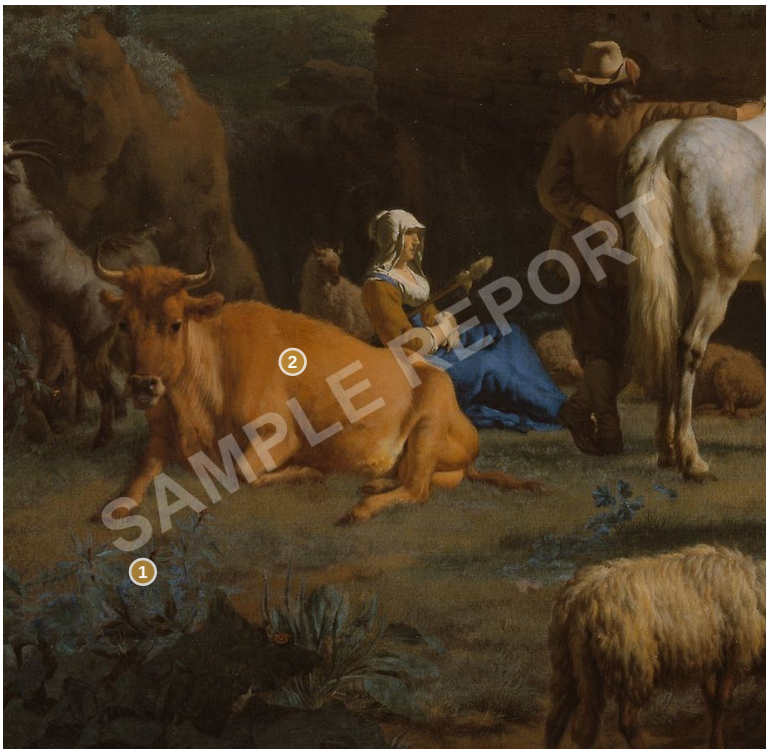
Detail, lower left foreground, area of pinpoint losses

- 1 Largest loss, approx. 3 mm, exposing ground layer" (dark scrub below the cow)
- 2 Abrasion to impasto highlights

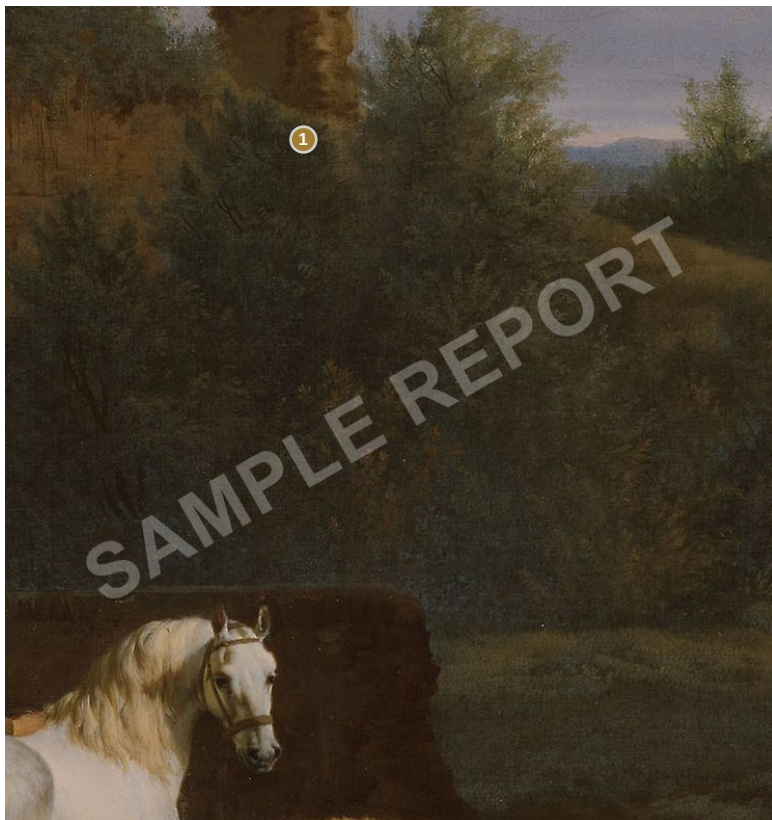
- 1 Old retouching, discoloured, visible in normal light

detail, ruins at centre left, old retouching
