Evidence from a NYS licensed inspectors
that striker plates are needed for
CSST gas line (flex pipe) installations

RE: Code violations/complaint

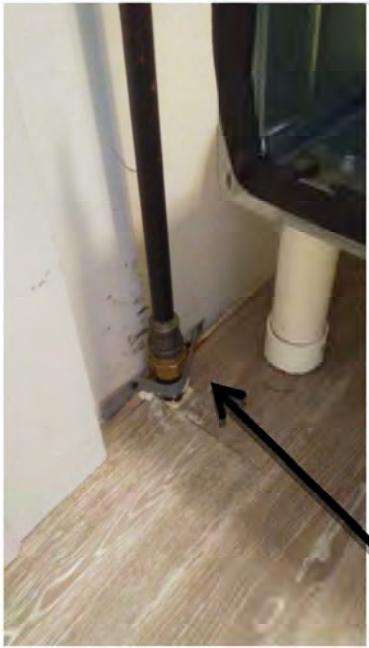
IFGC section 404.7 No protection against physical damage, as the pipes still to this day are not fastened, bolted or secured to the wall or floor (**it was explained that all units, such as this one, are incorrectly installed this way**). The pipes just come from below the floor board without any flange or recommended mounting

Mounting and screws are missing to hold CSST in place securely. Notice how sealant was used to incorrectly secure the pipe. See above illustration and more on page 40 of the manufacturer's guide.

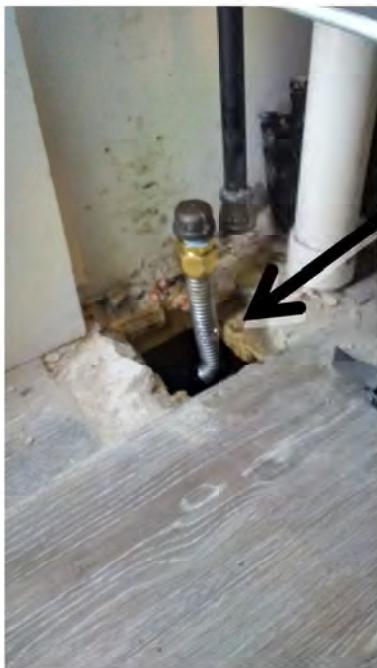
The Town Fire Marshal explained that the leak probably occurred due to the jerking of the flex pipes without any thing to hold it firm. It appears that movement without the fasteners caused the hole within the CSST flex pipes beneath the floor board.

This bubble is where the leak was also coming from. It appears that this leak has been under the floor board for a very long time. Apparently these unit pipes are installed close to objects that can rub and cause enough friction to pierce the CSST.

It did not matter how many times they tried to fix the top connectors, it would not work because it was punctured from below. Other units share the same hazard, which could potentially rupture the pipes like how it happened in this apartment unit.

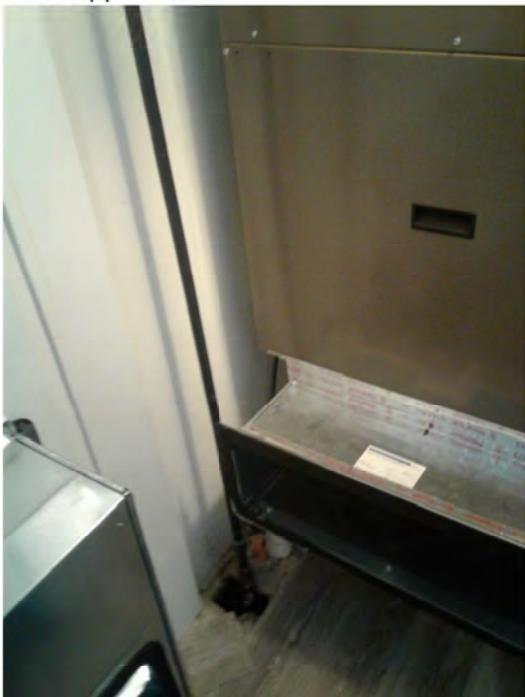
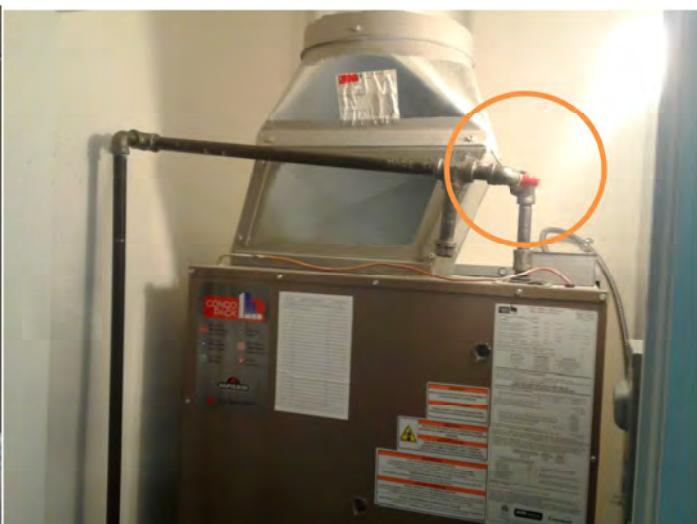
IFGC Section 407.2 Still no straps, brackets or hangers etc to hold pipes in place which would cause friction against objects beneath the floor board. This falls in line with the Marshal's theory of how the leak happened.

Pipes not secure to anything. They just come from beneath the floor at an angle into the furnace, which could also damage the unit internally due to physical contact.

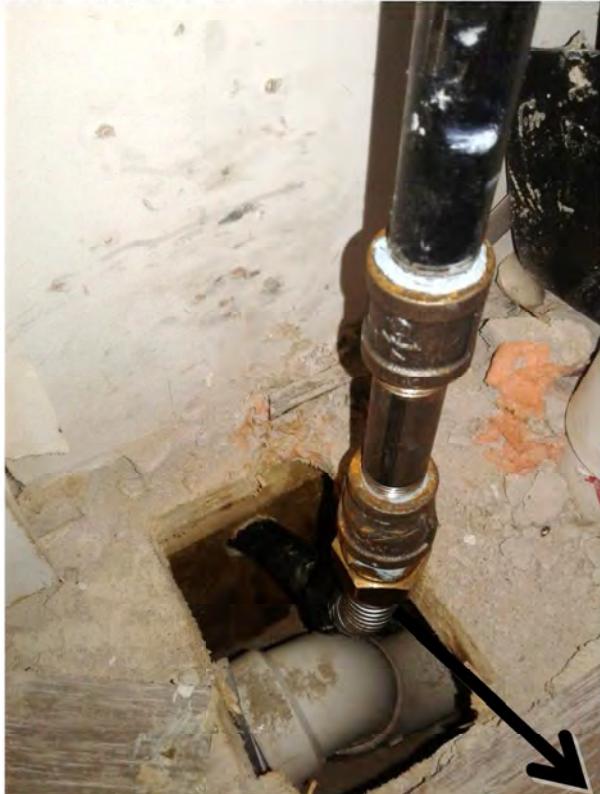
IFGC Section 404.4: Flex pipes are not installed in a chase or casing to guard against electrical wire shock or physical harm. There are no striker plates, mountings or anything to protect pipe surfaces.

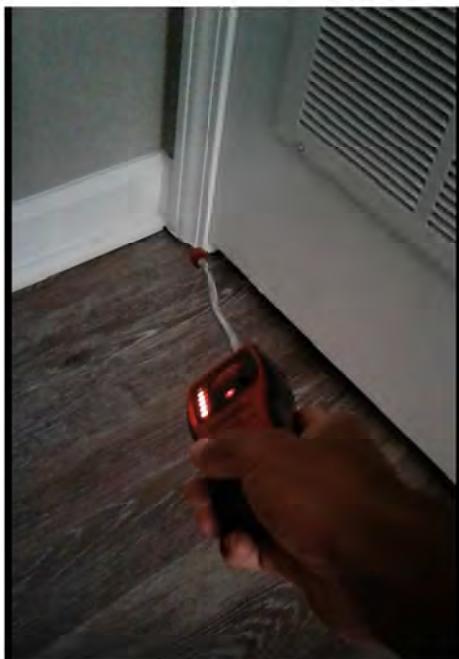
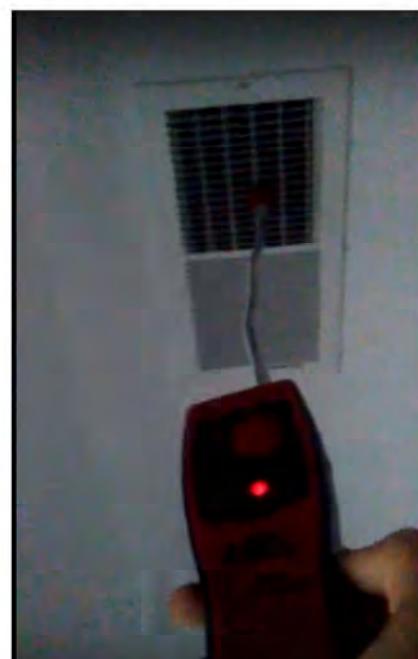
Video proof of the leak detected outside of the furnace closet and from the HVAC vents. Gas was actually coming out of the vents in small trace amounts.

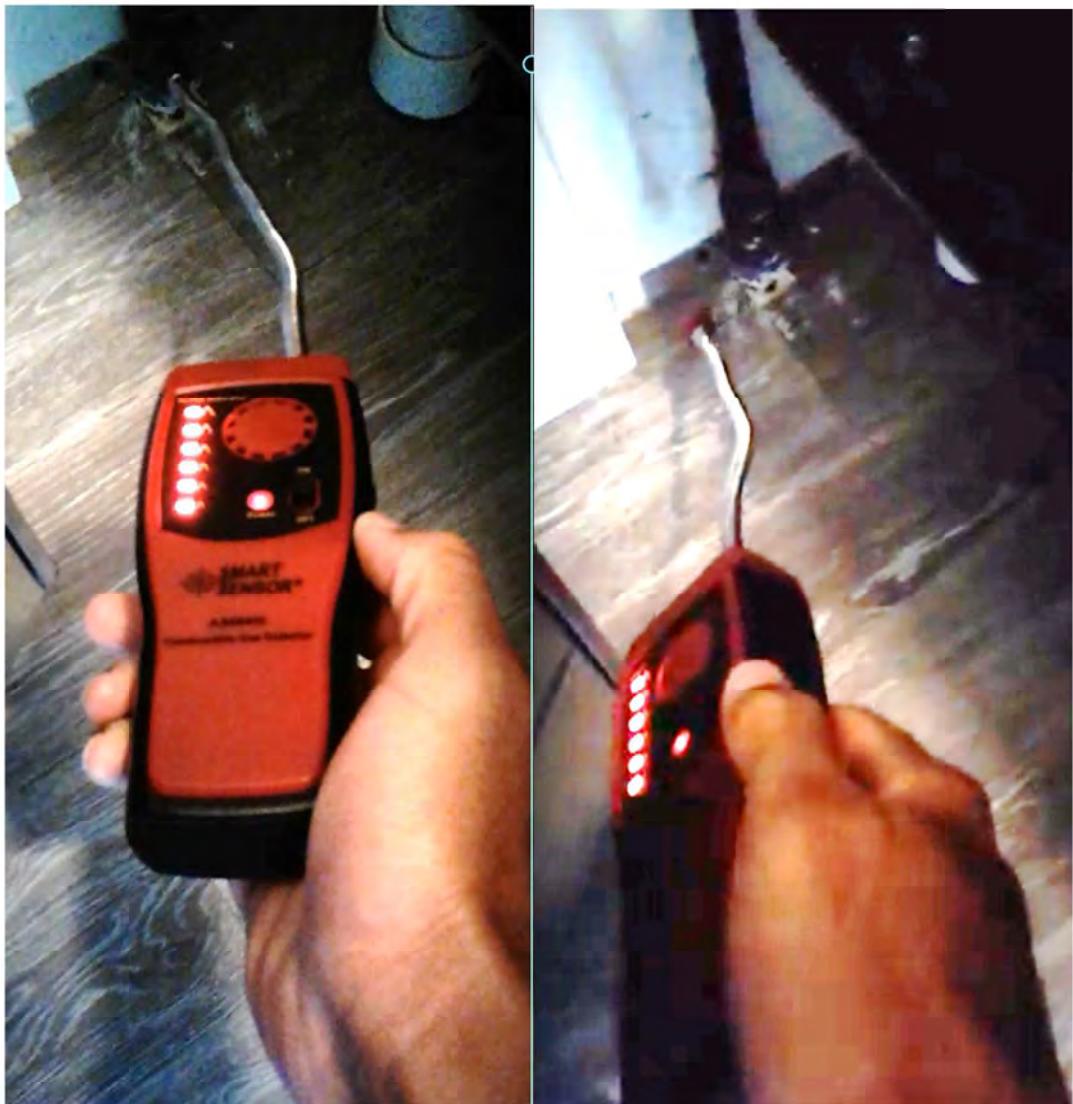
IFGC Section 406.7.1.1: Violation because the CSST flex pipe is outside and is encased behind the walls.

This picture directly to the left is from one of the first videos sent to the Landlord on 10/24/19. Please bear in mind that it took the Landlord about a month to fix this leak once I sent tangible evidence of this leak. It appears to be evident that prior to this video, the Landlord had been working on this leak, as there is caulking (code violation) all around the base of this connection.

It was so much gas that the detector/meter could pick it up outside of the furnace with the furnace door closed. When the maintenance crew would come over and open the door, I would tell them that I smell gas but they would say that it wasn't a leak and that it is normal for a unit to smell the way it did when the door was opened.

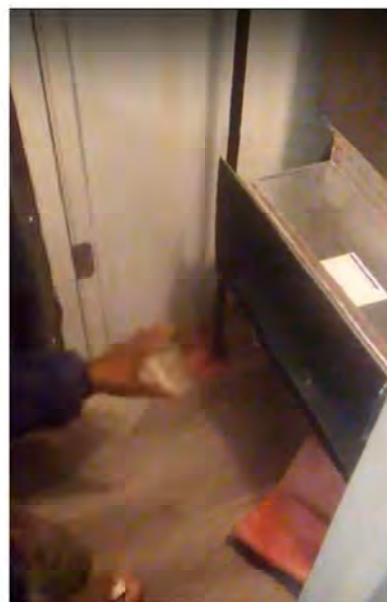
To the right is when the maintenance man installed insulation against the present HVAC technician's recommendations, thus more violations. I actually had to plead the Landlord to rip this out of the floor due to the insulation fibers we suffered breathing.

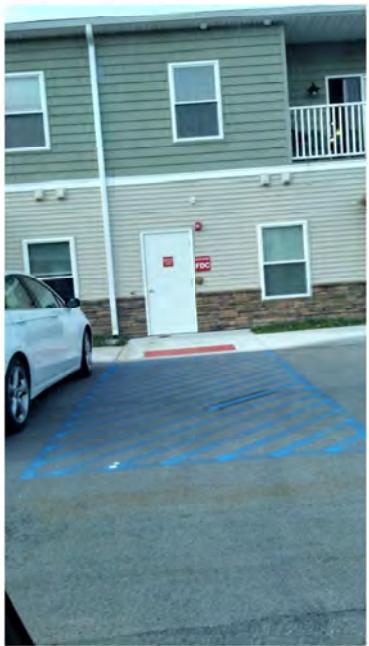
Town code Section 98-19 and 98-21, C: Fire Lanes are to have a, "minimum of 25 feet in width in multiple residence districts". No fire lane signs or designated lane of 25 feet in width are at this building. There are two parking spaces on each side of the FDC with one designated as a handicap space. Looking at the notations of the failed Final Building Inspection, it appears to be more issues of why it also failed.

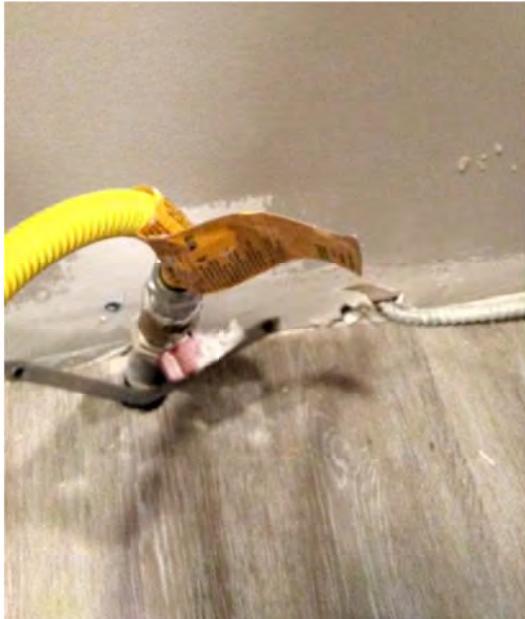
This is behind the gas stove. Notice the small cheap strap which does not hold the CSST firm in all directions and the holes in the wall with patching, which suggest confusion for a new construction. The only thing that appears correct is the use of the valve, which is not correctly placed in the furnace closet.

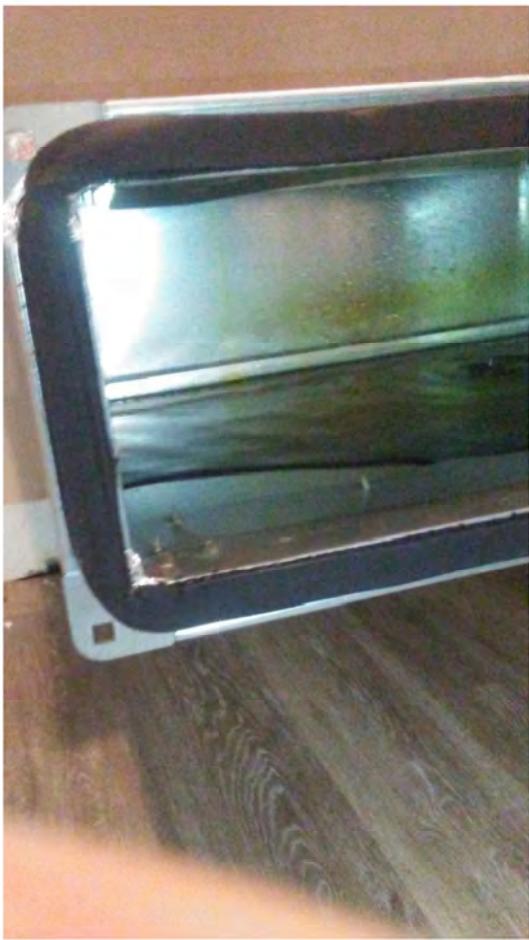
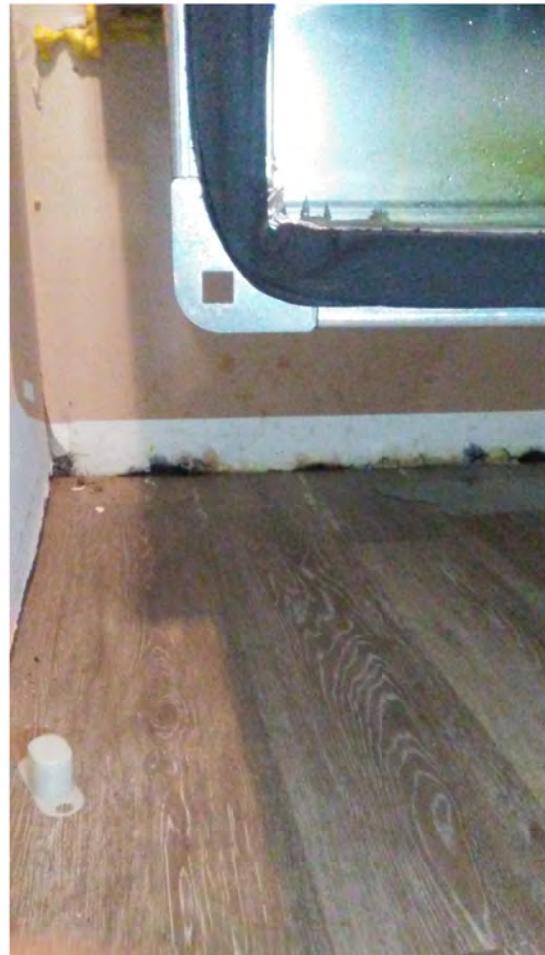
One of our neighbors in Unit# 1001 has a major leak in their HVAC unit. Water is pooling within the unit and on the floor. Water damage has warped the walls and is incased with mold. Water below and gas at the top is very dangerous. See picture below:
